**LABS**

**LABS - GOOD PRACTICES SHARING**

**25th Nov 2024**

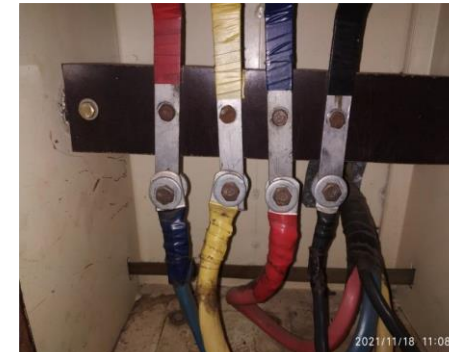
Rusted Nuts and Bolts In Electrical Installation

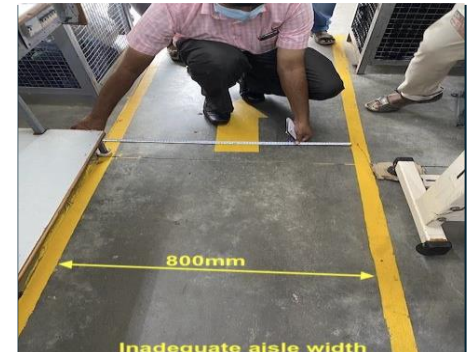
Inadequate Aisle Width

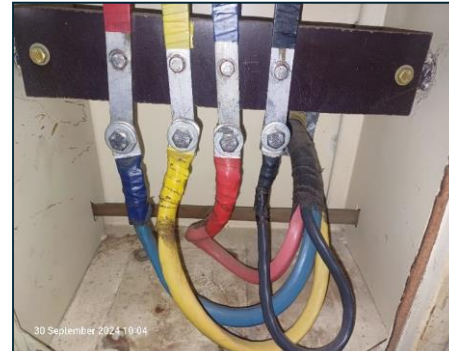
Replaced Rusted Nuts and Bolts in Electrical Installation

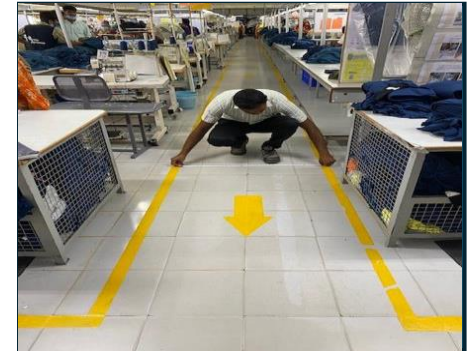
Adequate Aisle width is provided

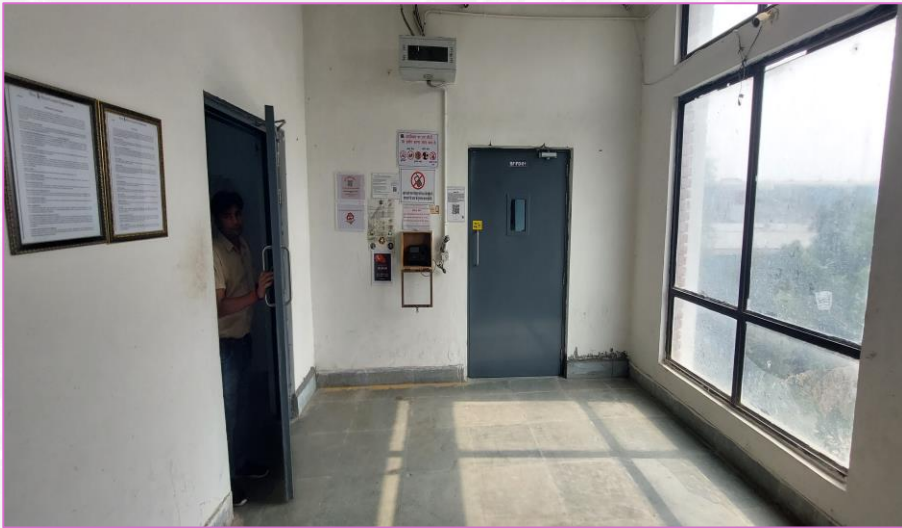
**Observation -** Factory Building has more than two floors and the enclosure for stairs is not found provided.

Staircase compartmentation with Fire doors

**CAP-** Provide an enclosure in staircase that conceals all openings with fire-rated material to ensure the safety.

**Remediation-** The factory has replaced the normal doors with self-closing, fire-rated doors and sealed openings with brick walls

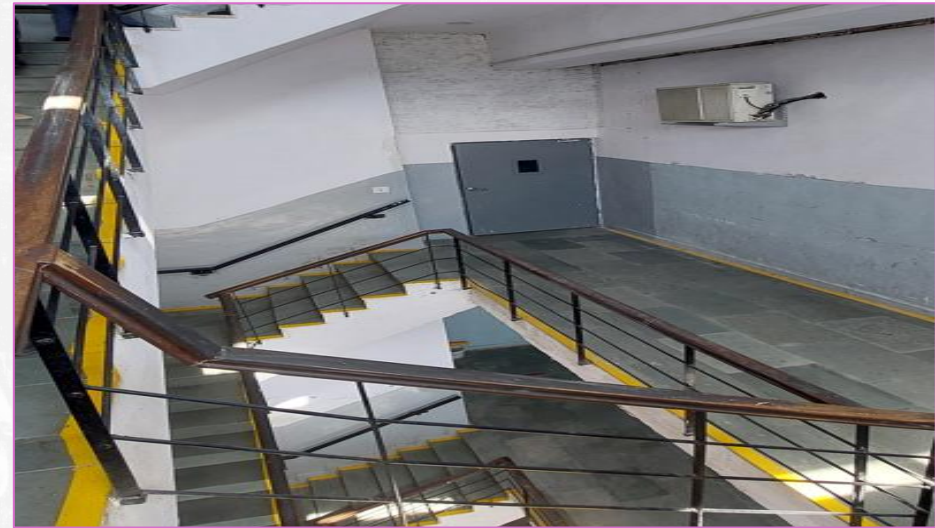
Staircase compartmentation with Fire doors & Brick work

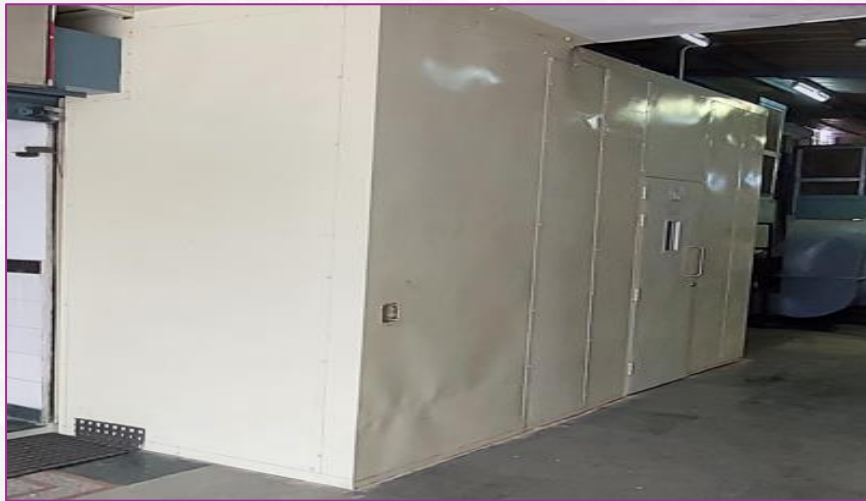
**Observation-** The boiler is installed on the terrace in a tin shed enclosure with no Fire Rated Separation with canteen on the same floor.

Boiler enclosure by Fire rated material and fire door

**CAP-** Provide separate enclosure with fire-rated material of up to 120 min resistance to ensure if any incident occurs in boiler it can be contained.

**Remediation-** The factory has replaced the normal doors with self-closing, fire-rated doors and sealed openings with brick walls/fire rated material

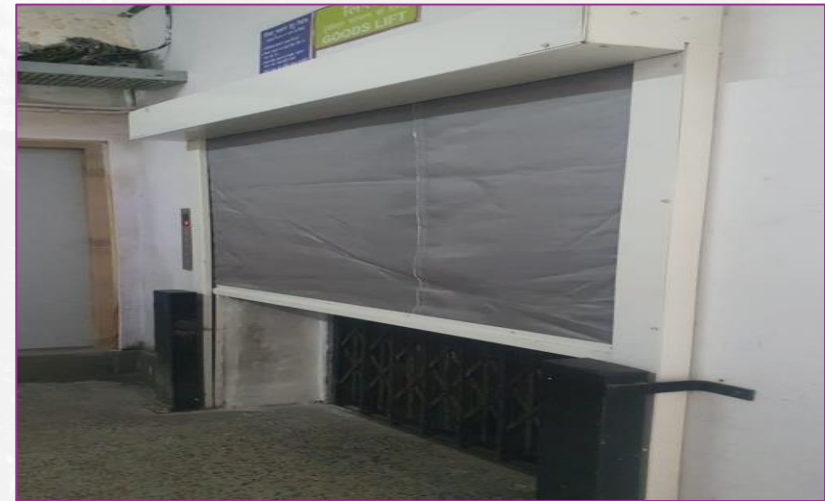
Panel room enclosure by fire door

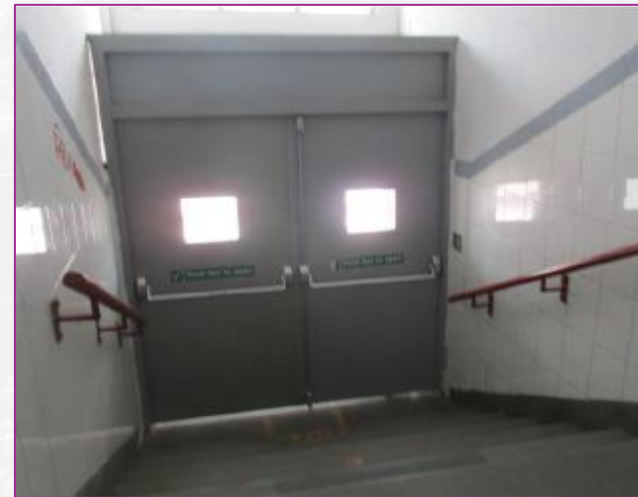
**Observation-** Fire-rated self-closing doors are not provided in any of the exits leading to staircase

Self-closing Fire door

**CAP-** Emergency exit to be provided with self-closing fire-rated door as per IS 3614

**Remediation-** The factory has replaced the normal doors with self-closing, fire-rated doors.

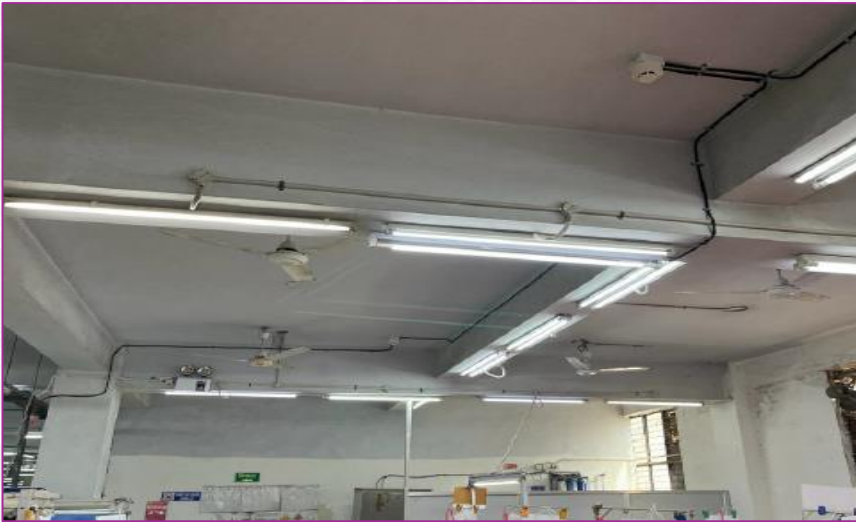
**Observation -** Factory basement section, North-East does not have any coverage of smoke detector .

Smoke detector installed

**CAP-** Smoke detection coverage would be provided in every location.

**Remediation-** The factory has installed a smoke detector synchronized with fire alarm panel.

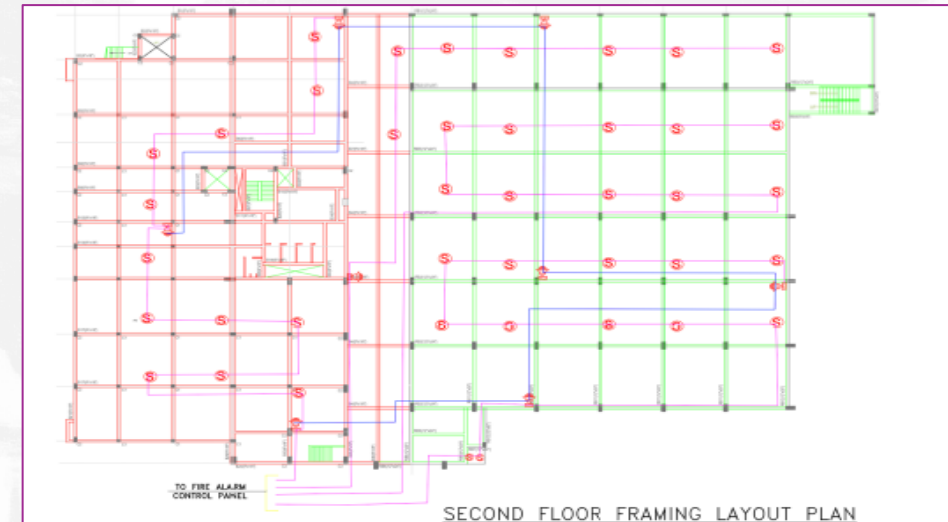
Smoke detector layout Plan

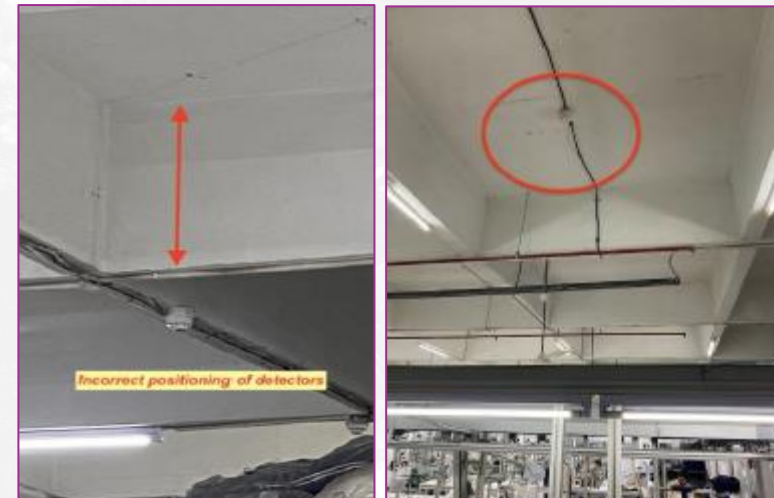
**Observation —** Smoke detector positioning was inadequate and found installed below ceiling level.

Smoke detector positioning before and after

**Remediation-** The factory has installed beam type smoke detector over ceiling more than 20 feet and replaced smoke detector to the highest point of the ceiling in 14 ft ceiling.

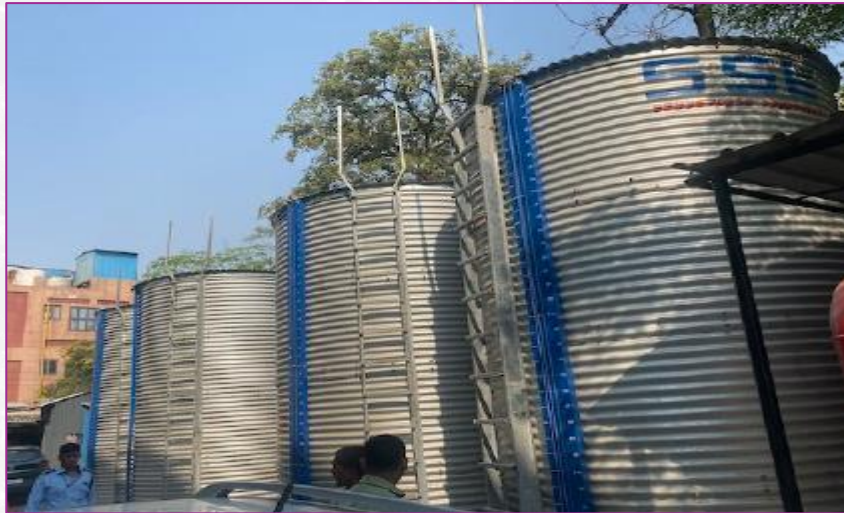
Additional water tanks installed by factory

**Remediation-** The factory has installed additional water tanks, either overhead or underground, to address the issue of water shortage.

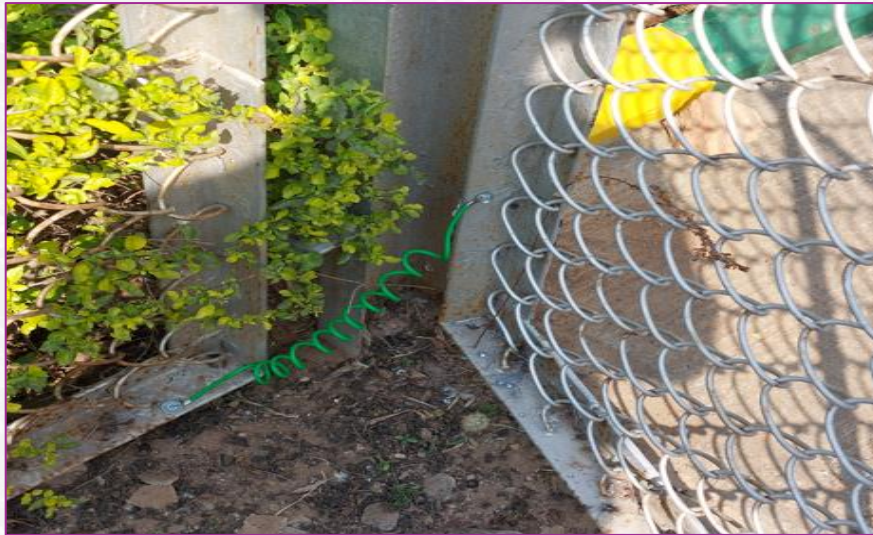
**Observation —** Bonding not provided over transformer gate/diesel tank .

Bonding provided over transformer gate

**Remediation-** The factory has provided bonding to dissipate the static charge and to keep all conductors at the same potential.

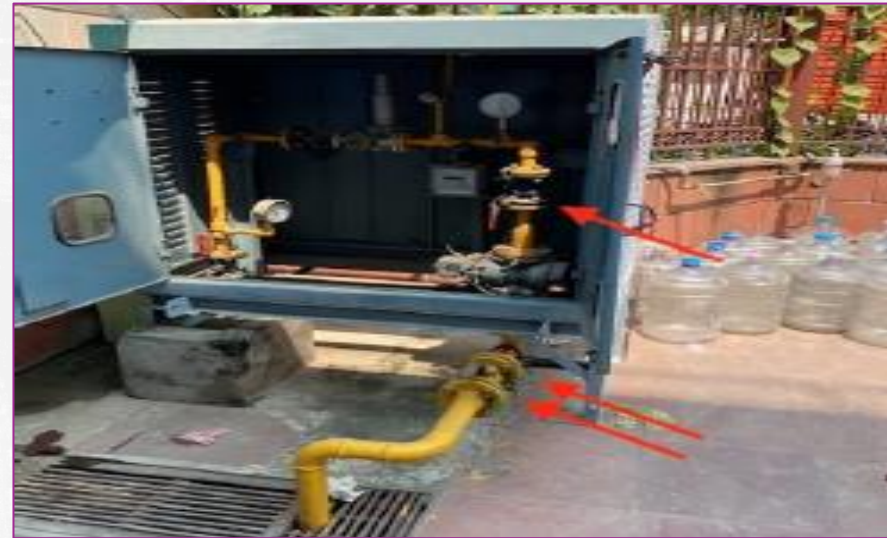
Bonding provided over LPG gas pipeline

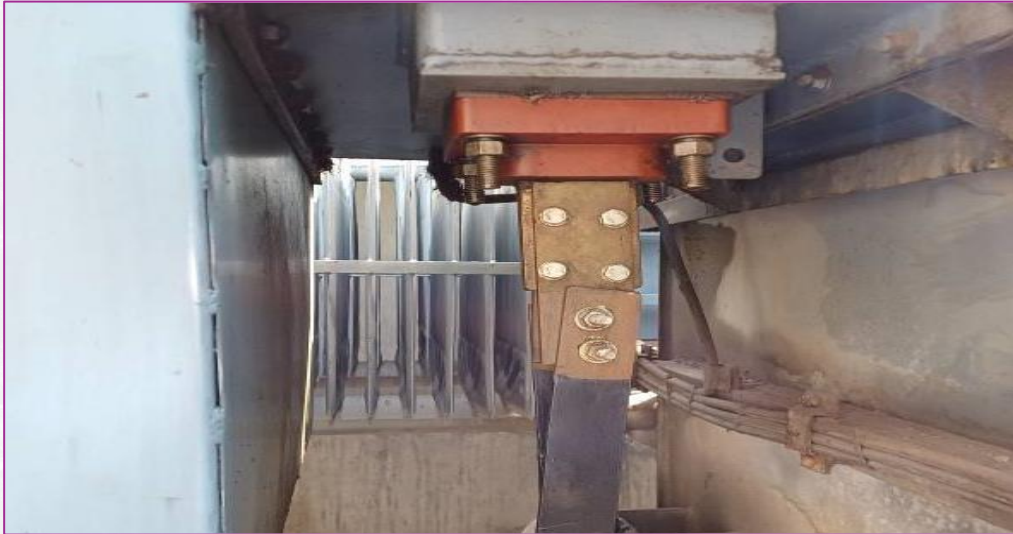
double Earthing provided to transformer

**CAP-** Factory will identify missing earthing in panels and provide earthing as per electrical standards.

**Remediation-** The factory has installed copper strips for earthing in specific locations as a remedial measure.

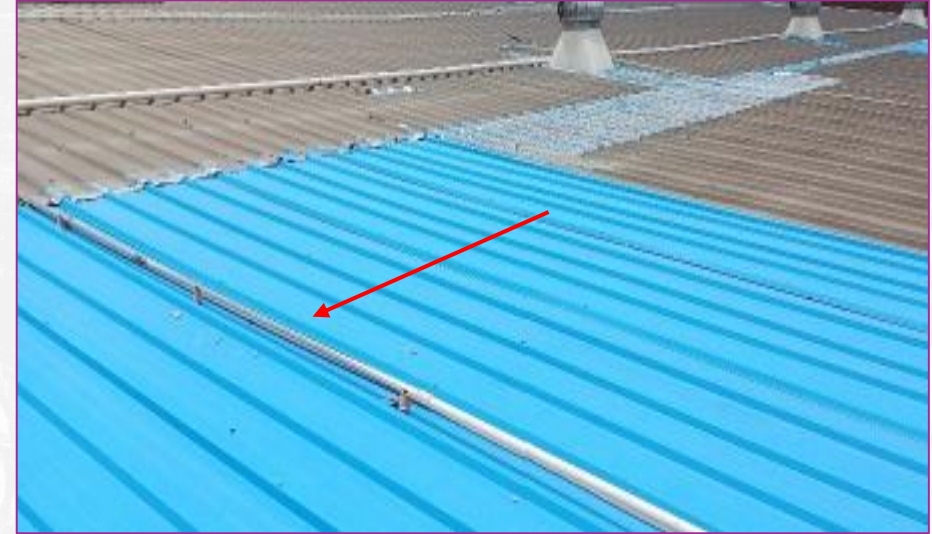
Eearthing provided to MS truss

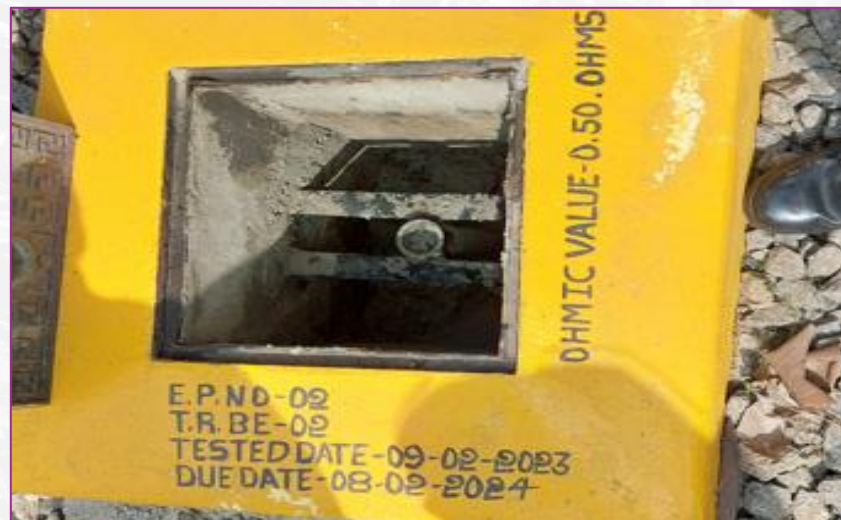
**Observation** — Earth pit were found poorly maintained/Earthing were found disconnected with earth strips

Earth pit maintained and monitored

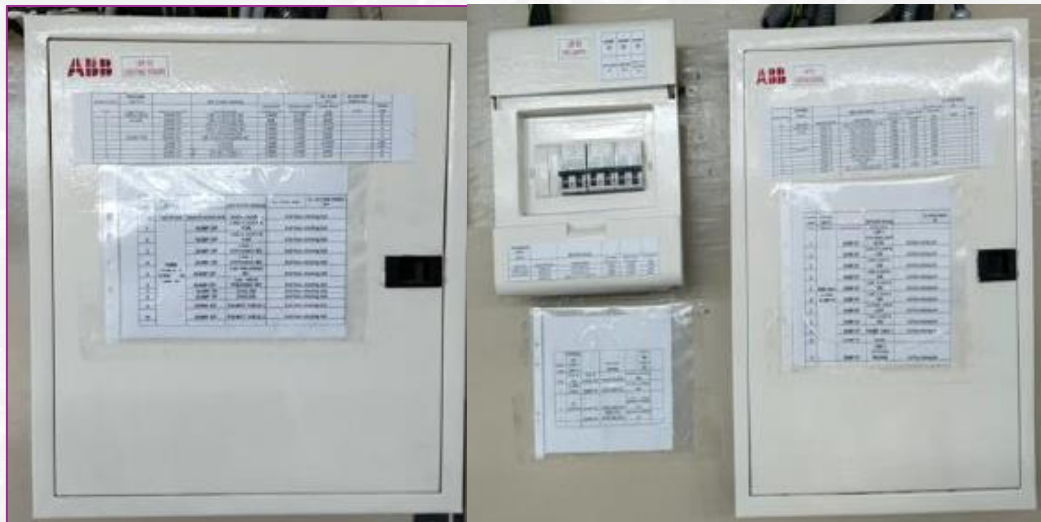
**Observation** — Proper identification markings were not provided on distribution boards, and current carrying capacity not calculated.

Current carrying capacity calculated and posted over DB

**Remediation-** The factory has provided proper identification over panel.

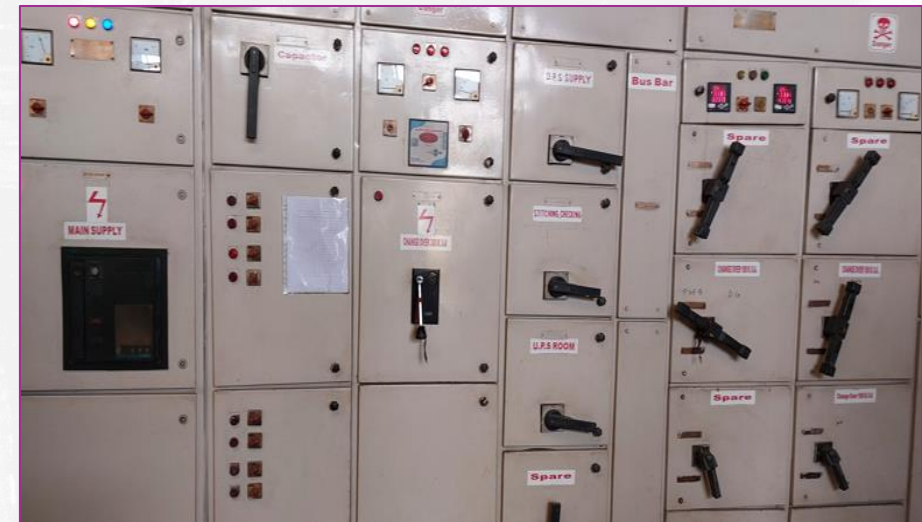
Proper identification provided over panel

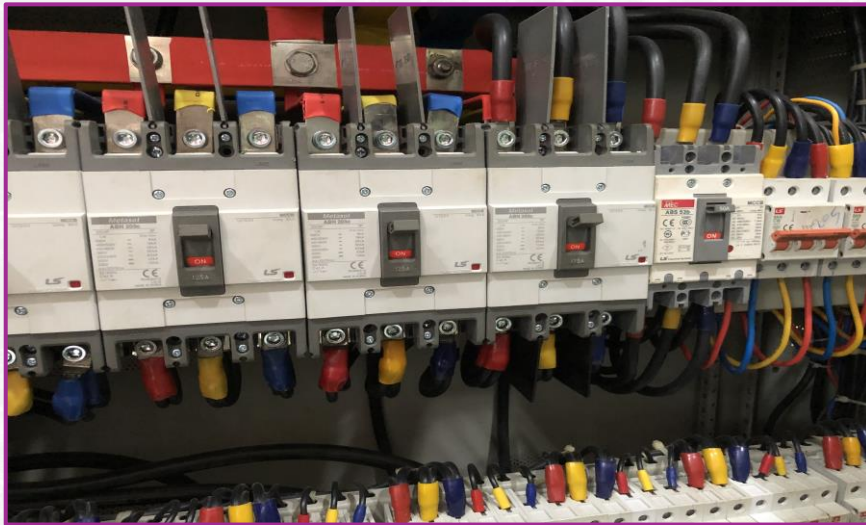
**Observation** — Lint & dust were observed inside the electrical panel.

Electrical panel has been cleaned

**Remediation-** The factory has cleaned electrical panel and implemented a weekly checklist to prevent lint accumulation in panel.

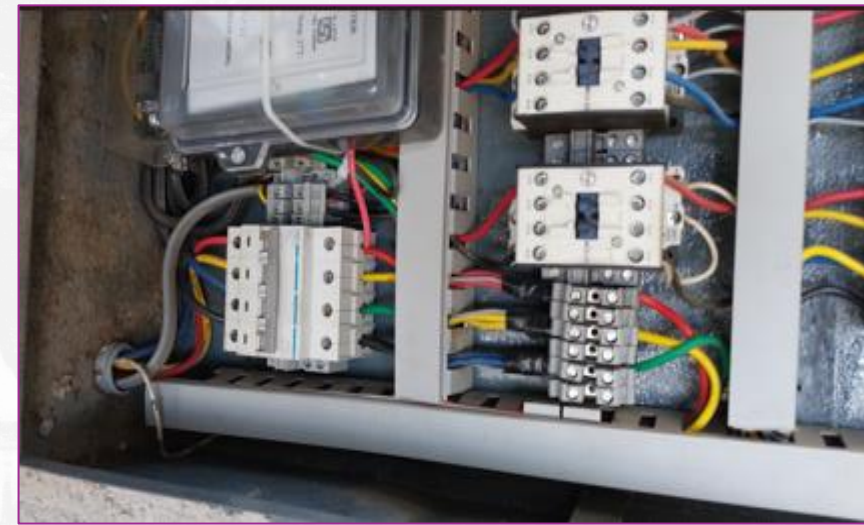
Electrical panel has been cleaned

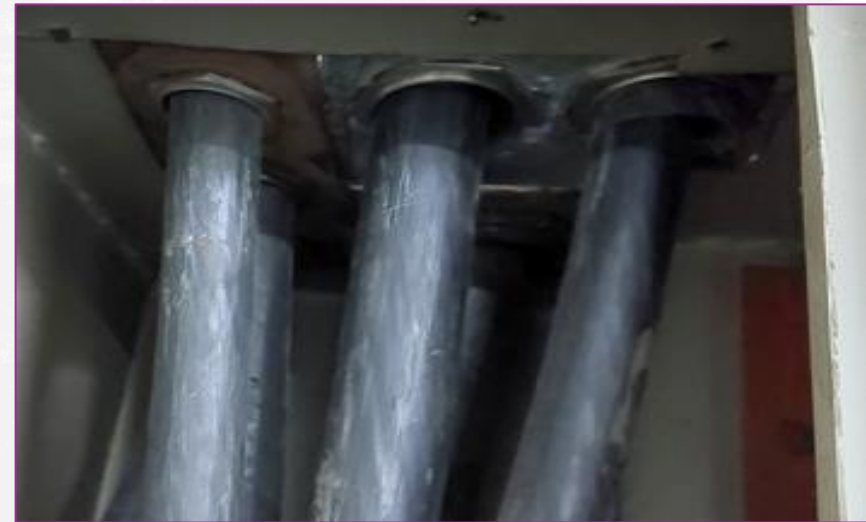
Glands provided over electrical panel

**Remediation-** The factory has provided lugs and glands in electrical panel.use of lugs and glands incorporated in SOP

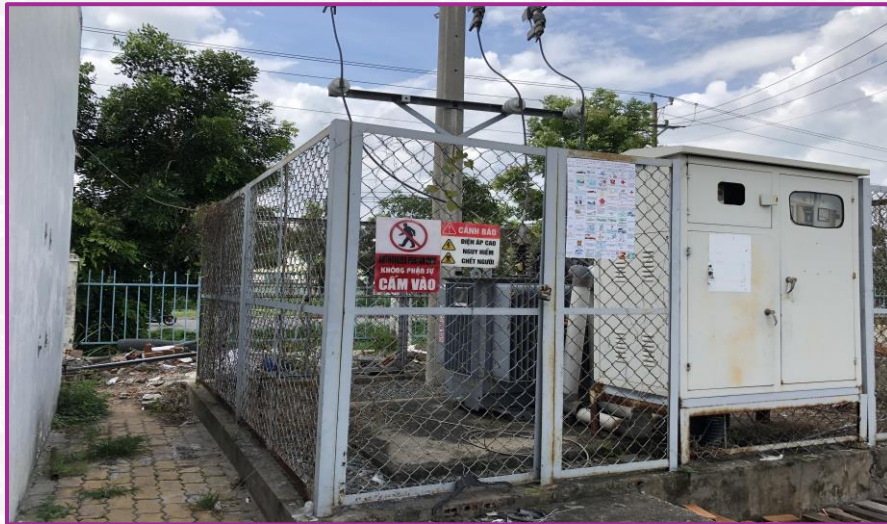
**Observation** — No proper danger or warning signage near HT meter room and transformer area.

Sign age provided over substation

**Remediation-** The factory has provided warning signage over hazardous electrical installation.

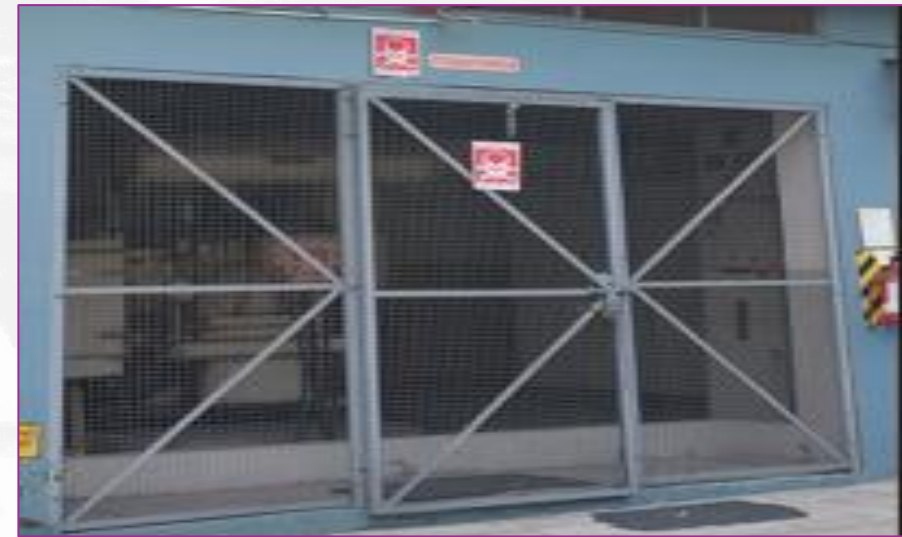
Warning signage provided

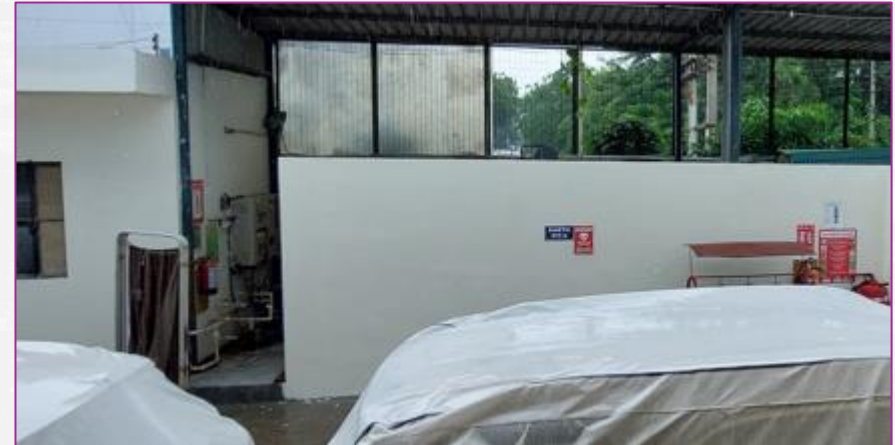
**Observation —** Hazardous installation installed adjacent to production with glass window towards production.

Wall separation provided between transformer & evacuation route

**Remediation-** The factory has provided separation between hazardous installation and production.

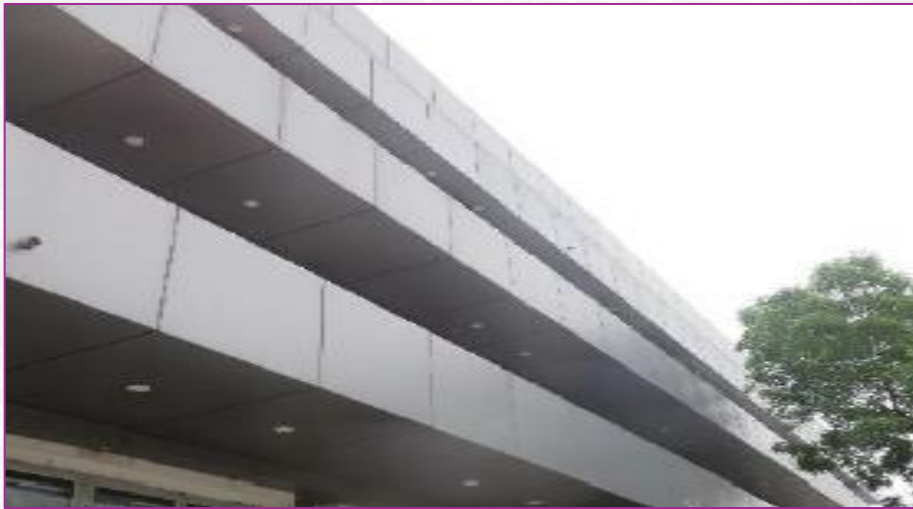
**Observation** — The structure element was found corroded.

Corroded structure repaired and covered

**CAP-** Will review the corroded structure and repair it.

**Remediation-** The factory has repaired corroded structure members .

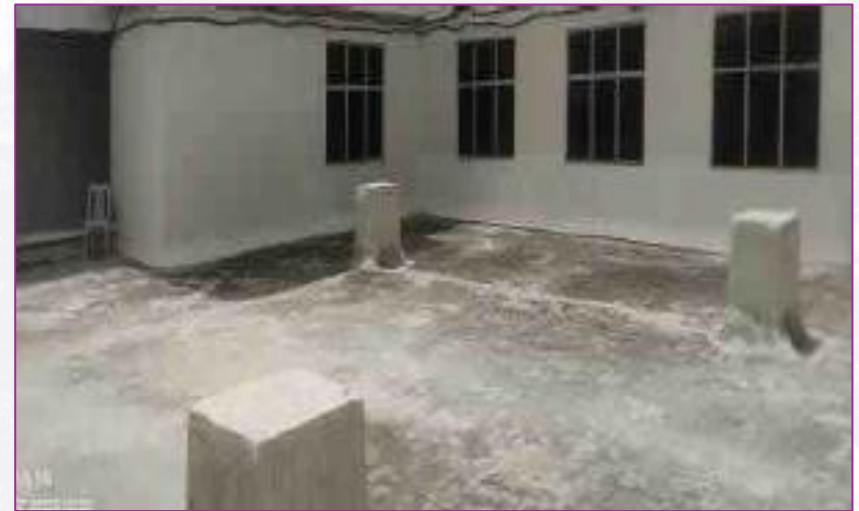
Corroded bars were repaired from column

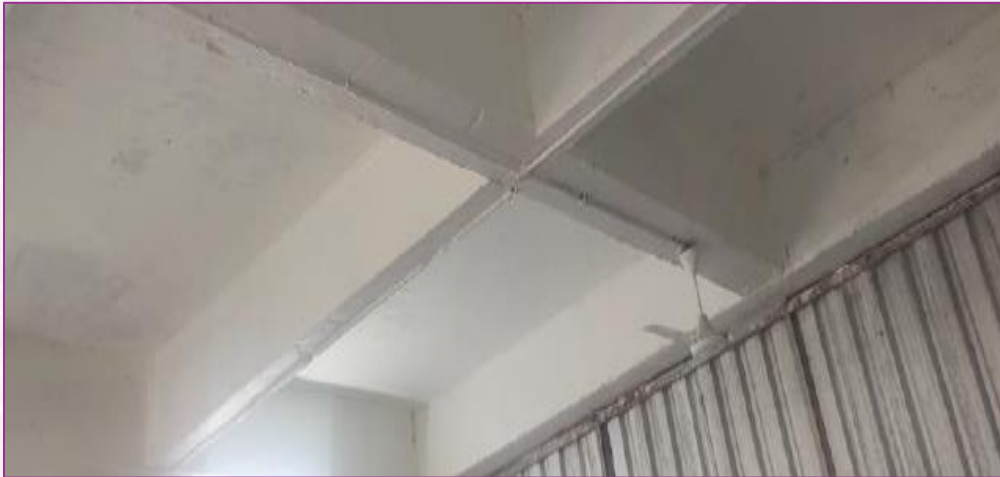
**Observation** — wall cladding/backside wall observed for dampness

Dampness has been addressed

**CAP-** Factory will review structure with NDT test for impact of dampness over structure and repair dampness.

**Remediation-** The factory has repaired dampness and removed leakages causing dampness.

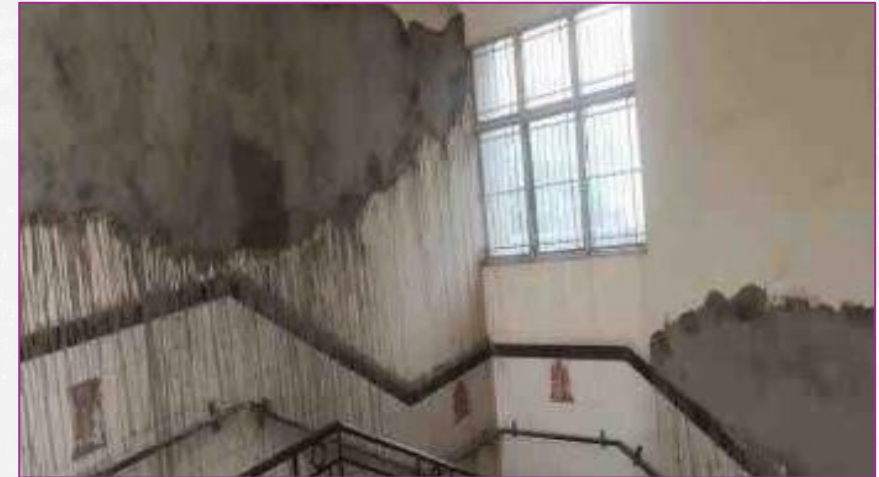
Dampness Repairs work has been done

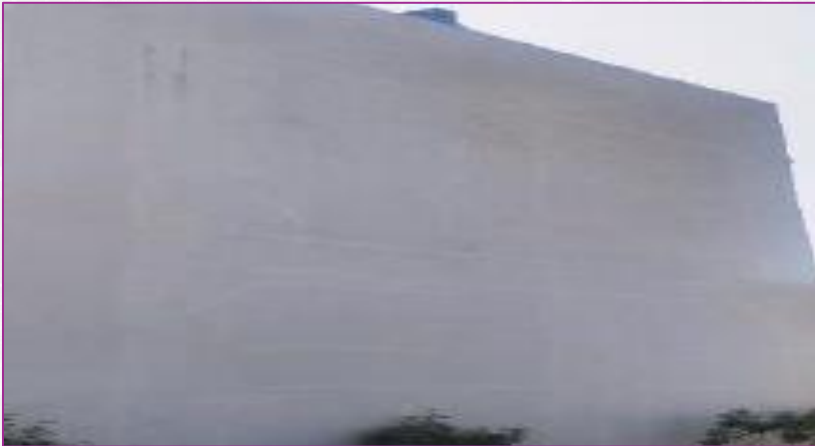
**Observation** — Cracks were observed on external wall/internal wall.

Non structural cracks were repaired

The factory situated at Khasra no. 15/19&22, Village Begumpur, Khatola, Gurugram, Harayana was visited by our engineer on 04-03-2024. The said brick wall is a non-structural filler wall. The cracks visible are due to the poor construction methodology and workmanship, along with the wear and tear. The said cracks are repaired by introducing reinforcement to stitch the cracks and finish the area with Murga jaali, mortar and plaster.

**CAP-** Will review cracks and get them repaired as per structural review.

**Remediation-** The factory has repaired cracks and initiated a structure audit to prevent reoccurrence of cracks

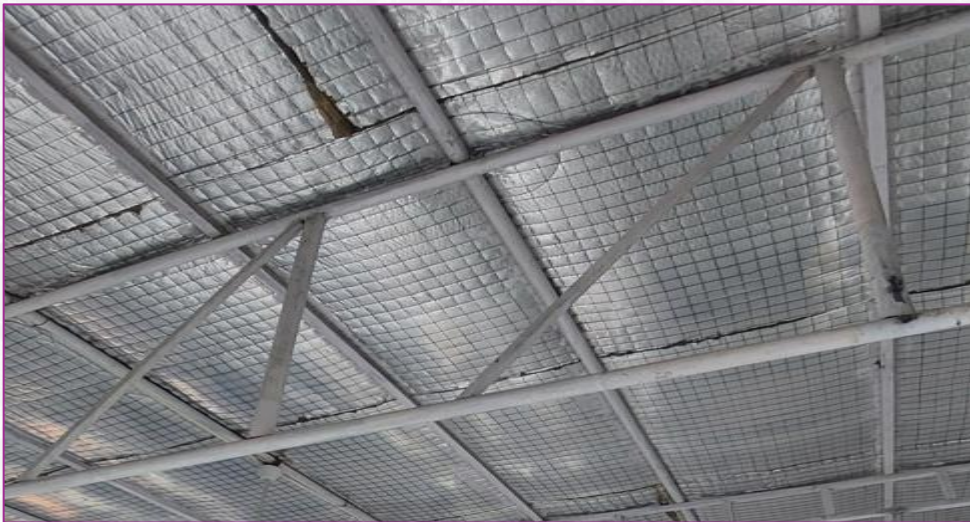
Bracing to MS structure

**Remediation-** The factory has appointed structural consultant and provided bracing along with survey report

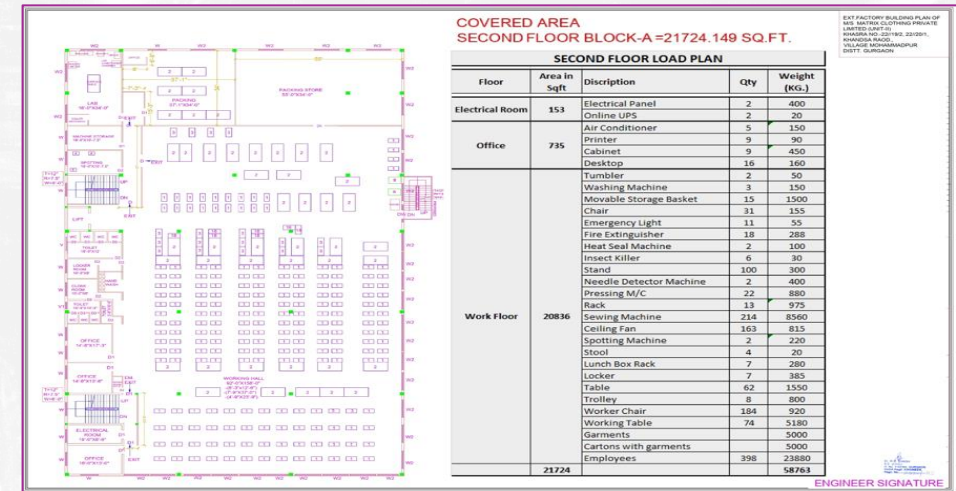
Load plan

**Remediation-** The factory has appointed structural for load plans and load is reviewed in every six months as per load plans
