# LABS

Life And Building Safety

**LABS - GOOD PRACTICES SHARING**

**3<sup>rd</sup> May 2024**

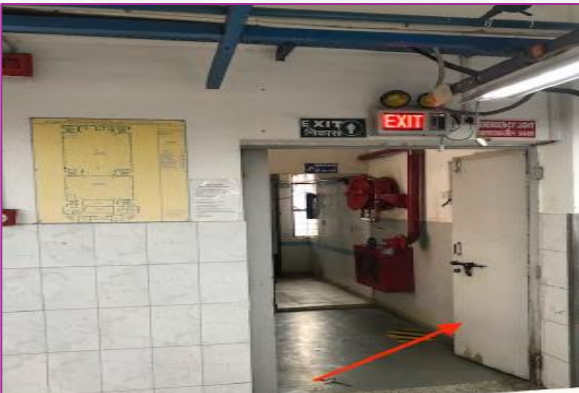
- Absence of fire-rated doors in the main exit at the production building.
- Fire-rated self-closing doors are not provided at protected staircases.
- Factory Building has more than two floors and the FR self-closing doors are not found provided on the stairs.

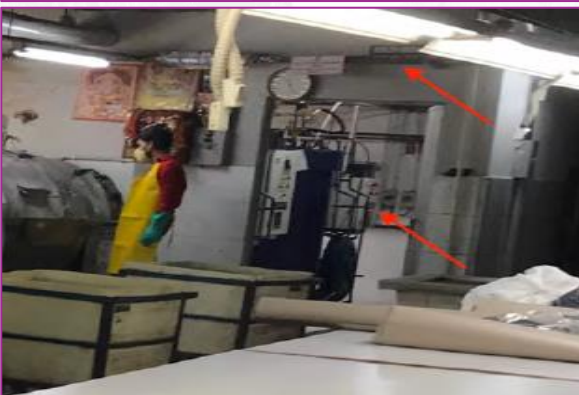
- Boilers installed on 2nd floor with washing without enclosure.
- Designated storage areas not separated by FR construction.
- Transformer room at Building 2 without FR-rated construction.

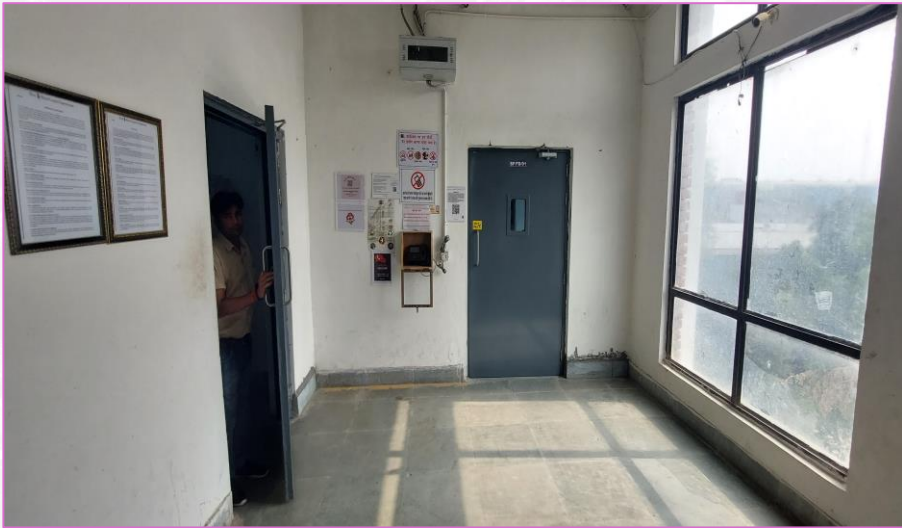
**Observation** - Factory Building has more than two floors and the enclosure for stairs is not found provided.

Staircase compartmentation with Fire doors

**CAP-** Provide an enclosure in staircase that conceals all openings with fire-rated material to ensure the safety.

**Remediation-** The factory has replaced the normal doors with self-closing, fire-rated doors and sealed openings with brick walls

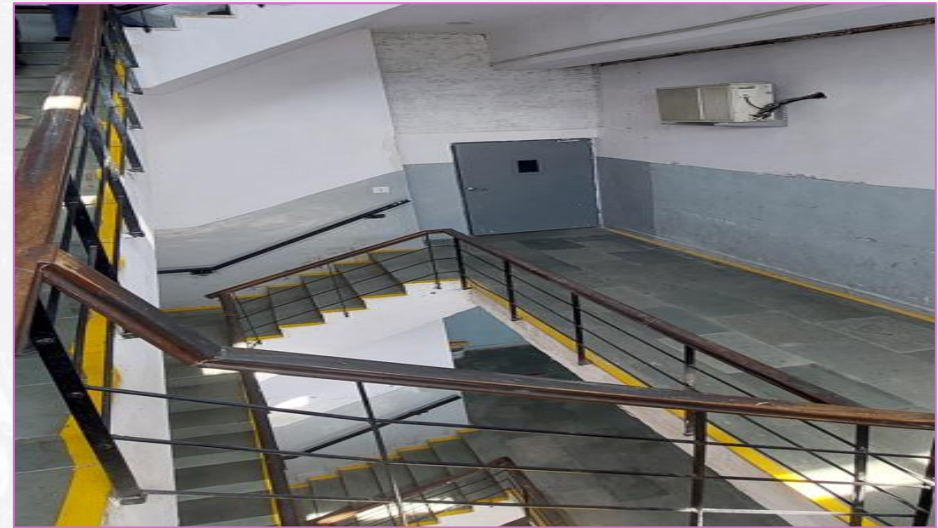
Staircase compartmentation with Fire doors & Brick work

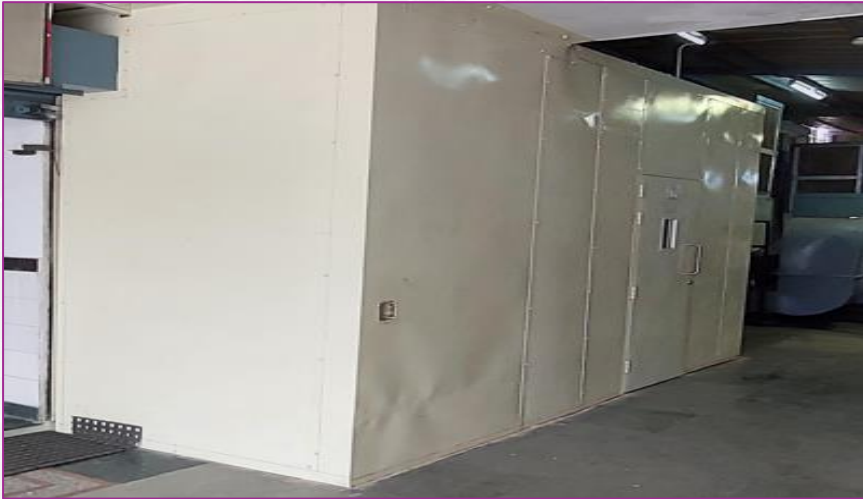
**Observation-** The boiler is installed on the terrace in a tin shed enclosure with no Fire Rated Separation with canteen on the same floor.

Boiler enclosure by Fire rated material and fire door

**CAP-** Provide separate enclosure with fire-rated material of up to 120 min resistance to ensure if any incident occurs in boiler it can be contained.

**Remediation-** The factory has replaced the normal doors with self-closing, fire-rated doors and sealed openings with brick walls/fire rated material

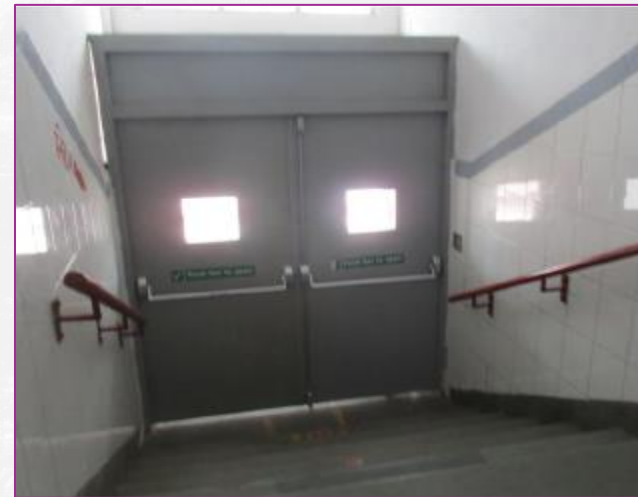
**Observation-** Fire-rated self-closing doors are not provided in any of the exits leading to staircase

Self-closing Fire door

**CAP-** Emergency exit to be provided with self-closing fire-rated door as per IS 3614

**Remediation-** The factory has replaced the normal doors with self-closing, fire-rated doors.

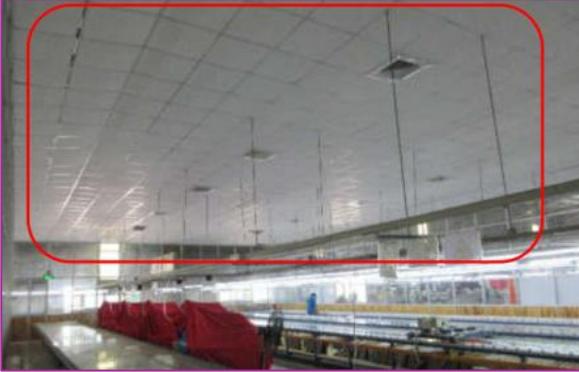
- Inadequate Fire Detector coverage.
- The provided smoke detection system is insufficient to cover the entire area of the factory.

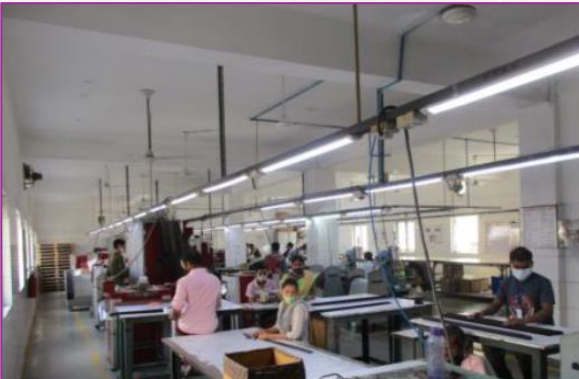
- Audible alarms with less volume observed in the basement and ground floor.
- Fire Alarm System were not installed in few locations.

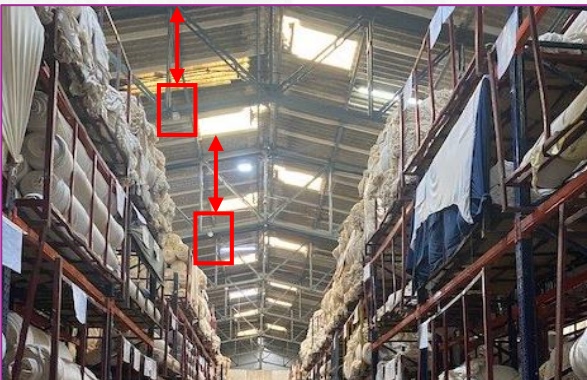
- Detectors are installed at low level from the true ceiling.
- Incorrect fire detector positioning was found at some places.

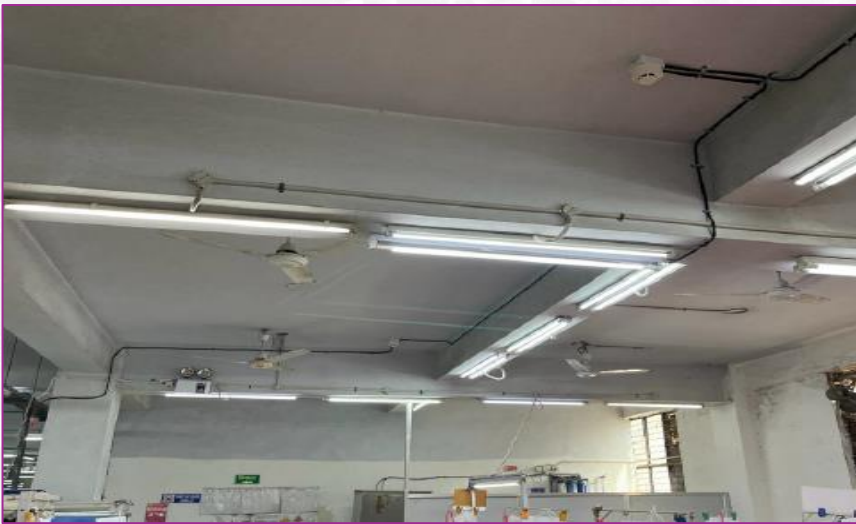
**Observation -** Factory basement section, Nort-East does not have any coverage of smoke detector .

Smoke detector installed

**CAP-** Smoke detection coverage would be provided in every location.

**Remediation-** The factory has installed a smoke detector synchronized with fire alarm panel.

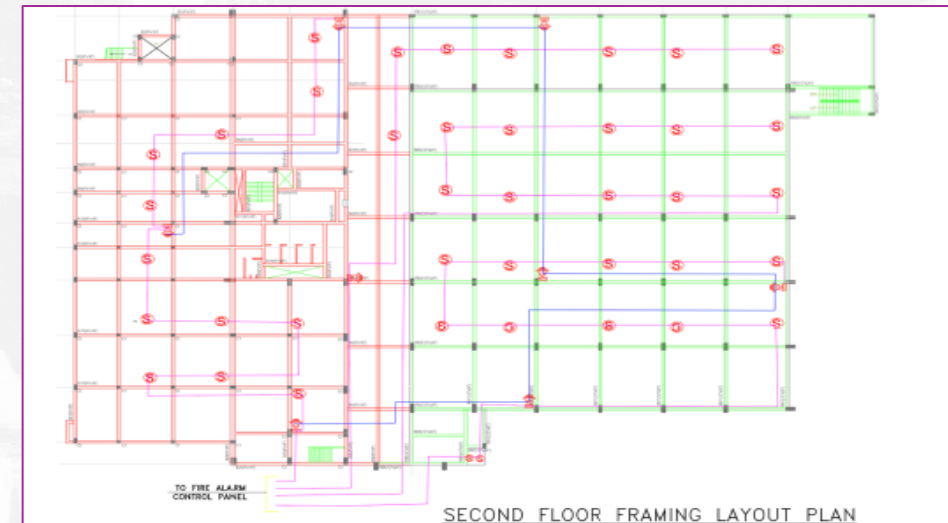
Smoke detector layout Plan

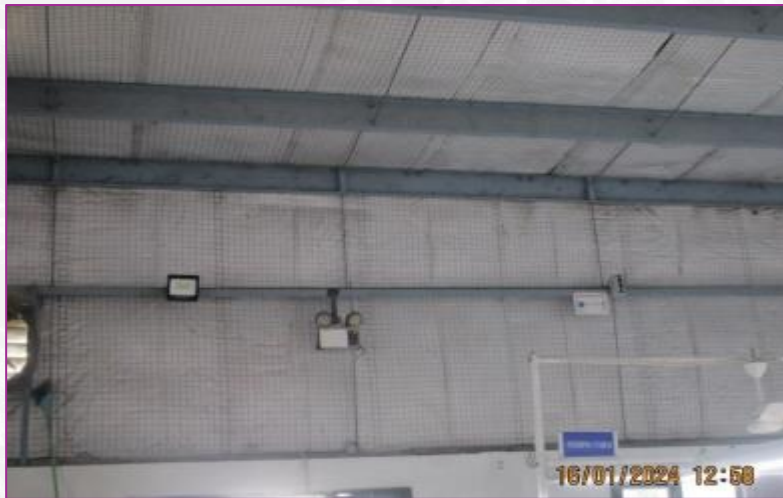
**Observation —** Smoke detector positioning was inadequate and found installed below ceiling level.

Beam type smoke detector installed for high roof

**CAP-** Smoke detector would be installed over the highest and flat part of ceiling .

**Remediation-** The factory has installed beam type smoke detector over ceiling more than 20 feet and replaced smoke detector to the highest point of the ceiling in 14 ft ceiling.

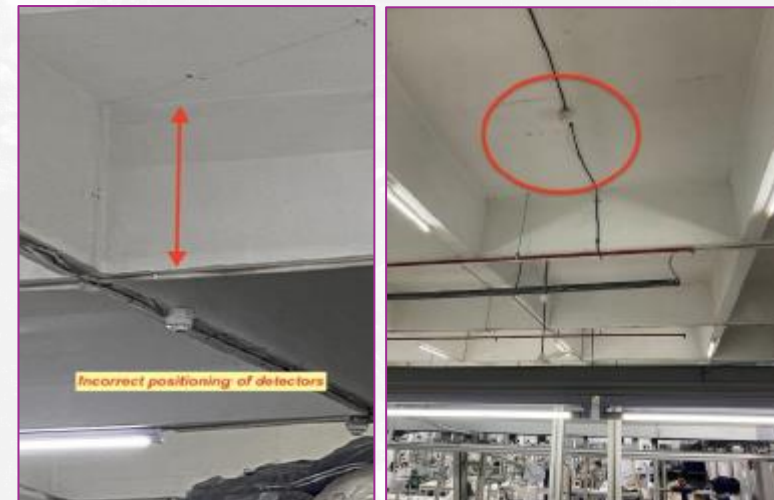
Smoke detector positioning before and after

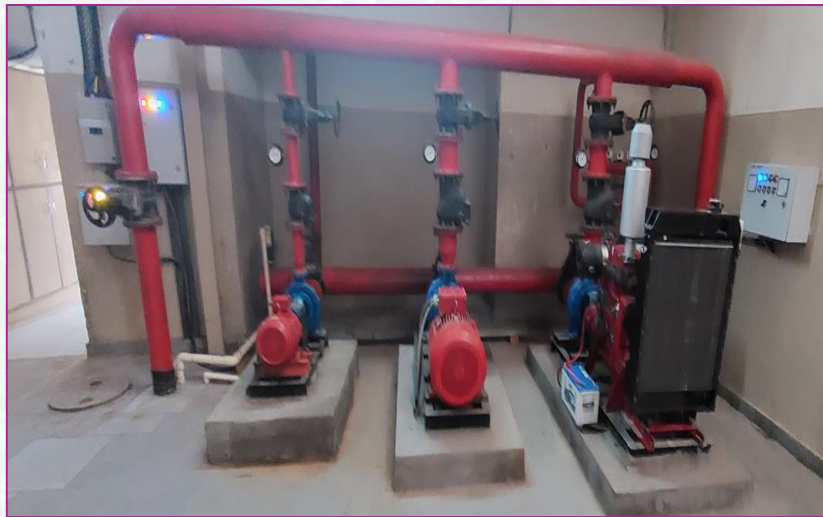
**Observation** — Only single fire pump installed for fire-fighting purpose. .

All 3 Fire pumps are installed

**CAP-** Ensure adequate fire pumps with electric and non-electric backup for firefighting.

**Remediation-** The factory has installed 3 fire pump jockey pump, main pump and diesel powered pump in the premises.

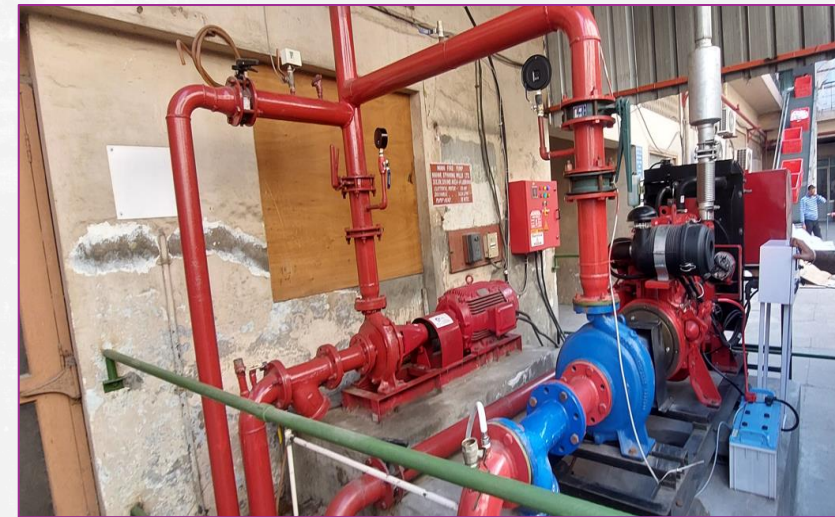
Backup Fire pumps are installed

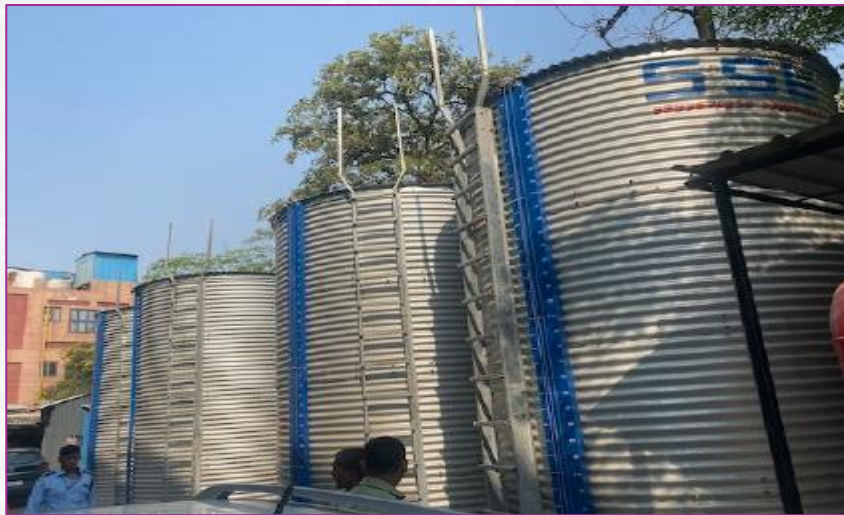
**Observation** — Insufficient water storage on premises for firefighting systems.

Additional water tanks installed by factory

**CAP-** Will ensure that the factory has a water capacity of 1.5 lakh litres specifically for fire-fighting purposes.

**Remediation-** The factory has installed additional water tanks, either overhead or underground, to address the issue of water shortage.

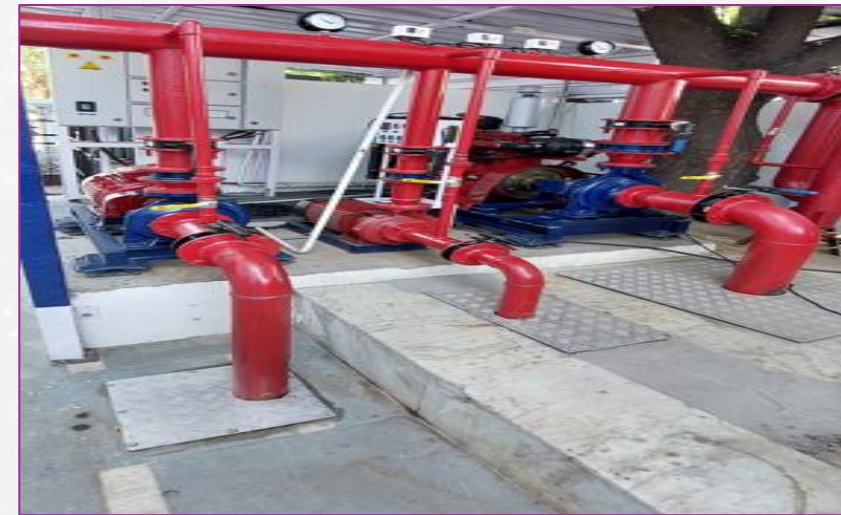
Underground water tank constructed

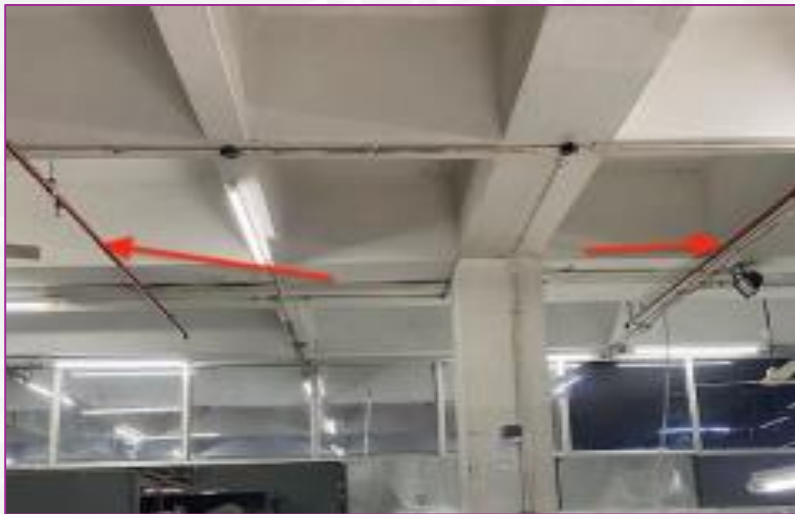
**Observation** — A Non-Sprinklered storage area exists with excessive storage and is not effectively separated by FR separation with production areas.

Additional water tanks installed by factory

**CAP-** Provide sprinkler system in storages areas .

**Remediation-** The factory has installed sprinklers in storage areas.

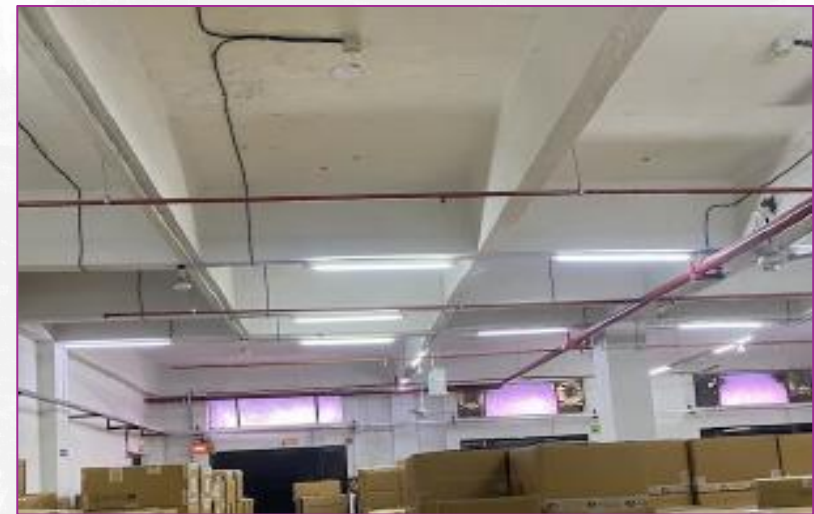
Sprinklers installed in material store

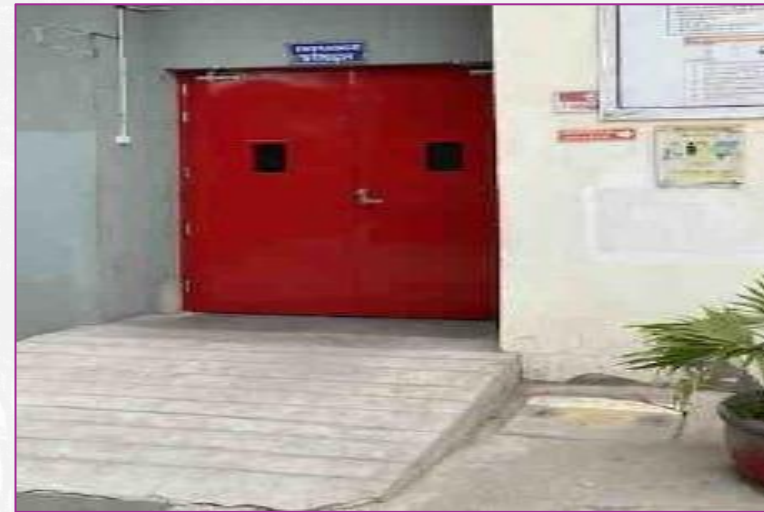
**Observation** — The factory exit door is equipped with a locking mechanism and a rolling shutter.

Fire door has been installed

**CAP-** All rolling shutters will be removed with outward opening doors for safe evacuation.

**Remediation-** The factory has installed Fire rated door at the final door with push bar in place of shutter or have removed shutter.

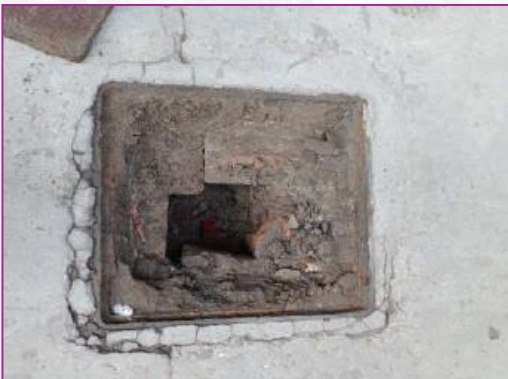
- Earth pits were found not maintained properly.
- Detail & layout plan of earth pit not available with the factory.

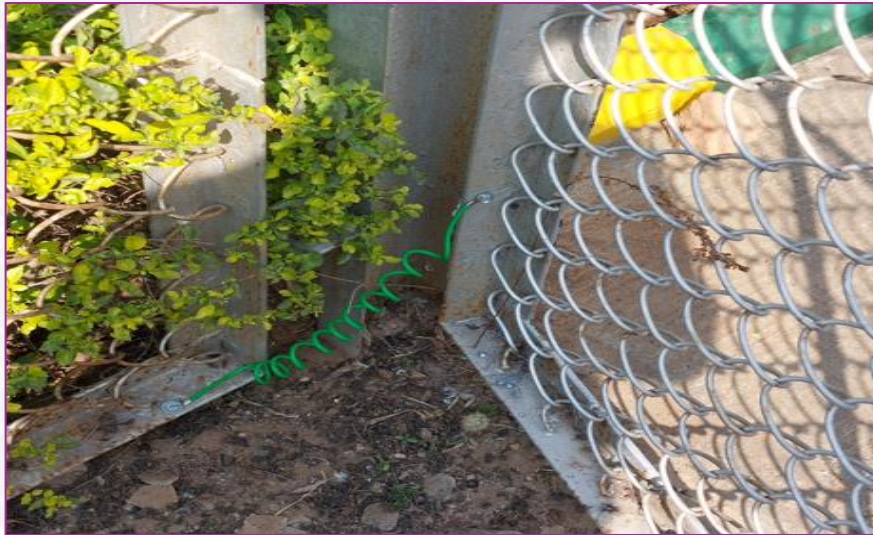
**Observation** — Bonding not provided over transformer gate/diesel tank .

Bonding provided over transformer gate

**CAP-** Bonding will be provided over to dissipate charge safety from advised system.

**Remediation-** The factory has provided bonding to dissipate the static charge and to keep all conductors at the same potential.

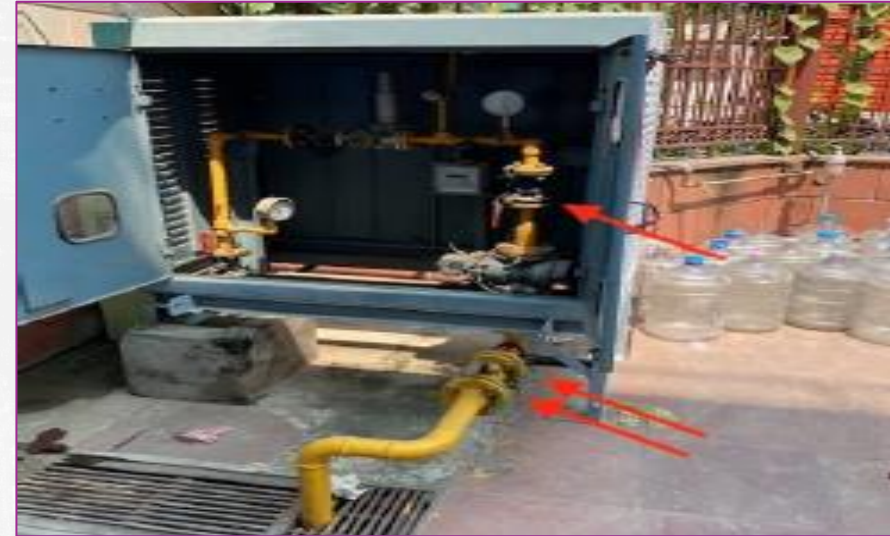
Bonding provided over LPG gas pipeline

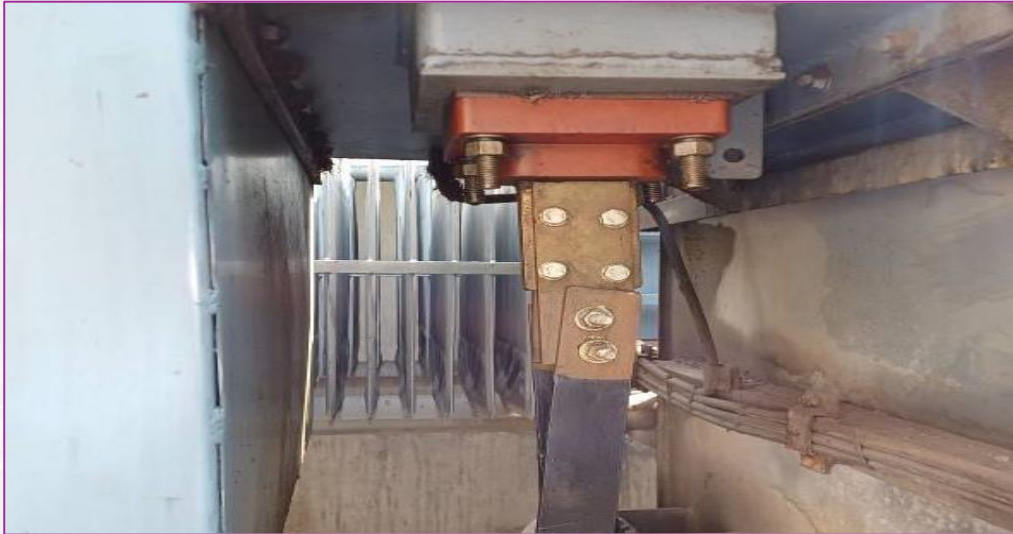
**Observation —** Body earthing not evident in distribution boards/Ms roof truss

double Earthing provided to transformer

**CAP-** Factory will identify missing earthing in panels and provide earthing as per electrical standards.

**Remediation-** The factory has installed copper strips for earthing in specific locations as a remedial measure.

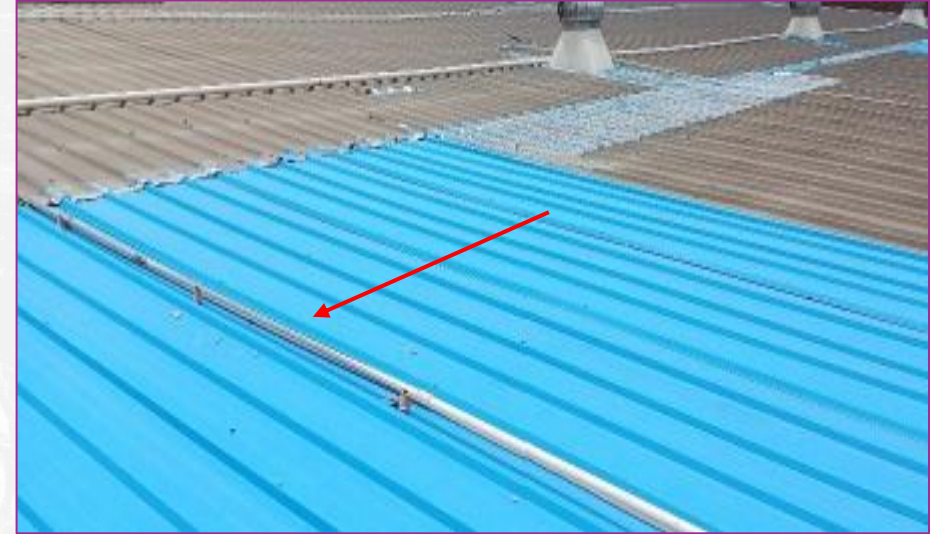
Eearthing provided to MS truss

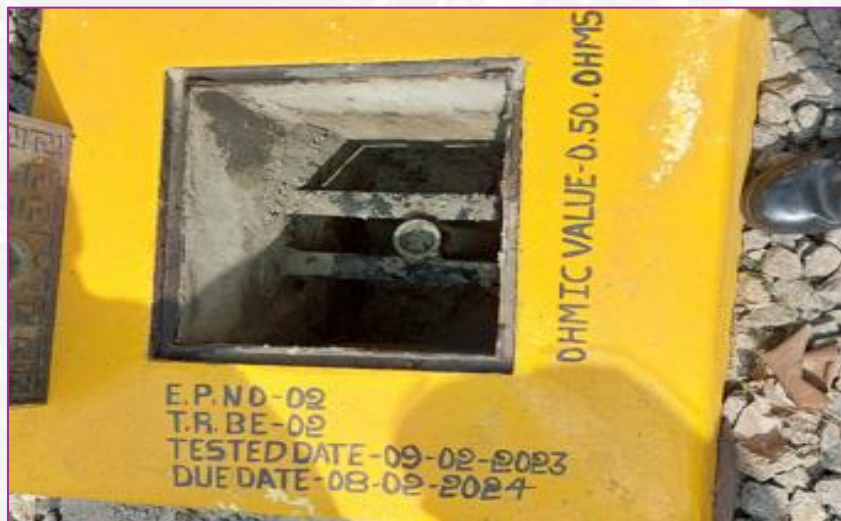
**Observation** — Earth pit were found poorly maintained/Earthing were found disconnected with earth strips

Earth pit maintained and monitored

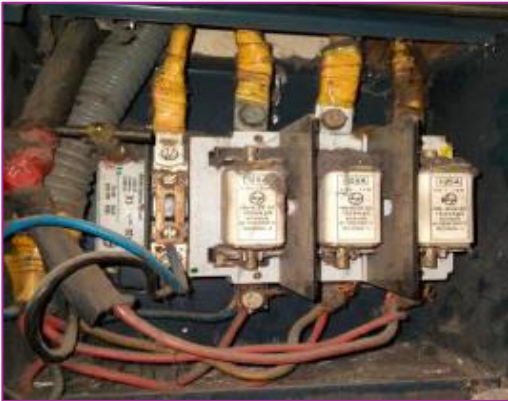
- Lint & Dust observed inside electrical panels.

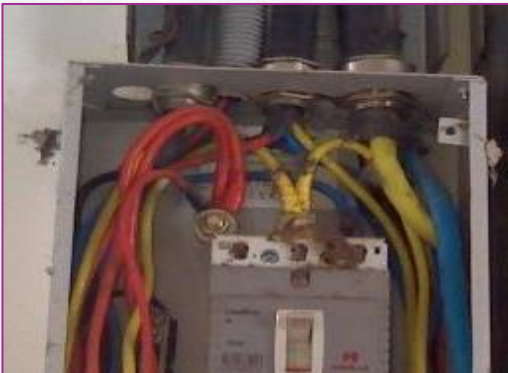
- Cables were not terminated with proper lugs and glands
- Glands were missing inside the electrical panel, allowing access for insects.

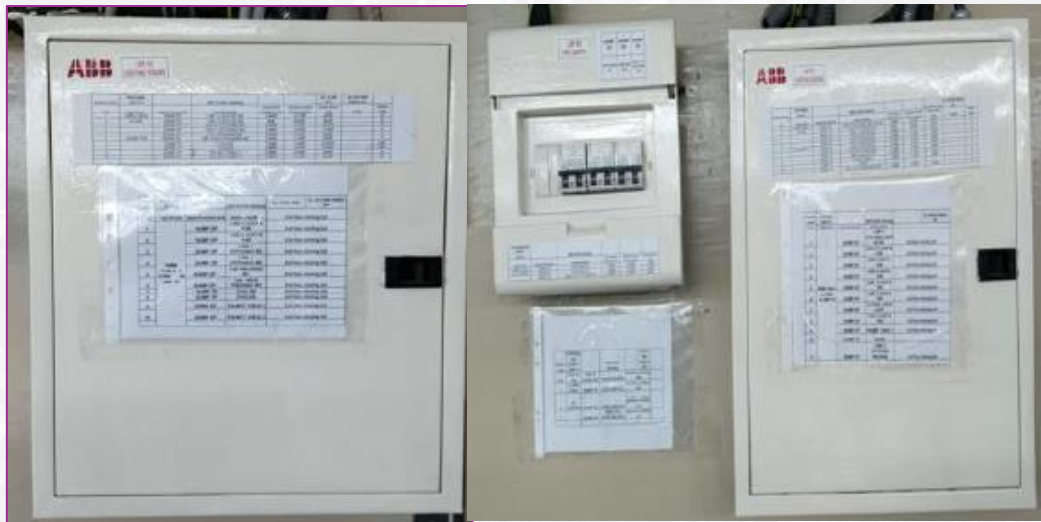
**Observation** — Proper identification markings were not provided on distribution boards, and current carrying capacity not calculated.

Current carrying capacity calculated and posted over DB

**Remediation-** The factory has provided proper identification over panel.

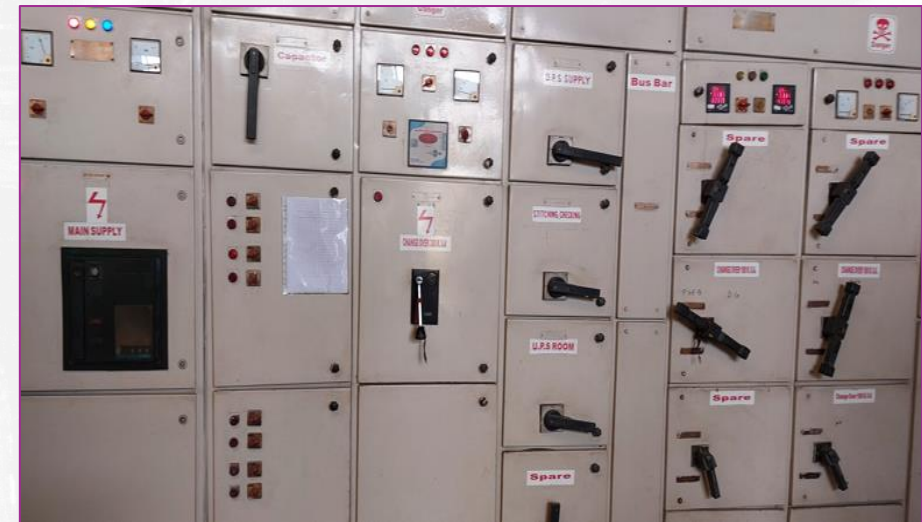
Proper identification provided over panel

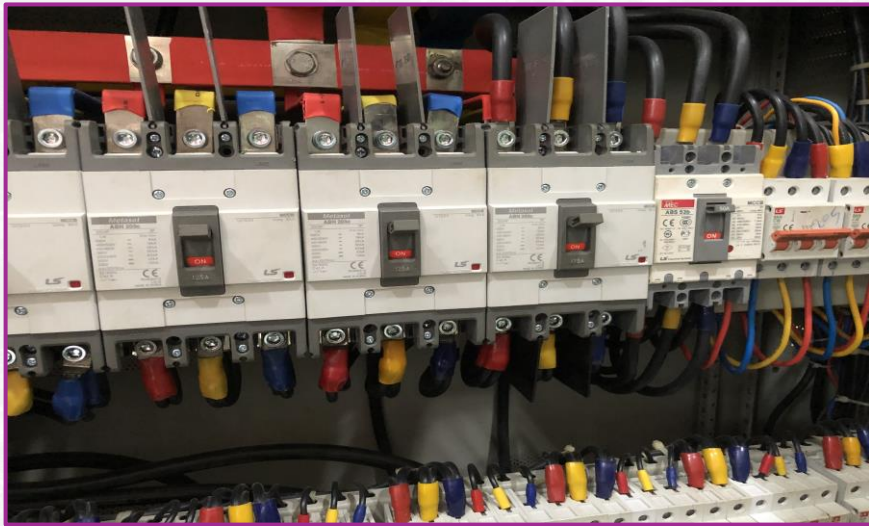
**Observation** — Lint & dust were observed inside the electrical panel.

Electrical panel has been cleaned

**Remediation-** The factory has cleaned electrical panel and implemented a weekly checklist to prevent lint accumulation in panel.

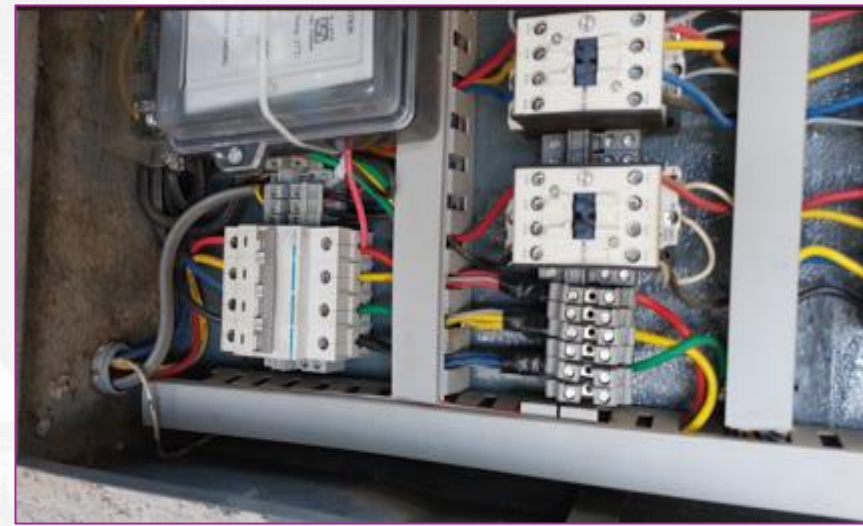
Electrical panel has been cleaned

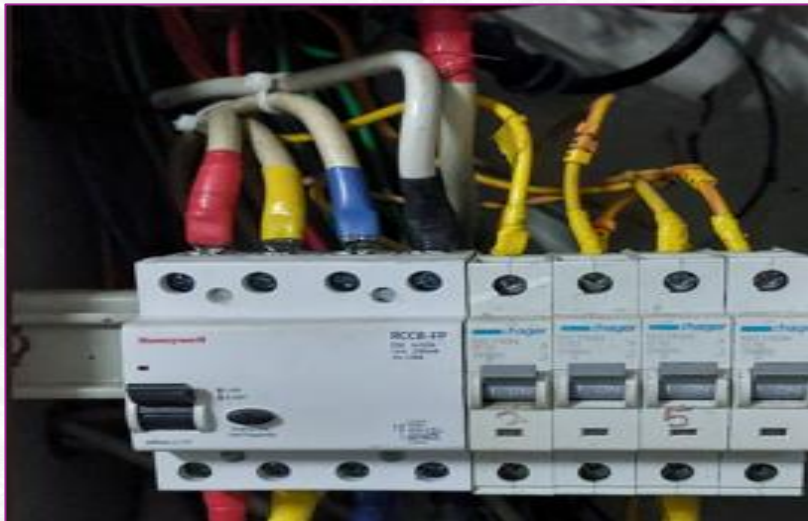
Lugs provided for electrical panel

**Remediation-** The factory has provided lugs and glands in electrical panel.use of lugs and glands incorporated in SOP

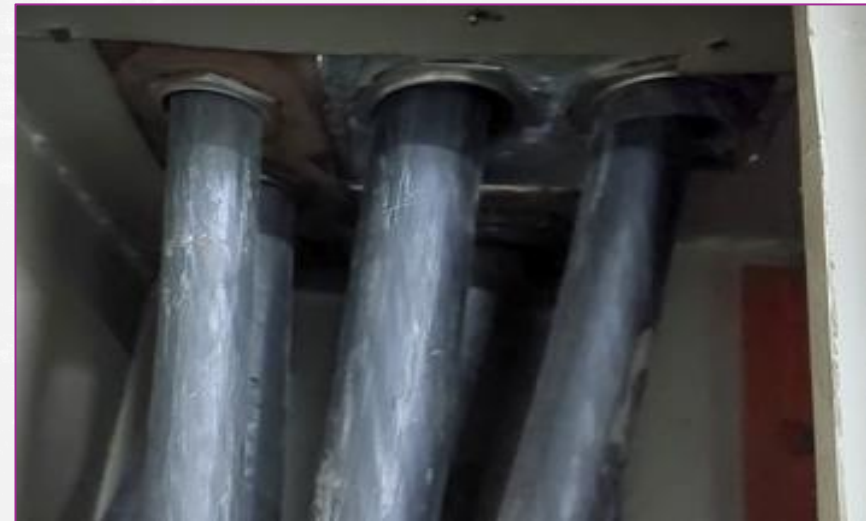
Glands provided over electrical panel

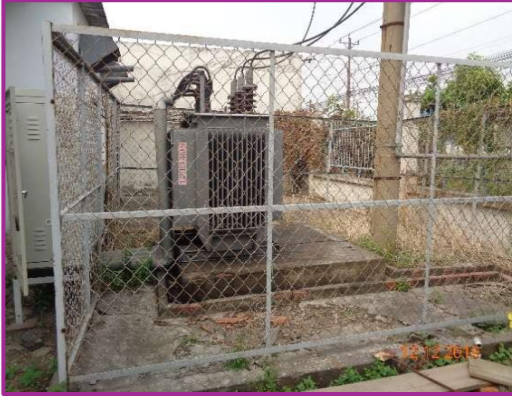
- Adequate warning/danger, voltage level signage were not posted over transformer, substation.

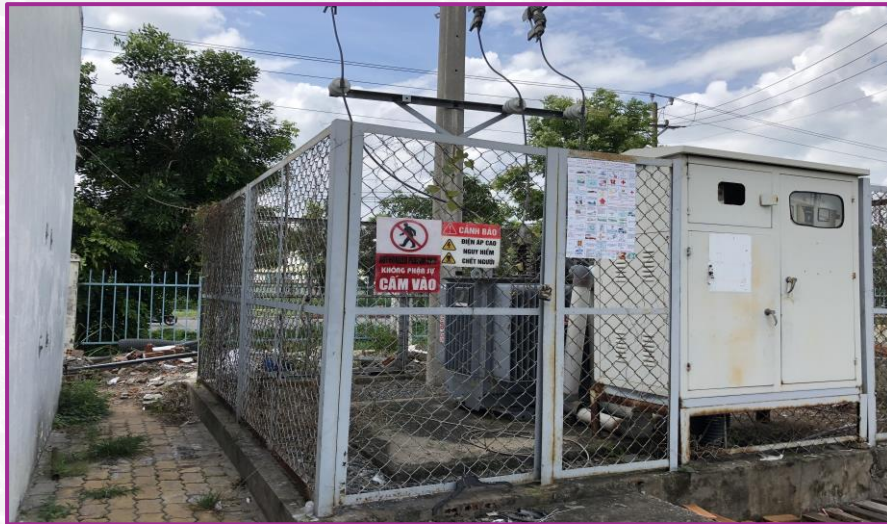
**Observation** – No proper danger or warning signage near HT meter room and transformer area.

Sign age provided over substation

**Remediation-** The factory has provided warning signage over hazardous electrical installation.

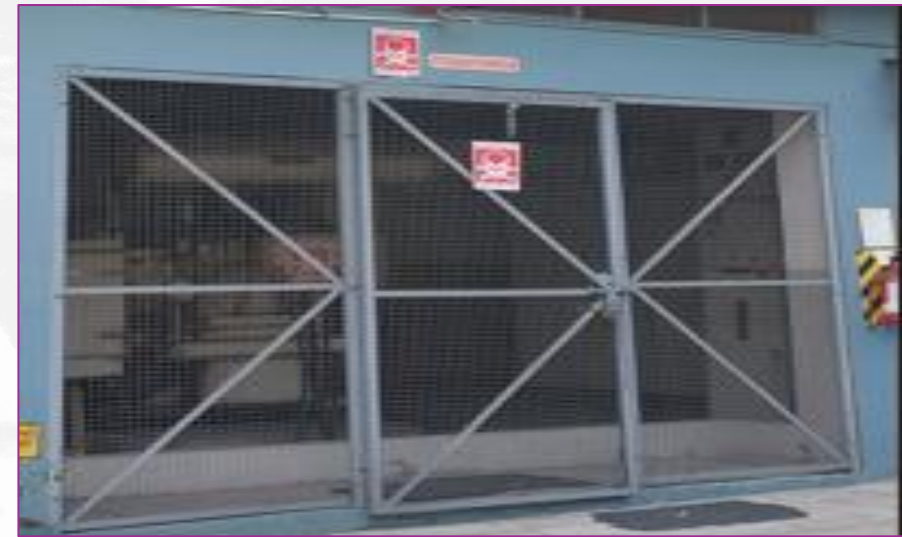
Warning signage provided

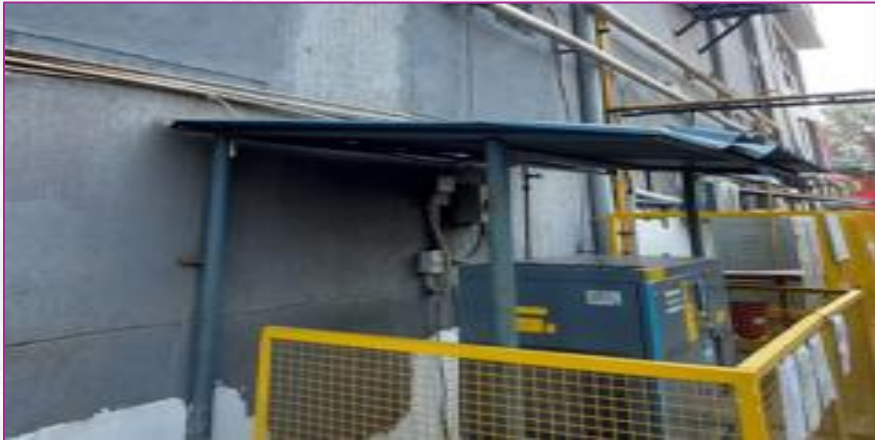
**Observation —** Hazardous installation installed adjacent to production with glass window towards production.

Window opening towards compressors has been closed

**Remediation-** The factory has provided separation between hazardous installation and production.

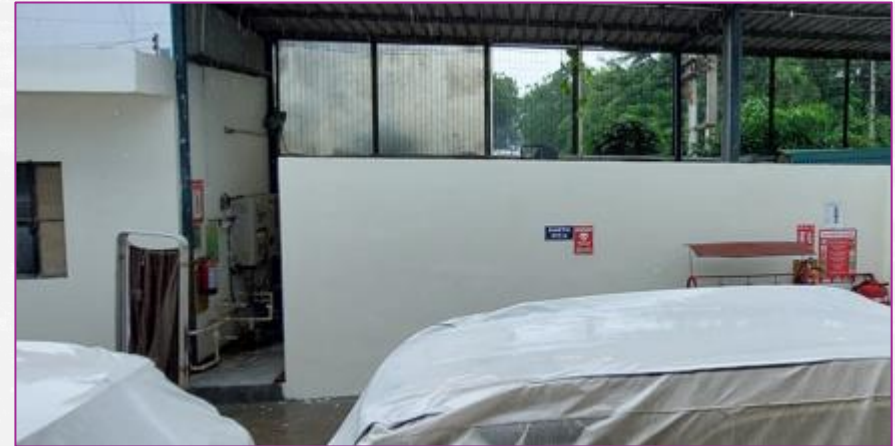
Wall separation provided between transformer & evacuation route

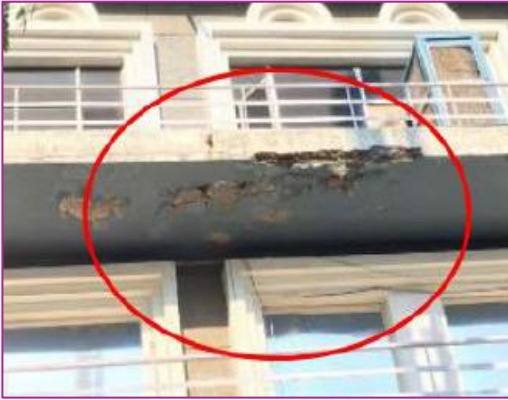
- Significant corrosion making the structural element (beams, columns, truss) etc ineffective that may lead further structural damage.

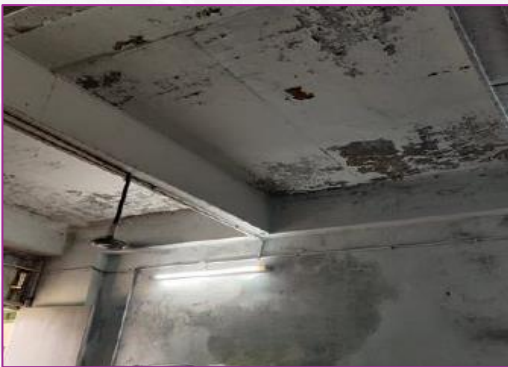
- Dampness observed over Floor Roof and walls.

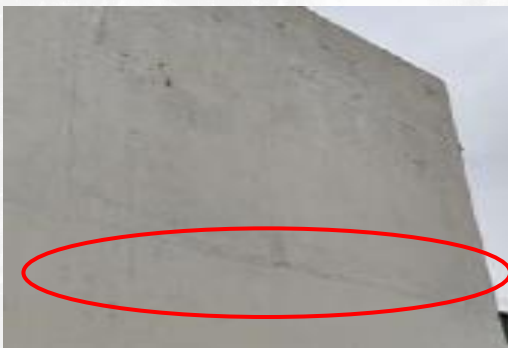
- Cracking observed over back side of building
- Cracks were observed over columns/beams

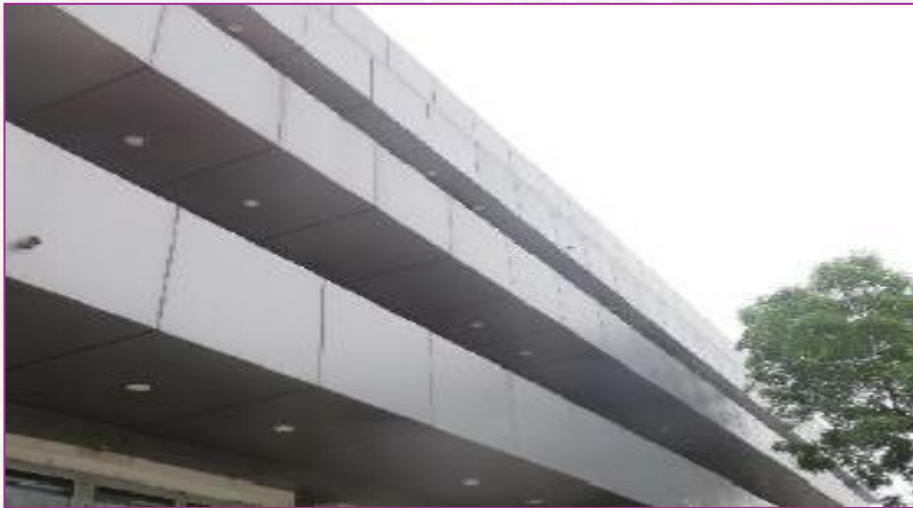
**Observation —** The structure element was found corroded.

Corroded structure repaired and covered

**CAP-** Will review the corroded structure and repair it.

**Remediation-** The factory has repaired corroded structure members .

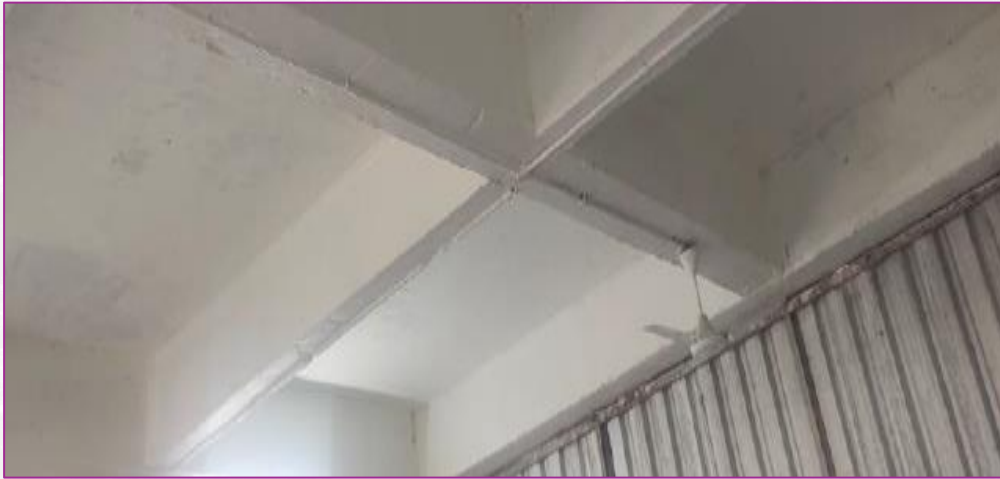
**Observation** — wall cladding/backside wall observed for dampness

Dampness has been addressed

**CAP-** Factory will review structure with NDT test for impact of dampness over structure and repair dampness.

**Remediation-** The factory has repaired dampness and removed leakages causing dampness.

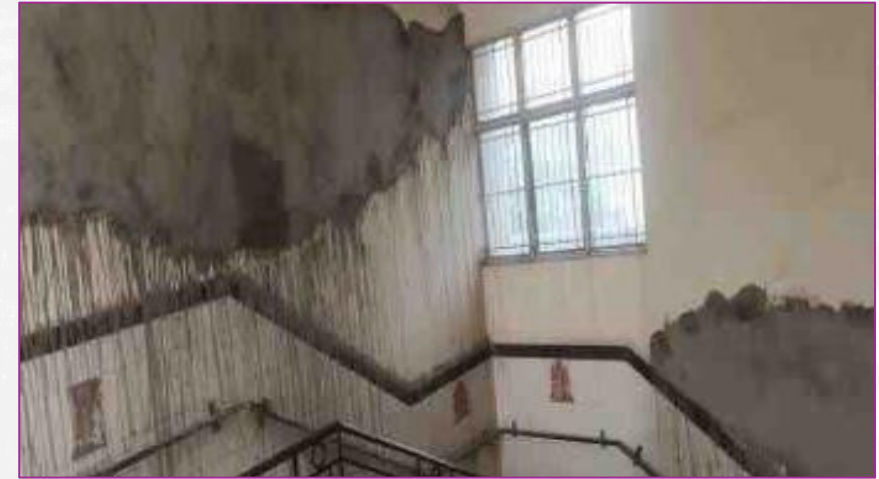
Dampness Repairs work has been done

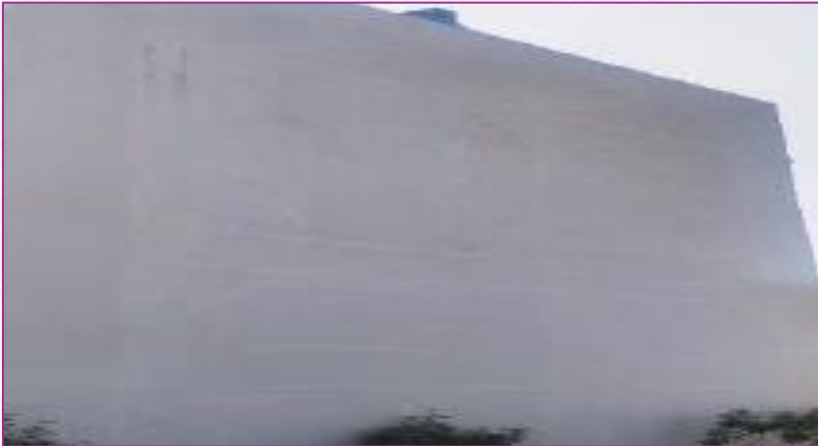
**Observation** — Cracks were observed on external wall/internal wall.

Non structural cracks were repaired

The factory situated at Khasra no. 15/19&22, Village Begumpur, Khatola, Gurugram, Harayana was visited by our engineer on 04-03-2024. The said brick wall is a non-structural filler wall. The cracks visible are due to the poor construction methodology and workmanship, along with the wear and tear. The said cracks are repaired by introducing reinforcement to stitch the cracks and finish the area with Murga jaali, mortar and plaster.

**CAP-** Will review cracks and get them repaired as per structural review.

**Remediation-** The factory has repaired cracks and initiated a structure audit to prevent reoccurrence of cracks

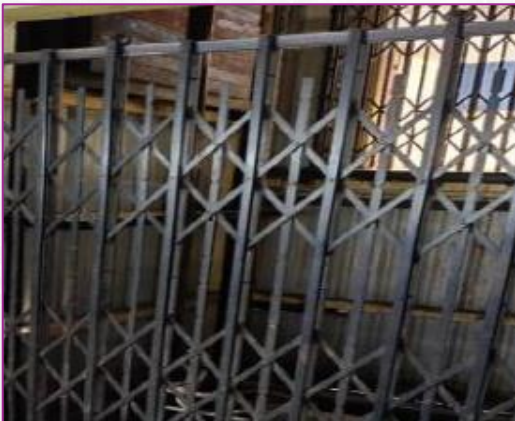
- Goods Lift Side walls & 2nd floor External walls at North, West Side found to be inadequate to resist later forces

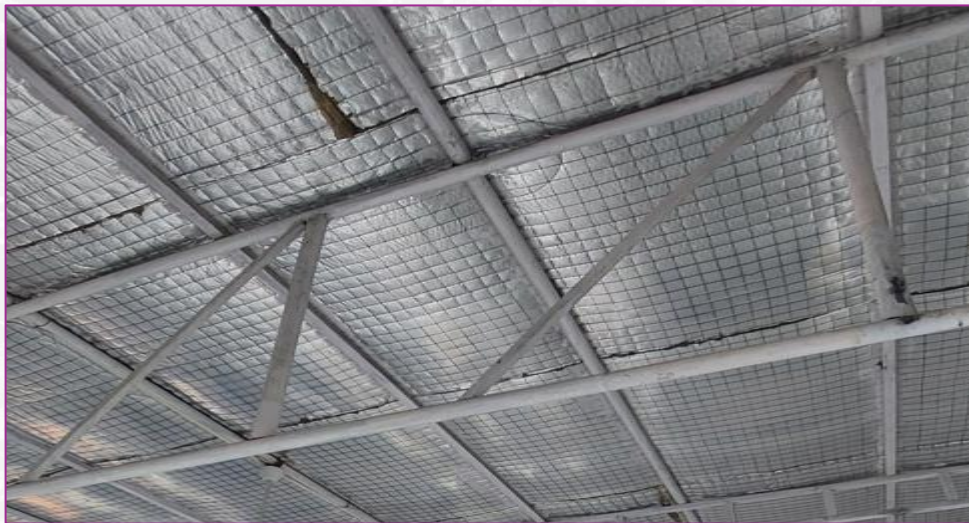
Bracing to MS structure

**Remediation-** The factory has appointed structural consultant and provided bracing along with survey report

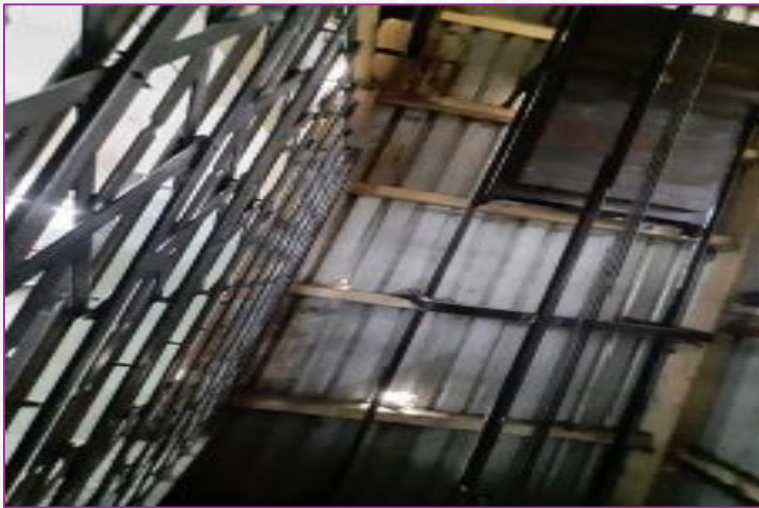
**Observation** — Goods Lift Side walls & 2nd floor External walls at North, West Side found to be inadequate to resist later forces.

Structural member has been reinforced

**Remediation-** The factory has appointed structural consultant and provided support member in lift

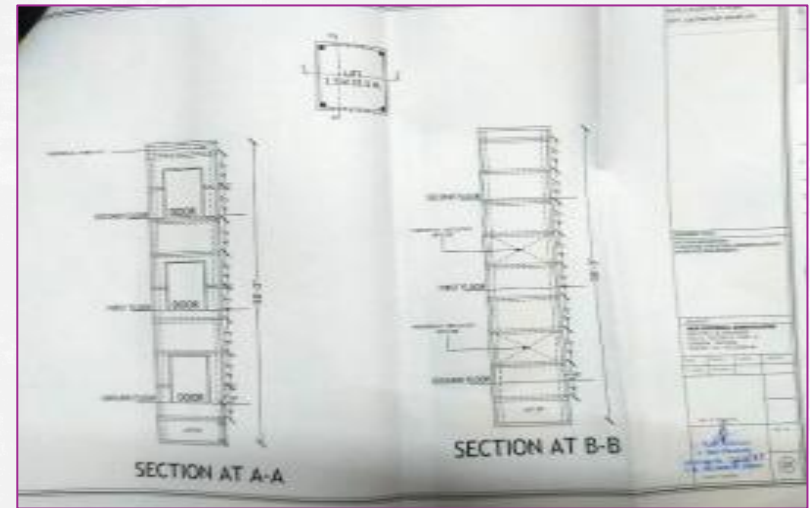
structural drawing of the Goods lift
