**LABS Initiative**

## Methodology for Preliminary Safety Assessments in Cambodia

Issue 6| 22 April 2022

**Archetype**

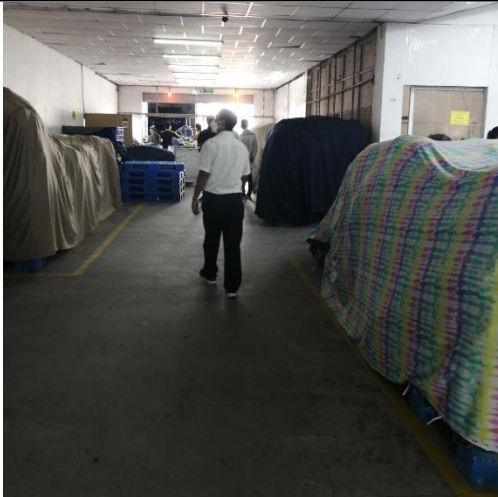
**Figure 9** Excessive ‘in-process’ storage stacked on Sewing floor

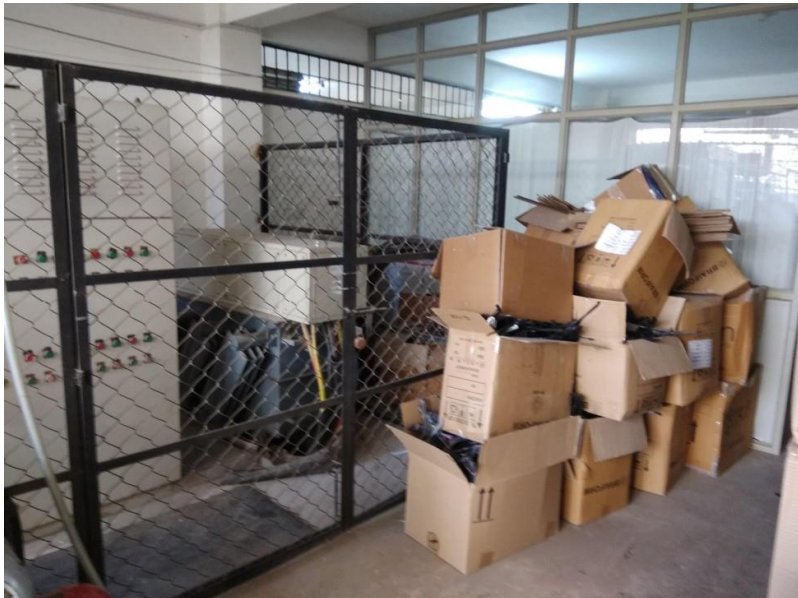
Ref No.	Issue Type	Sub-header
ELEC-n	E5 : Distribution	Combustible/flammable materials present
Observations: Combustible material storage next to the main LT panel room metal fence.

Figure N Storage of combustible material near main LY panel metal fencing.

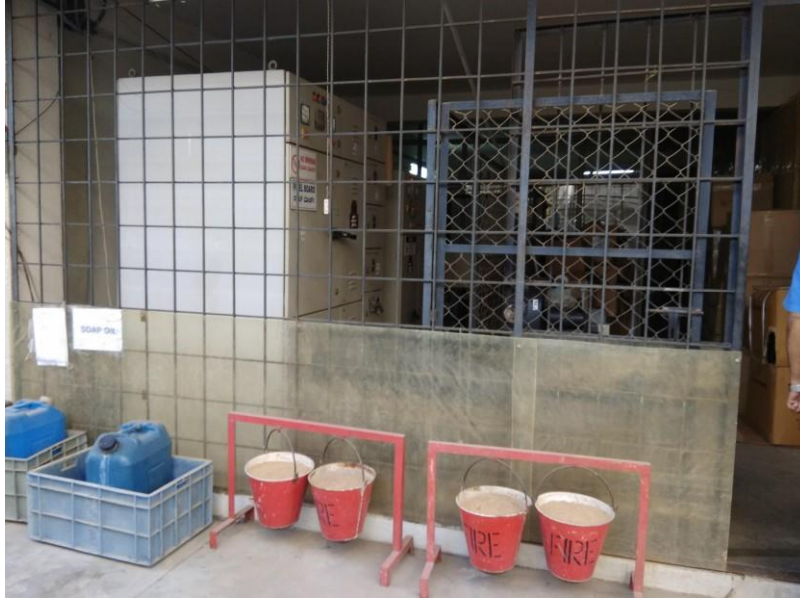
Observations: Exposed main electrical panel room to external weather condition.

Figure N Exposed main Electrical panels

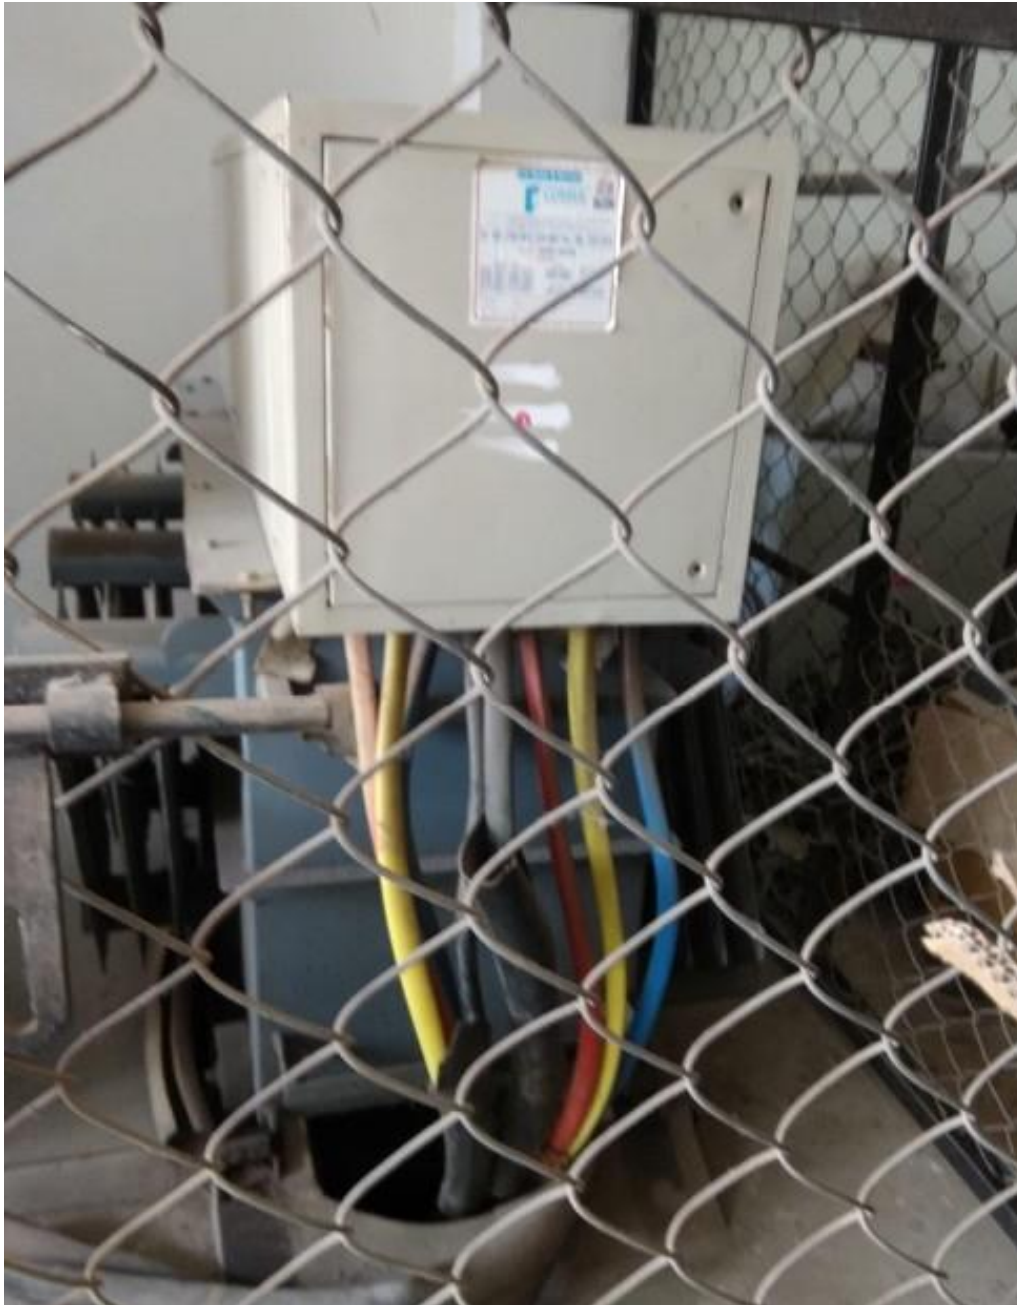
Observations: Cables are terminated without fixing of cable armor into the gland, there is no other insulation available on outer sheet.

Figure N Improper termination of cables.

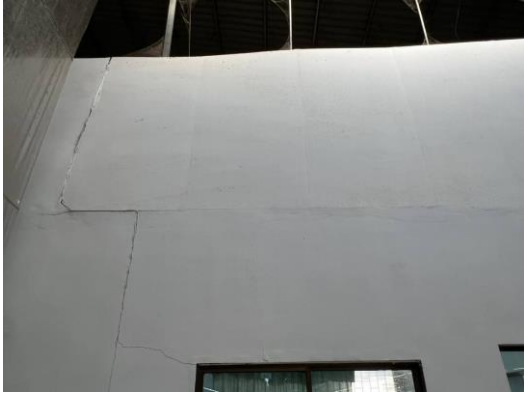
Ref No.	Issue Type	Sub-Issue Type
<b>STR2</b>	S6 – Visible Distress in Non-Structural Members	Cracking
Observations: Smartboard wall at HR/Nurse Office was cracked and bended

<p>Figure 35: Smartboard wall was cracked and bended</p>

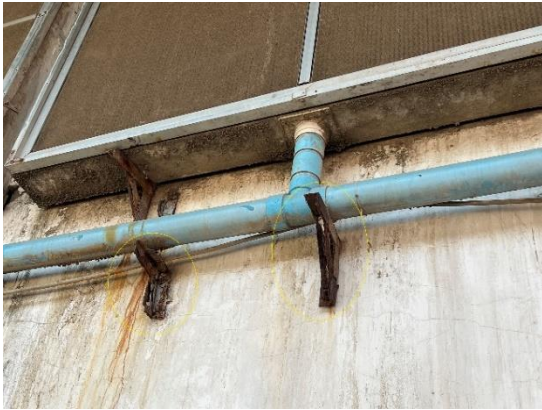
Ref No.	Issue Type	Sub-Issue Type
<b>STR3</b>	S9 – Maintenance	Structural steelwork corrosion
Observations: Steel support corrosion at building B

<p>Figure 37: Steel support corrosion</p>

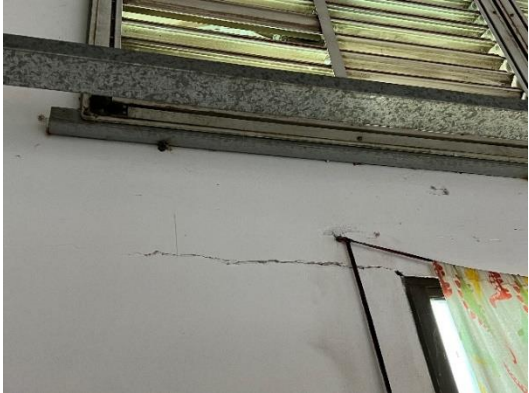
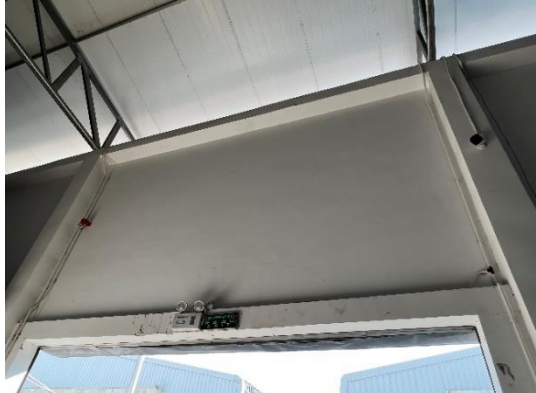
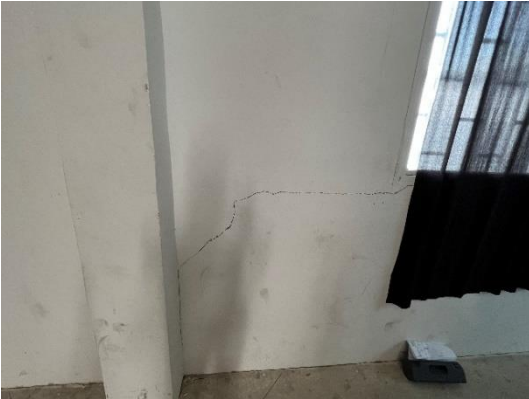
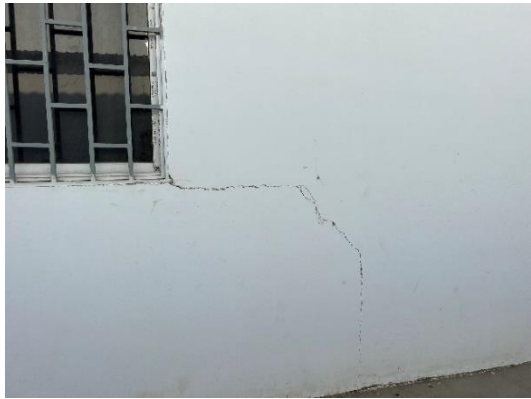
Ref No.	Issue Type	Sub-Issue Type
STR4	Visible distress in nonstructural members	Cracking
Observations: Wall cracking at building A, B, C, and Hostel building

Figure 39: Wall cracking at building A

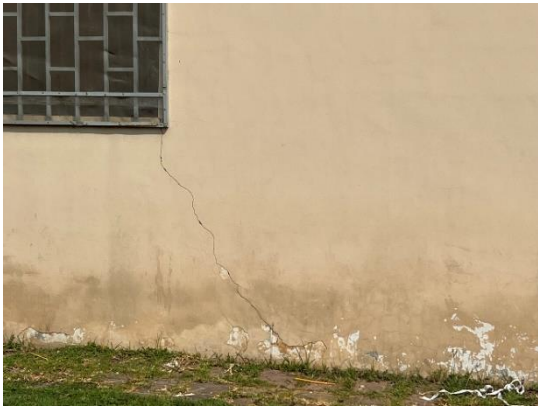
Figure 45: Wall cracking at Hostel building

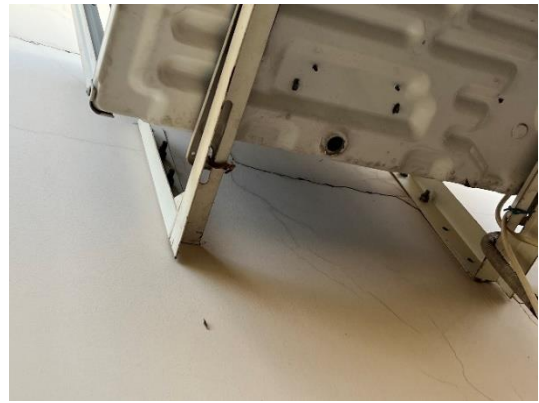
Figure 46: Wall cracking at Hostel building

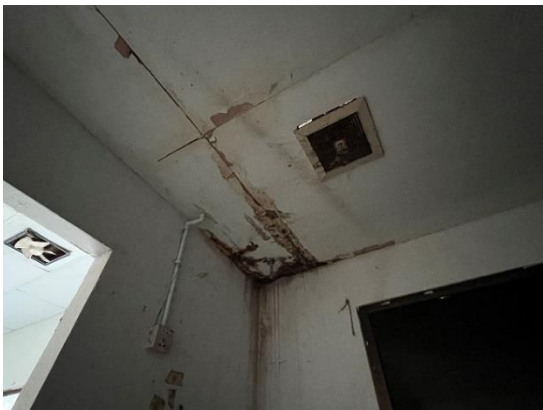
Ref No.	Issue Type	Sub-Issue Type
STR5	Maintenance	Lack of maintenance
Observations: Ceiling has been damaged by water leakage at building A and mezzanine floor building A

Figure 47: Ceiling has been damaged at building A		Figure 48: Ceiling has been damaged at mezzanine floor

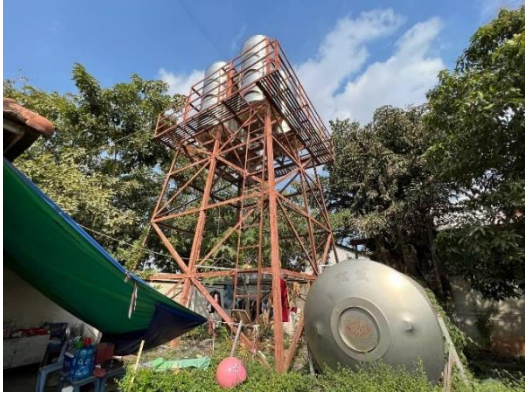
Ref No.	Issue Type	Sub-Issue Type
<b>STR6</b>	Vertical structural system	Water tanks on suspended floors/roof
Observations: Non-engineered and corroded steel structure supporting the water tank

<p>Figure 49: Non-engineered steel structure</p>

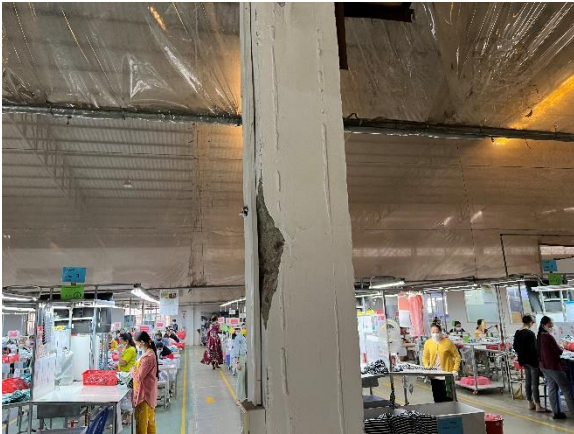
Ref No.	Issue Type	Sub-Issue Type
<b>STR7</b>	Maintenance	Lack of maintenance
Observations: Column damaged by drilling and observable broken floor tiles at building B

<p>Figure 51: Column damaged by drilling</p>

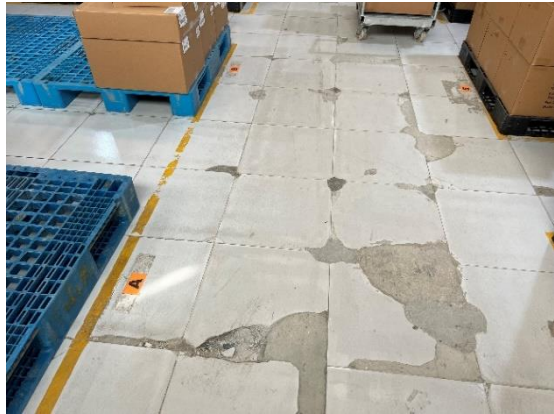
<p>Figure 52: Broken floor tiles were observed</p>

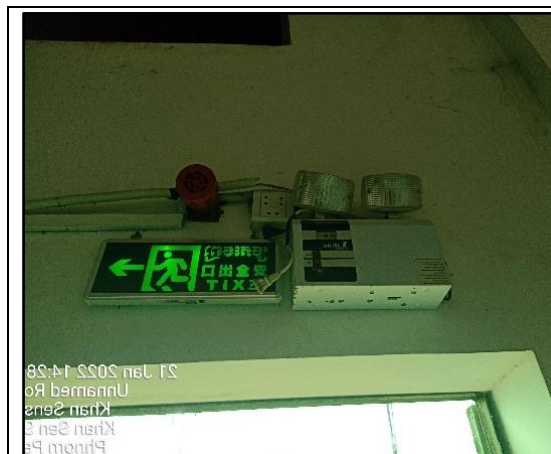
**Figure 10:** Inadequate back up power to emergency lighting

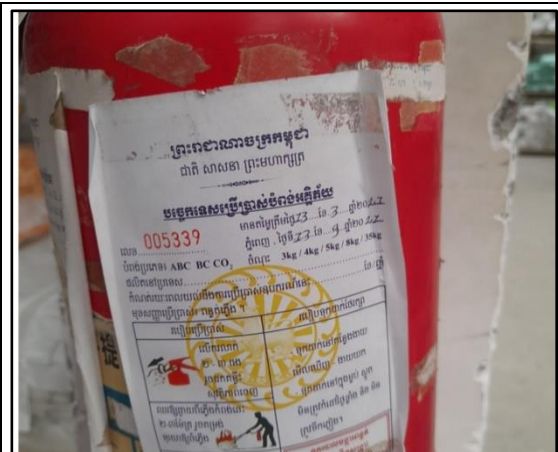
**Figure11:** Fire Extinguisher was not checked regularly at Dormitory

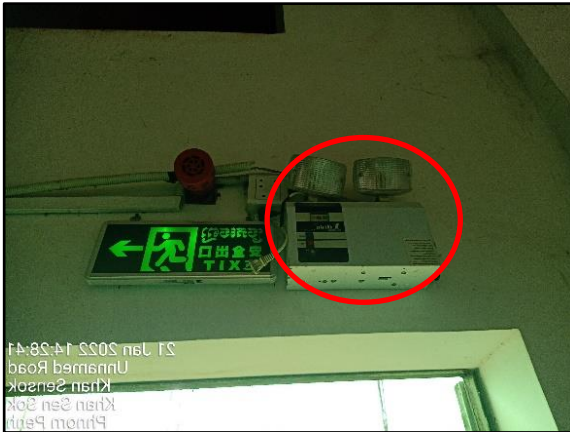
Ref No.	Issue Type	Sub-Issue Type
FIRE-06	F3: Fire Safety System	Emergency Lighting
<b>Observation</b>		<b>Location:</b> Building A
Inadequate back up power for emergency light

<b>Figure 21:</b> Inadequate back up power for emergency light

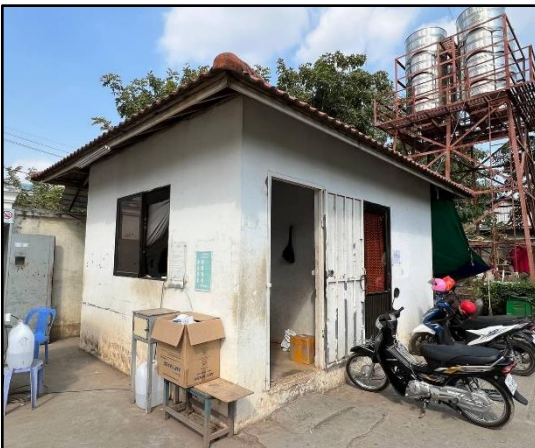
Ref No.	Issue Type	Sub-Issue Type
FIRE-07	F3: Fire Safety System	Fire Alarm
<b>Observation</b>		<b>Location:</b> Guard House
No Main Fire Alarm control panel for factory

<b>Figure 22:</b> No Main Fire Alarm control panel for factory

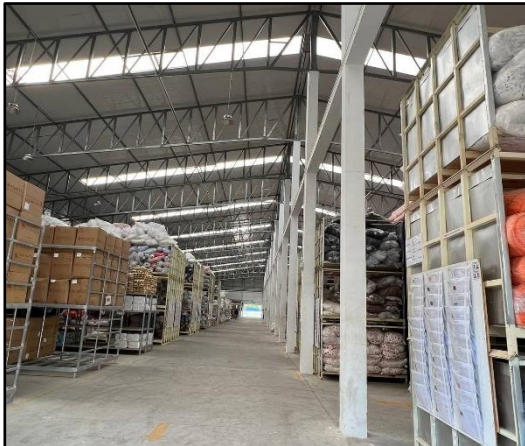
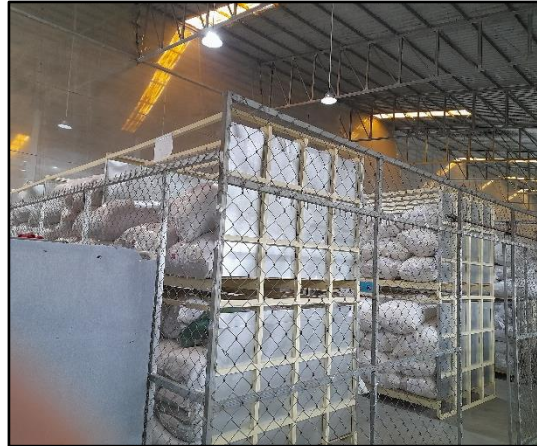
Ref No.	Issue Type	Sub-Issue Type
FIRE-11	Provision for fire fighting	Access
<b>Observation</b>		<b>Location:</b> Storage all area
No sprinkler system for storage area

<b>Figure 28:</b> No sprinkler system		<b>Figure 29:</b> No sprinkler system

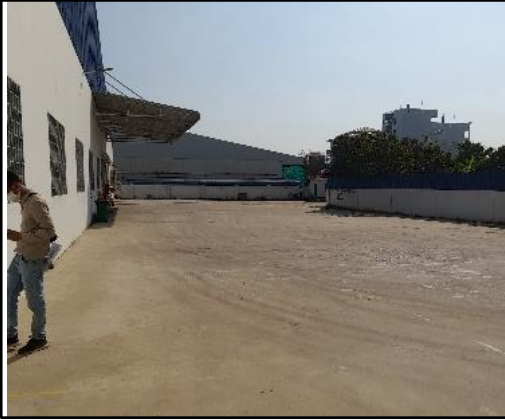
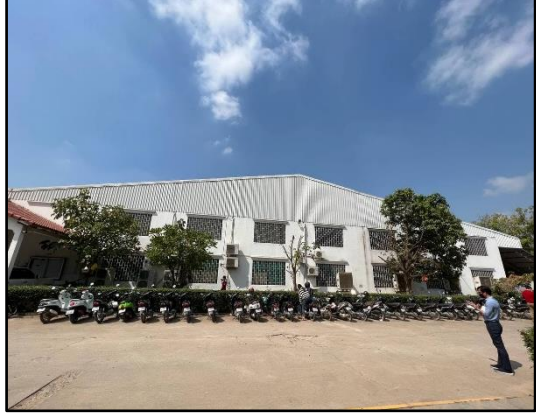
Ref No.	Issue Type	Sub-Issue Type
FIRE-14	Provision for Fire Fighting	Water Supply
<b>Observation</b>		<b>Location:</b> External
Fire Hydrant were not available for factory

<b>Figure 34 : No Fire Hydrant</b>		<b>Figure 35: No Fire Hydrant</b>

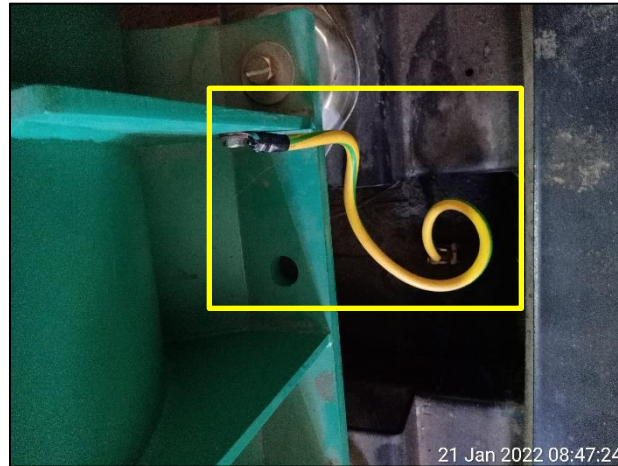
Figure 11: Incorrect size PE Earthing cable for generator at generator room.

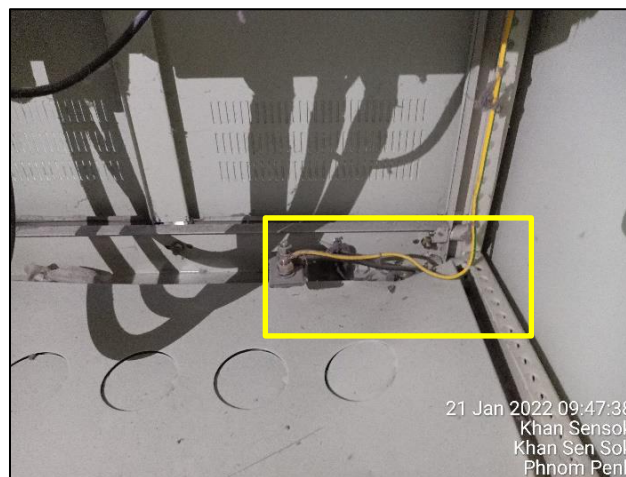
Figure 14: Missing PE Earthing bar installation for Electrical panel at building A

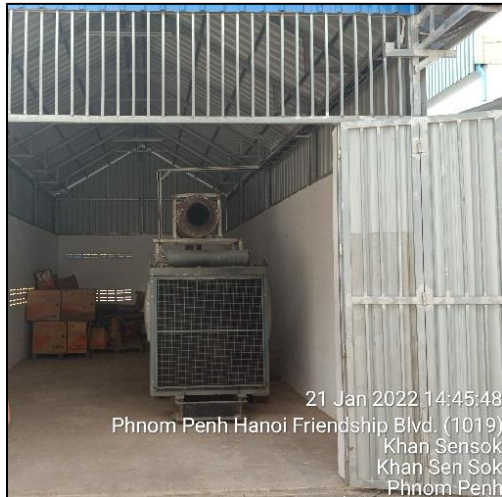
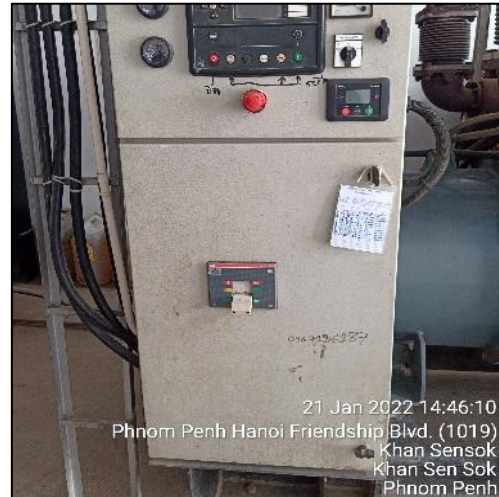
Figure 21: 500kVA Generator Room 02 without fan ventilation system at behind Building C.

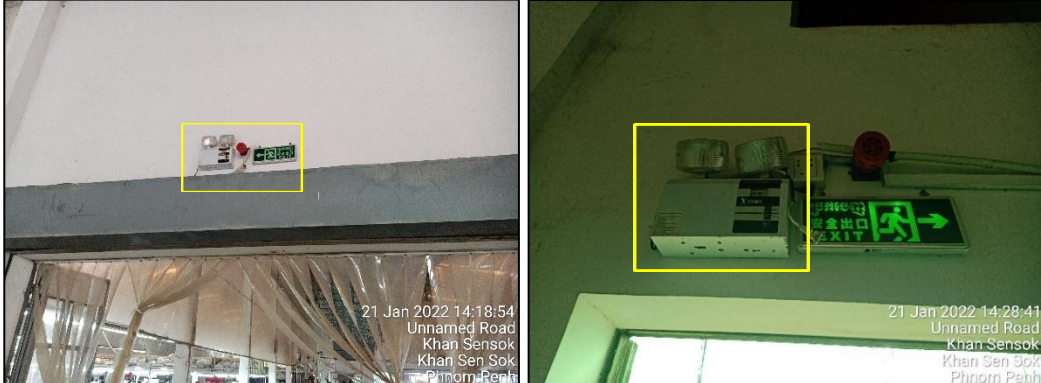
Ref No.	Issue Type	Sub-Header
ELEC-1	E1 : Supplies to Life Safety System	Power supply to emergency lighting
Observations: Random Emergency & Exit Lights were tested at Production Building A & B, some fitting were not working and some just lighted on less than 10minutes with Localized Battery Backup.

<p>Figure 29: Power Back Up Fail for Emergency &amp; Exit Light in Production during testing.</p>

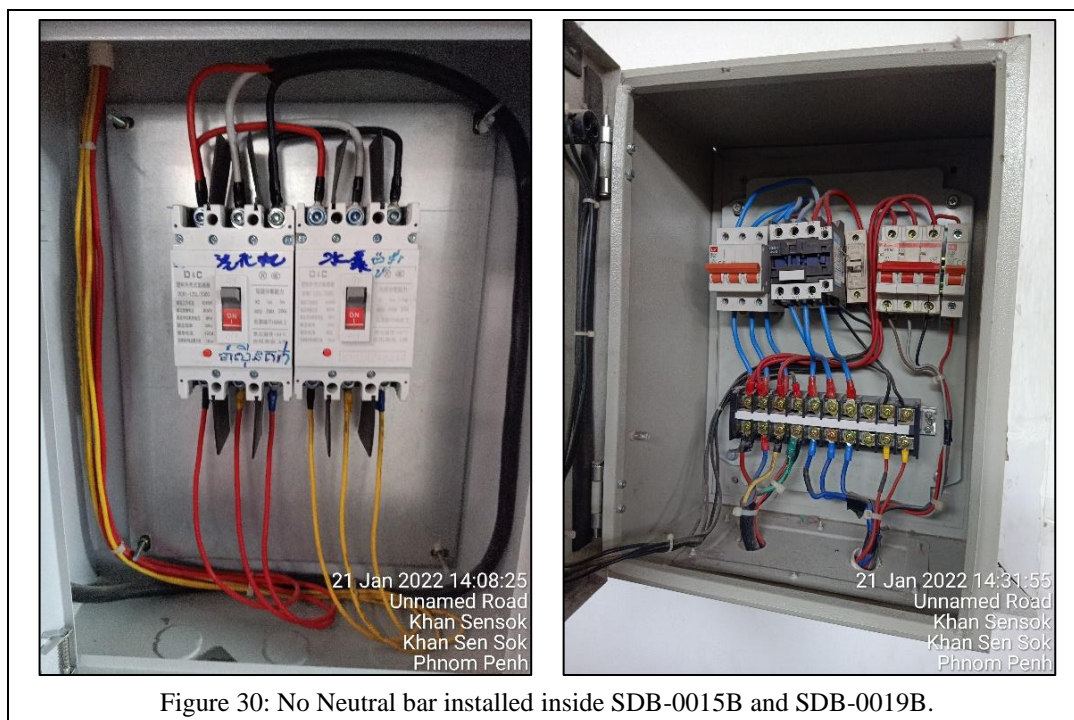
Ref No.	Issue Type	Sub-Header
ELEC-3	E2 : Earthing & Bonding	Break in neutral connection
Observations: There were no Neutral Bar for: <ul style="list-style-type: none"> <li>- SDB-0015B in Building B</li> <li>- SDB-0019B in Boiler Room</li> </ul>

Figure 30: No Neutral bar installed inside SDB-0015B and SDB-0019B.

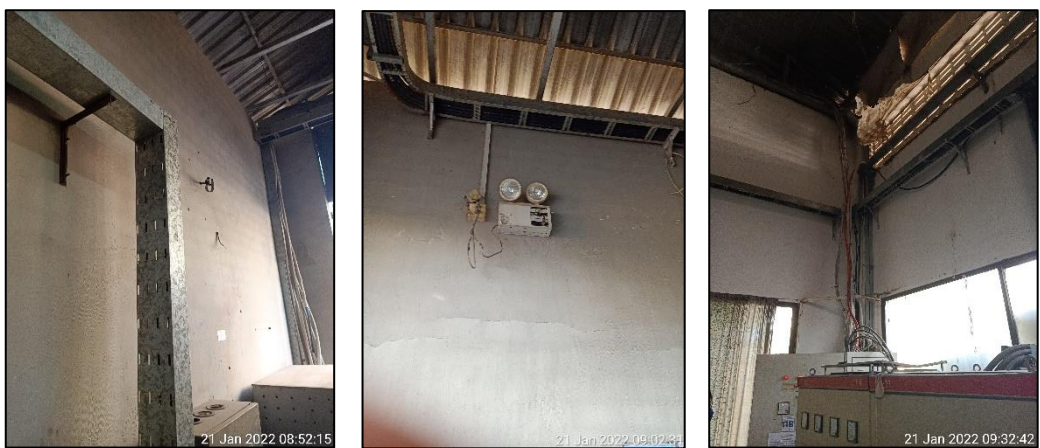
Ref No.	Issue Type	Sub-Header
ELEC-4	E2 : Earthing & Bonding	Insufficient bonding of equipment
<p>Observations: There were many missing of Earthing bonding cables connected to:</p> <ul style="list-style-type: none"> <li>- Cable Routing (Ladder, Tray, Trunking...) in all areas</li> <li>- Fuel Daily Tanks in Generator Room 01 &amp; 02</li> <li>- Above Ground Fuel Storage Tank</li> <li>- Electrical Panel door frames (LVMSB/MTS 01&amp;02 panels, Switching Panel...in Generator Room 01)</li> <li>- Electrical Panel door frames (SDB-0019B in Boiler Room)</li> <li>- Electrical Panel door frames (DB-0010B in Building B)</li> <li>- Boiler and Pump Boiler Enclosures</li> <li>- Washing Machines in Building B</li> </ul>

Figure 31: No Earthing bonding cable connected to cable routing (Tray, Ladder, Trunking...)

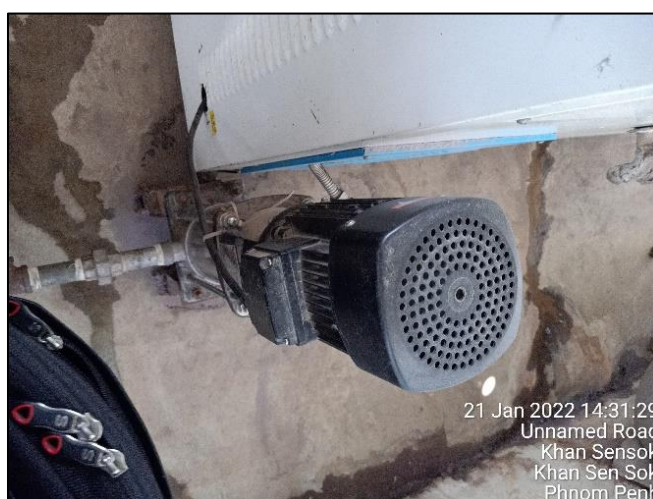
Figure 35: No Earthing bonding cable connected to boiler and pump boiler enclosure.

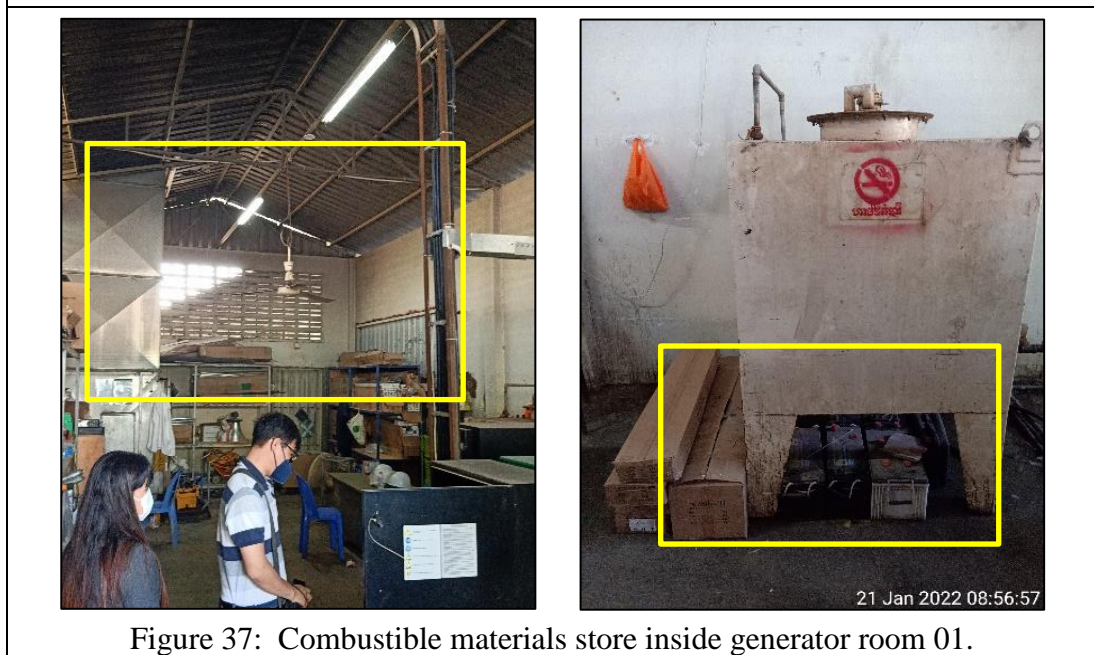
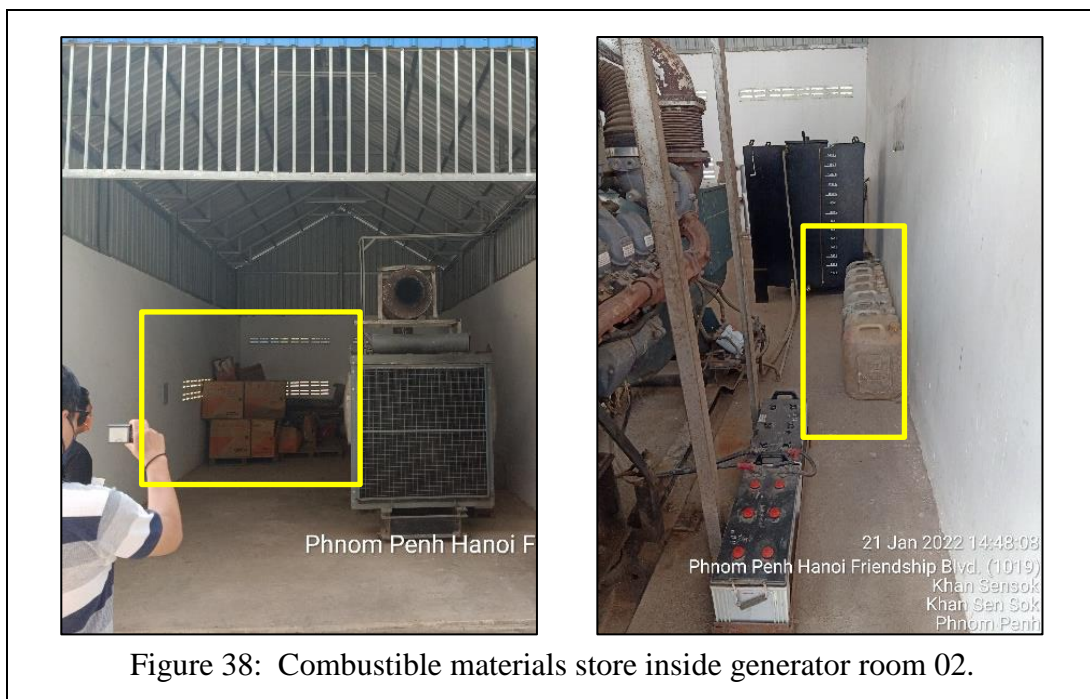
Ref No.	Issue Type	Sub-Header
ELEC-6	E3 : Generators	Inadequate generator ventilation

Observations: The Generator Room 01 & 02 used as a storage with combustible materials.

Figure 38: Combustible materials store inside generator room 02.

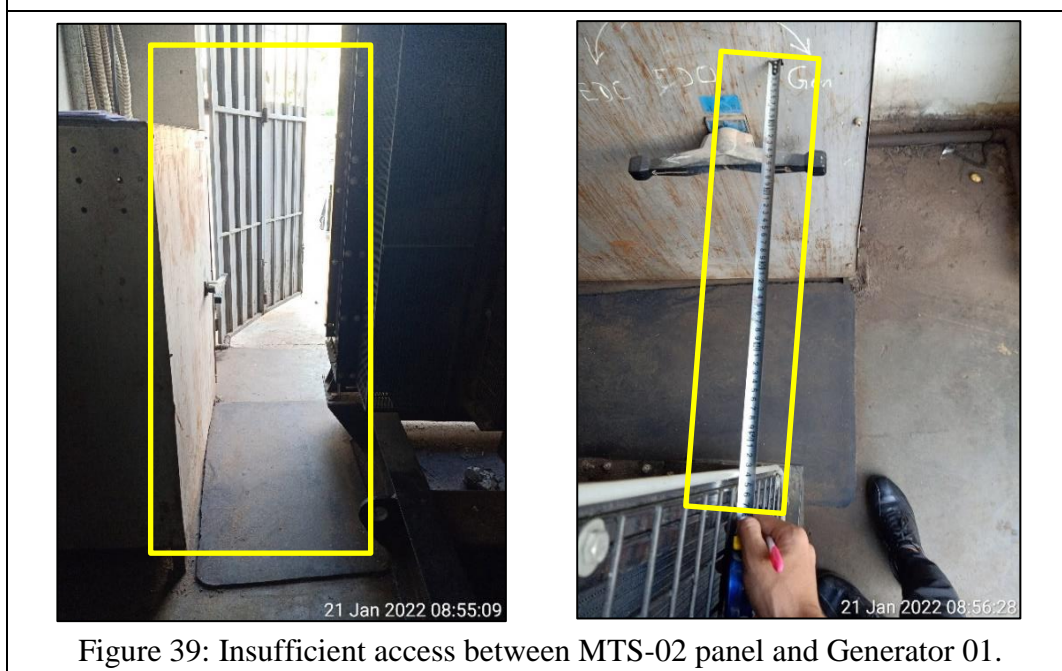
Figure 39: Insufficient access between MTS-02 panel and Generator 01.

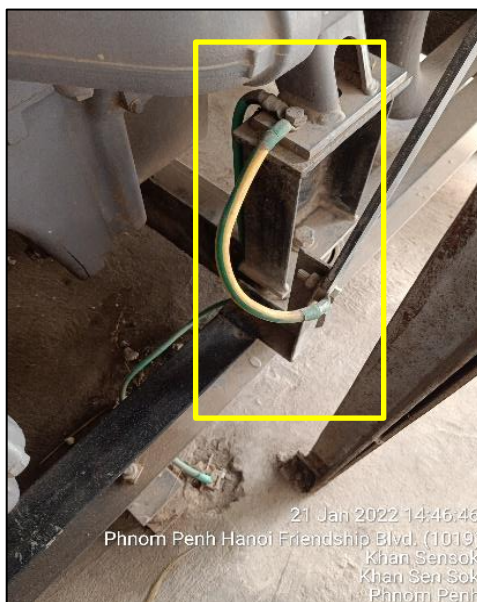
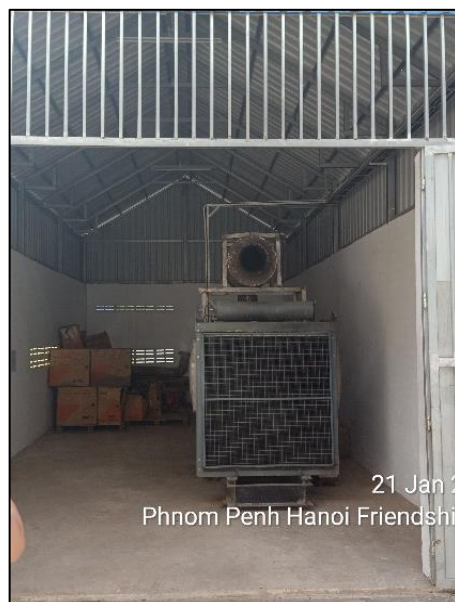
Figure 41: Insufficient generator 02 earthing with two separate points.

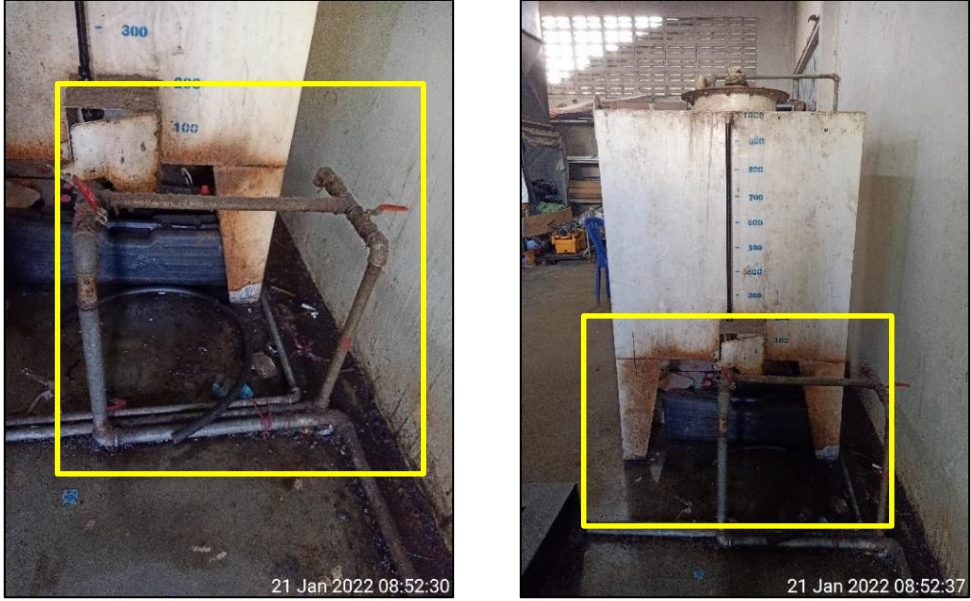
<p>Figure 42: Fuel Leak from Daily Tank.</p>

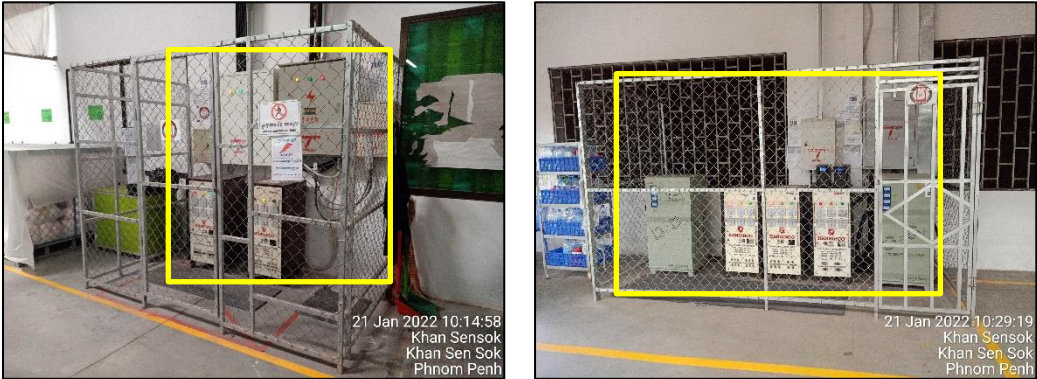
<p>Figure 43: Insufficient Access to wall mounted DBs that blocked by floor standing Voltage Stabilizers.</p>

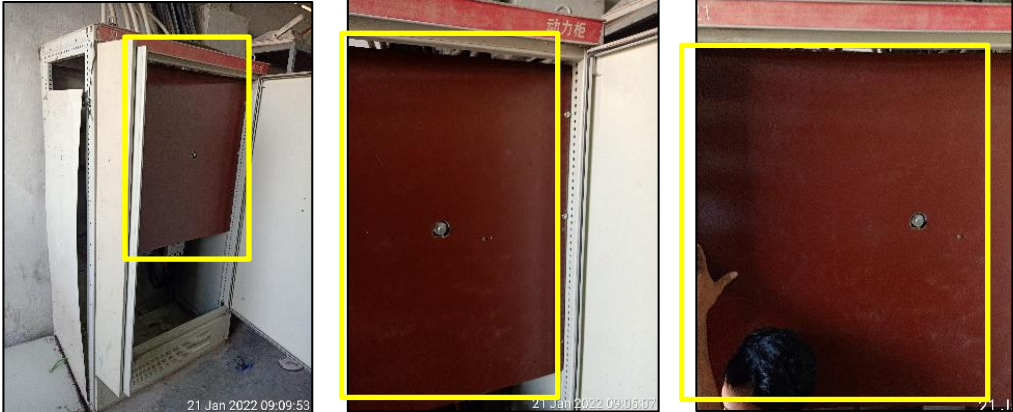
<p>Figure 44: Panels cover damaged and replaced with unsafe flash guard when need to open to the LVMSB/MTS 01 &amp; 02 cover.</p>

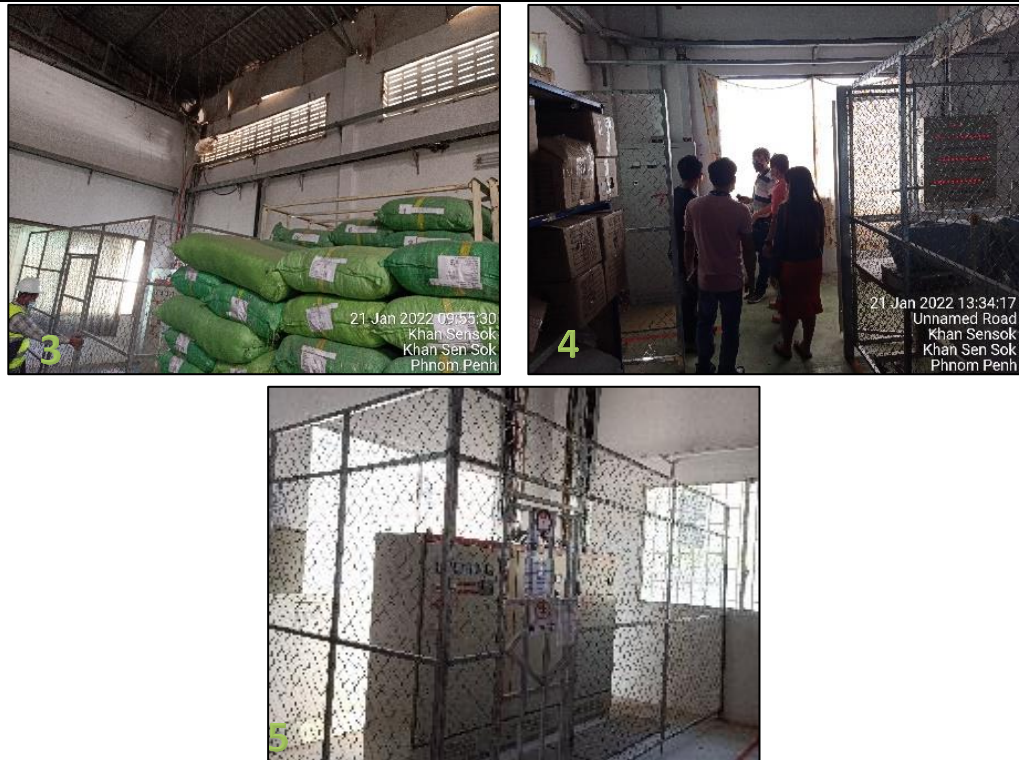
Figure 45: Inadequate/No number of Normal and Emergency Lighting inside:

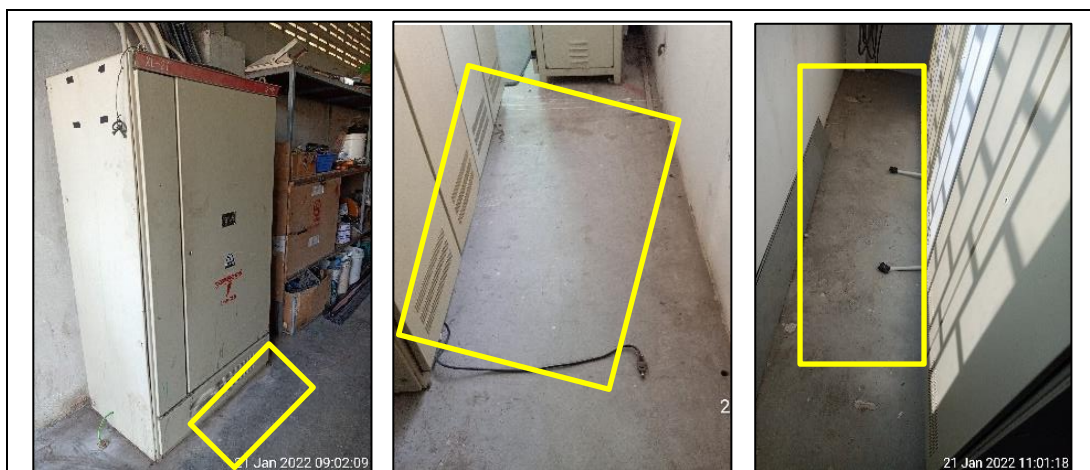
Figure 46: Inadequate rubber floor mats for MTS-01 panel, MDBS & DBs panel.

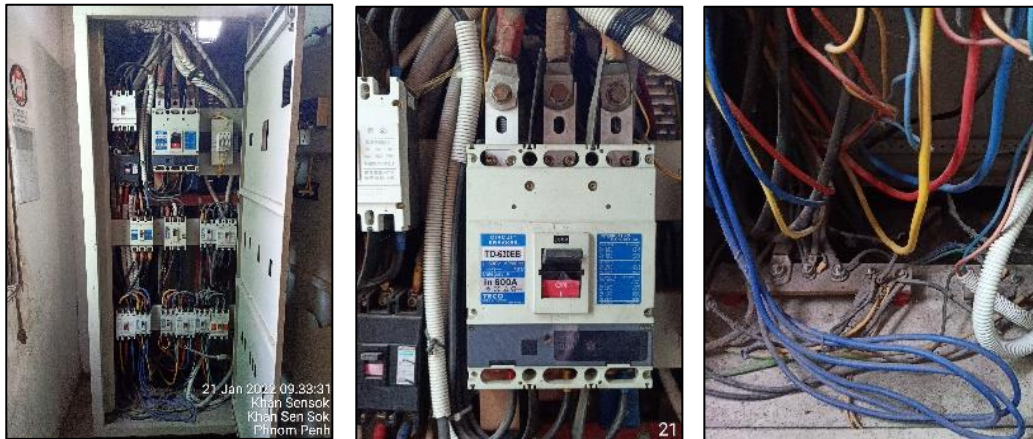
Figure 49: Inadequate cable segregation for LV cables inside MDB-001B

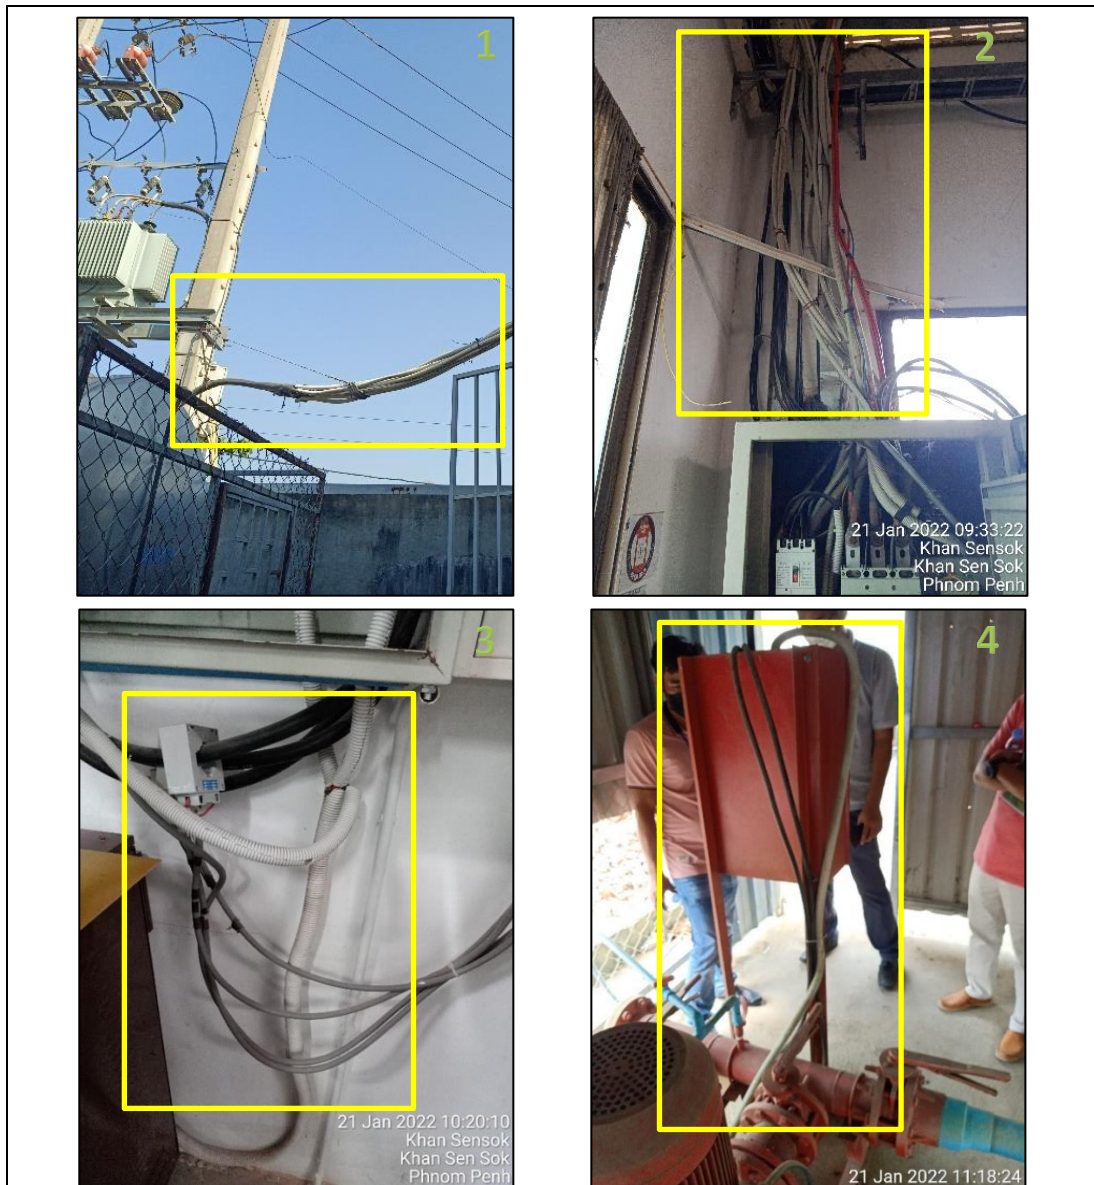
Figure 50: Inadequate cable support for:

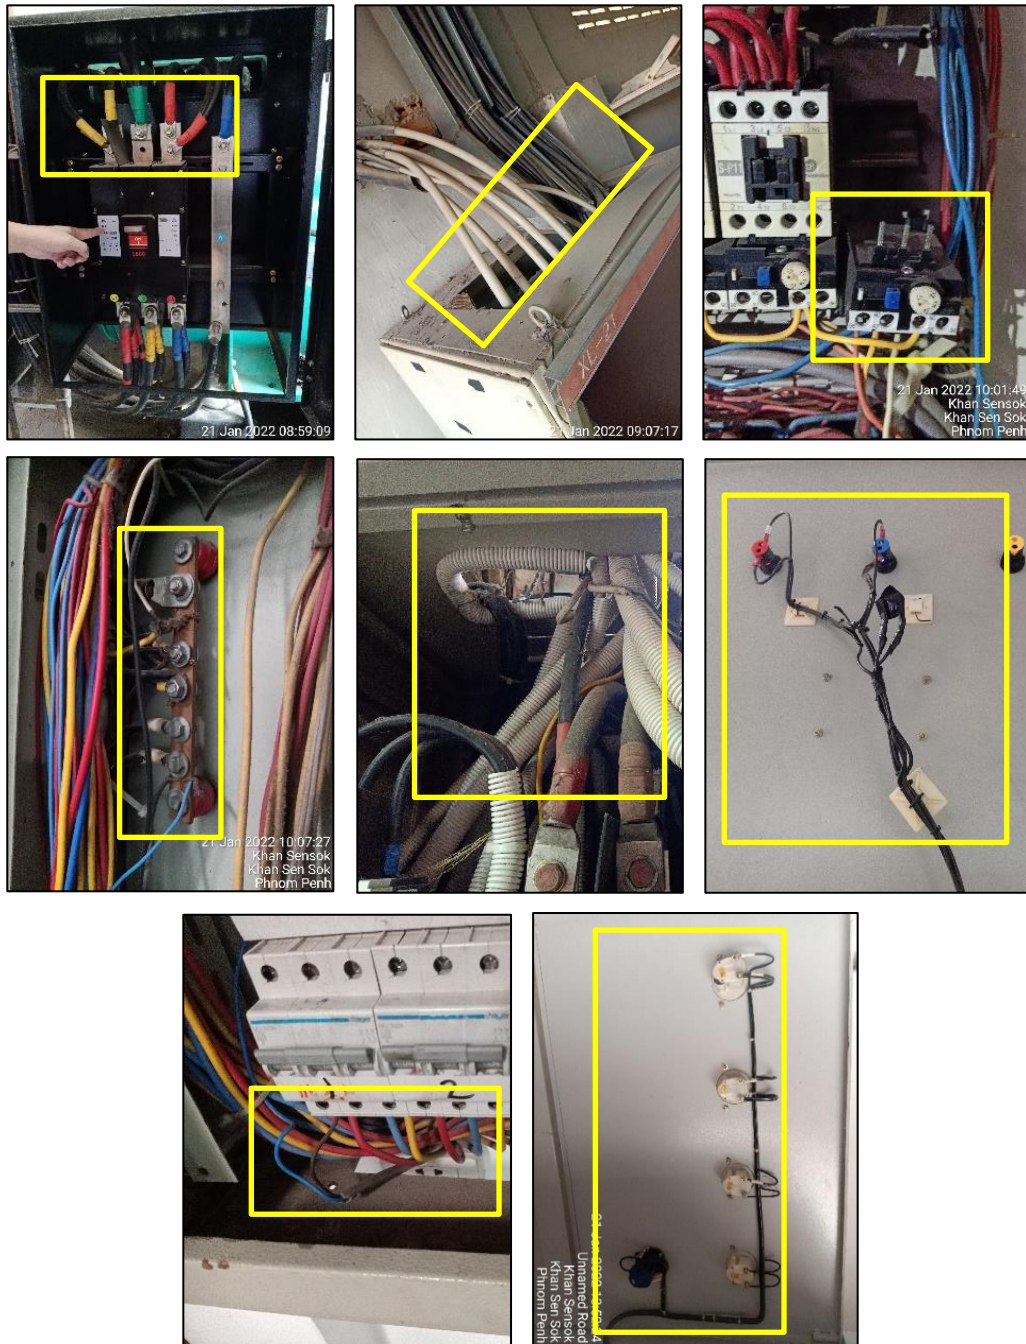
Figure 51: Inadequate cable support and panels component broken.

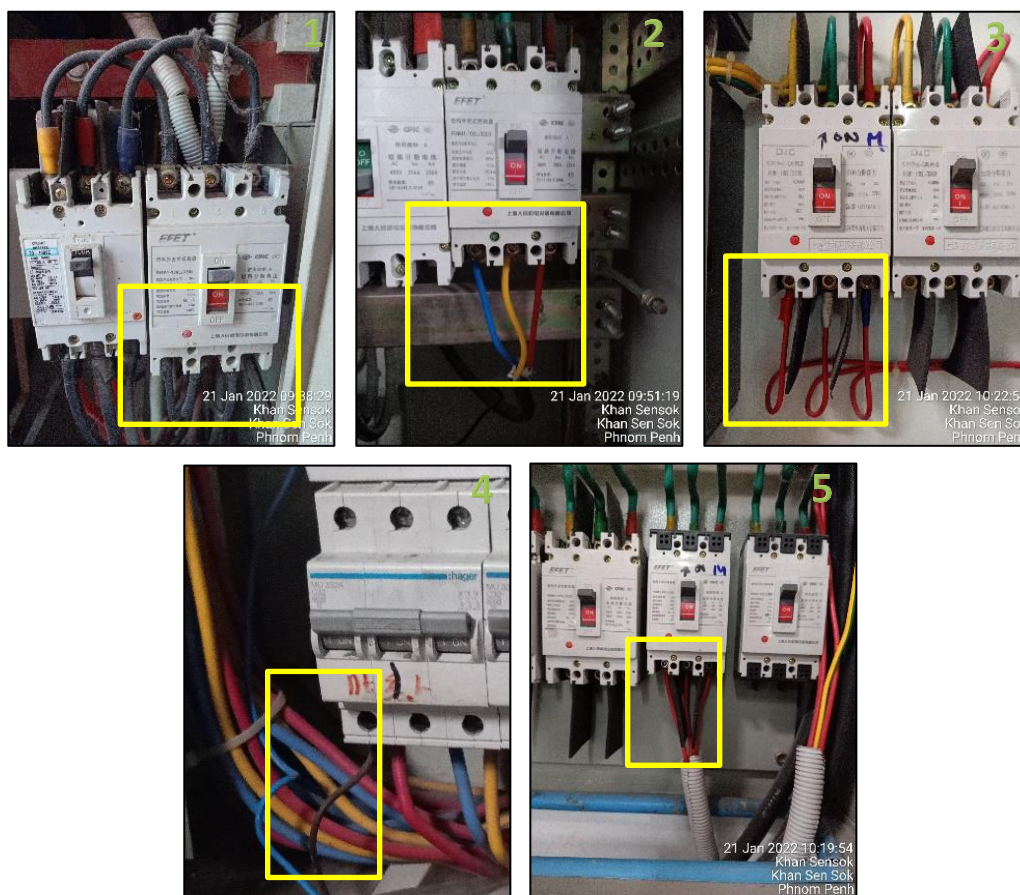
Figure 52: Under size of cable cross-sectional area compare to circuit breakers:

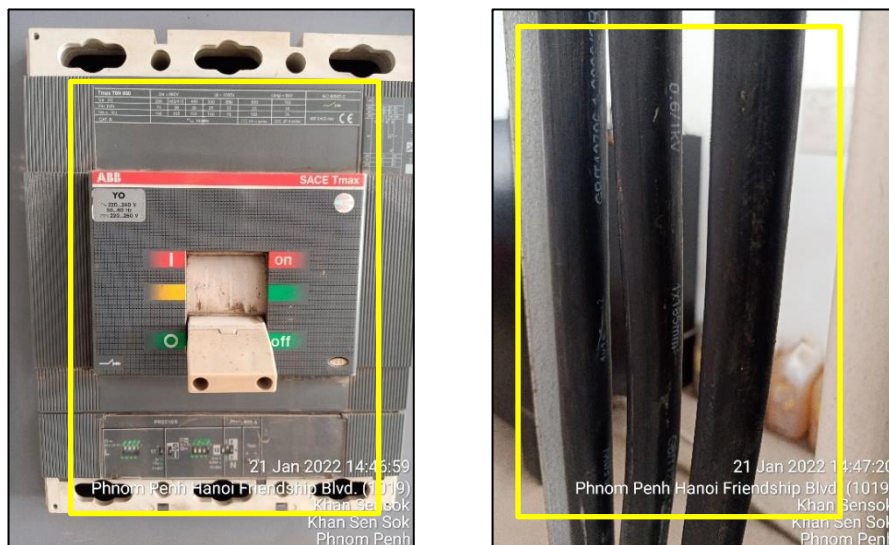
Figure 54: Under size of phases cable cross-sectional area compare to circuit breaker from Generator 02 panel to ATS panel inside Building C.

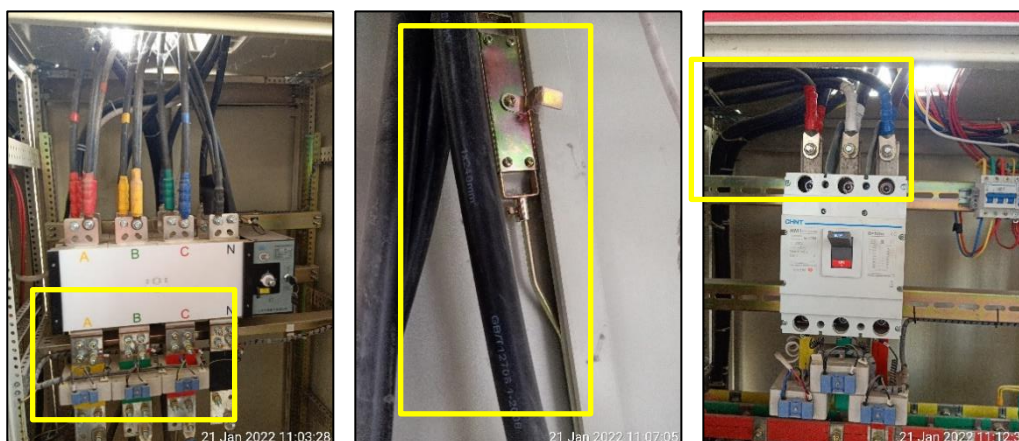
Figure 55: Under size of phases cable cross-sectional area 240sqmm from ATS panel to 800A circuit breaker in MDB-003B panel inside Building C.

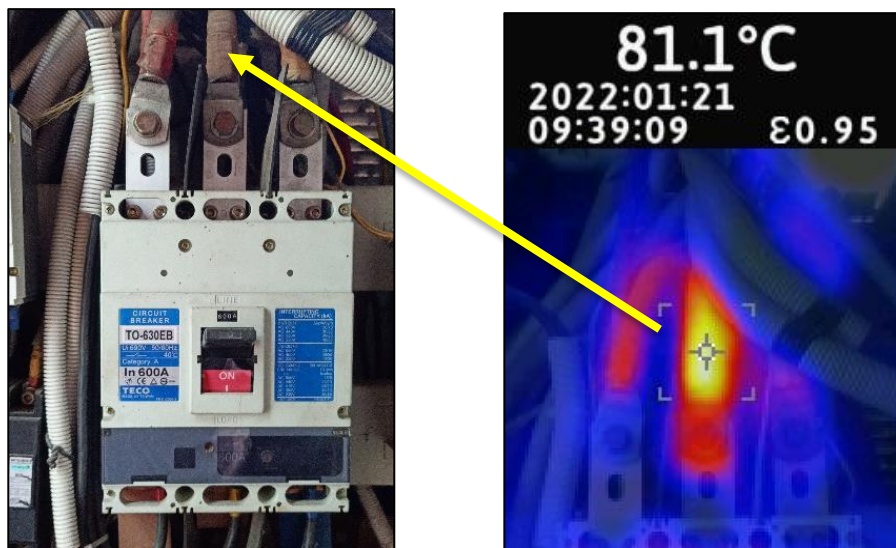
Figure 62: Inside the Electrical Panel "MDB-001B" in Building A and thermal scanning image
