LABS

Life And Building Safety

LABS - GOOD PRACTICES SHARING

22 March 2023

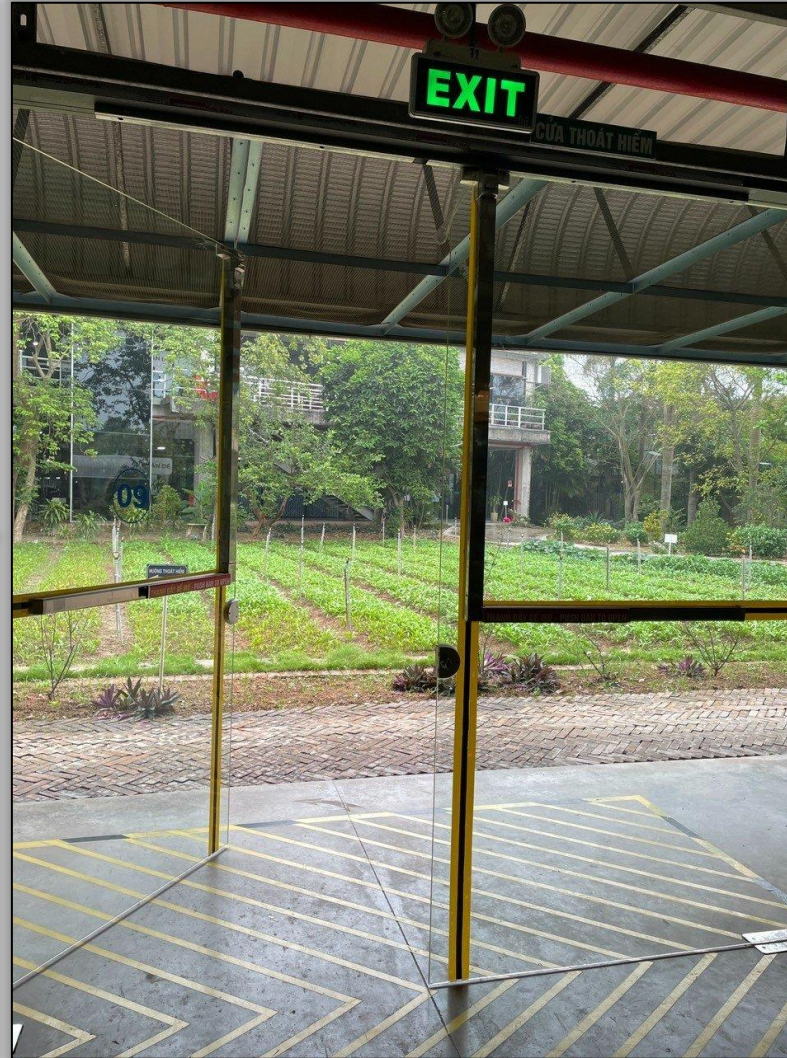
Locking mechanism on the exit doors

Identified

Remediated

1. **LABS Standard 6.9.4:** Doors shall not be locked in the direction of egress under any conditions. All existing hasps, locks, slide bolts, and other locking devices shall be removed.
2. **Challenges**
3. **Remediation quantity and cost**
4. **Remediation timeline**

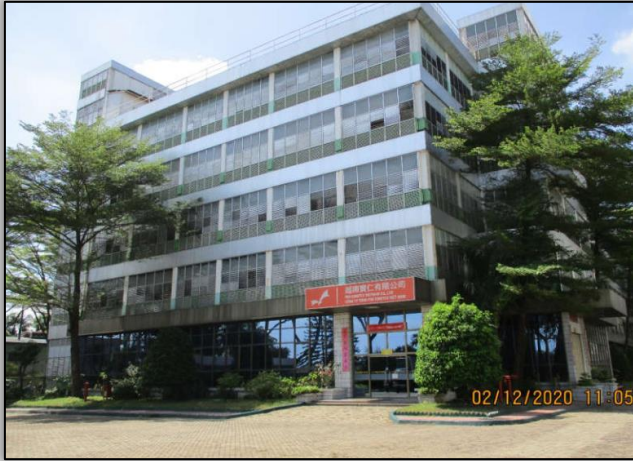
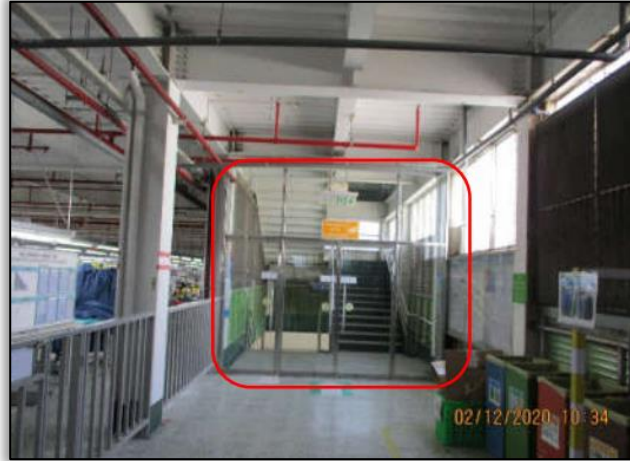
Fire rated enclosure of exit stairs

Inadequate fire rated enclosure of stairs for the multiple floors building

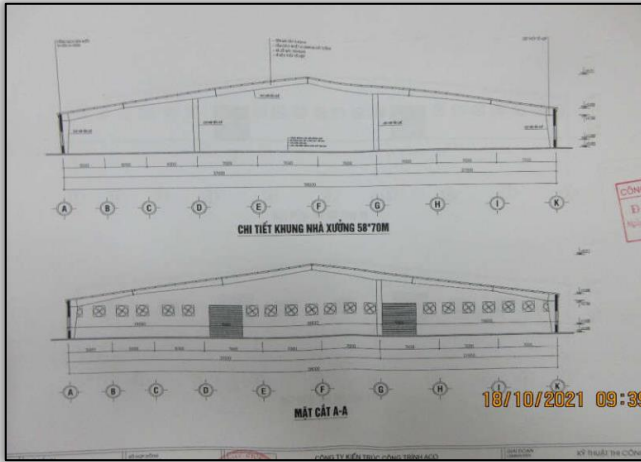
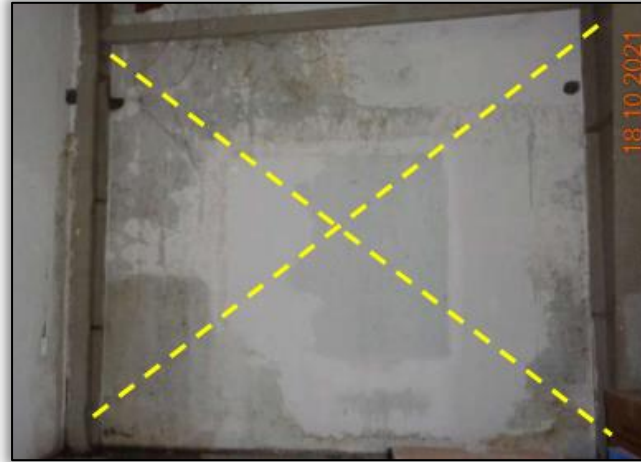
Missing column bracings in the production buildings

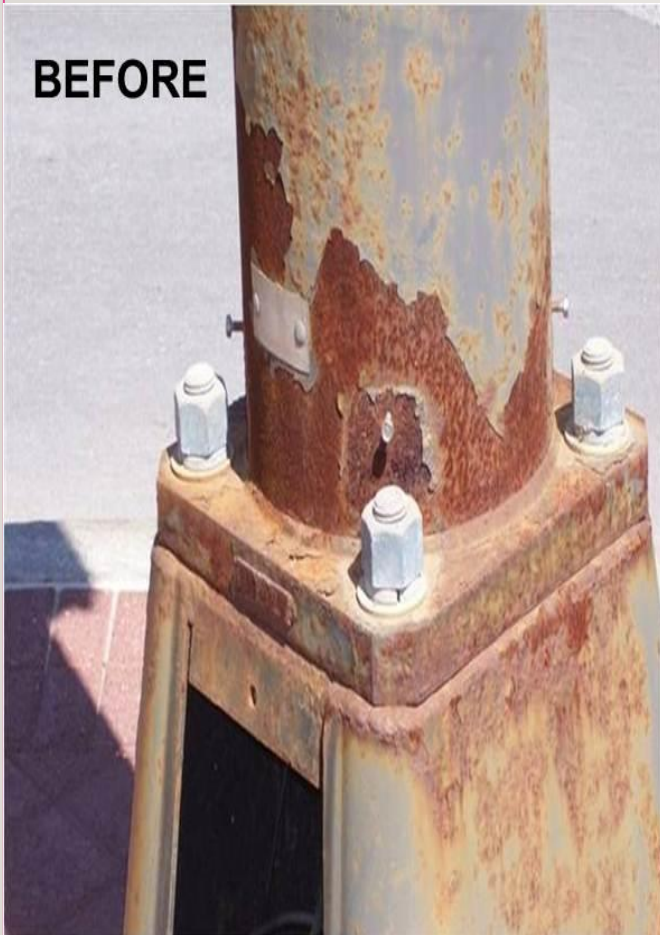
BEFORE

The surface of a reactive metal slowly reacts with the moisture and air present in the atmosphere; as a result, a brownish compound is formed on the surface. The compound formed on the surface makes the metal appear dull and deteriorate which results in the structural integrity fail (Load Bearing capacity) this leads to injuries and metal structure collapse accidents.

Process to remediate issue: The rusting of metal can be prevented by greasing, painting, galvanizing, anodizing.
