LABS
Life And Building Safety

LABS - GOOD PRACTICES SHARING

05th June 2025

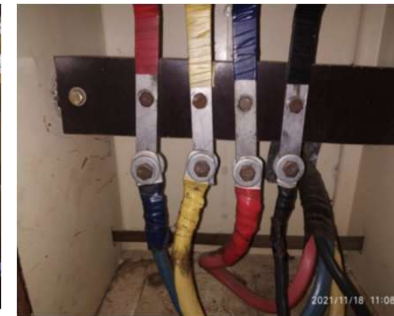
Rusted Nuts and Bolts In Electrical
Installation

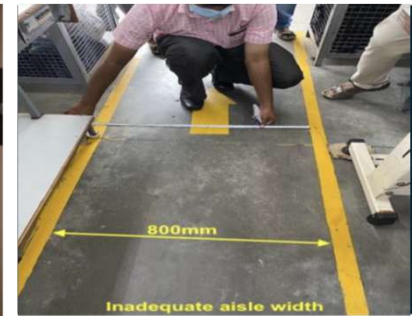
Inadequate Aisle Width

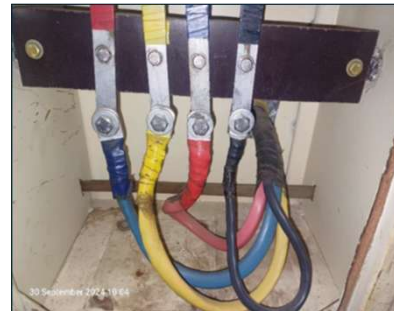
Replaced Rusted Nuts and Bolts in
Electrical Installation

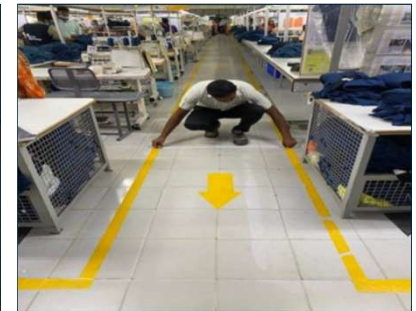
Adequate Aisle width is provided

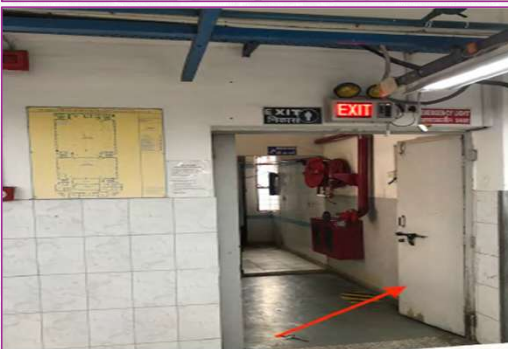
- Absence of fire-rated doors in the main exit at the production building.
- Fire-rated self-closing doors are not provided at protected staircases.
- Factory Building has more than two floors and the FR self-closing doors are not found provided on the stairs.

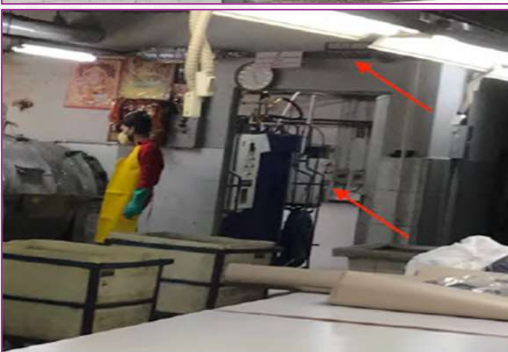
- Boilers installed on 2nd floor with washing without enclosure.
- Designated storage areas not separated by FR construction.
- Transformer room at Building 2 without FR-rated construction.

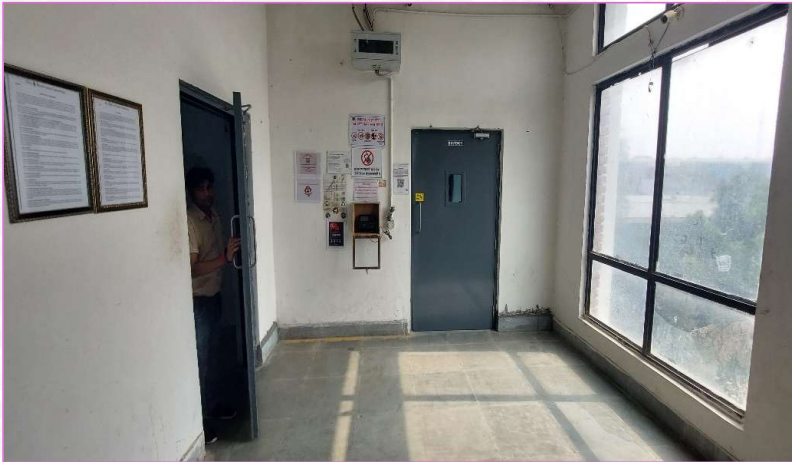
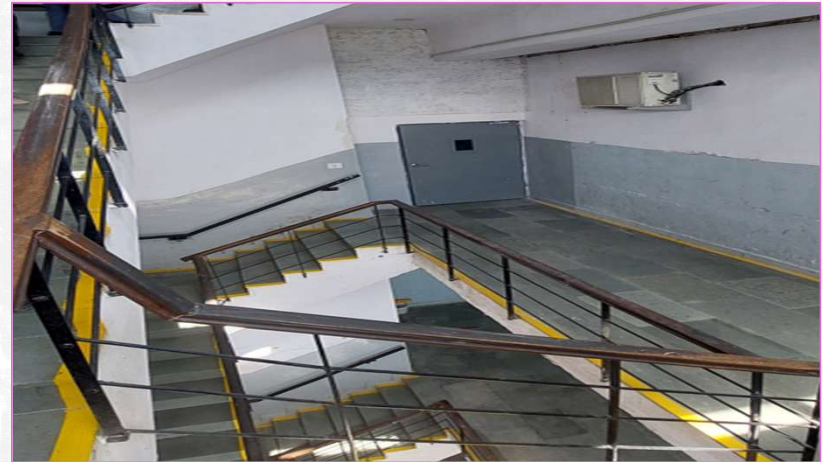
Observation - Factory Building has more than two floors and the enclosure for stairs is not found provided.

Staircase compartmentation with Fire doors

Staircase compartmentation with Fire doors & Brick work

CAP- Provide an enclosure in staircase that conceals all openings with fire-rated material to ensure the safety.

Remediation- The factory has replaced the normal doors with self-closing, fire-rated doors and sealed openings with brick walls

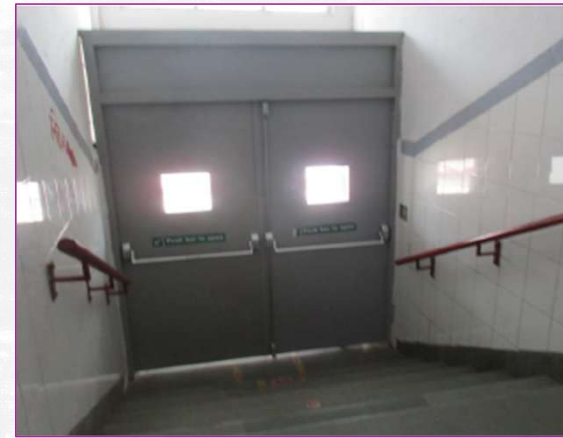
Observation- Fire-rated self-closing doors are not provided in any of the exits leading to staircase

Self-closing Fire door

CAP- Emergency exit to be provided with self-closing fire-rated door as per IS 3614

Remediation- The factory has replaced the normal doors with self-closing, fire-rated doors.

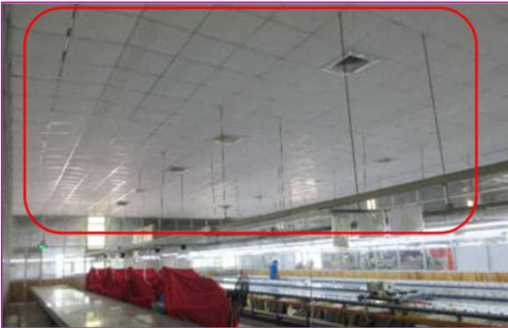
- Inadequate Fire Detector coverage.
- The provided smoke detection system is insufficient to cover the entire area of the factory.

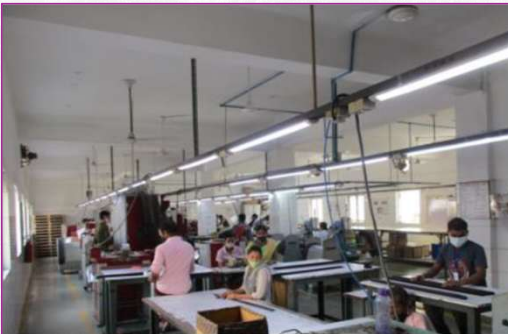
- Audible alarms with less commute observed in the basement and ground floor.
- Fire Alarm System were not installed in few locations.

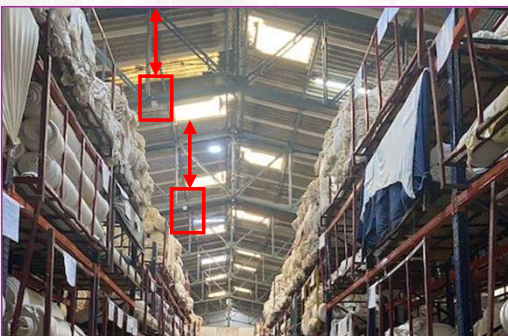
- Detectors are installed at low level from the true ceiling.
- Incorrect fire detector positioning was found at some places.

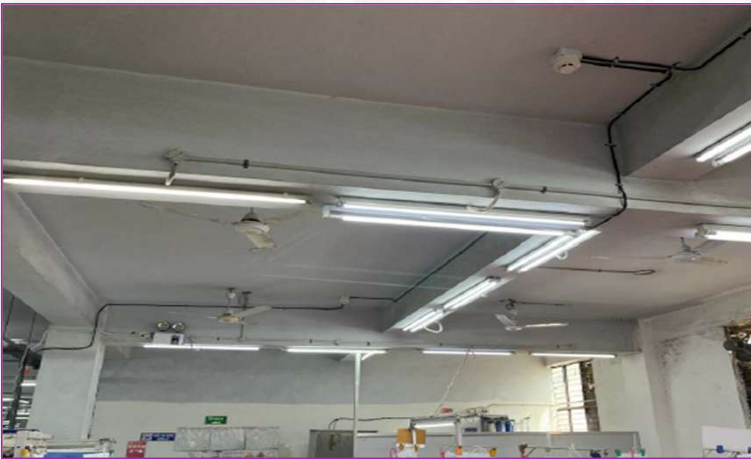
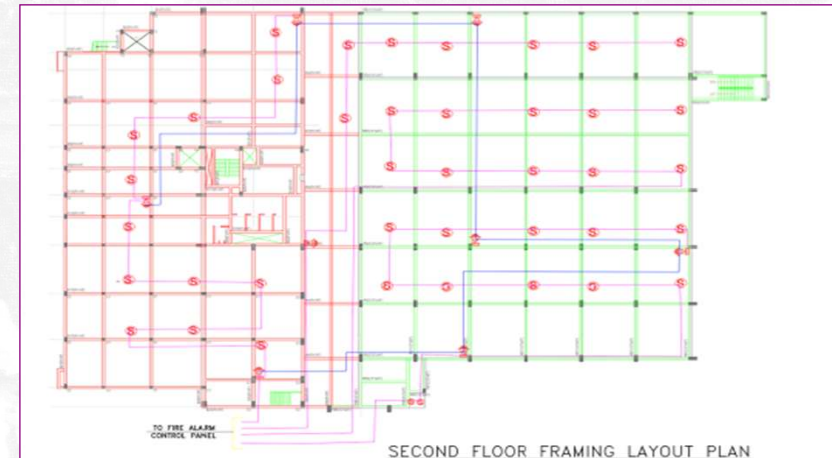
Observation - Factory basement section, North-East does not have any coverage of smoke detector .

Smoke detector installed

Smoke detector layout Plan

CAP- Smoke detection coverage would be provided in every location.

Remediation- The factory has installed a smoke detector synchronized with fire alarm panel.

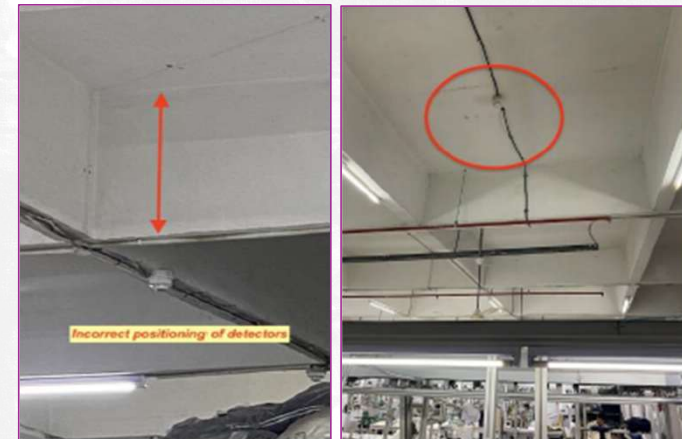
Observation — Smoke detector positioning was inadequate and found installed below ceiling level.

Smoke detector positioning before and after

CAP- Smoke detector would be installed over the highest and flat part of ceiling .

Remediation- The factory has installed beam type smoke detector over ceiling more than 20 feet and replaced smoke detector to the highest point of the ceiling in 14 ft ceiling.

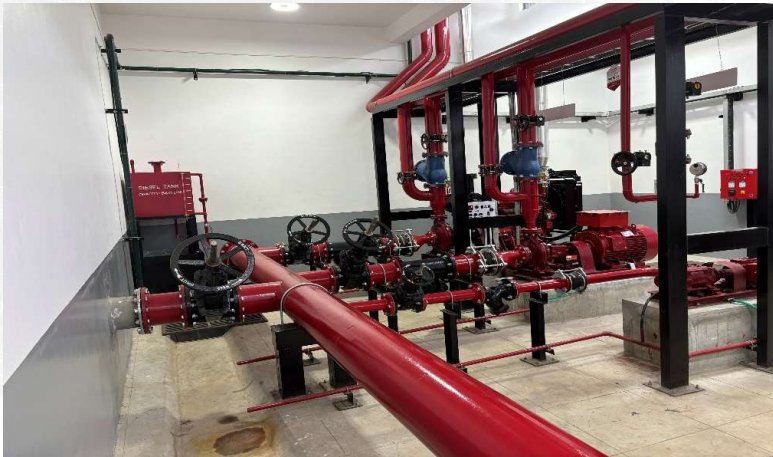
- Absence of fire pumps in the installed fire water line at the premises.
- Pump-set back-up not provided
- Only single fire pump installed for fire-fighting purpose.
- Diesel backup fire pump not provided.

All 3 Fire pumps are installed

CAP- Ensure adequate fire pumps with electric and non-electric backup for firefighting.

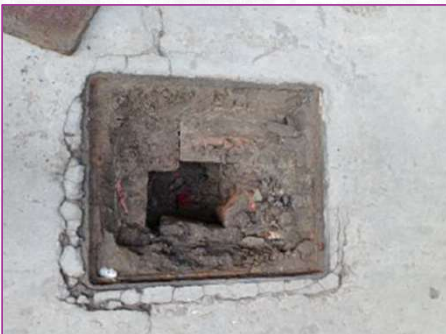
- Earth pits were found not maintained properly.
- Detail & layout plan of earth pit not available with the factory.

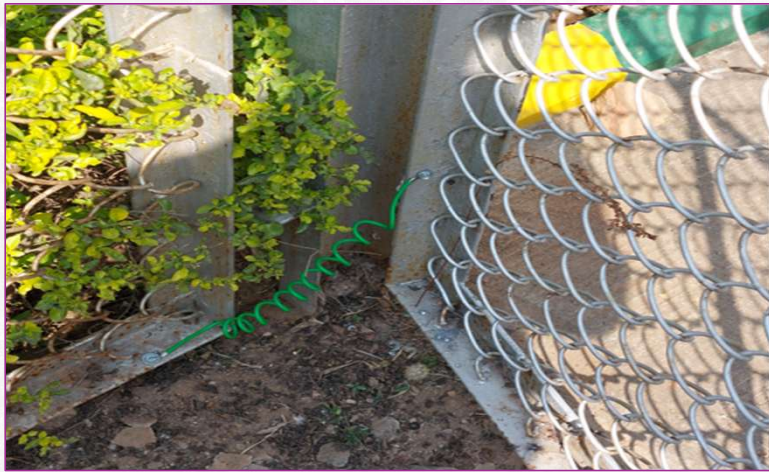
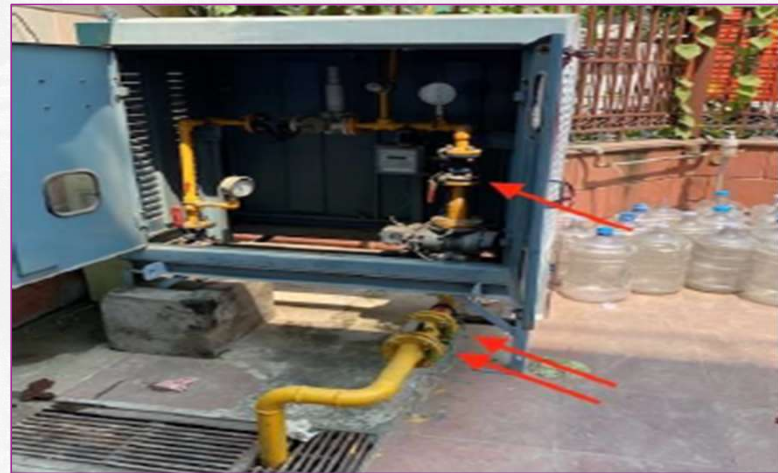
Observation — Bonding not provided over transformer gate/diesel tank .

Bonding provided over transformer gate

Bonding provided over LPG gas pipeline

CAP- Bonding will be provided over to dissipate charge safety from advised system.

Remediation- The factory has provided bonding to dissipate the static charge and to keep all conductors at the same potential.

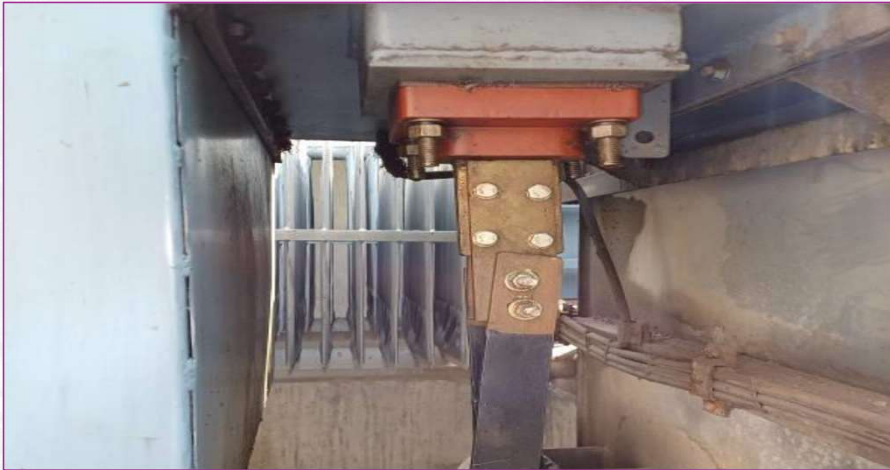
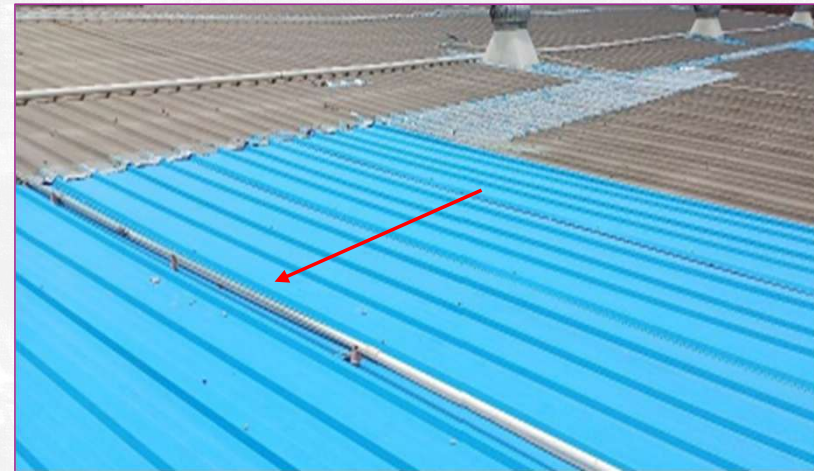
double Earthing provided to transformer

Eearthing provided to MS truss

CAP- Factory will identify missing earthing in panels and provide earthing as per electrical standards.

Remediation- The factory has installed copper strips for earthing in specific locations as a remedial measure.

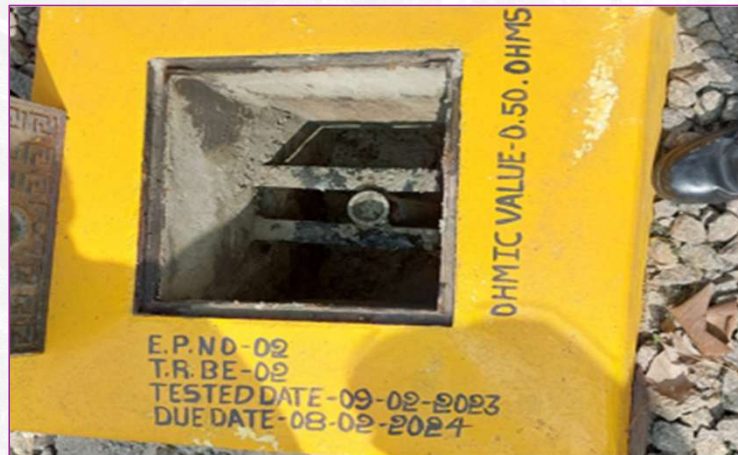
Observation — Earth pit were found poorly maintained/Earthing were found disconnected with earth strips

Earth pit maintained and monitored.

CAP- All earth pits will be maintained as per standard continuity check and resistance check will be carried out on same.

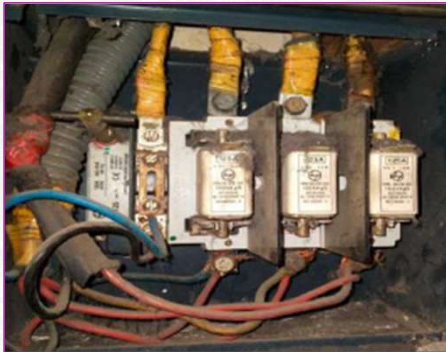
- Lint & Dust observed inside electrical panels.

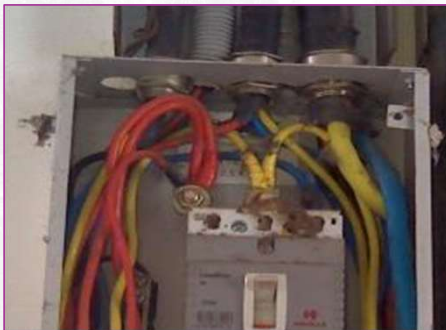
- Cables were not terminated with proper lugs and glands
- Glands were missing inside the electrical panel, allowing access for insects.

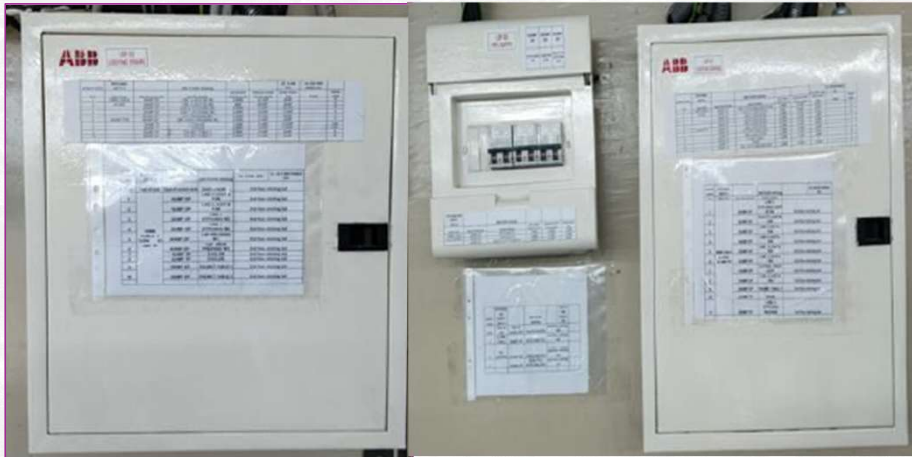
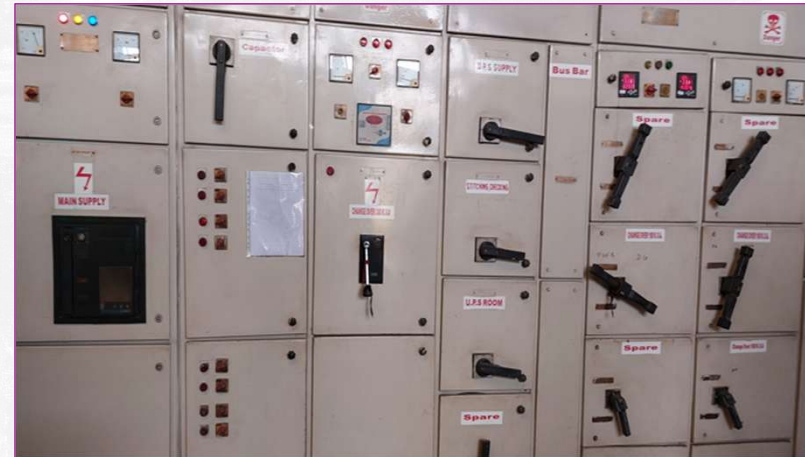
Observation — Proper identification markings were not provided on distribution boards, and current carrying capacity not calculated.

Current carrying capacity calculated and posted over DB

Proper identification provided over panel

CAP- Distribution board identification and current carrying capacity will be prepared .

Remediation- The factory has provided proper identification over panel.

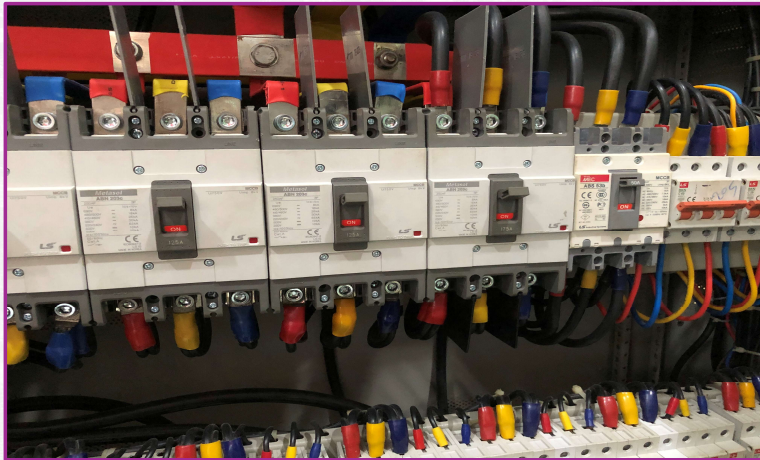
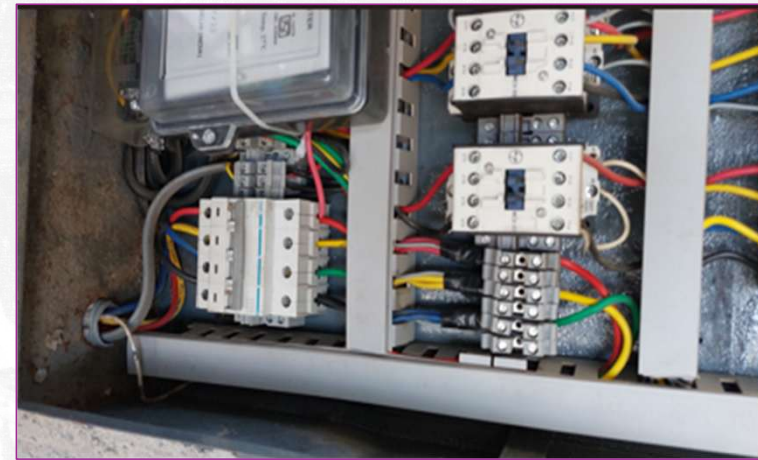
Observation – Lint & dust were observed inside the electrical panel.

Electrical panel has been cleaned.

CAP- Lint and dust would be cleaned and a monitoring plan would be set up.

Remediation- The factory has cleaned electrical panel and implemented a weekly checklist to prevent lint accumulation in panel.

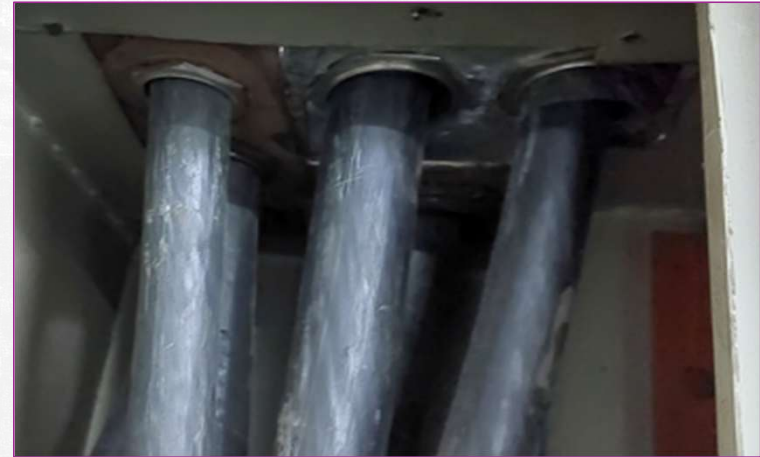
Glands provided over electrical panel

Remediation- The factory has provided lugs and glands in electrical panel. use of lugs and glands incorporated in SOP

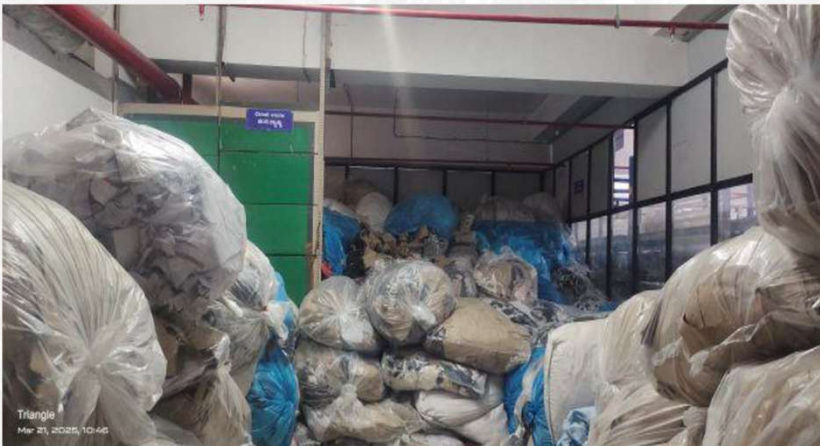
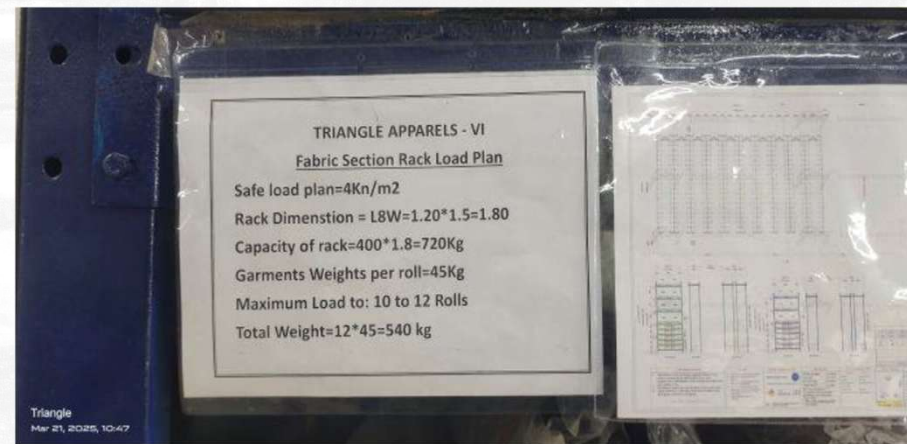
Controlled Storage

Load plan for the racking systems

Remediation- The factory has floor load plans and monitoring system at regular intervals

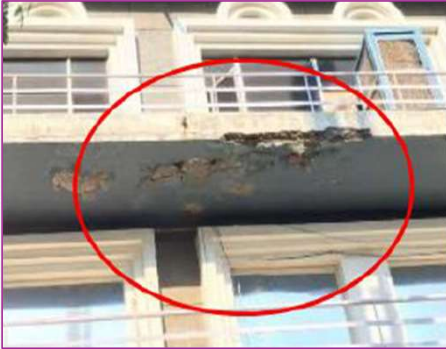
- Significant corrosion making the structural element (beams, columns, truss) etc ineffective that may lead further structural damage.

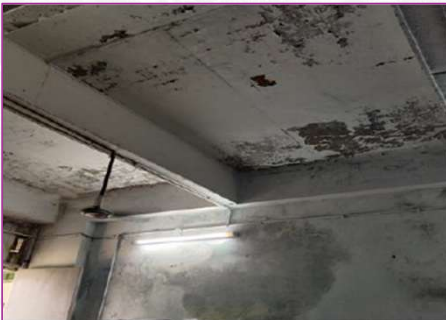
- Dampness observed over Floor Roof and walls.

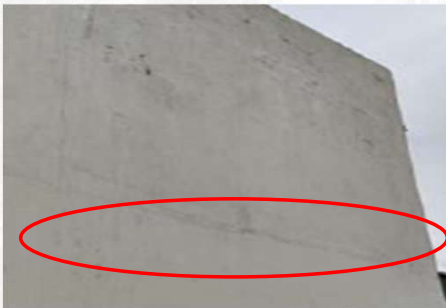
- Cracking observed over back side of building
- Cracks were observed over columns/beams

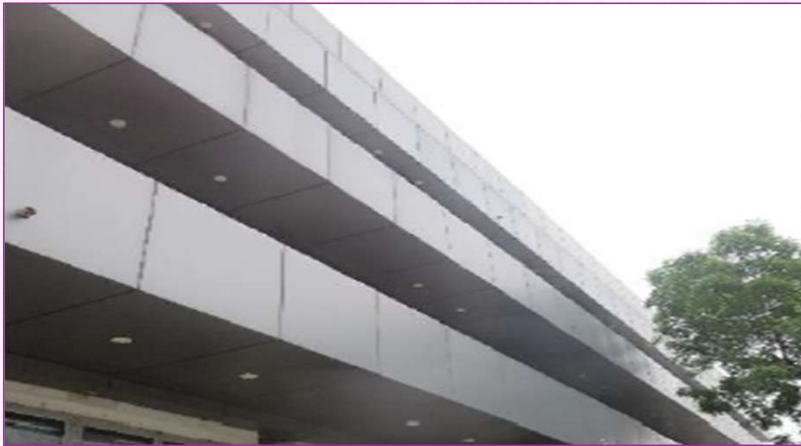
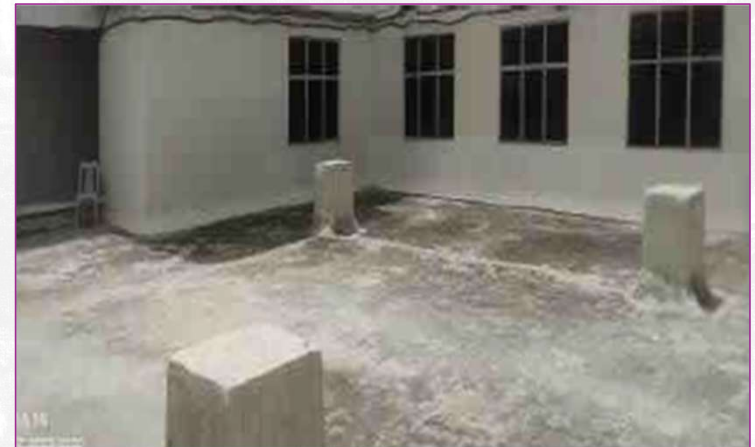
Observation — The structure element was found corroded.

Corroded structure repaired and covered

Corroded bars were repaired from column

CAP- Will review the corroded structure and repair it.

Remediation- The factory has repaired corroded structure members .

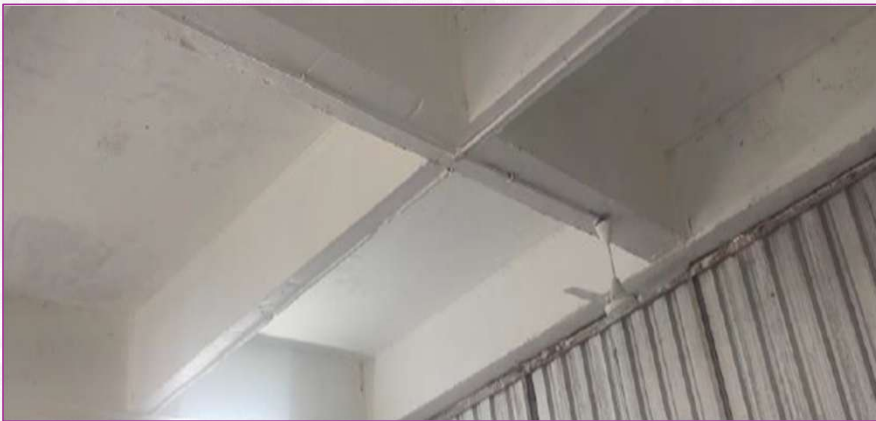
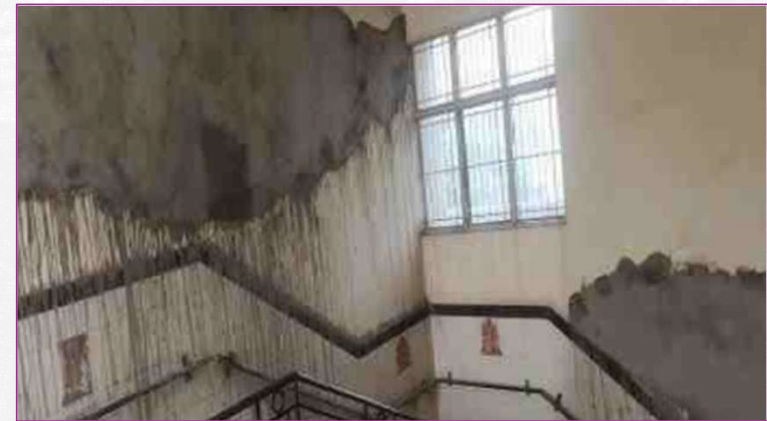
Observation — wall cladding/backside wall observed for dampness

Dampness has been addressed

Dampness Repairs work has been done

CAP- Factory will review structure with NDT test for impact of dampness over structure and repair dampness.

Remediation- The factory has repaired dampness and removed leakages causing dampness.

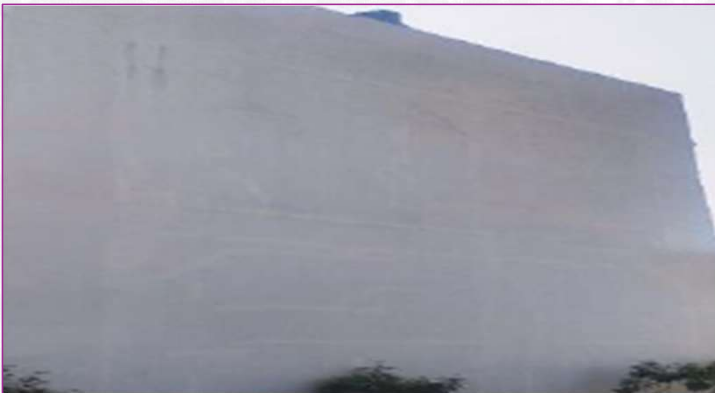
Observation — Cracks were observed on external wall/internal wall.

Non structural cracks were repaired

The factory situated at Khasra no. 15/19&22, Village Begumpur, Khatola, Gurugram, Harayana was visited by our engineer on 04-03-2024. The said brick wall is a non-structural filler wall. The cracks visible are due to the poor construction methodology and workmanship, along with the wear and tear. The said cracks are repaired by introducing reinforcement to stitch the cracks and finish the area with Murga jaali, mortar and plaster.

CAP- Will review cracks and get them repaired as per structural review.

Remediation- The factory has repaired cracks and initiated a structure audit to prevent reoccurrence of cracks

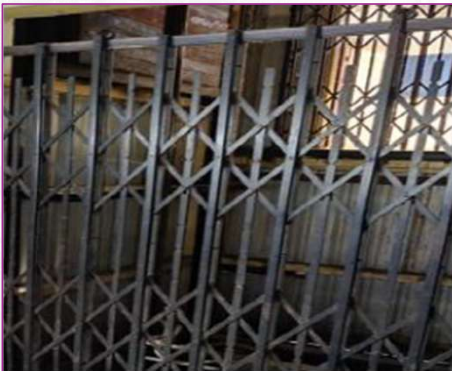
- Goods Lift Side walls & 2nd floor External walls at North, West Side found to be inadequate to resist later forces

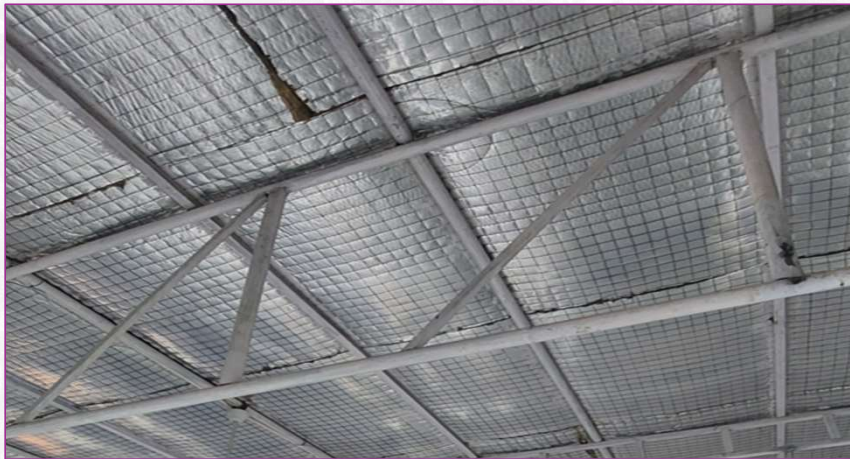
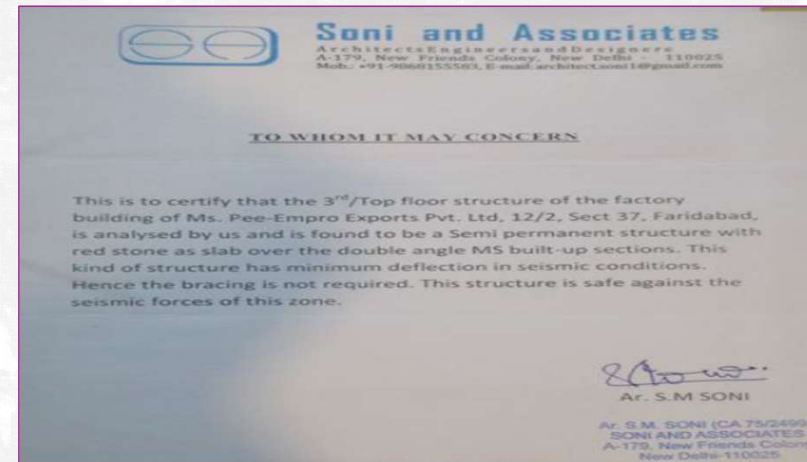
- Seismic bracings are not provided for added MS structures as lateral support structural system.

Bracing to MS structure

Survey report

Remediation- The factory has appointed structural consultant and provided bracing along with survey report
