**LABS Initiative**

## Methodology for Preliminary Safety Assessments in Cambodia

Issue 6| 22 April 2022

**Archetype**

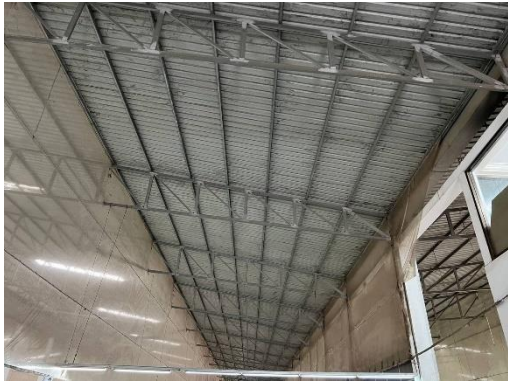
Ref No.	Issue Type	Sub-Issue Type
STR1	S2 –Lateral Structural System	Steel buildings: Bracing missing/incomplete
Observations: No bracing were observed in Building A, B and C.

<p>Figure 33: The vertical support system not apparent</p>

Issue type	S2 –Lateral Structural System
Sub Issue Type	Steel buildings: Bracing missing/incomplete
Reference Number	STR1
Details Of Issue Found	No bracing was observed in Building A, B and C
CAP Priority	SP3
Recommended Action Deadline Date	07 Sep 2022
Responsible Person	
Recommended Action	Factory to appoint Structural Engineer to check the tighten of bracing systems in the factory then propose the properly remedial measures if needed. Refer to Clause 8.18 of the LABS Standard
Comments	
Photo(s)

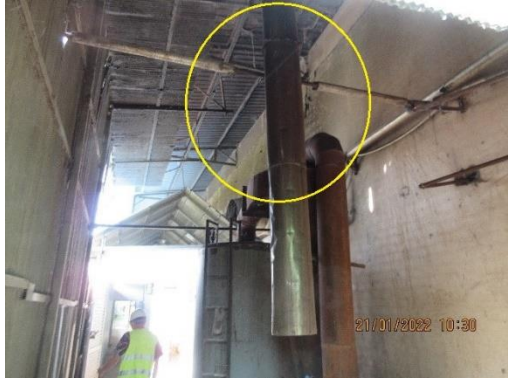
<p>Figure 34: The vertical support system not apparent</p>

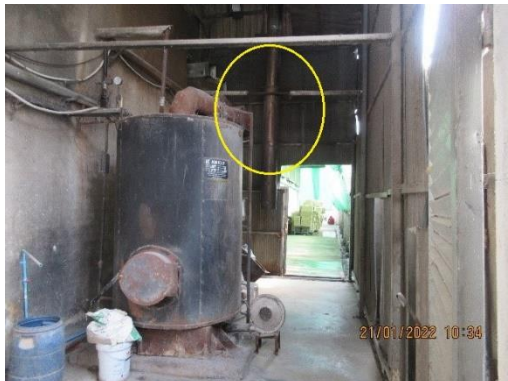
Ref No.	Issue Type	Sub-Issue Type
STR1	S9 – Maintenance	Lack of maintenance
Observations: The vertical support system was not apparent, the old chimney was hung without support

<p>Figure 33: The vertical support system not apparent</p>

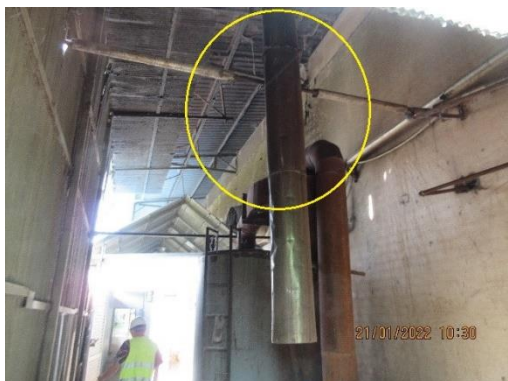
<p>Figure 34: The vertical support system not apparent</p>

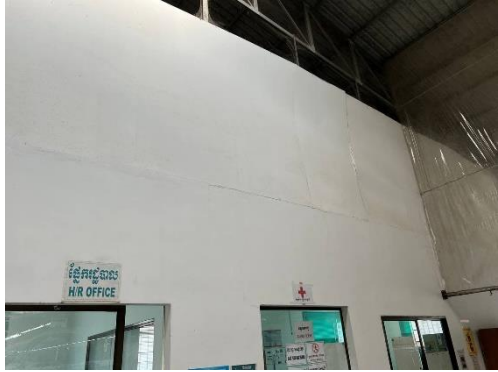
Ref No.	Issue Type	Sub-Issue Type
<b>STR2</b>	S6 – Visible Distress in Non-Structural Members	Cracking
Observations: Smartboard wall at HR/Nurse Office was cracked and bended

<p>Figure 36: Smartboard wall was cracked and bended</p>

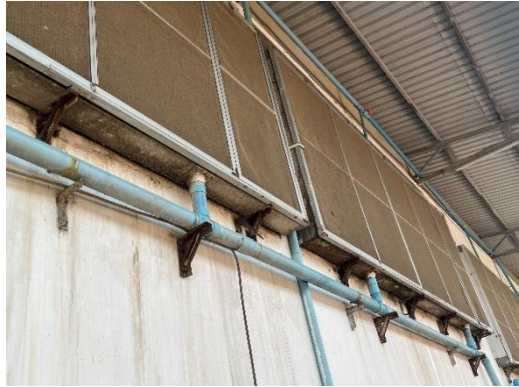
Ref No.	Issue Type	Sub-Issue Type
<b>STR3</b>	S9 – Maintenance	Structural steelwork corrosion
Observations: Steel support corrosion at building B

<p>Figure 38: Steel support corrosion</p>

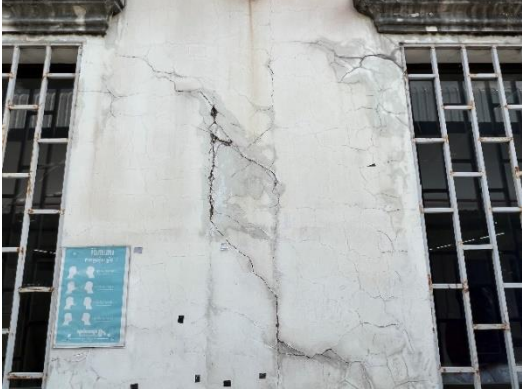
Ref No.	Issue Type	Sub-Issue Type
STR4	Visible distress in nonstructural members	Cracking
Observations: Wall cracking at building A, B, C, and Hostel building

Figure 39: Wall cracking at building A

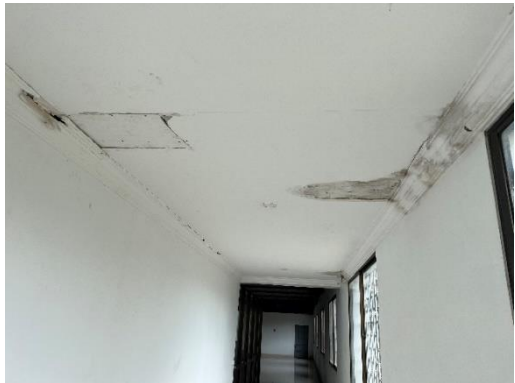
Ref No.	Issue Type	Sub-Issue Type
STR5	Maintenance	Lack of maintenance
Observations: Ceiling has been damaged by water leakage at building A and mezzanine floor building A

Figure 47: Ceiling has been damaged at building A		Figure 48: Ceiling has been damaged at mezzanine floor

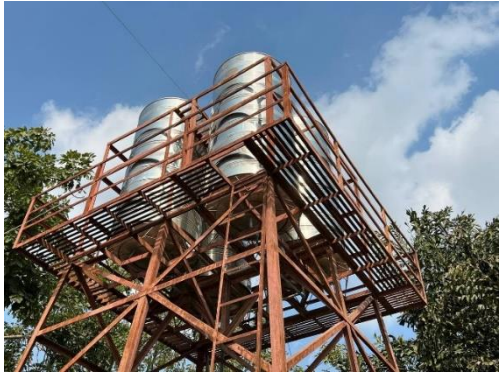
Ref No.	Issue Type	Sub-Issue Type
<b>STR6</b>	Vertical structural system	Water tanks on suspended floors/roof
Observations: Non-engineered and corroded steel structure supporting the water tank

<p>Figure 50: Visible corrosion on steel structure</p>

Issue type	S1: Vertical structural system
Sub Issue Type	Water tanks on suspended floors/roof
Reference Number	STR6
Details Of Issue Found	
CAP Priority	SP2
Recommended Action Deadline Date	23 Mar 2022
Responsible Person	
Recommended Action	
Comments	
Photo(s)

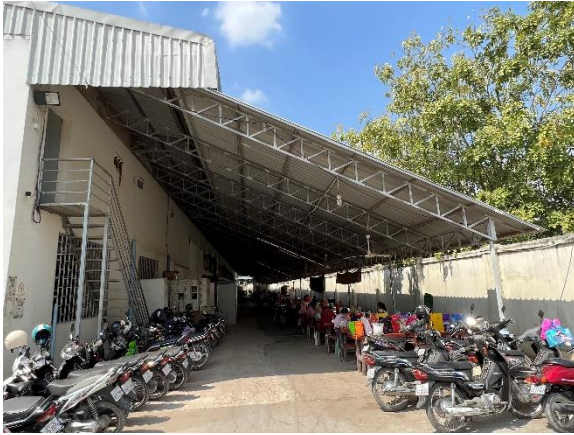
Figure 53: Dining Table Area

Observations: Dining Table Area, Generator room, Compressor Room, Scrap fabric storage, Workshop were built with unskilled worker

Issue type	S7: Performance of Extensions/Additions
Sub Issue Type	Non-engineered structural additions
Reference Number	STR4
Details Of Issue Found	Dining Table Area, Generator room, Compressor Room, Scrap fabric storage, Workshop were built with unskilled worker

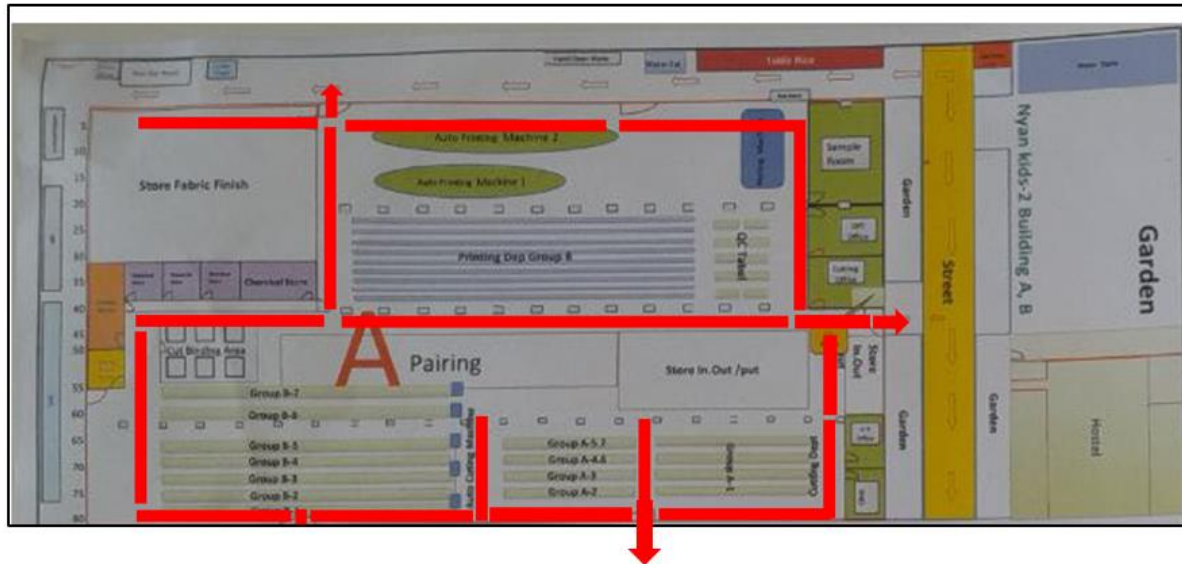
Figure 7: Escape Path and Final Exit for Building A

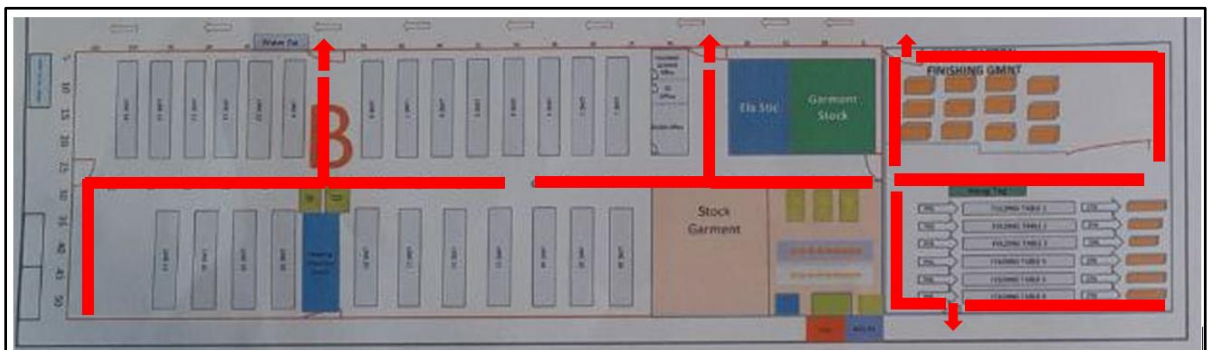
Figure 8: Escape Path and Final Exit for Building B

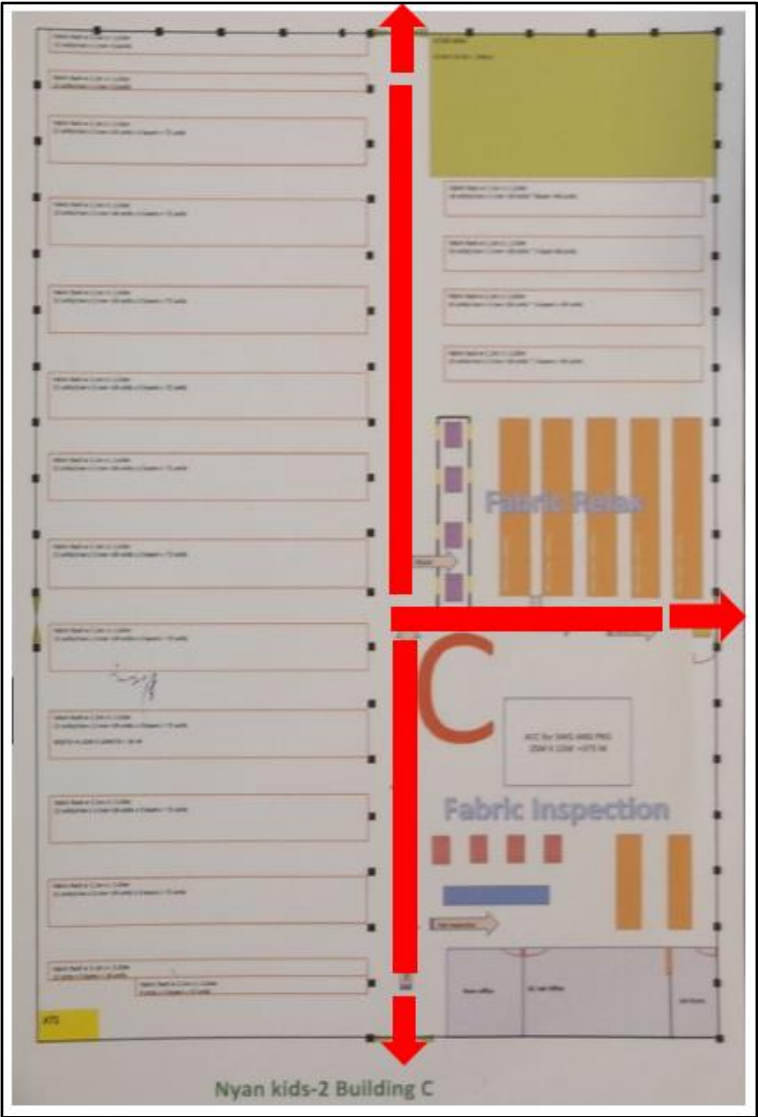
Figure 9: Escape Path and Final Exit for Building C

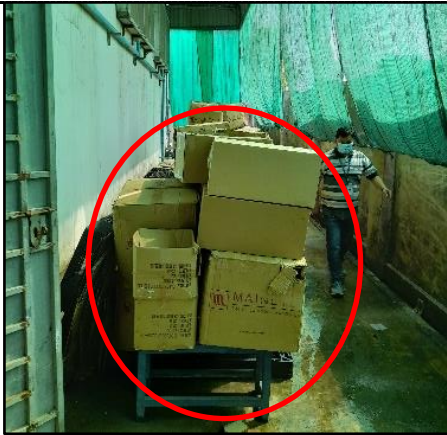
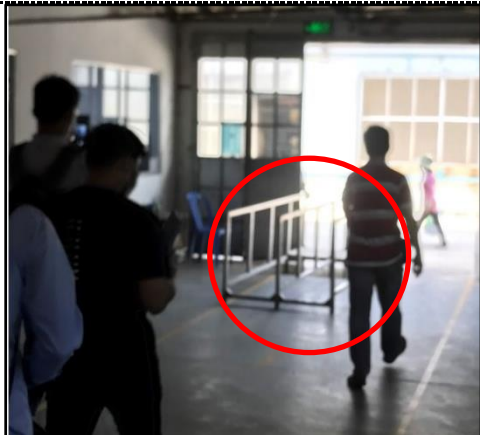
Ref No.	Issue Type	Sub-Issue Type
FIRE-01	Means of Escape	Exit door
<b>Observation</b>		<b>Location:</b> Behind Production Building B
Exit door was not free from temporary obstruction

Figure 12: Exit door was not free from temporary obstructed		Figure 13: Exit door was not free from temporary obstructed

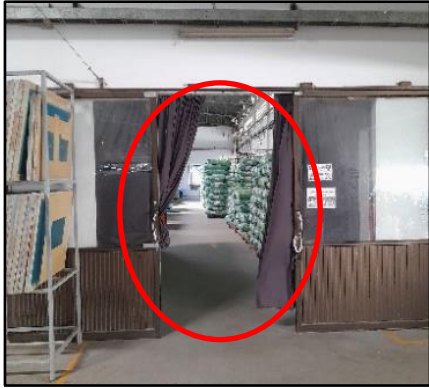
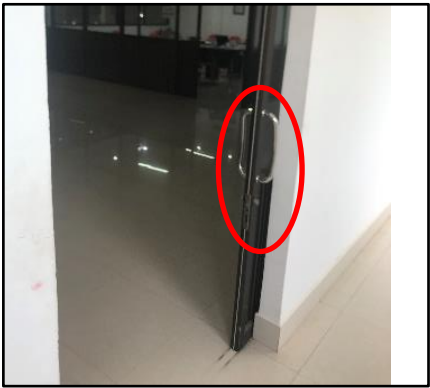
Ref No.	Issue Type	Sub-Issue Type
FIRE-02	Means of Escape	Exit Door
<b>Observation</b>		<b>Location:</b> In building A
Exit door were not side hung to swing correctly

<b>Figure 14:</b> Door were not side hung		<b>Figure 15:</b> Door were not side hung

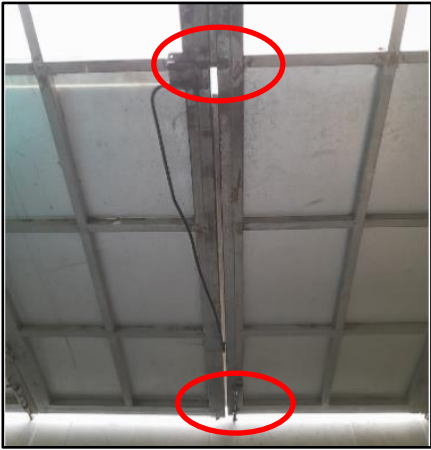
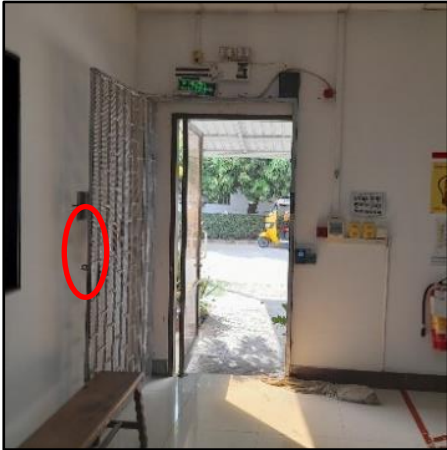
Ref No.	Issue Type	Sub-Issue Type
FIRE-03	F1: Mean of Escape	Exit doors
<b>Observation</b>		<b>Location:</b> All building
Exit Door have locking devices in all building

<b>Figure 16:</b> Exit door with lock device		<b>Figure 17:</b> Exit door with lock device
Ref No.	Issue Type	Sub-Issue Type

Recommended Action	Replace outside locks with locking mechanisms that allow easy opening from inside without the use of a key in accordance with Cl. 6.1 and 6.9 of the LABS Standard
Comments	
Photo(s)	<div style="display: flex; justify-content: space-around;"> <div style="text-align: center;">   <p>F1.4.2.1 Exit door with lock device.JPG</p> </div> <div style="text-align: center;">   <p>F1.4.2.2 Exit door with lock device.JPG</p> </div> </div>

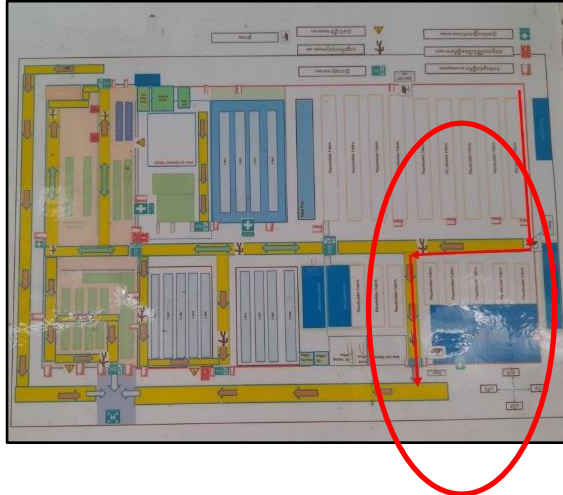
FIRE-04	Means of Escape	Floor Exit
<b>Observation</b>		<b>Location:</b> Building B
Travel distance to alternative exit was excessive in Building B

<p><b>Figure 18:</b> Travel distance building B is 83m</p>

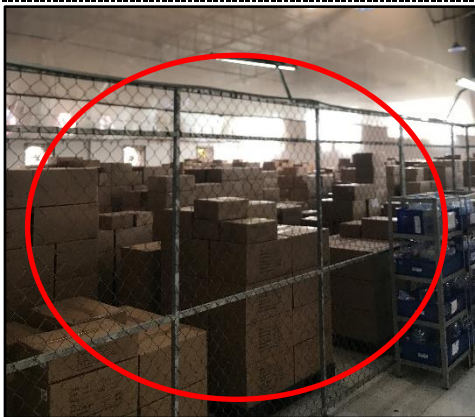
Ref No.	Issue Type	Sub-Issue Type
FIRE-05	Fire Safety Construction	Protection of opening
<b>Observation</b>		<b>Location:</b> Building B
Separation of different occupancies was incomplete

<p><b>Figure 19:</b> Separation of different occupancies was incomplete</p>

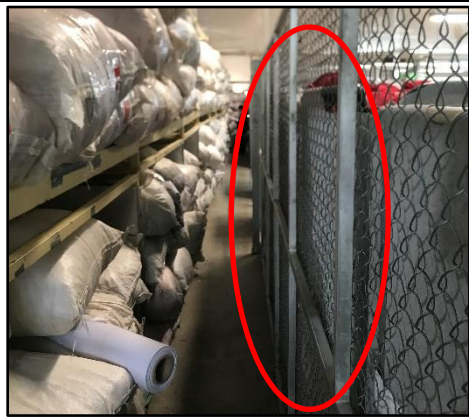
<p><b>Figure 20:</b> Separation of different occupancies was incomplete</p>

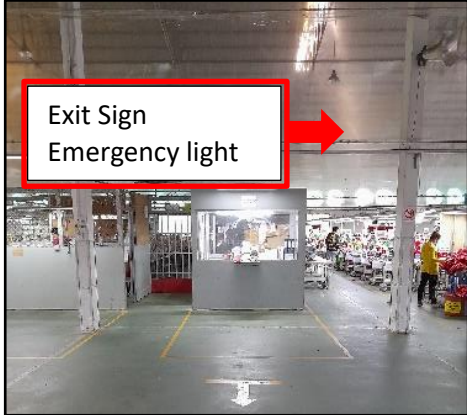
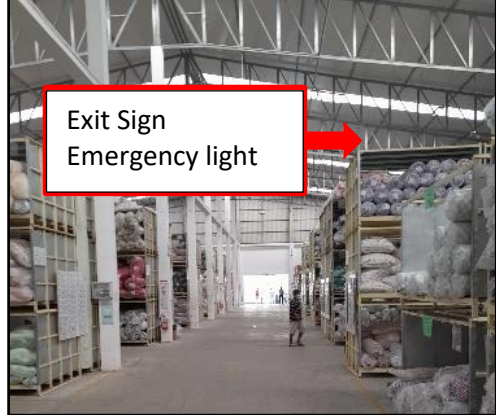
Ref No.	Issue Type	Sub-Issue Type
FIRE-08	F1: Mean of Escape	Exit Signage
<b>Observation</b>		<b>Location:</b> All building
Inadequate emergency light and exit sign for escape path

<b>Figure 23:</b> Inadequate emergency light and exit sign		<b>Figure 24:</b> Inadequate emergency light and exit sign

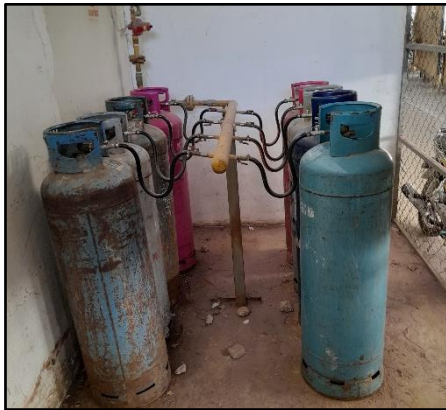
Ref No.	Issue Type	Sub-Issue Type
FIRE-09	F3: Fire Safety System	Fire Detection
<b>Observation</b>		<b>Location:</b> Gas storage close to Building A
No gas detector for gas storage close to building A

<b>Figure 25:</b> No gas detector for gas storage close to building A

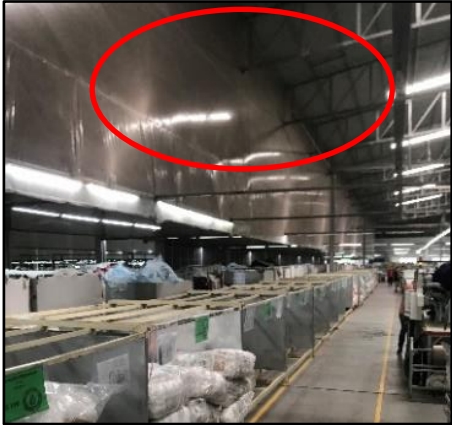
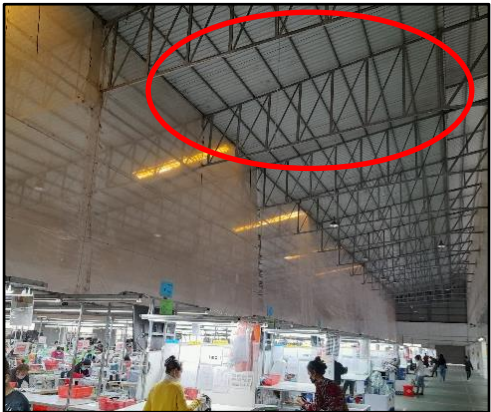
Ref No.	Issue Type	Sub-Issue Type
FIRE-10	Fire Safety System	Fire Detection
<b>Observation</b>		<b>Location:</b> Building all building
Inadequate Fire Detector Coverage

<b>Figure 26:</b> Inadequate Fire Detector-A		<b>Figure 27:</b> Inadequate Fire Detector-A

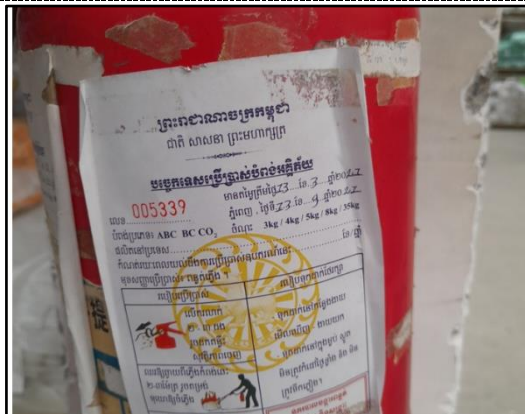
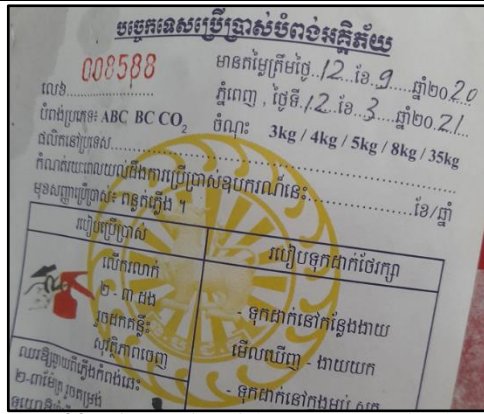
Ref No.	Issue Type	Sub-Issue Type
FIRE-13	F4: Provision for Fire Fighting System	Fire Fighting System
<b>Observation</b>		<b>Location:</b> Dormitory
Fire Extinguishers in dormitory were expired

<b>Figure 32:</b> Fire Extinguishers was not check		<b>Figure 33:</b> Fire Extinguishers was not check

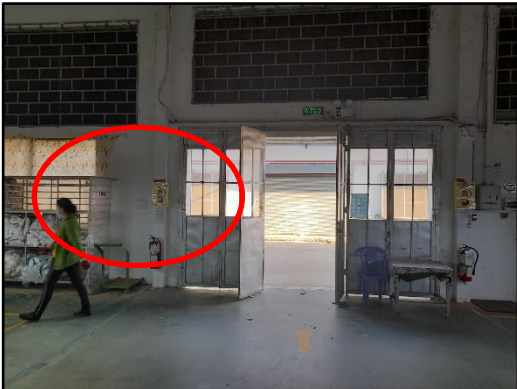
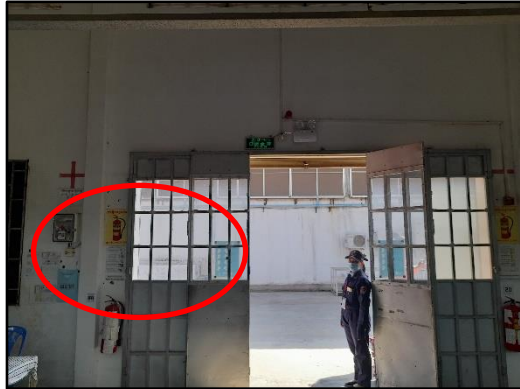
Ref No.	Issue Type	Sub-Issue Type
FIRE-15	Maintenance and House Keeping	Emergency Plan
<b>Observation</b>		<b>Location:</b> Building A and building B
Inadequate Emergency layout

<b>Figure 36: Inadequate Emergency layout A</b>		<b>Figure 37: Inadequate Emergency layout B</b>

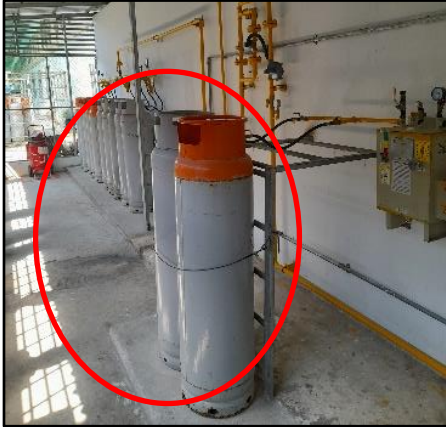
Ref No.	Issue Type	Sub-Issue Type
FIRE-16	Maintenance and House Keeping	House Keeping
<b>Observation</b>		<b>Location:</b> Building B
Over capacity gas storage behind building B

<b>Figure 38:</b> Over gas capacity storage behind building B

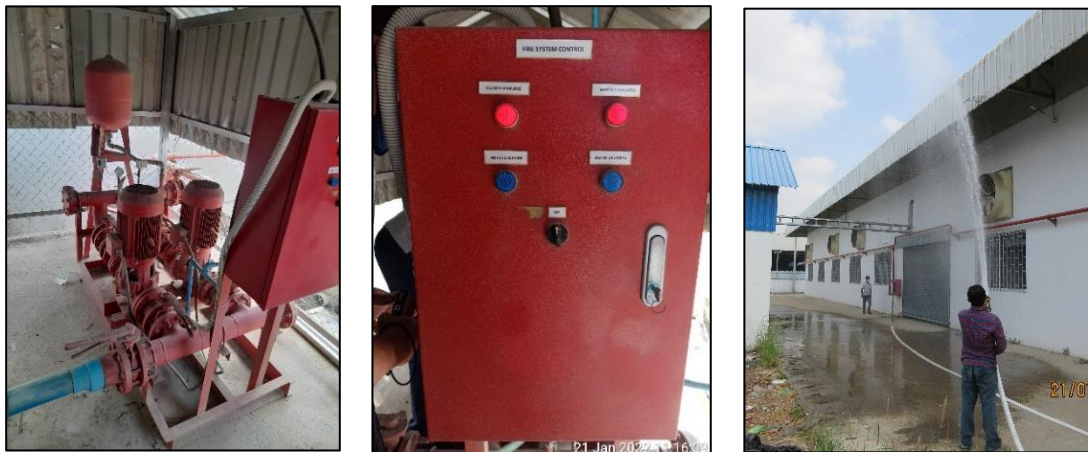
The fire pump station included 2 mains electrical pumps 11kW/each and no main diesel pump. Pumps can be started during testing.

Figure 7: Fire Pump Station and Fire Hose testing

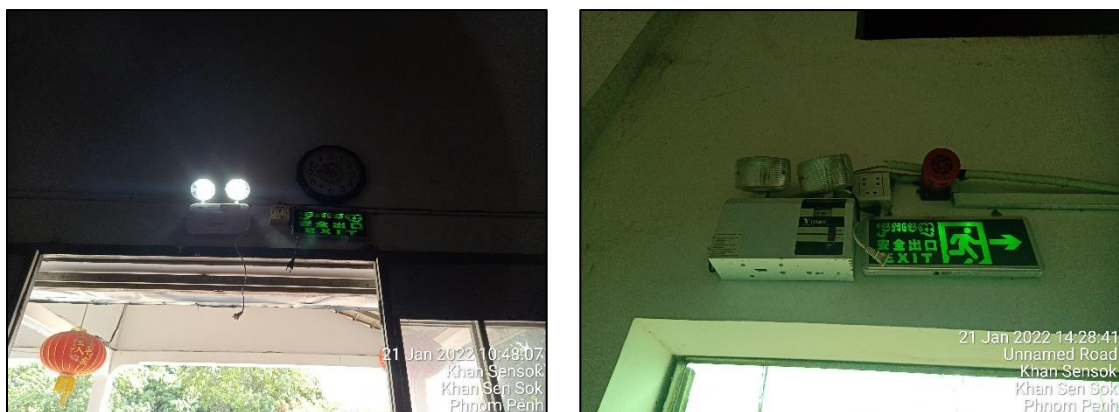
Figure 8: Emergency & Exit Lighting Testing Time at Building A

Random emergency and exit lights were tested at main production building; *some* were not working and some just lighted on less than 10 minutes with battery power.

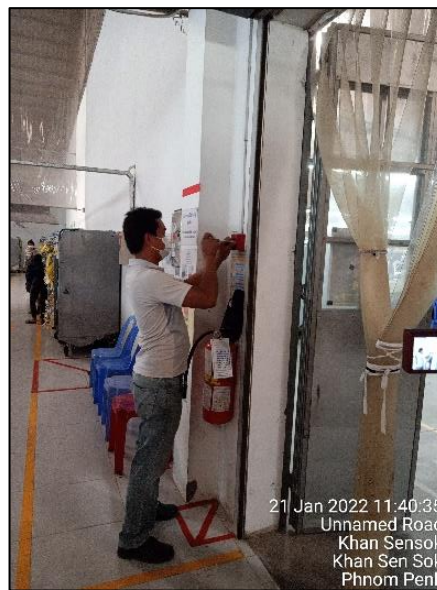
Figure 9: Fire Detection & Alarm (MCPs) tested at Building B.

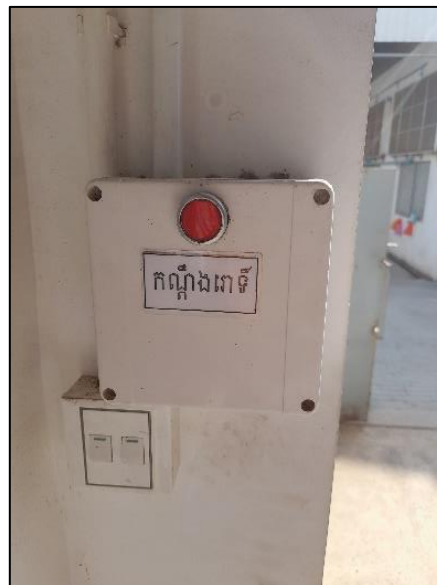
Figure 10: Fire Detection & Alarm (MCPs) tested at Building C.

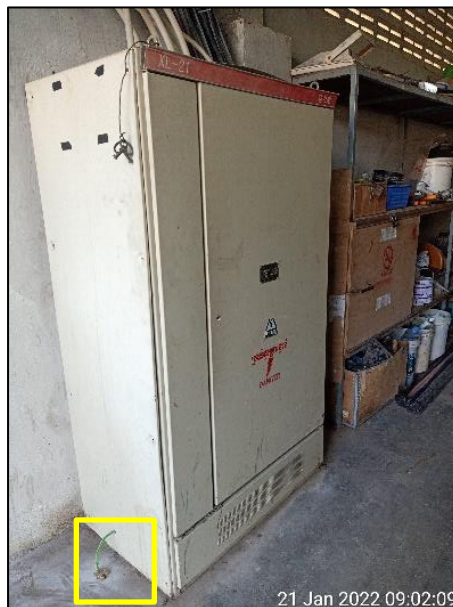
Figure 12: Incorrect size PE Earthing cable for generator panel at generator room.

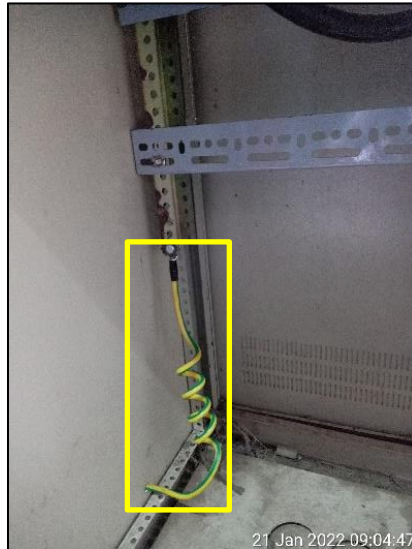
Figure 13: Incorrect PE Earthing cable installation for Electrical panel at building A

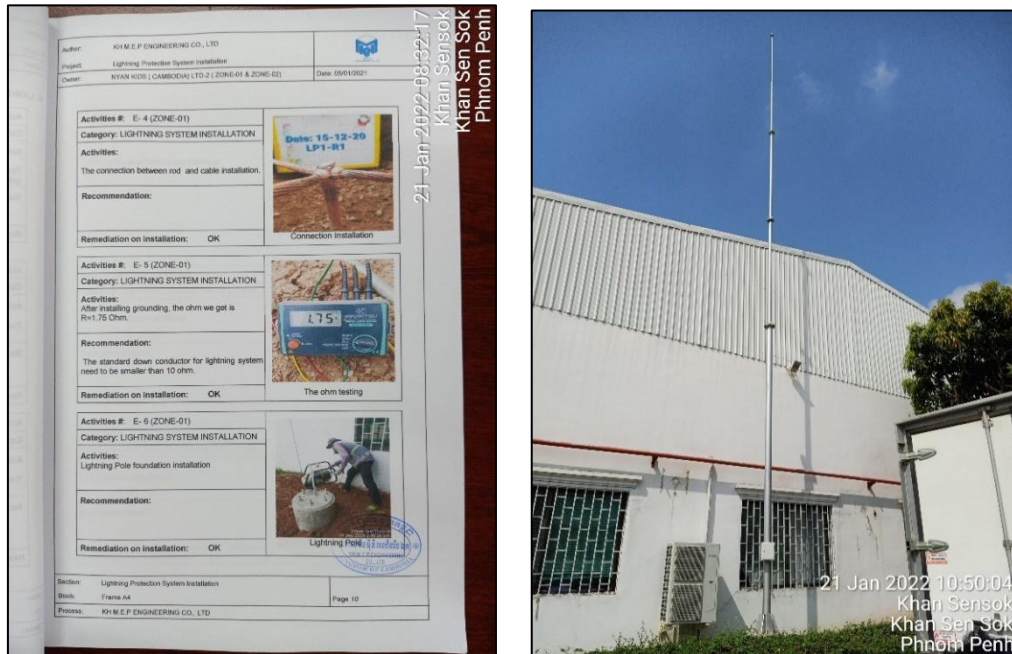
A new Early Streaming Emission (ESE) lightning protection system is provided on the roof top of Main Production Building, however, there was no Lightning protection layout and record of testing and report provided for review.

Figure 15: Lightning Protection System Air Terminal Zone 01 installed on Steel Pole near Building A with earthing resistance testing report.

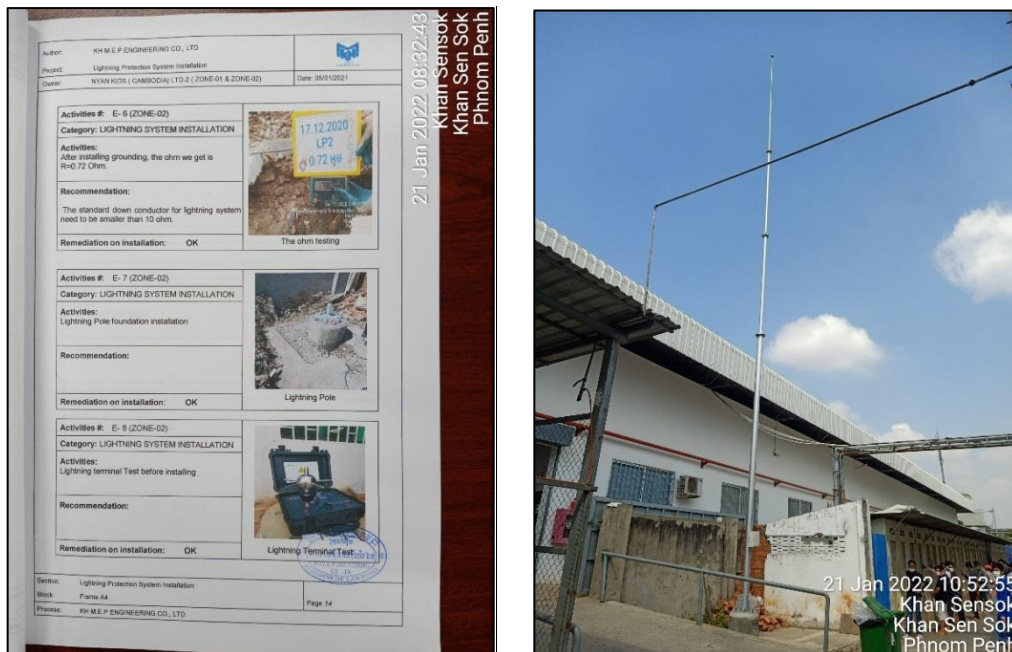
Figure 16: Lightning Protection System Air Terminal Zone 02 installed on Steel Pole near Building C with earthing resistance testing report.

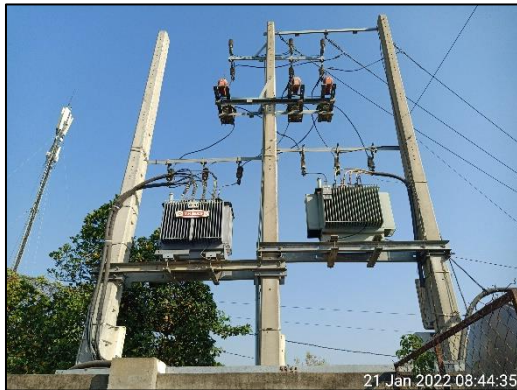
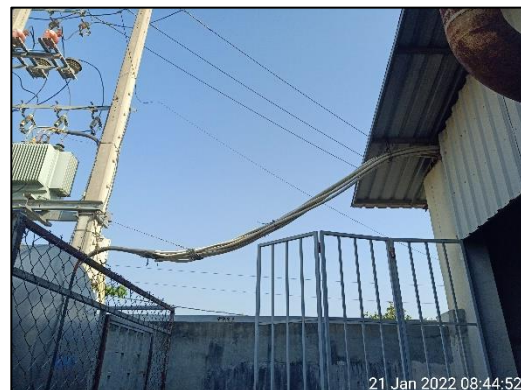
Figure 17: Pole mounted oil type transformers at outside of Factory Boundary (Belong to EDC) with overhead LV cables to LVMSB/MTS panel in Generator Room 01 near Building A.

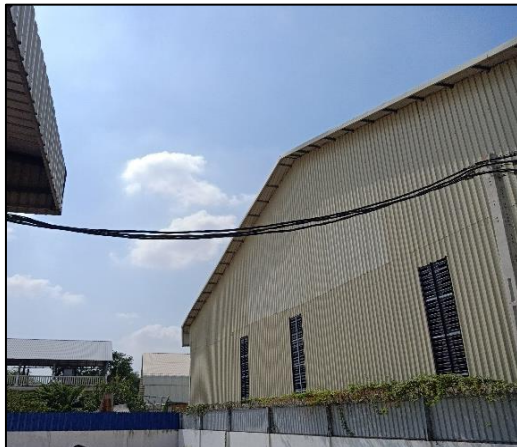
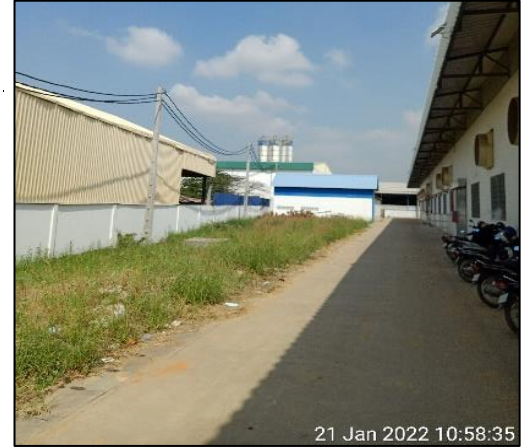
Figure 18: Incoming Overhead LV cables from another 400kVA Pole mounted oil type transformer to LVMSB/ATS panel in Electrical Room inside Building C.

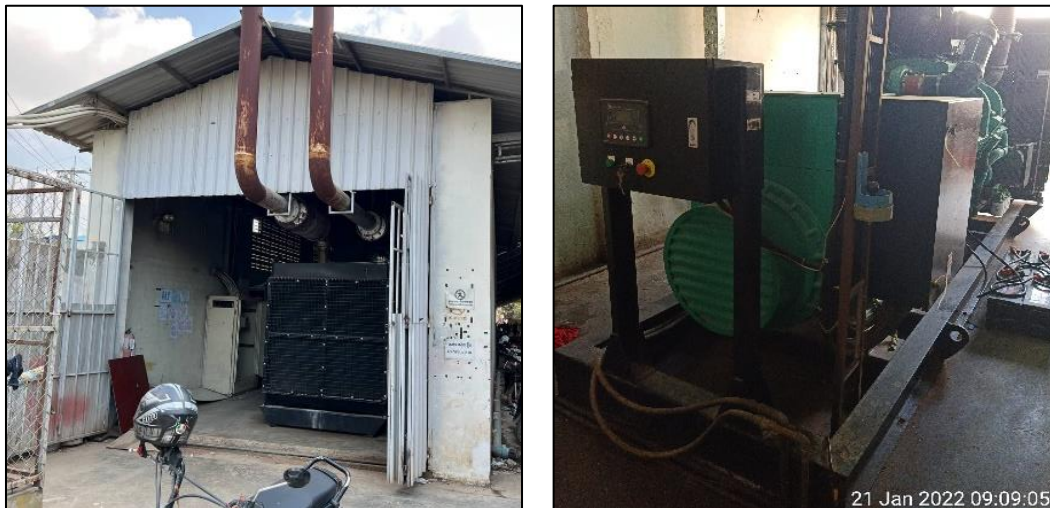
Figure 19: 900kVA Generator Room 01 without ventilation fan near Building A.

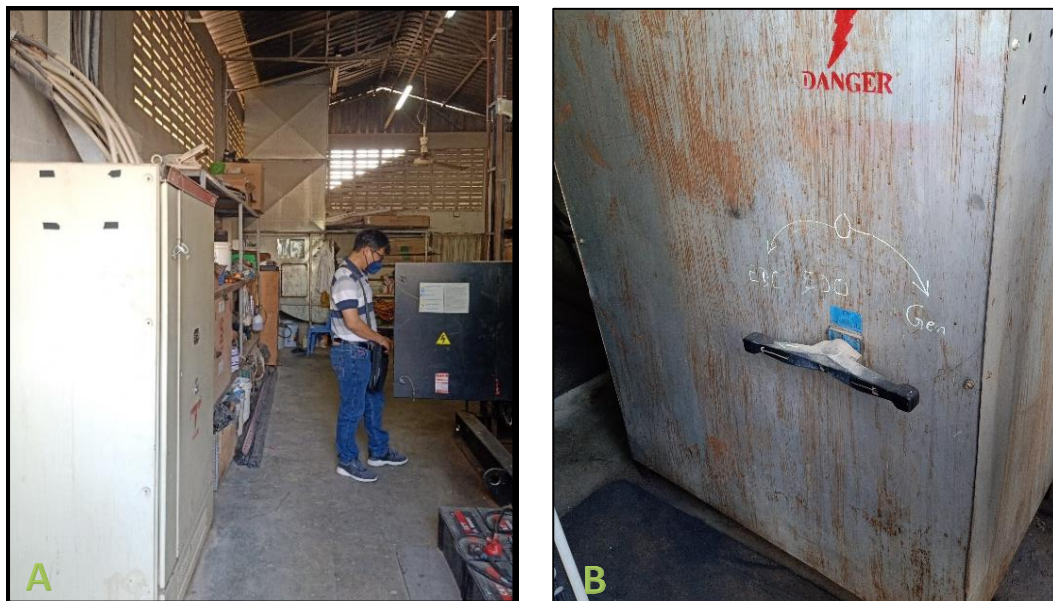
Figure 20:

- A: 1 side of MTS panel 01 connected from 1nos of 400kVA pole mounted oil type transformer and another side connected from 900kVA Diesel Generator 01.

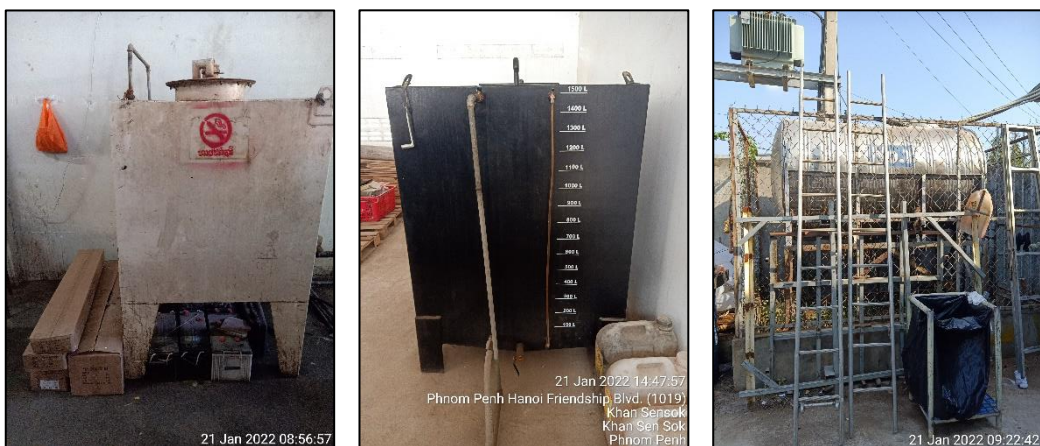
Ref No.	Issue Type	Sub-Header
ELEC-4	E2 : Earthing & Bonding	Insufficient bonding of equipment
<p>Observations: There were many missing of Earthing bonding cables connected to:</p> <ul style="list-style-type: none"> <li>- Cable Routing (Ladder, Tray, Trunking...) in all areas</li> <li>- Fuel Daily Tanks in Generator Room 01 &amp; 02</li> <li>- Above Ground Fuel Storage Tank</li> <li>- Electrical Panel door frames (LVMSB/MTS 01&amp;02 panels, Switching Panel...in Generator Room 01)</li> <li>- Electrical Panel door frames (SDB-0019B in Boiler Room)</li> <li>- Electrical Panel door frames (DB-0010B in Building B)</li> <li>- Boiler and Pump Boiler Enclosures</li> <li>- Washing Machines in Building B</li> </ul>

Figure 32: No Earthing bonding cable connected Fuel Daily Tanks and Bulk fuel storage tank.

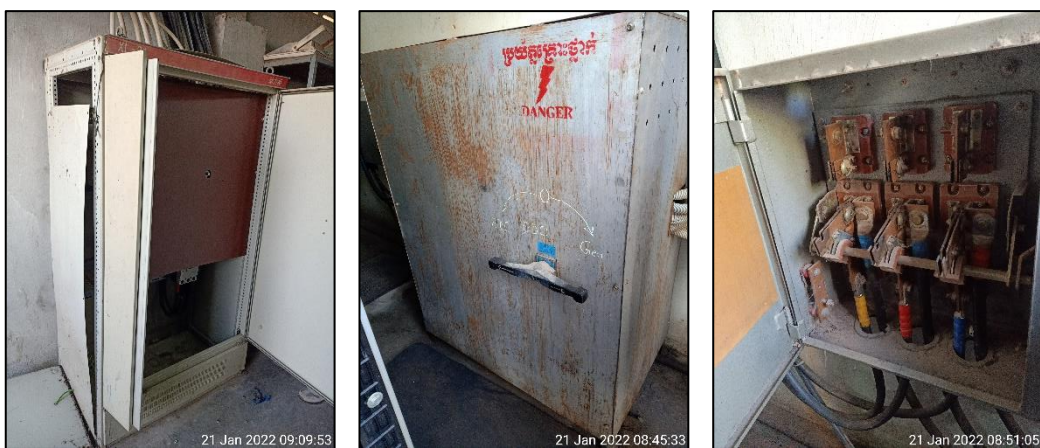
Figure 33: No Earthing bonding cable connected Electrical Panel Door Frames in Generator Room 01.

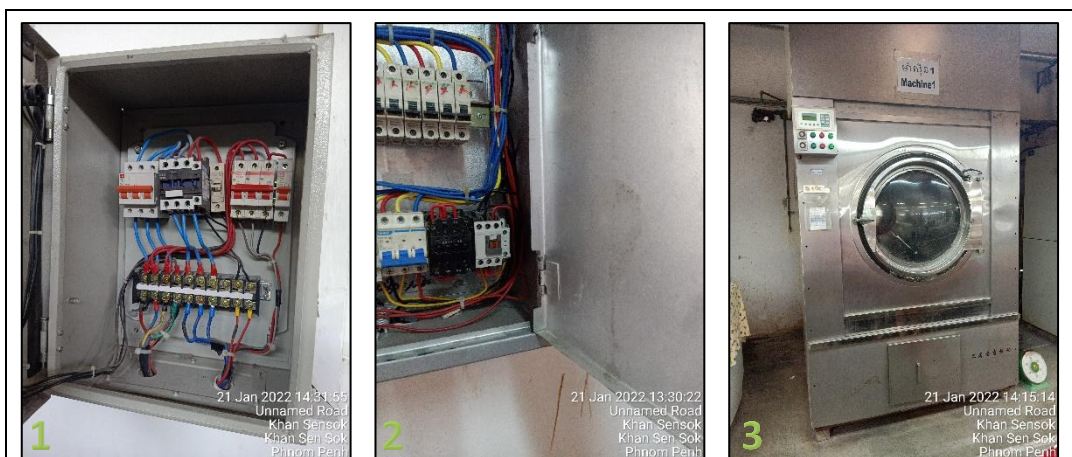
Figure 34: No Earthing bonding cable connected to:

1. Electrical Panel door frames (SDB-0019B in Boiler Room)
2. Electrical Panel door frames (DB-0010B in Building B)
3. Washing Machines in Building B

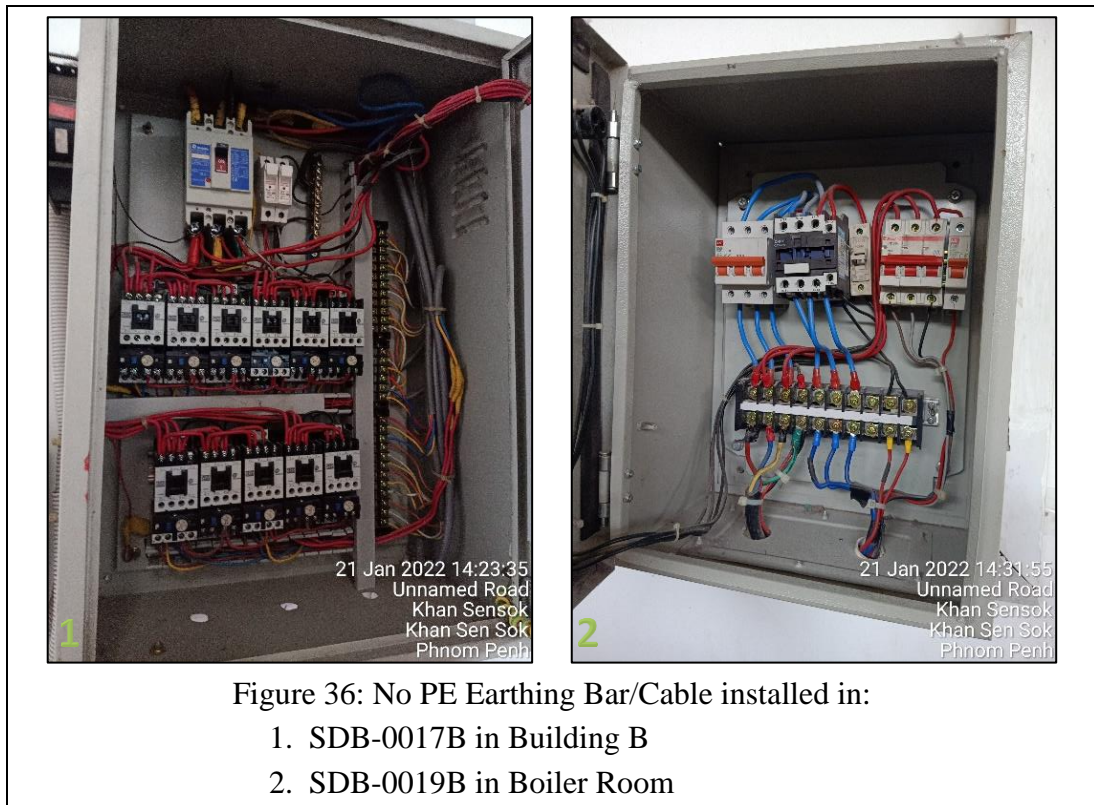
Ref No.	Issue Type	Sub-Header
ELEC-5	E2 : Earthing & Bonding	Insufficient bonding of equipment
Observations: There were missing PE Earthing Bar/Cable for: <ul style="list-style-type: none"> <li>- SDB-0017B in Building B</li> <li>- SDB-0019B in Boiler Room</li> </ul>

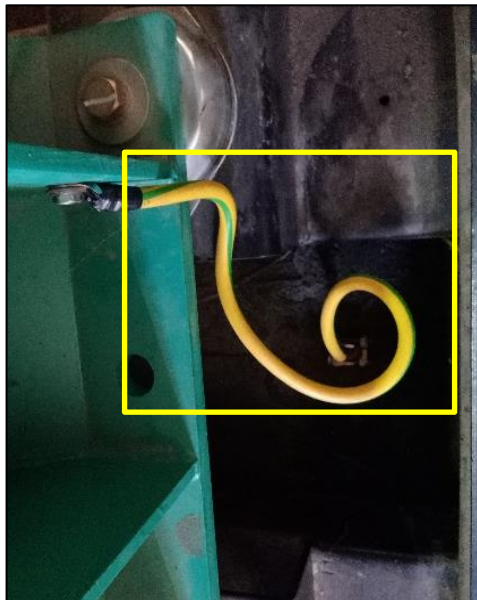
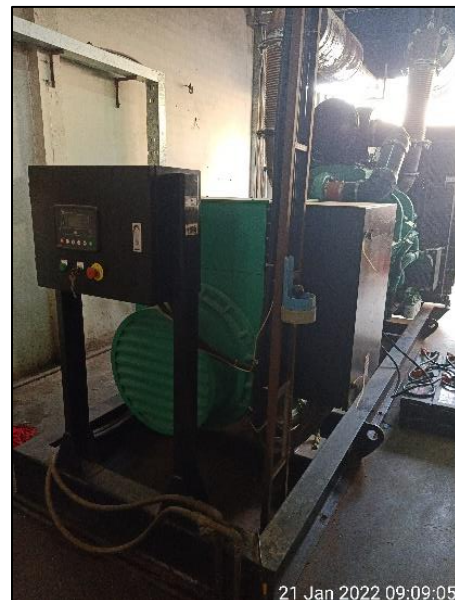
Observations: There were insufficient generator 01 & 02 earthing with two separate points.

Figure 40: Insufficient generator 01 earthing with two separate points.

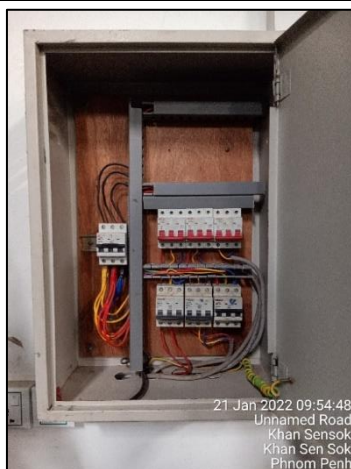
Observations: There were Combustible/flammable materials (wood) installed in SDB-001B in Building A and SDB-0016B in Building B.

Figure 47: Combustible/flammable materials (wood) installed in SDB-001B.

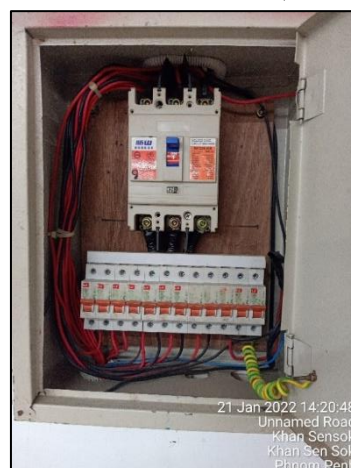
Figure 48: Combustible/flammable materials (wood) installed in SDB-0016B.

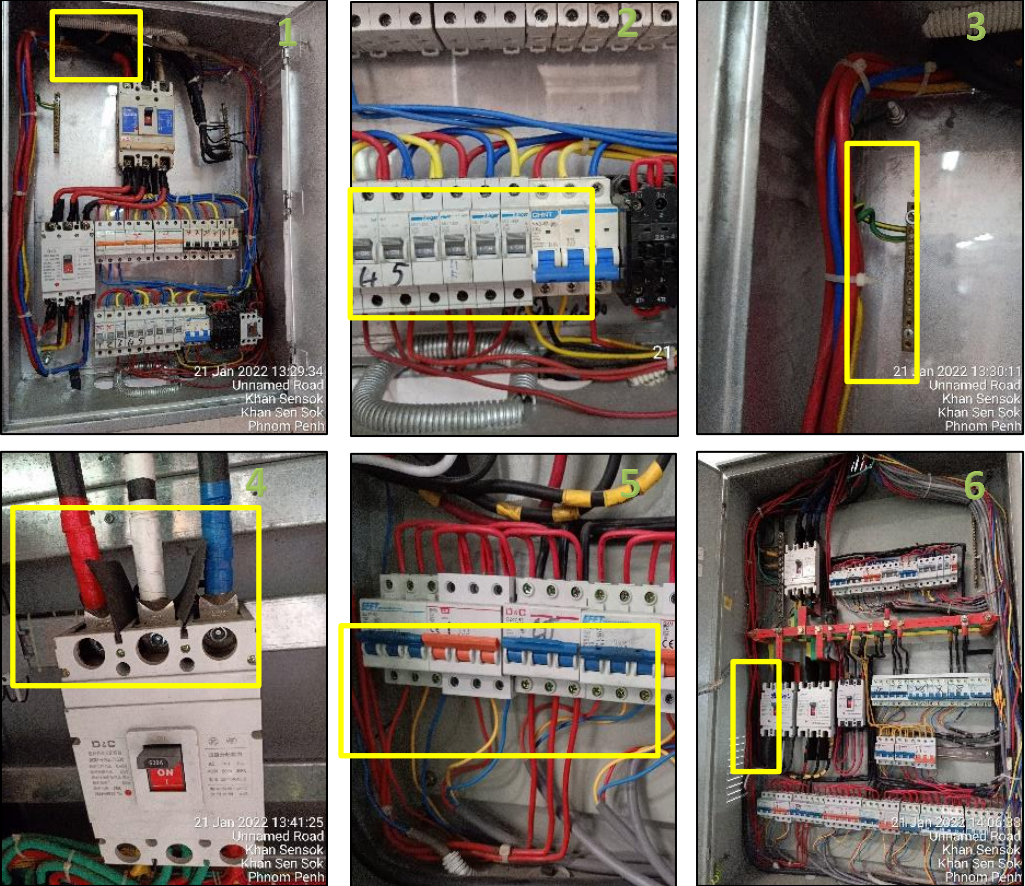
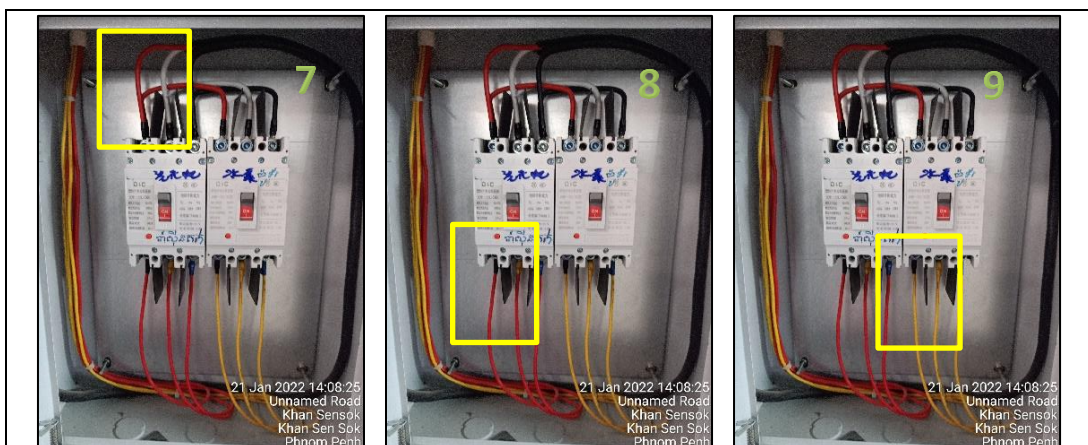
ELEC-19	E5 : Distribution	Incorrect cable installation
<p>Observations: In Building B, there were some issues founded as below:</p> <ol style="list-style-type: none"> <li>1. 50sqmm cable connected to 250A circuit breaker (under size of phase cable) in DB-0010B.</li> <li>2. 2.5sqmm cable connected to 63A, and also 40A circuit breakers (under size of phase cable) in DB-0010B.</li> <li>3. Under size of PE cable for DB-0010B.</li> <li>4. 185sqmm cable connected to 630A circuit breaker (under size of phase cable) in DB-0013B.</li> <li>5. 1.5sqmm cable connected from 32A circuit breaker (under size of phase cable) in DB-0012B.</li> <li>6. 10sqmm cable connected from 100A circuit breaker (under size of phase cable) in DB-0012B.</li> <li>7. Incoming 10sqmm cable connected to 100A circuit breaker (under size of phase cable) in DB-0015B.</li> <li>8. Outgoing 6sqmm cable connected from 100A circuit breaker (under size of phase cable) in DB-0015B.</li> <li>9. Outgoing 4sqmm cable connected from 80A circuit breaker (under size of phase cable) in DB-0015B.</li> </ol>

Figure 53: Under size of cable cross-sectional area compare to circuit breakers:

1. 50sqmm cable connected to 250A circuit breaker in DB-0010B.
2. 2.5sqmm cable connected to 63A, and also 40A circuit breakers in DB-0010B.
3. Under size of PE cable for DB-0010B.
4. 185sqmm cable connected to 630A circuit breaker in DB-0013B.
5. 1.5sqmm cable connected from 32A circuit breaker in DB-0012B.
6. 10sqmm cable connected from 100A circuit breaker in DB-0012B.
7. Incoming 10sqmm cable connected to 100A circuit breaker in DB-0015B.
8. Outgoing 6sqmm cable connected from 100A circuit breaker in DB-0015B.
9. Outgoing 4sqmm cable connected from 80A circuit breaker in DB-0015B.

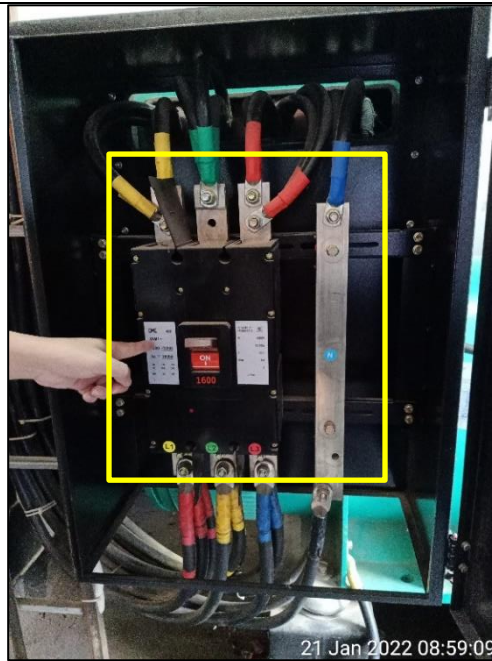
Ref No.	Issue Type	Sub-Header
ELEC-22	E5 : Distribution	Incorrect cable installation
<p>Observations: Normal insulation power cables connected from Main Distribution Board inside Building A to Fire System control panel in FF pump station and Unprotected Outgoing cables/circuits (Circuits drawn without protective device) from Generator 01 panel to both of MTS panel 01 &amp; 02.</p>		
<p>Figure 57: Normal insulation power cables from MDB in Building A to FF pump control panel.</p>

Figure 58: Unprotected Outgoing cables/circuits to MTS panel 01

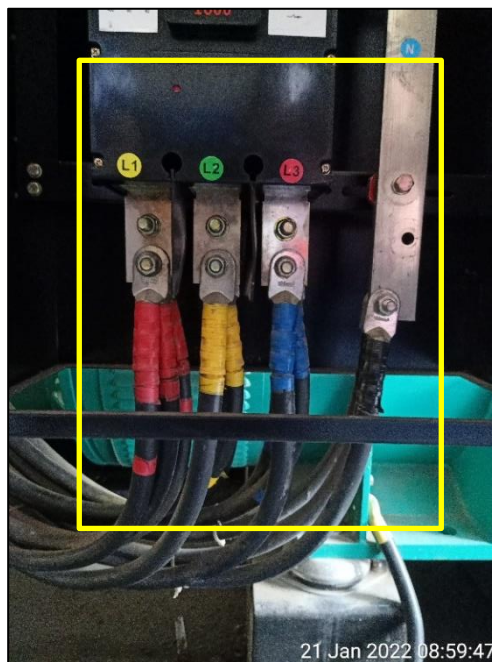
Figure 59: Unprotected Outgoing cables/circuits to MTS panel 02.
