LABS
Life And Building Safety

LABS - GOOD PRACTICES SHARING

05th June 2025

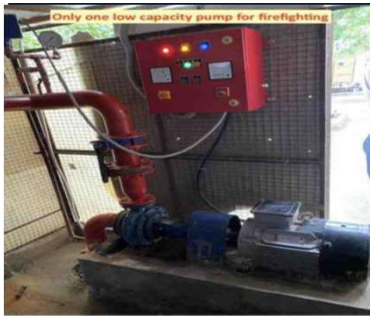
Fire Pumps Not Installed

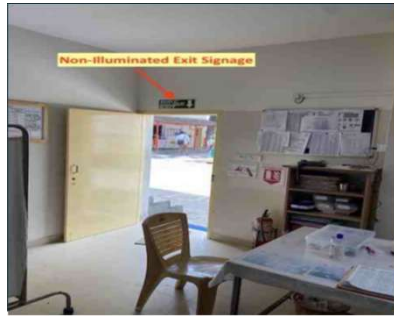
Non Illuminated Exit Signage
Insatlled

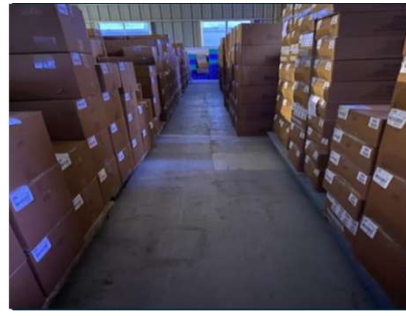
Storage Area Without Sprinkler
System

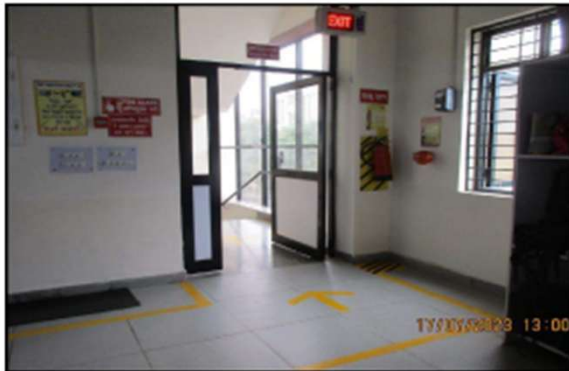
Normal Exit doors with lockable device

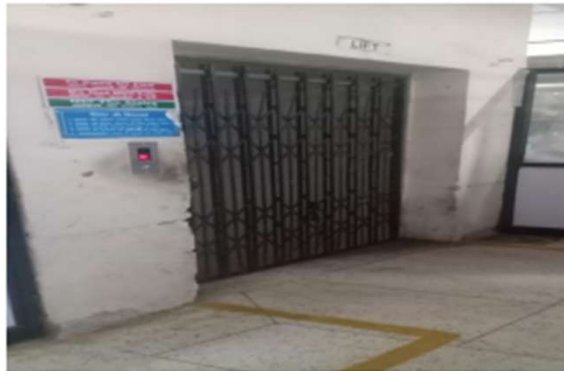
No separation of lift shaft

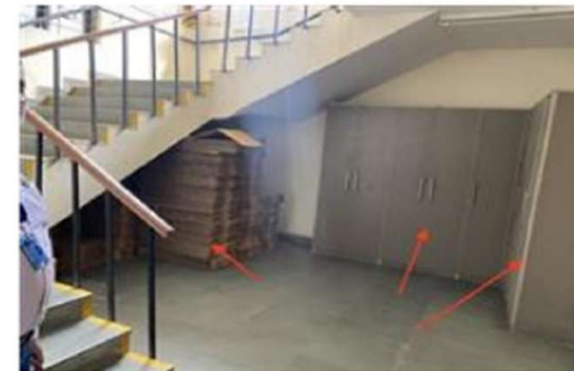
Material Storage under the staircase

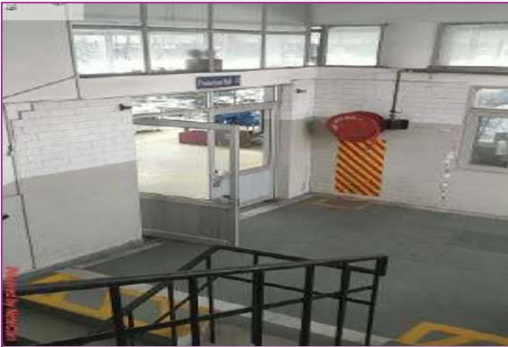
- Lack of enclosure of Stairs connecting more than 2 floors.
- Unsealed penetrations in stair enclosures

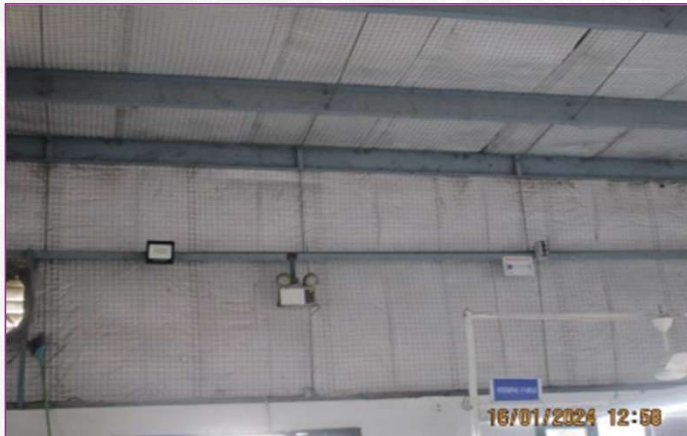
Observation — Smoke detector positioning was inadequate and found installed below ceiling level.

CAP- Smoke detector would be installed over the highest and flat part of ceiling .

Beam type smoke detector installed for high roof

Remediation- The factory has installed beam type smoke detector over ceiling more than 20 feet and replaced smoke detector to the highest point of the ceiling in 14 ft ceiling.

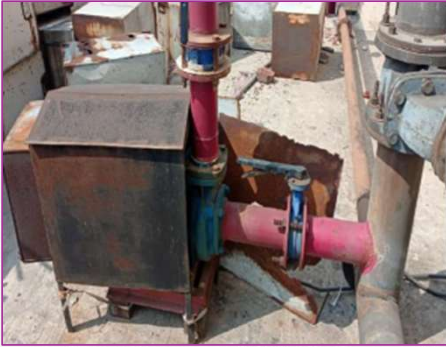
- Absence of fire pumps in the installed fire water line at the premises.
- Pump-set back-up not provided
- Only single fire pump installed for fire-fighting purpose.
- Diesel backup fire pump not provided.

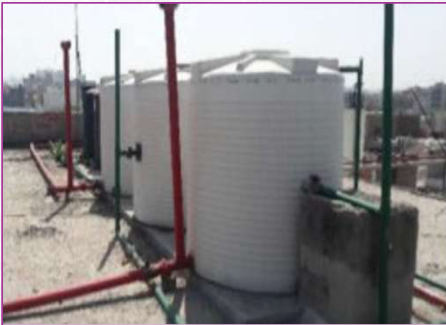
- Insufficient water storage on premises for firefighting systems.
- Only 10 KL dedicated water available for fire fighting.

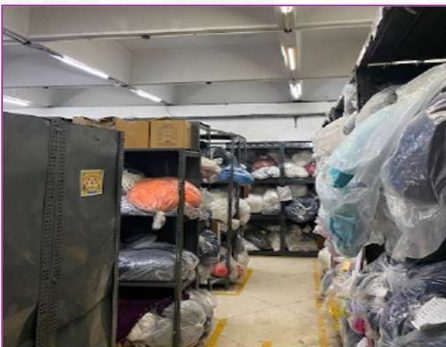
- A Non-Sprinklered storage area exists with excessive storage and is not effectively separated by FR separation with production areas.
- No fire-rated compartmentation is provided between the non-sprinklered storage area.

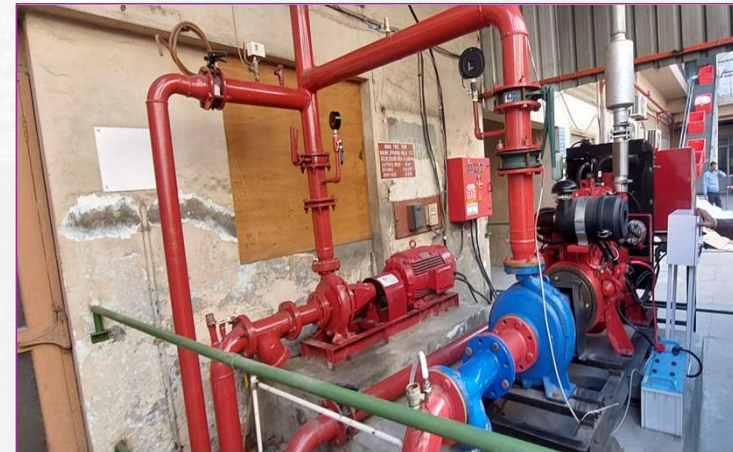
All 3 Fire pumps are installed

Backup Fire pumps are installed

Remediation- The factory has installed 3 fire pump jockey pump, main pump and diesel-powered pump in the premises.

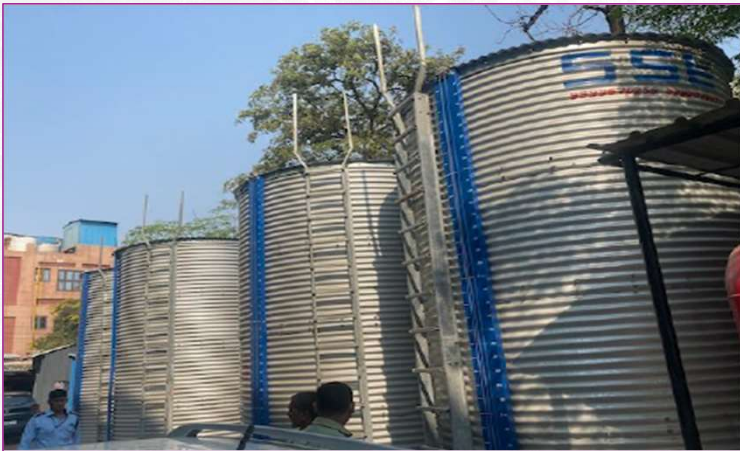
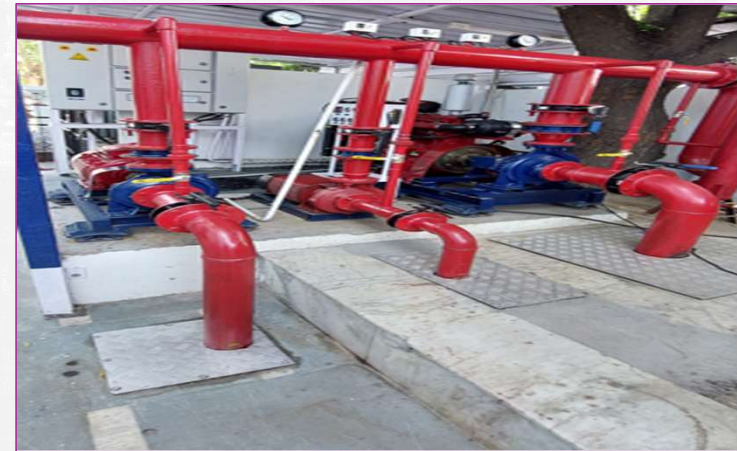
Observation – Insufficient water storage on premises for firefighting systems.

Additional water tanks installed by factory

Underground water tank constructed

CAP- Will ensure that the factory has a water capacity of 1.5 lakh litres specifically for fire-fighting purposes.

Remediation- The factory has installed additional water tanks, either overhead or underground, to address the issue of water shortage.

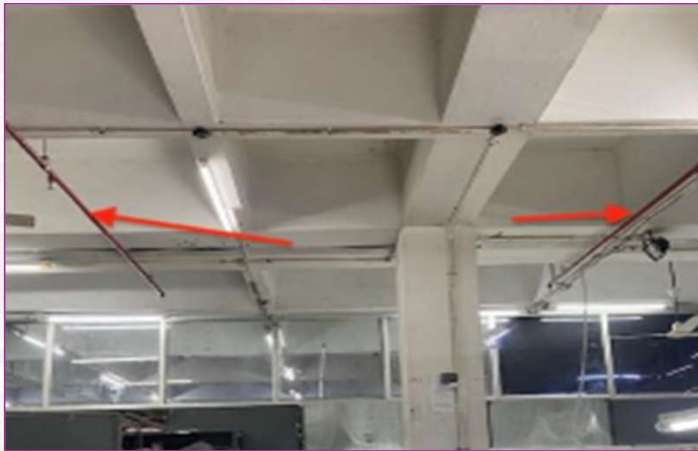
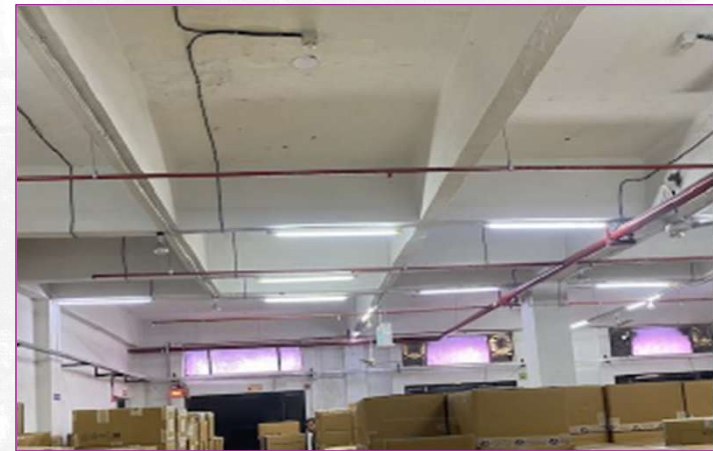
Observation — A Non-Sprinklered storage area exists with excessive storage and is not effectively separated by FR separation with production areas.

Additional water tanks installed by factory

Sprinklers installed in material store

CAP- Provide sprinkler system in storages areas .

Remediation- The factory has installed sprinklers in storage areas.

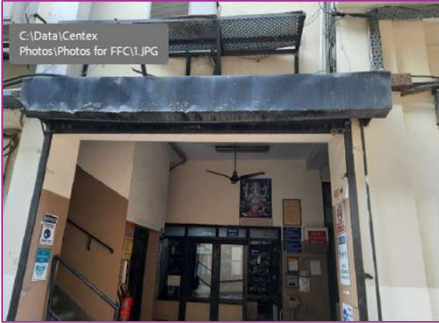
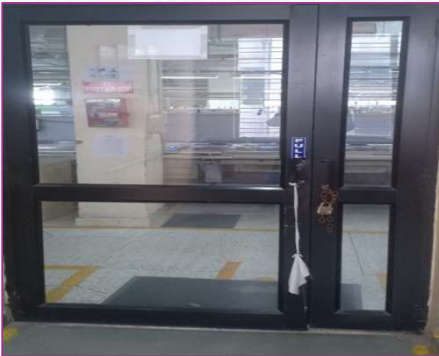
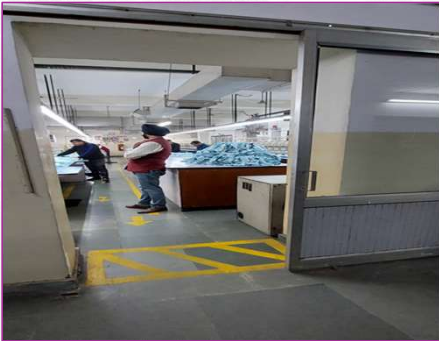
- Exit doors in the factory have locking devices /have rolling shutters with the locking mechanism.
- Exit doors not side hung to swing correctly in the direction of escape.
- Lockable device installed over exit door from outside.

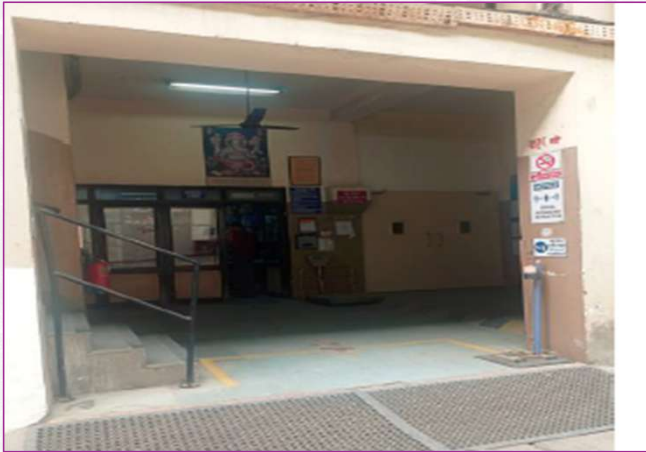
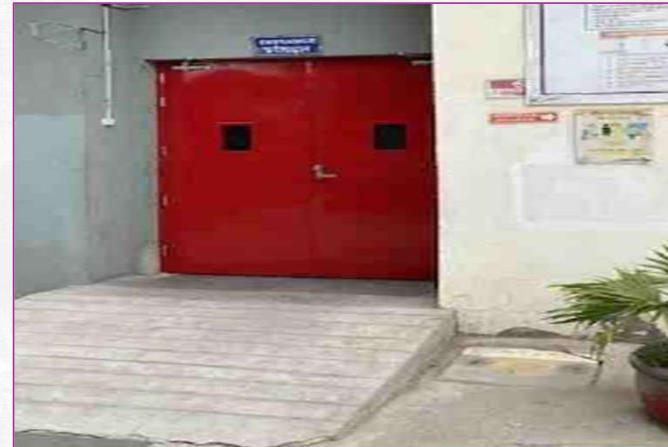
Observation — The factory exit door is equipped with a locking mechanism and a rolling shutter.

Rolling shutter has been removed

Fire door has been installed

CAP- All rolling shutters will be removed with outward opening doors for safe evacuation.

Remediation- The factory has installed Fire rated door at the final door with push bar in place of shutter or have removed shutter.

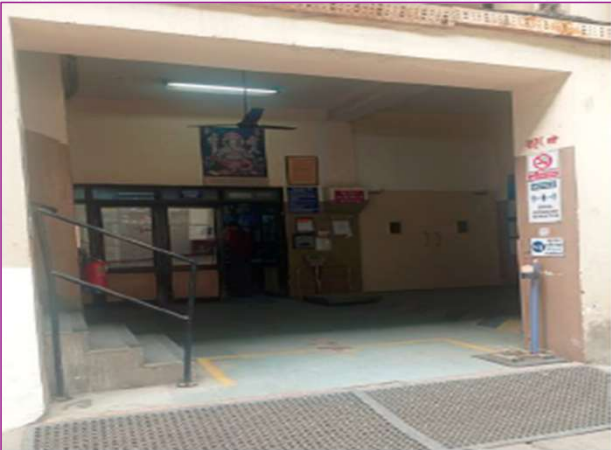
Observation — The factory exit door is equipped with a locking mechanism and a rolling shutter.

Remediation- The factory have removed shutter and kept exit open.

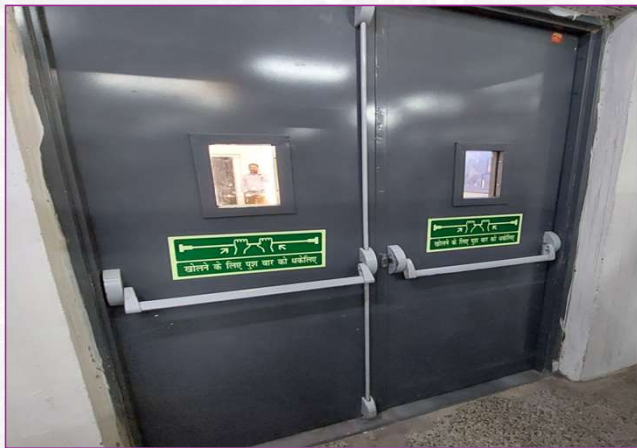
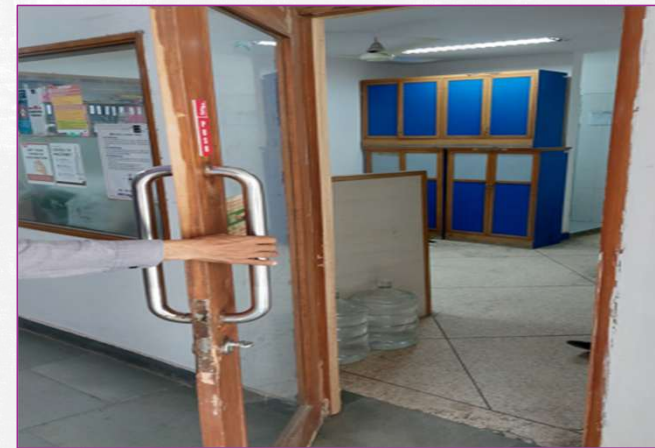
Observation — Lockable device installed on all exit doors from outside/inside .

Push bar has been install over doors

Rotating latch mechanism installed to bypass lock

CAP- Lockable device would be removed and locking arrangement would be revised.

Remediation- The factory has installed a fire-rated door with a push bar or mechanism that allows for bypassing the outside lock from the inside.

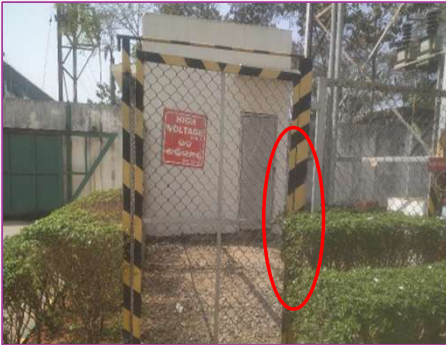
- Gate at the transformer yard is not looped with the fence for continuity of earthing
- Equipotential bonding (body earthing) to dissipate static charge not provided to Diesel day tank.

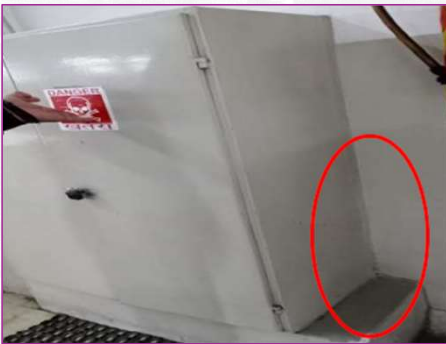
- Proper body earthing not evident in various distribution boards.
- Single body earthing provided to DG set.
- Earthing not provided to MS roof truss.

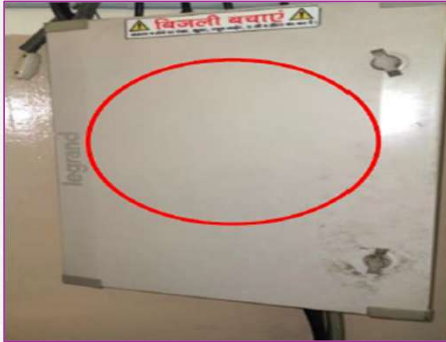
- Proper identification markings were not provided on distribution boards.
- Cable current carrying capacity chart provided on distribution boards.

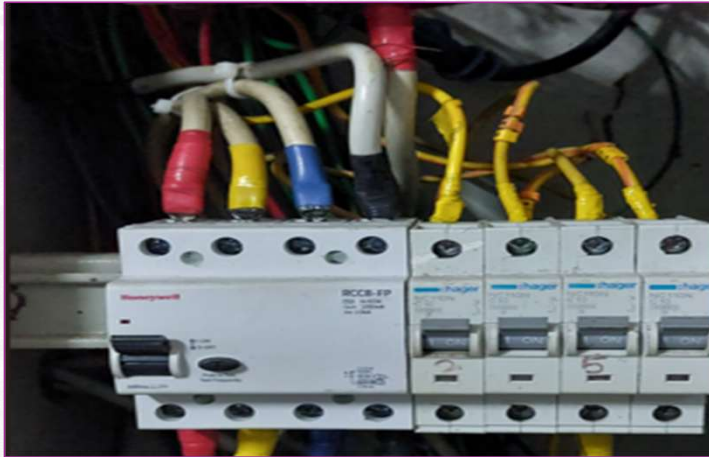
Lugs provided for electrical panel

CAP- Lugs and glands will be provided for electrical fitting.

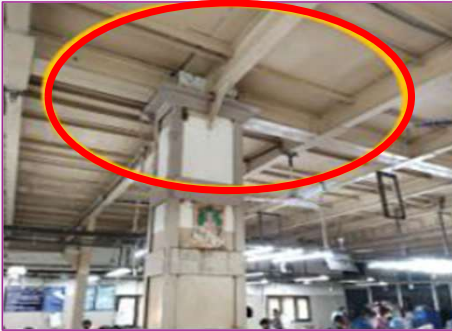
- Intermediate column stress check as jacking work with steel angle section visible over column

Observation – Intermediate column were observed stress due to overloading.

CAP- Factory has appointed the Structural Consultant and the consultant has provided the stability certificate for first floor and below the floor level.

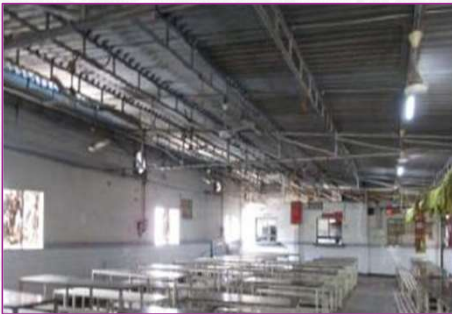
- Seismic bracings are not provided for added MS structures as lateral support structural system.

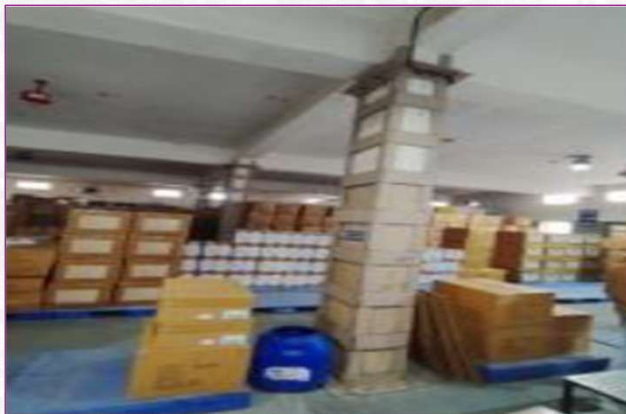
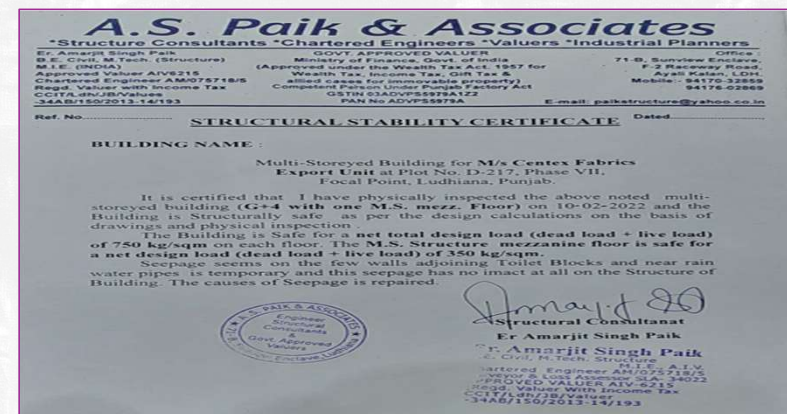
Jacketing provided for column level below

Stability certificate t

Remediation- The factory has assessed all column in building and provided jacketing of below column, verified through the structural engineer

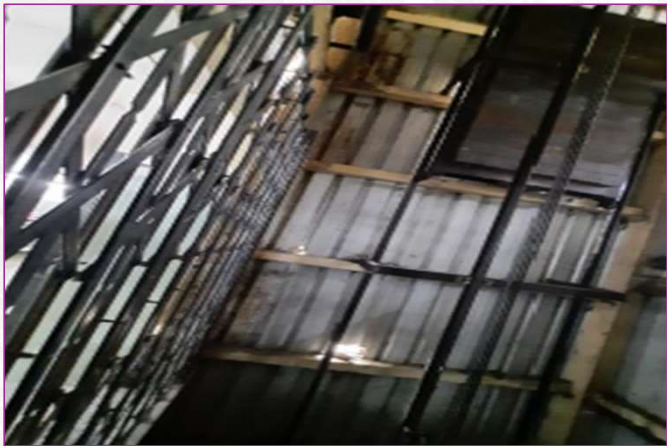
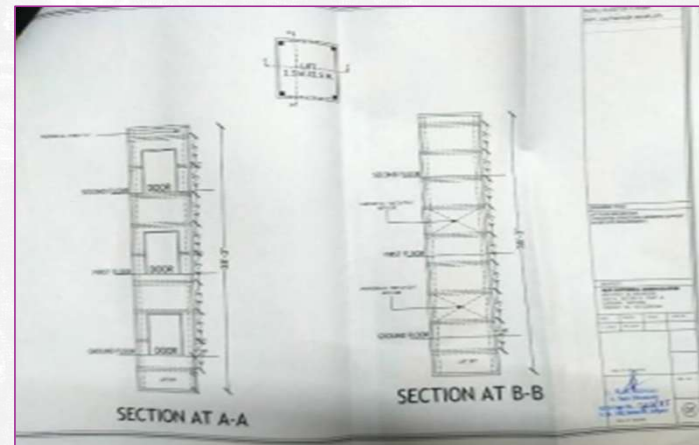
Observation — Goods Lift Side walls & 2nd floor External walls at North, West Side found to be inadequate to resist later forces.

Structural member has been reinforced

structural drawing of the Goods lift

CAP- Factory to appoint a Structural Engineer to review the extent

Remediation- The factory has appointed structural consultant and provided support member in lift
