# LABS

Life And Building Safety

**LABS - GOOD PRACTICES SHARING**

**3<sup>rd</sup> May 2024**

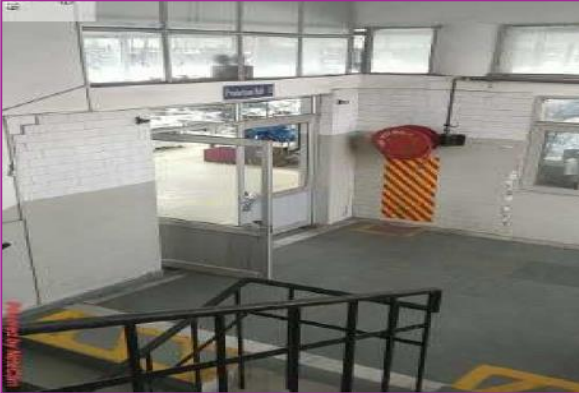
- Lack of enclosure of Stairs connecting more than 2 floors.
- Unsealed penetrations in stair enclosures

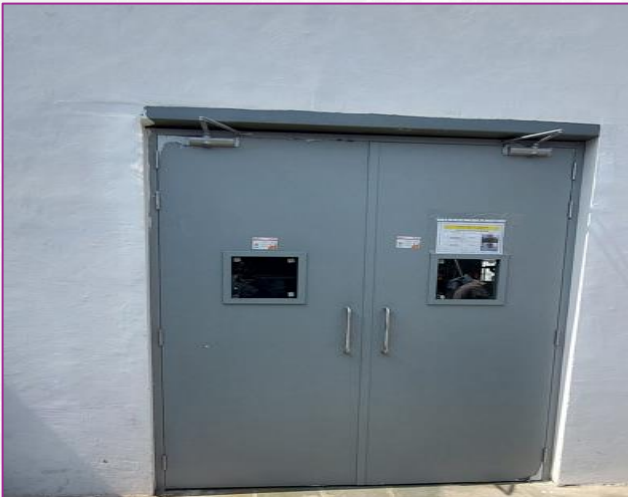
**Observation-** Fire-rated self-closing doors are not provided in any of the exits leading to staircase

Self-closing Fire door

**CAP-** Emergency exit to be provided with self-closing fire-rated door as per IS 3614

**Remediation-** The factory has replaced the normal doors with self-closing, fire-rated doors.

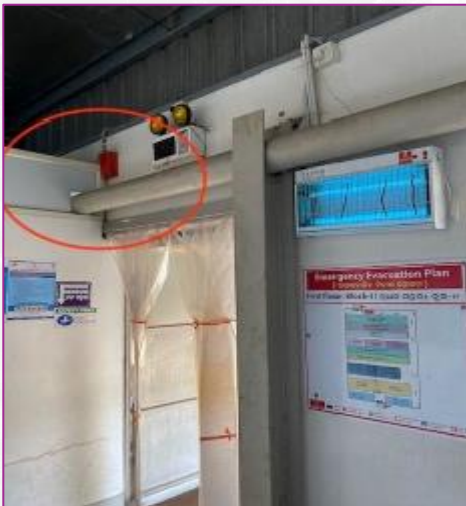
Extra hooters are added near exits

**CAP-** To improve the audibility of the fire alarm, an additional fire alarm will be installed.

**Remediation-** The factory has installed extra hooters to enhance the audibility of alarm system.

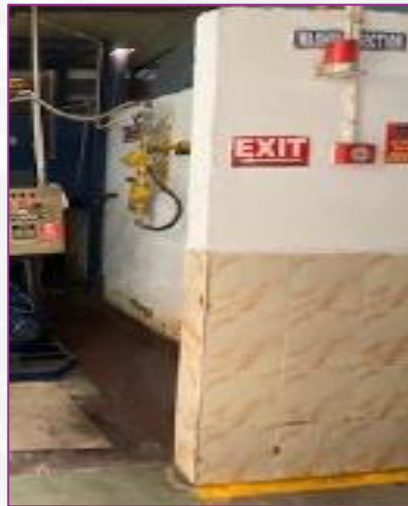
Visual hooters are added in utility area

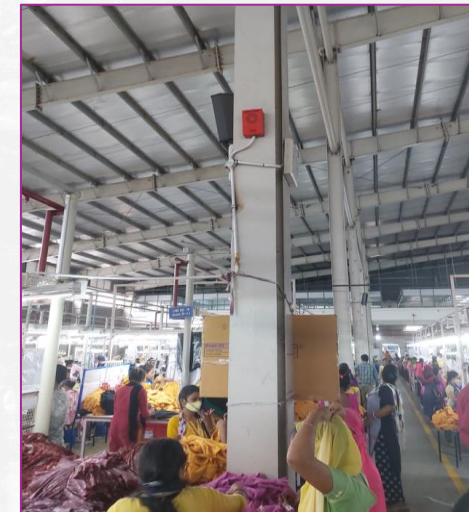
Extra hooters are added in floor

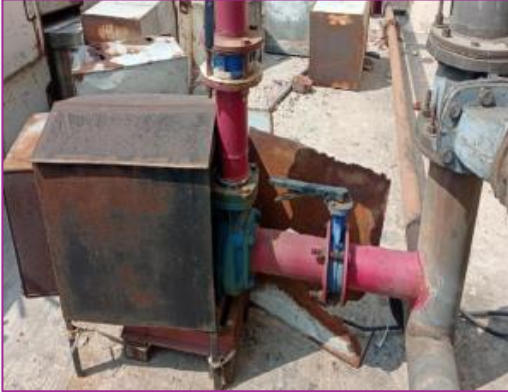
- Absence of fire pumps in the installed fire water line at the premises.
- Pump-set back-up not provided
- Only single fire pump installed for fire-fighting purpose.
- Diesel backup fire pump not provided.

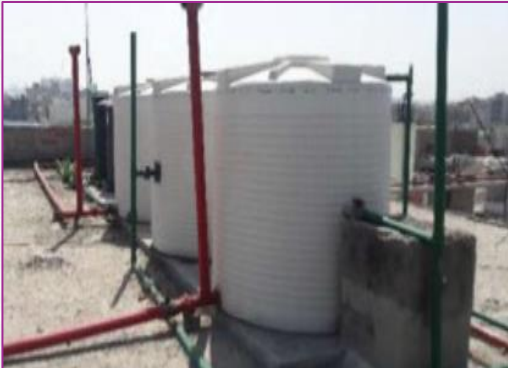
- Insufficient water storage on premises for firefighting systems.
- Only 10 KL dedicated water available for fire fighting.

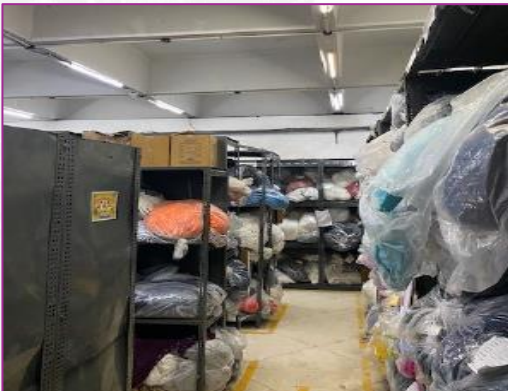
- A Non-Sprinklered storage area exists with excessive storage and is not effectively separated by FR separation with production areas.
- No fire-rated compartmentation is provided between the non-sprinklered storage area.

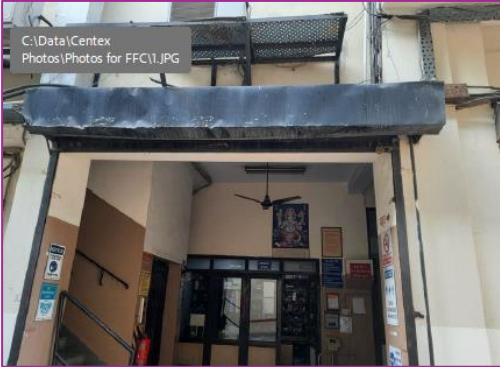
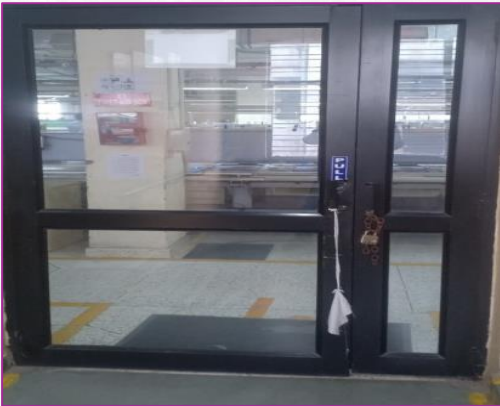
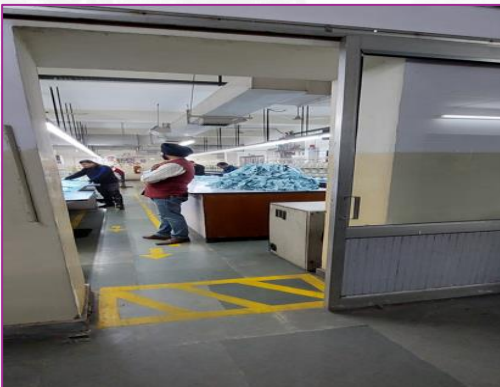
- Exit doors in the factory have locking devices /have rolling shutters with the locking mechanism.
- Exit doors not side hung to swing correctly in the direction of escape.
- Lockable device installed over exit door from outside.

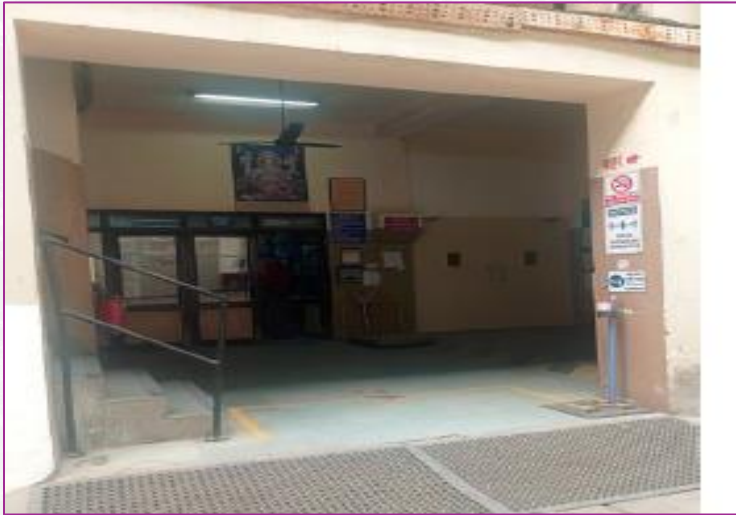
**Observation** — The factory exit door is equipped with a locking mechanism and a rolling shutter.

Rolling shutter has been removed

**CAP-** All rolling shutters will be removed with outward opening doors for safe evacuation.

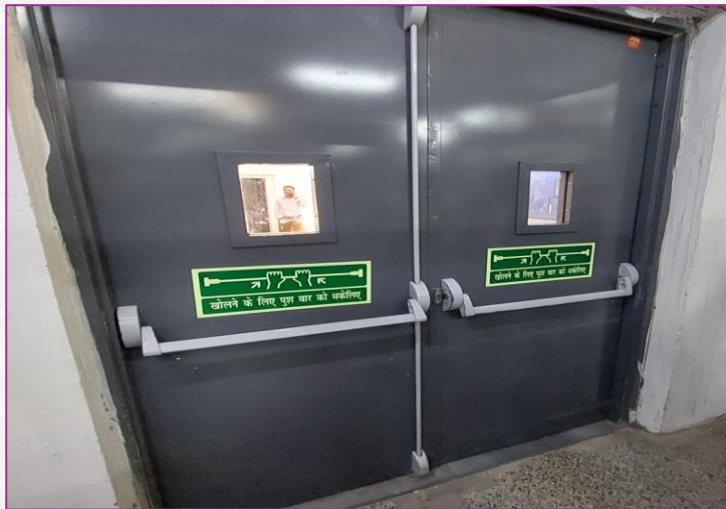
Push bar has been install over doors

**CAP-** Lockable device would be removed and locking arrangement would be revised.

**Remediation-** The factory has installed a fire-rated door with a push bar or mechanism that allows for bypassing the outside lock from the inside.

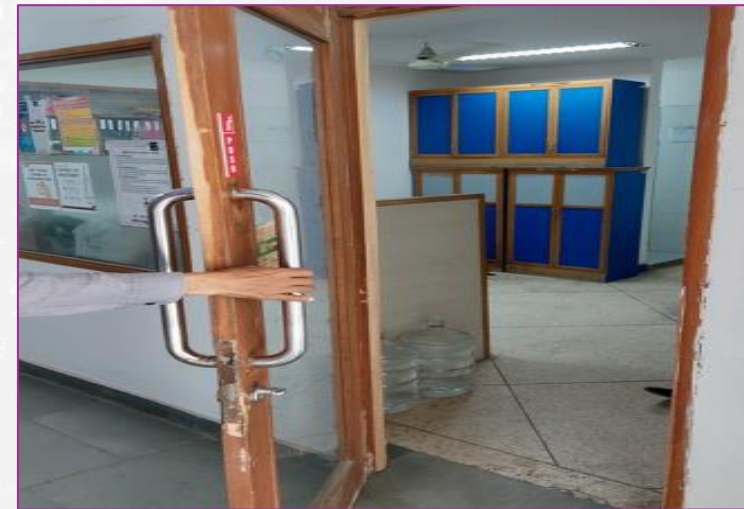
Rotating latch mechanism installed to bypass lock

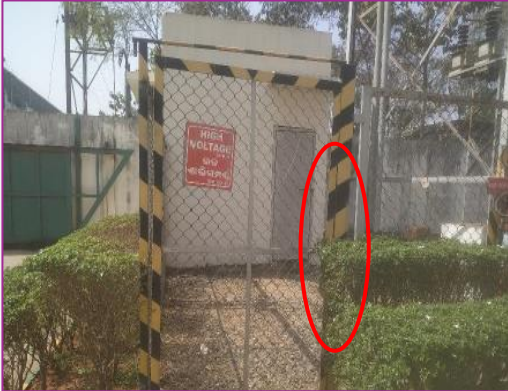
- Gate at the transformer yard is not looped with the fence for continuity of earthing
- Equipotential bonding (body earthing) to dissipate static charge not provided to Diesel day tank.

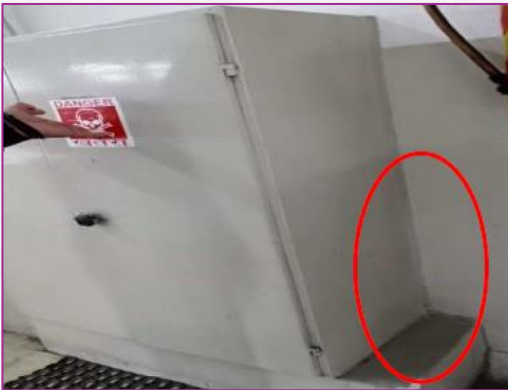
- Proper body earthing not evident in various distribution boards.
- Single body earthing provided to DG set.
- Earthing not provided to MS roof truss.

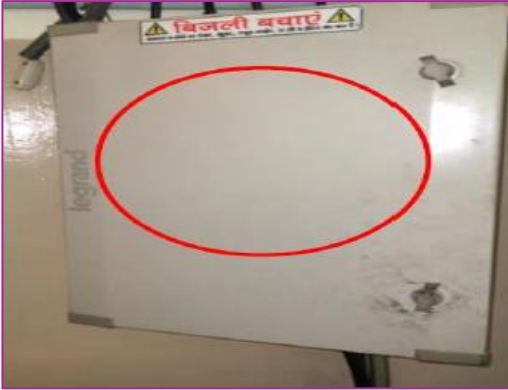
- Proper identification markings were not provided on distribution boards.
- Cable current carrying capacity chart provided on distribution boards.

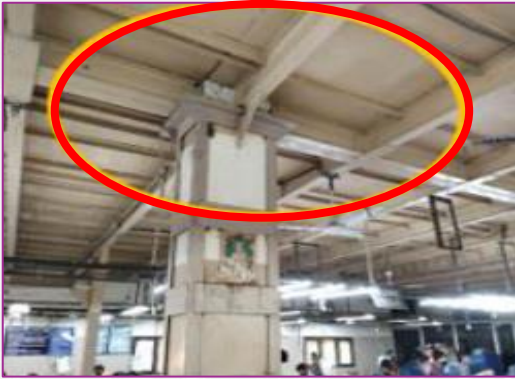
- Intermediate column stress check as jacketing work with steel angle section visible over column

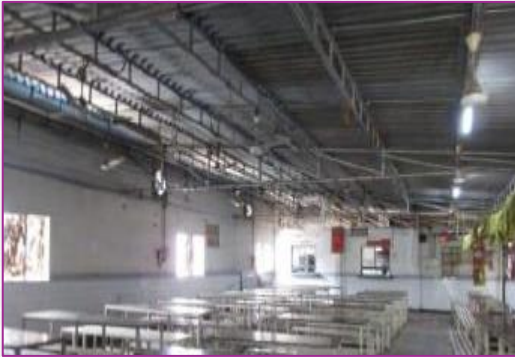
- Seismic bracings are not provided for added MS structures as lateral support structural system.

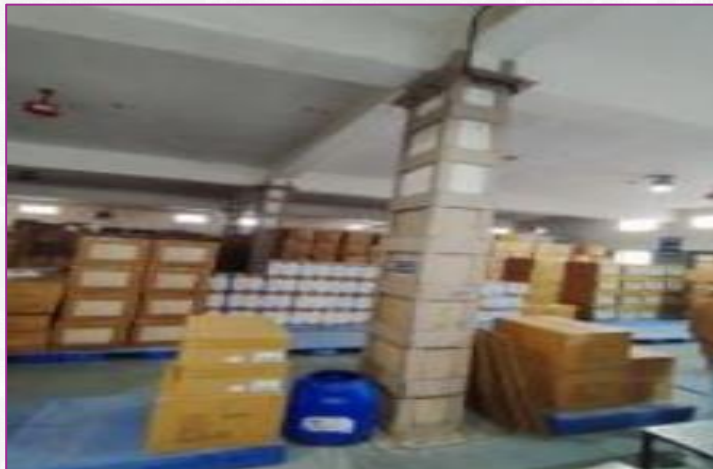
**Observation** — Intermediate column were observed stress due to overloading.

Jacketing provided for column level below

**CAP-** Factory has appointed the Structural Consultant and the consultant has provided the stability certificate for first floor and below the floor level.
