## LABS Initiative

# Methodology for Preliminary Safety Assessments in Indonesia

Issue 1.2| 24th May, 2023

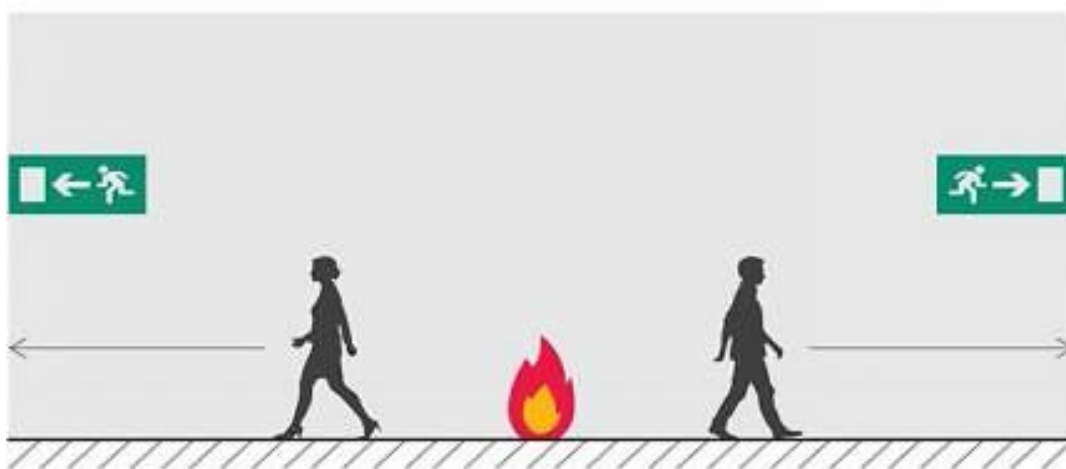
Figure 4 Alternative directions of escape

A general principle of design for means of escape is that persons should have alternative directions of escape. This is so that in the event of a fire, occupants can escape without having to approach the fire source.

Even when there are alternative escape routes as illustrated above, the distance that people need to travel to reach a place of relative safety (e.g., protected stair core) must be limited.

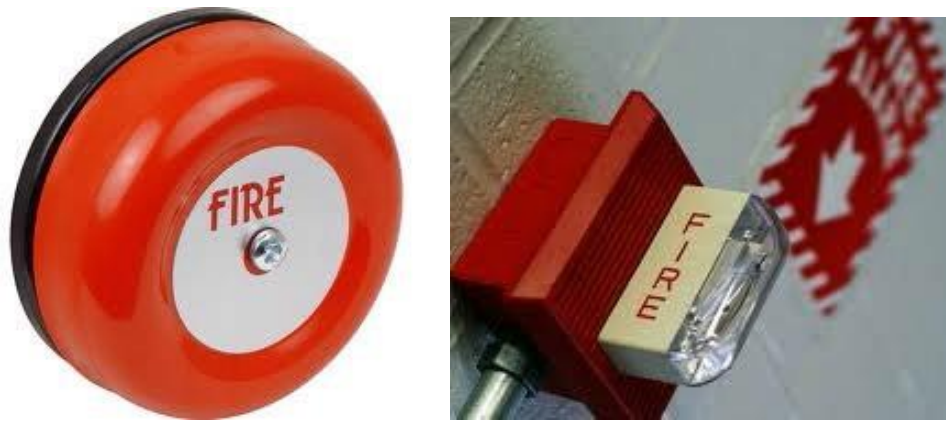
Figure 13: Example automatic sounder (left) and visual notified (right)

It is very important that alarm will be heard so the sounders should provide a minimum sound level usually around 65dB throughout the building but importantly 5dBA above any background noise. This is particularly important in noisy places such as factories or places where people may have ear protection. In some circumstances the sounders would need to be augmented with visual strobes.

The system should incorporate at least two fire alarm sounders, even if the recommended sound pressure levels could be achieved with one sounder. At least one sounder should be provided in each fire compartment.

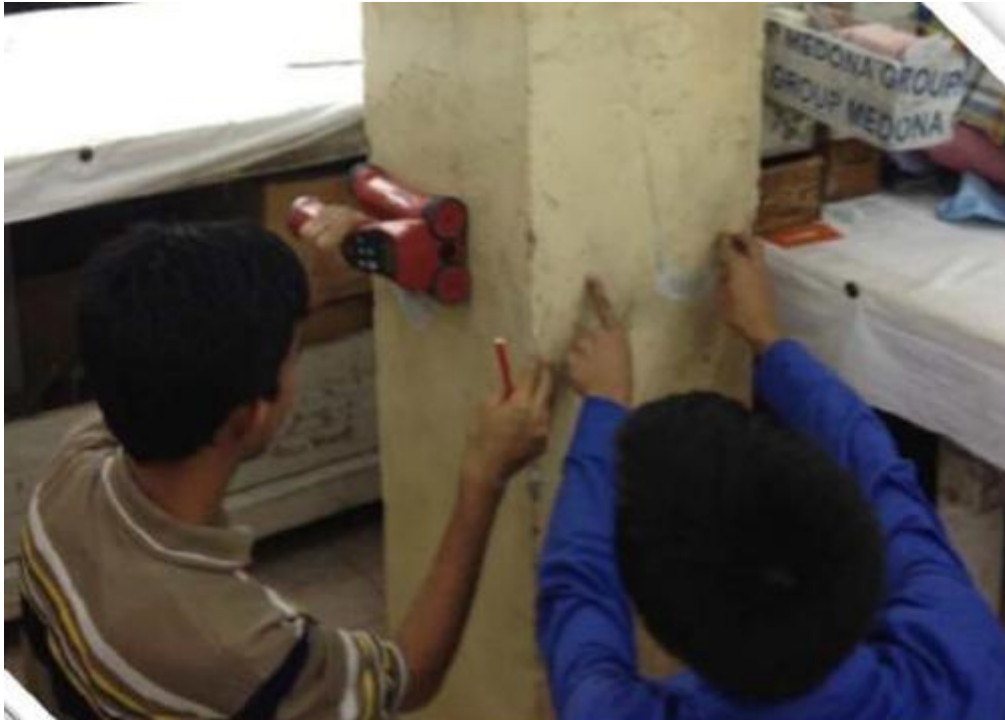
## Check reinforcement

With a Ferro Scanner

- Digital camera
- Schmidt hammer
- Hilti PS250 Ferro scanner and screen (or equivalent) which must be capable of providing reinforcement bar diameters. The results of the Ferro scan must be capable of being read in advance of departing the factory.
- Thermal Camera (Fluke or equivalent)
- Thermometer (to measure ambient temperature)
- Geological hammer and/or chisel
- 5m tape
- Laser measure
- Binoculars
- Torch
- First aid kit
- PPE (gloves, goggles, mask)
- Clipboard
- Paint scraper
- Calipers
- Crack ruler
- AAA batteries
- Tyvek suit

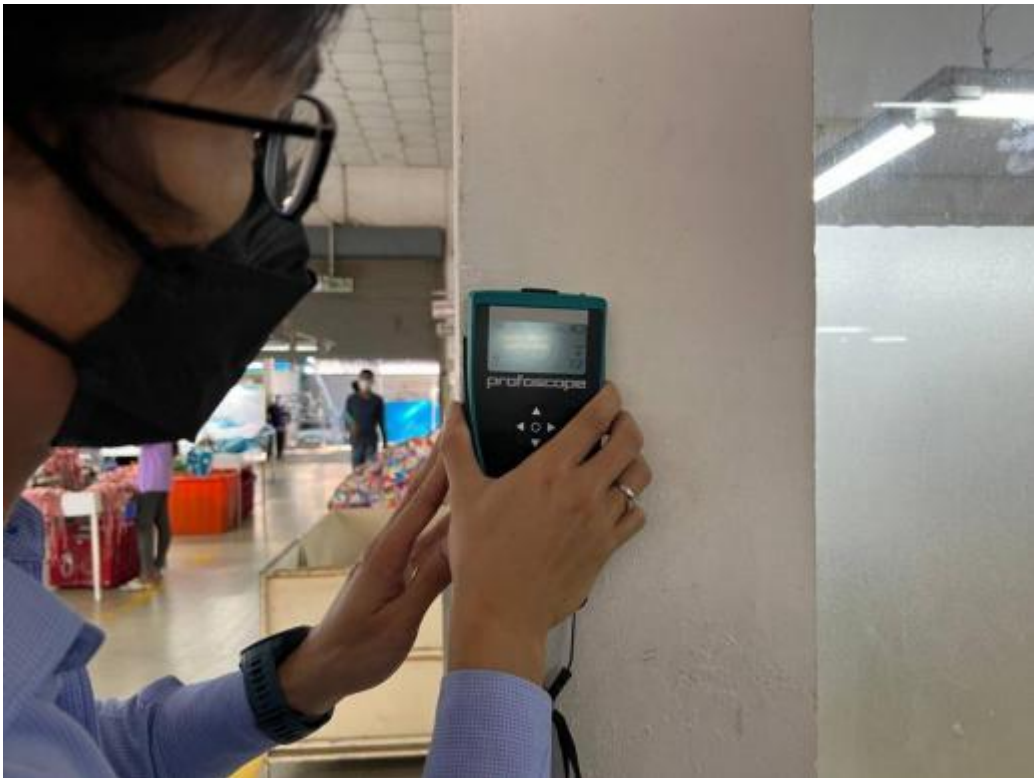
With a Cover Meter

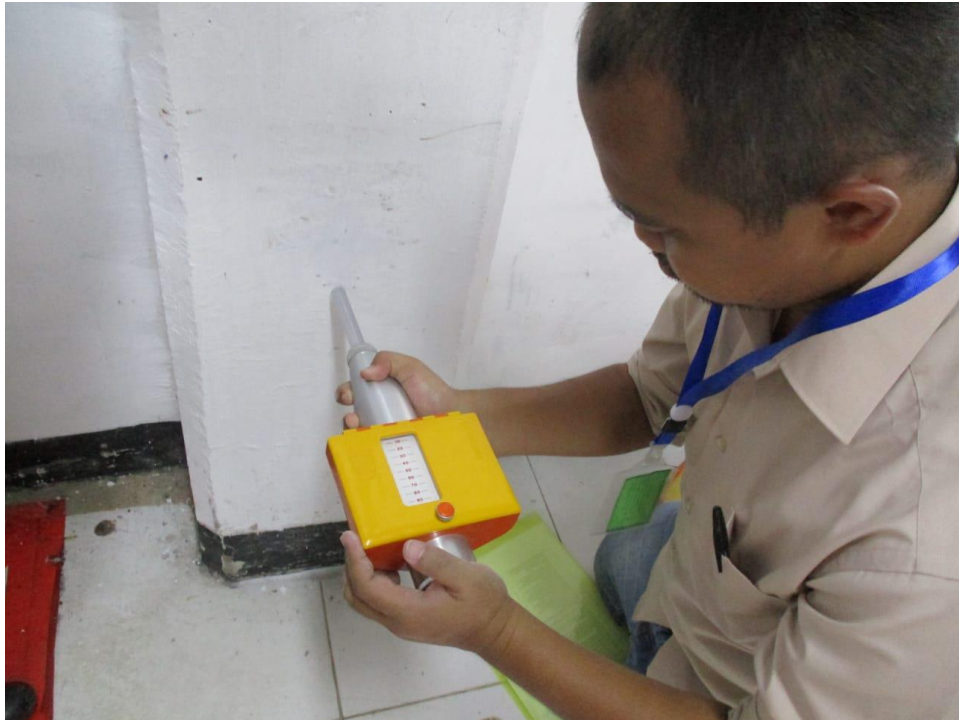
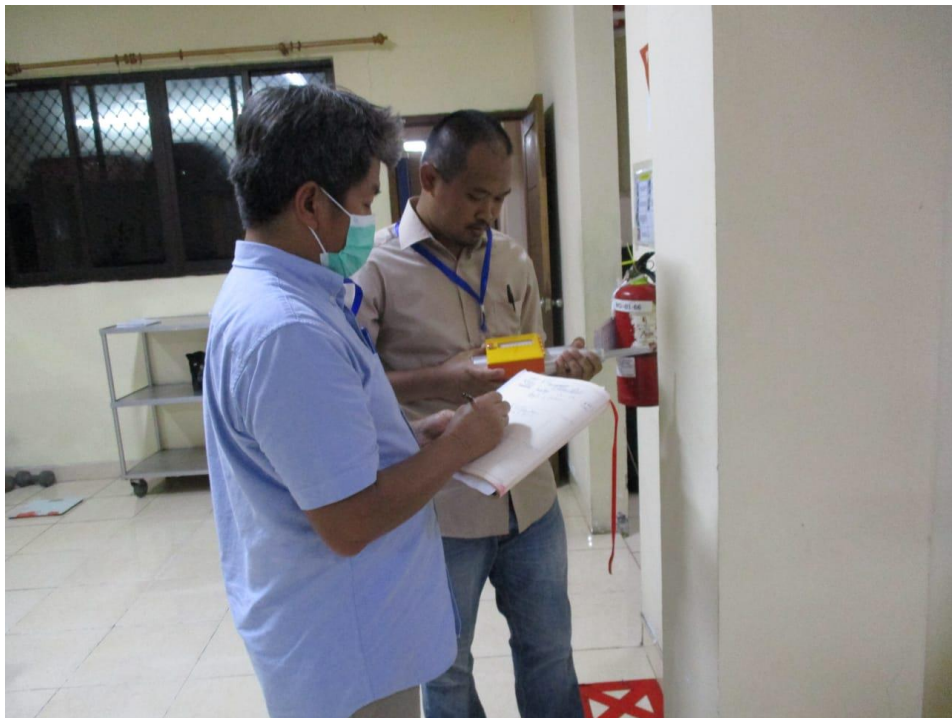
## Check concrete

Test with the Rebound Hammer

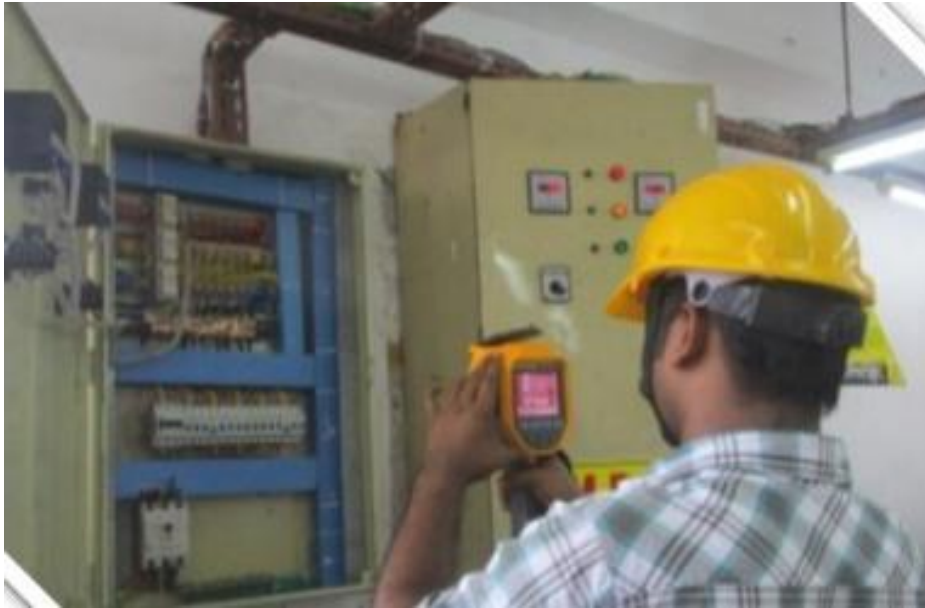
## Thermographic Scanning

Using an Infra-Red camera, scan electrical equipment, operating at normal conditions.

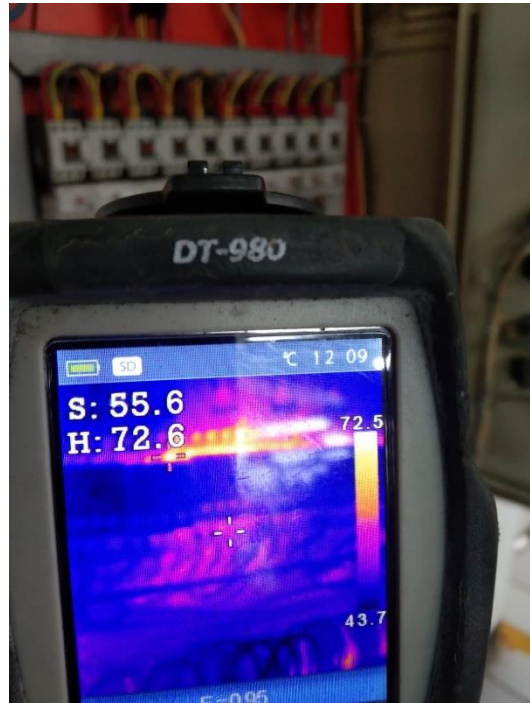
Identify connections operating at a higher-than-normal temperature.

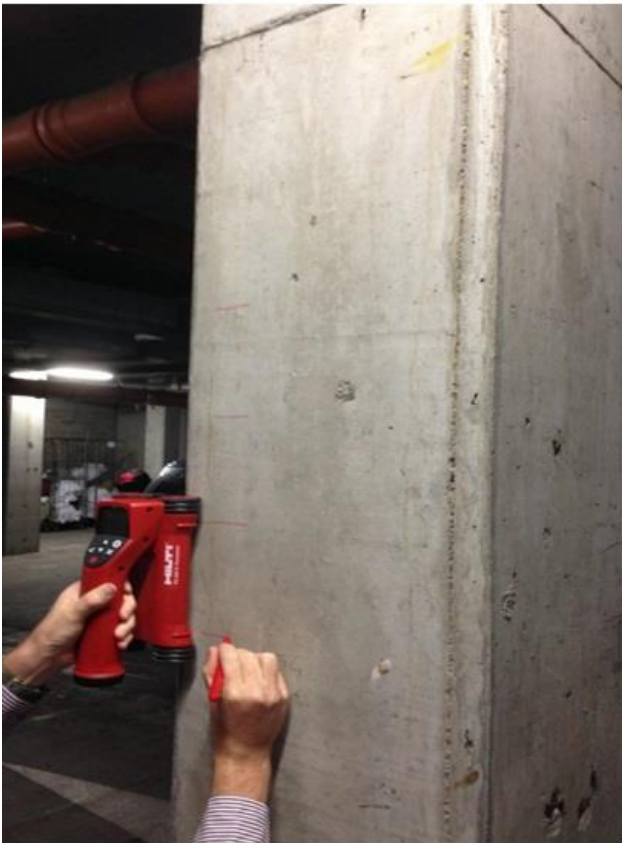
## Step 1 Horizontal Guidelines

Create horizontal guidelines on surface of concrete using the lugs on the scanning device (150mm apart)

- When scanning columns, scan as high as you can to avoid long starter bars/laps (which will distort bar diameter readings)
- Using “Image Scan” you will scan four rows horizontally

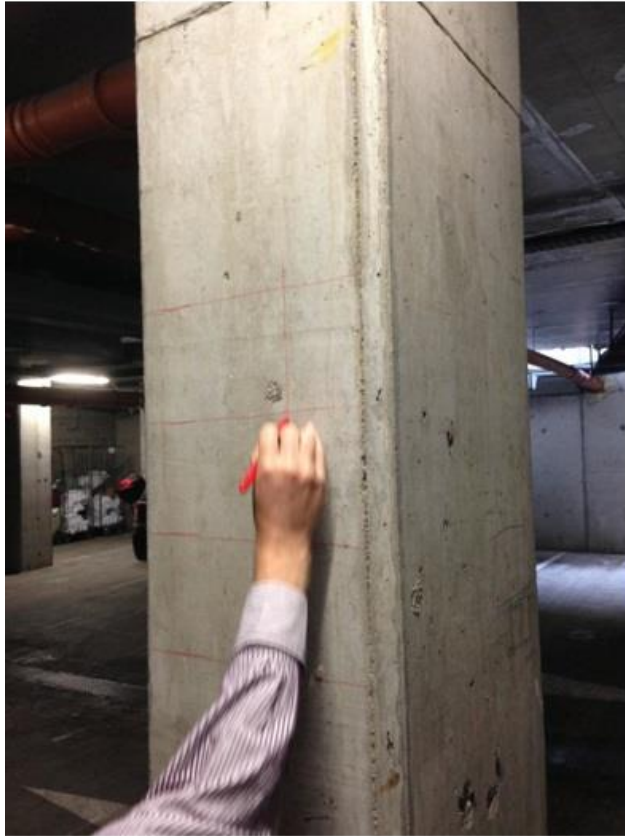
Step 2 Vertical Guidelines

Mark vertical guidelines on the surface of the concrete

- For narrow column as shown here, a single vertical scan is sufficient to pick up the shear link steel
- The vertical main steel is picked up by the horizontal scan
- horizontal scan

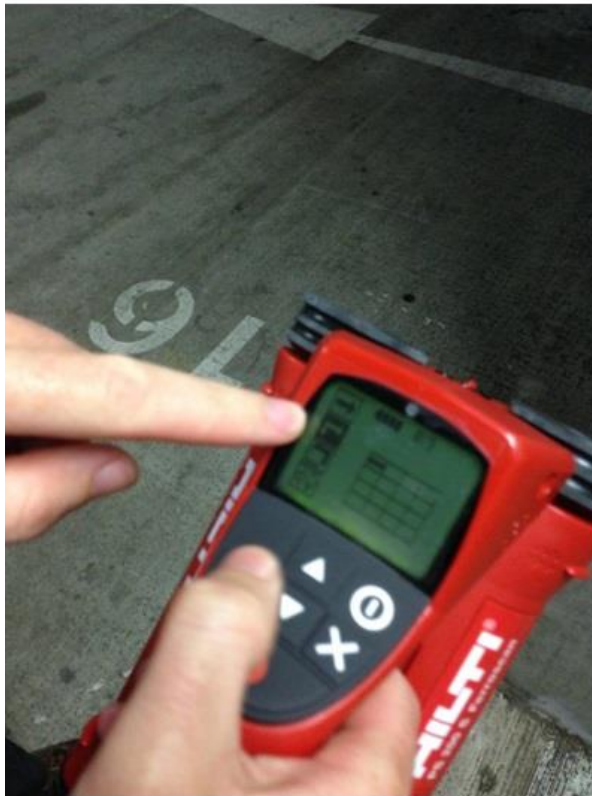
Step 3 Image Scan”

- I. Turn on the machine using the Button

- “Image Scan” is recommended as it allows 4x4 scan grid (600 x 600mm area) and gives details for bar size and cover
- “Quick scan” is a single row and gives indication of steel with cover, but not diameter
- The third option is a collection of 9 images scans to cover an area of 1.8 m x1.8m

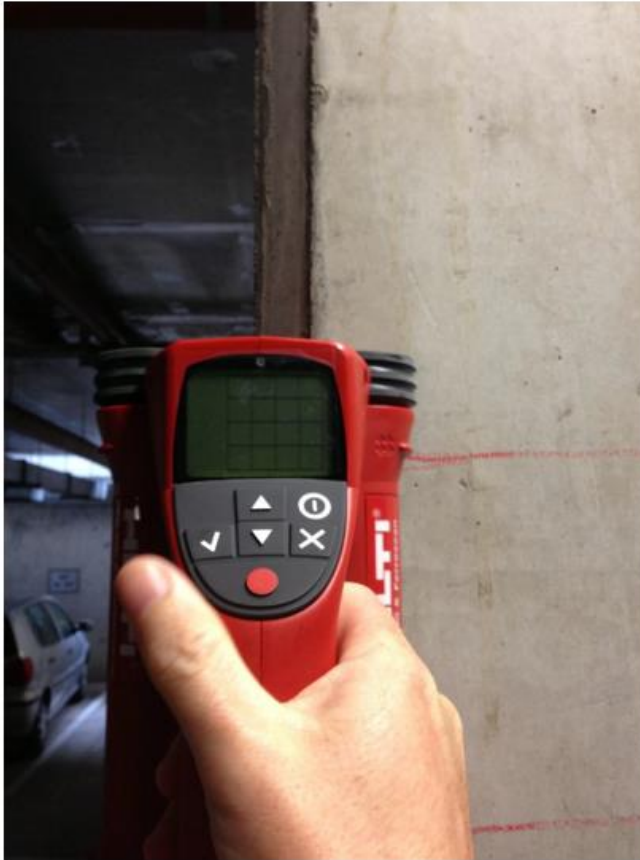
Step 4 Horizontal Scan Row 1 START

- I. Place the scanner such that the center is in line with the outside face of the column (there is a plastic lug at the center on the top face of the scanner which indicates where the scan starts) the plastic lug on the side of the scanner is lined up with the guideline (see photo below)
- II. Press the button

to hear the “beep” which starts the scan. Roll the scanner carefully sideways travelling from left to right over the column (take ~5 seconds to scan 600mm)

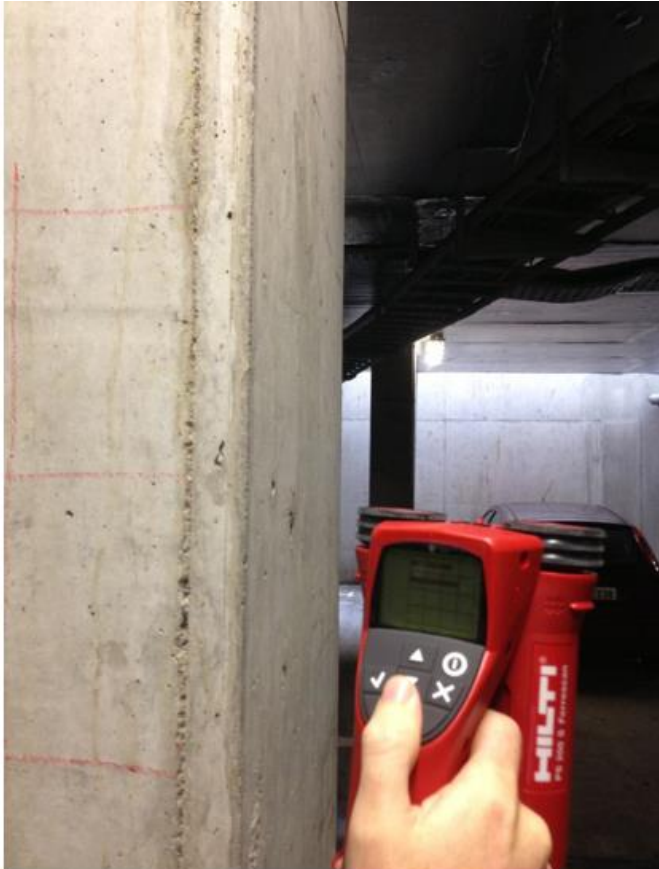
Step 5 Horizontal Scan Row 1 END

Roll off the column. If you have scanned 600mm the scanner will stop automatically. If not, you should press the

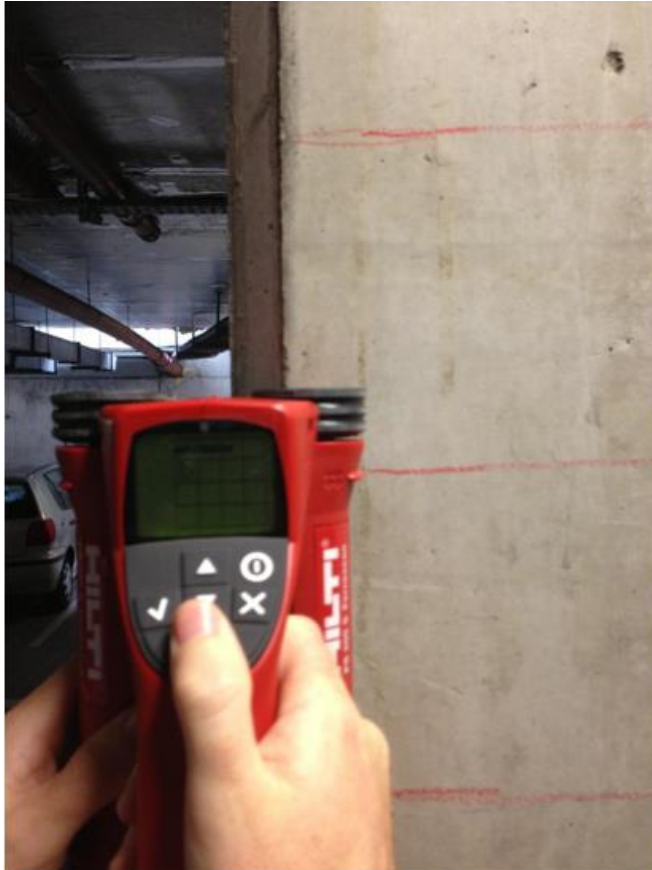
Step 6 Complete Horizontal Scans

Repeat for rows 2, 3, and 4, following the guidelines carefully

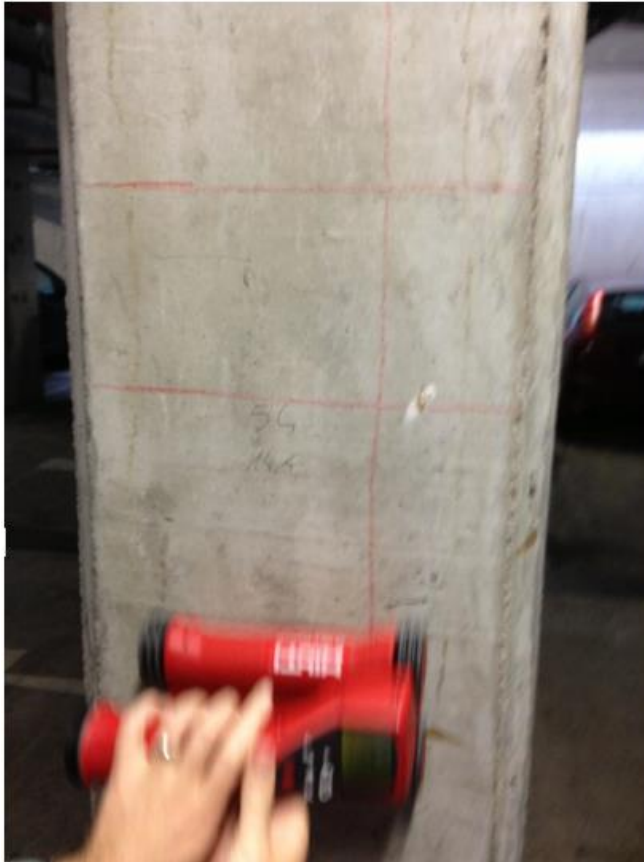
Step 7 Vertical Scans

The scan strip is indicated

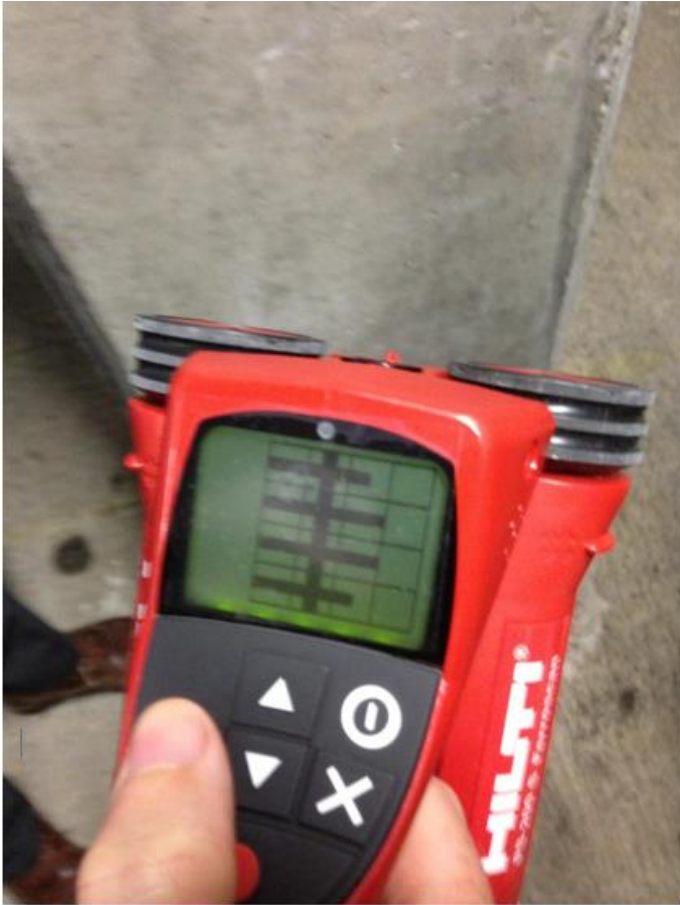
Step 8 Complete Scan

On completion of all rows and strips, press the

button to complete image scan.

You will then be back at the home screen where you will see you scan has registered as one of nine (capacity of scanner)

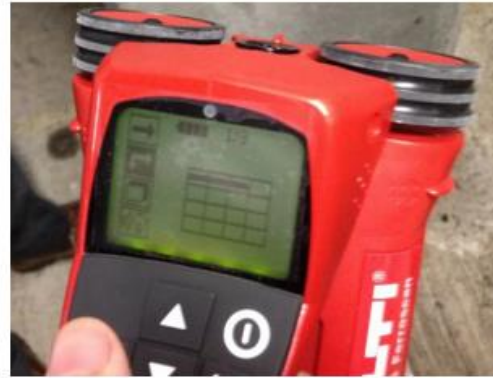
## Step 9 Transfer Scan to Monitor

From the home screen, select “Open Project” and select or create your project

- Monitor is not touch screen – use controls on either side!

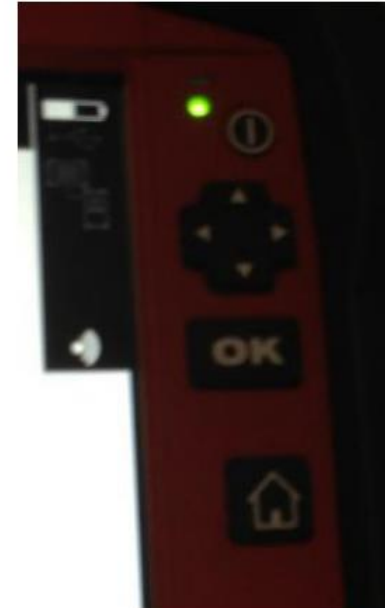
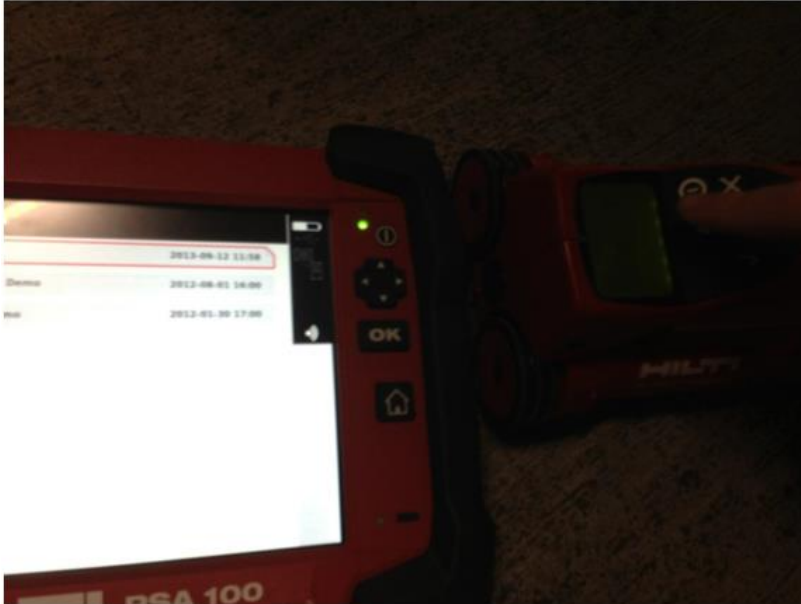
Step 9 Transfer Scan to Monitor

- I. Line up the infrared ports of the scanning device and the monitor
- II. On scanning device, press the

- It is easy to do this on the floor or table top to free your hands

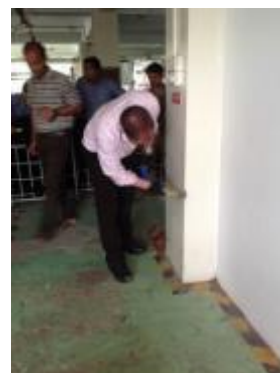
### Step 2. Remove render

- I. Mark out a square using the Ferro scan crayon approximately 150mm x 150mm.
- II. Wear gloves and eye protection provided in the kit bag.
- III. Using the geological hammer or hammer and chisel break off the surface render.
- IV. Note that you will not be able to 'grind' the surface right to the edge of the 'breakout'.

You are aiming to have a prepared surface of at least 100mm x 100mm.

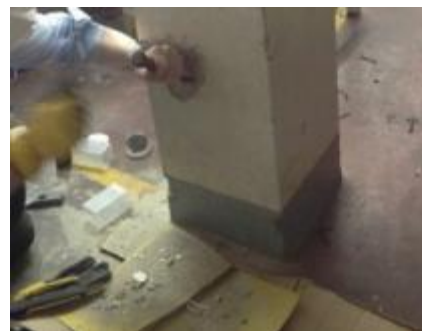
### Step 3. Preparation of the exposed concrete surface

- I. Wear gloves and the dust mask provided in the kit bag (use a new mask each day).
- II. Using the abrasive stone, grind heavily textured or soft surfaces, or surfaces with loose mortar, until they are smooth and free of loose material over an area of at least 100mm by 100mm. If lots of aggregates are visible, a larger area may need to be prepared. Smooth-formed or troweled surfaces may be tested without grinding.
- III. Using the brush provided in the kit bag remove surface dust.
- IV. Remove any water present on the surface of the concrete.

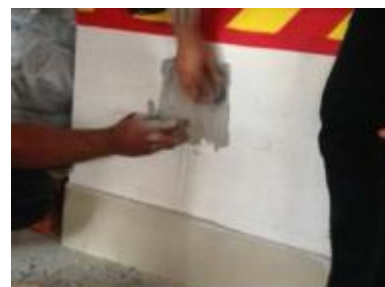
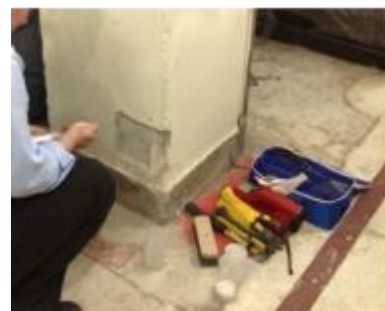
### Step 4. Schmidt Hammer use

- I. Take a minimum of nine valid readings to obtain a reliable estimate of the rebound number for a test location.
- II. Ensure that no two impact points are closer than 25mm and none are within 25mm of an edge (hence the prepared area must be at least 100mm square).

- VI. Examine each impression made on the surface after impact and if the impact has crushed or broken through a near-to-surface void, discount the result.

- VII. Avoid placing the hammer directly on aggregate, as this will return a false result.

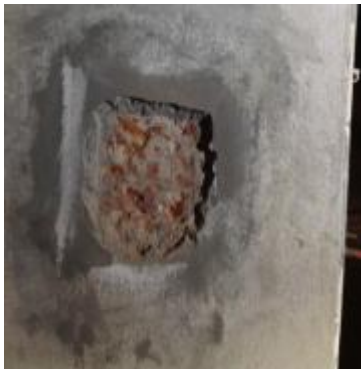
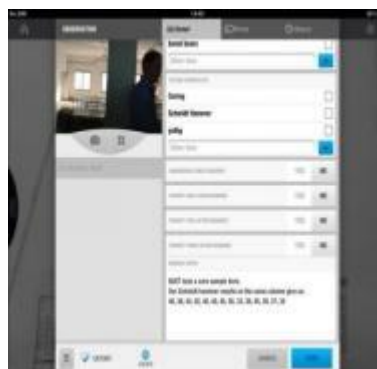
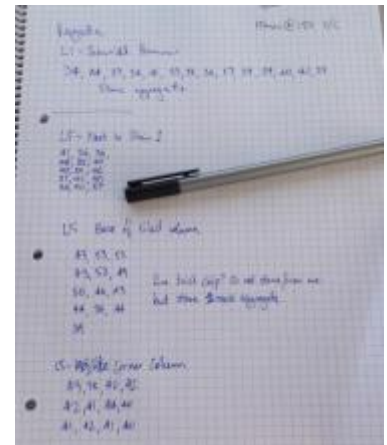
Step 5. Record results

- I. Write down the results in notebook or directly into tablet app. Photograph results with iPad
- II. After the assessment, add the results to the master database.

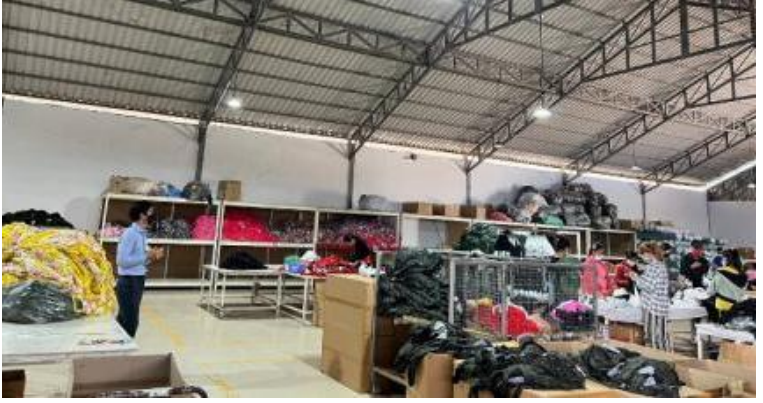
| <p><b>2.7kN/m<sup>2</sup> (1.5m High)</b></p> <p>1.5m high disordered bundles</p> <p><b>Assume density of loose clothing i.e., 1.8kN/m<sup>2</sup>/m height</b></p> <p>Stack height of 1.5m Equivalent area load of 2.7kN/m<sup>2</sup></p> | |

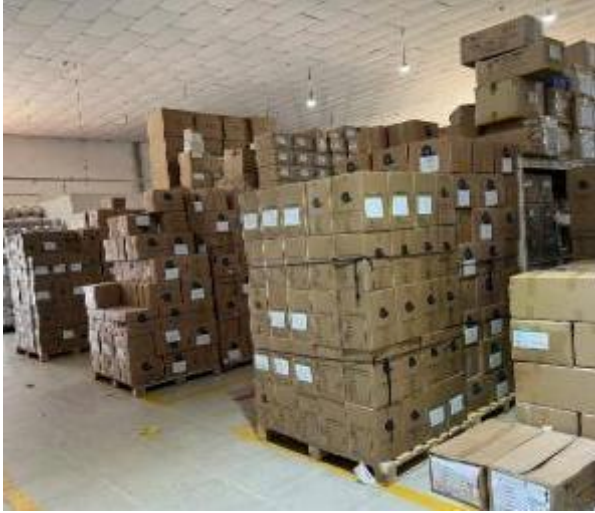
| <p><b>Can be up to <math>4.0\text{kN/m}^2</math> (2.0m High) depending on contents of boxes</b></p> <p>Denim factory</p> <p>Boxes are 45cm x 37cm x 11cm</p> <p><b>Assume density of packed clothing i.e., <math>2.0\text{kN/m}^2/\text{m}</math> height</b></p> <p>Stack height of 2.0m Equivalent area load of <math>4.0\text{kN/m}^2</math></p> | | |

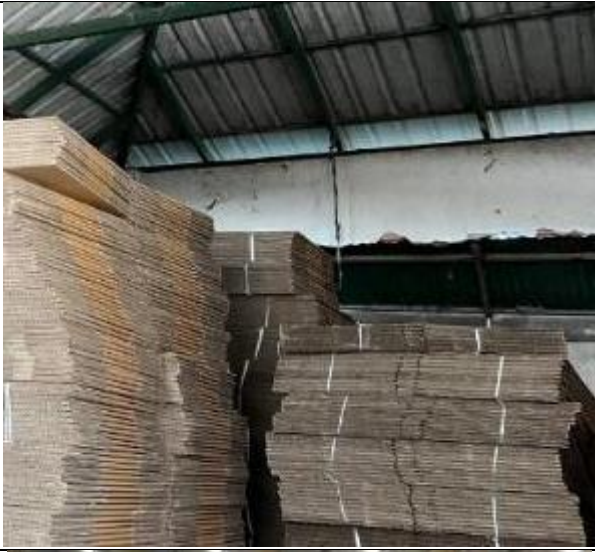
| <p><b><math>2.5\text{kN/m}^2</math> (2.0m High)</b></p> <p>Stacked flat cardboard up to 2m high</p> <p><b>Assume density of packed cardboard i.e., <math>1.25\text{kN/m}^2/\text{m}</math> height</b></p> <p>Thus, 2m high stack = <math>2.5\text{kN/m}^2</math></p> <p>Alternative measurement: -</p> <p>Density = <math>125\text{kg/m}^3</math></p> <p>This was determined by weighing a sample of</p> | | |

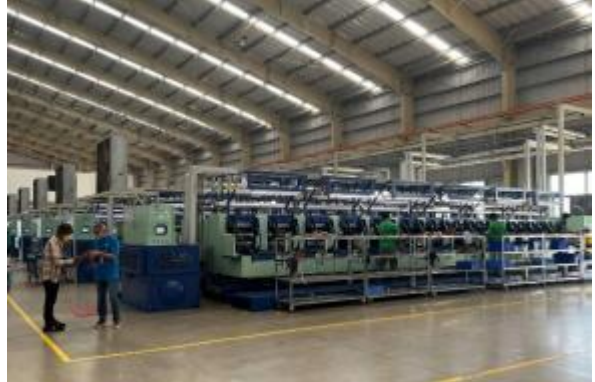
| <p>Heavy Machinery Measure weight on site</p> | | |

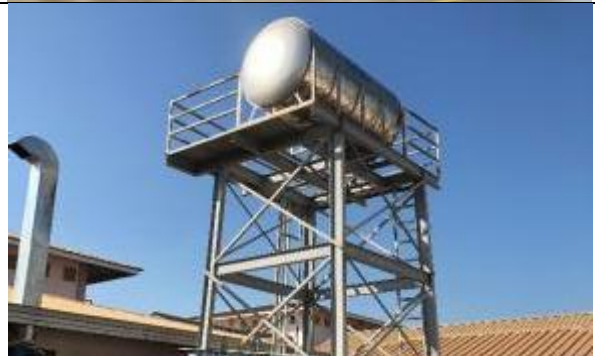
| <p><b><math>10\text{ kN/m}^2/\text{m}</math> height</b></p> <p>Measure height of plinths and calculate weight</p> <p>Record tank capacities and consider total load on slabs, beams or columns</p> | | |

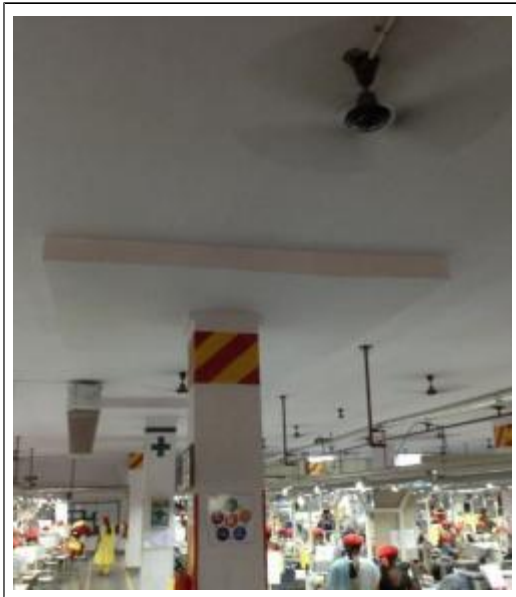
Figure N Typical flat slab with drop panels

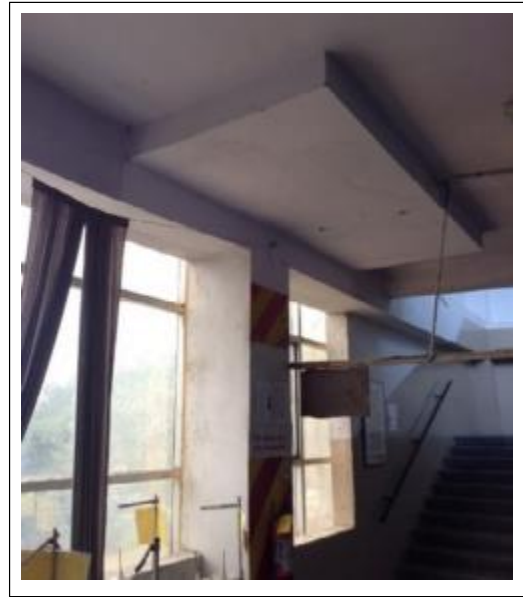
Figure N Typical floor structure at link between Part A and

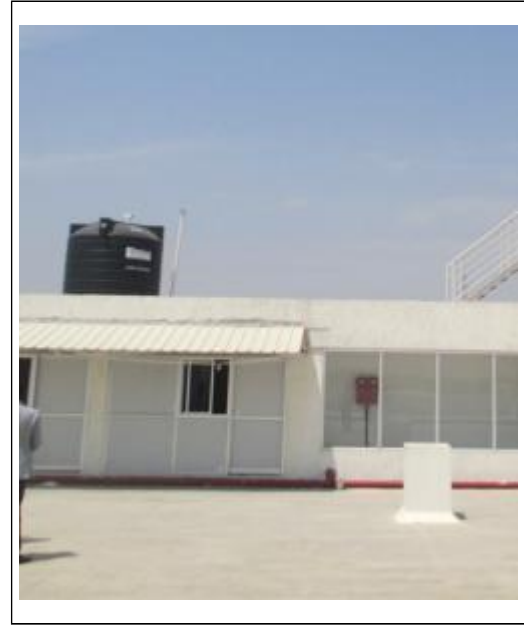
Figure N Water tank on columns at Roof level – GL E/7-8. Approx. storage – 24,000 liters Similar tank at GL E/2-3

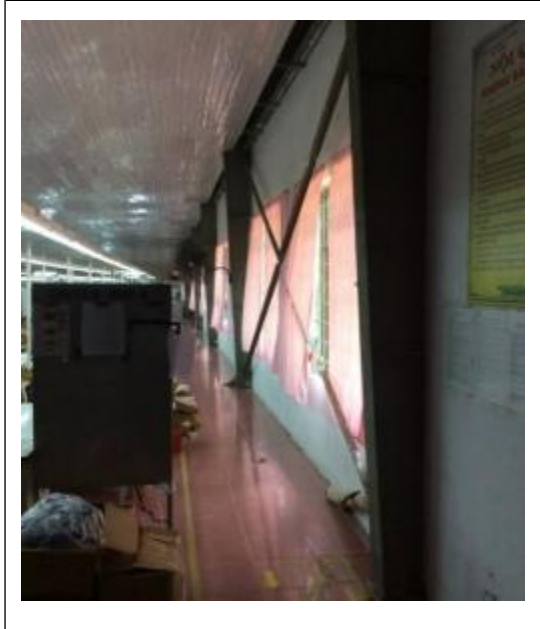
Figure N Typical braced bay – suspended ceilings throughout so portal frames not visible. External masonry wall built tight to outside of column flange

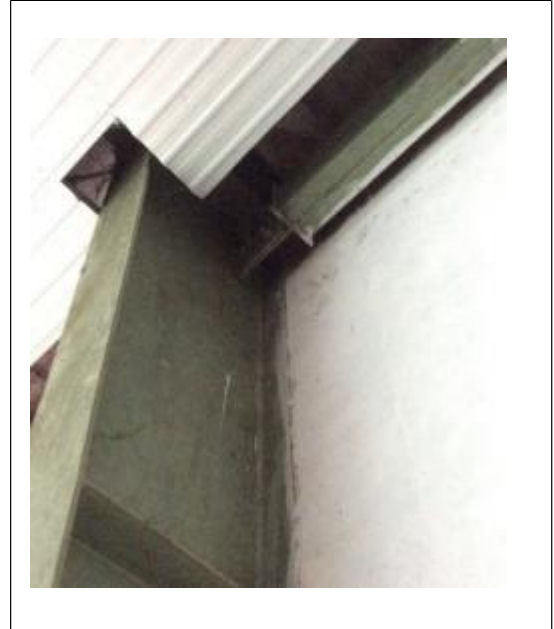
Figure N Typical eaves detail – eaves beam visible

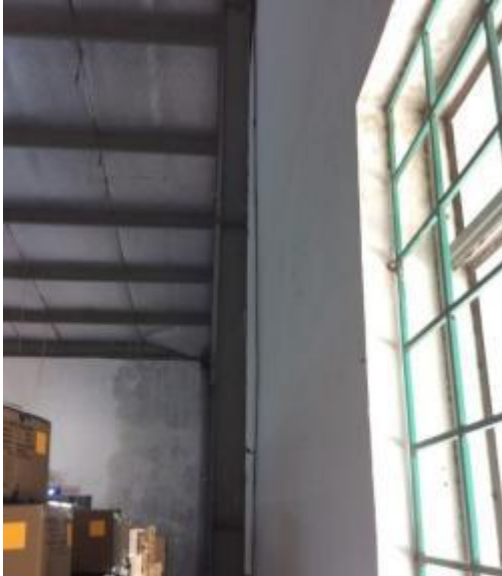
| Ref No. | STRUC-1 |
|---|---|
| Observations: Bowing of unrestrained masonry wall on northern gable of Building 5-10. Apparent deflection to concrete canopy on this wall. | |

Figure N Bowing of masonry wall which is not restrained by steel columns in gable – c.30-40mm deflection at mid height of wall

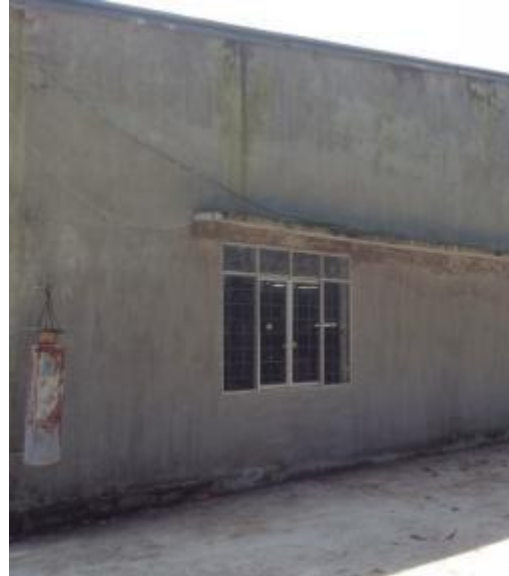
Figure N View of northern gable wall with apparent repairs / new render. Concrete canopy appears to have deflected

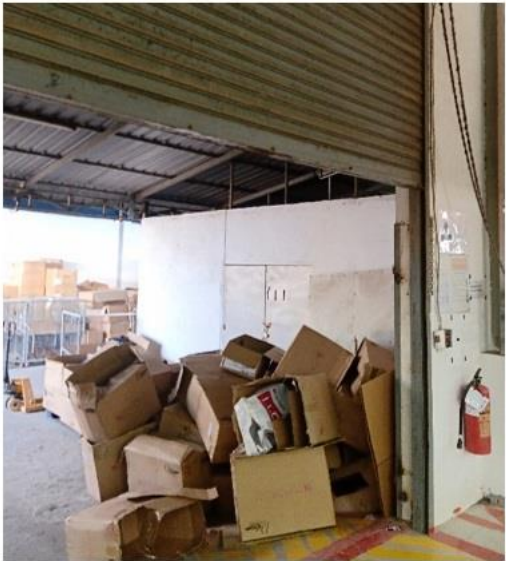
**Figure 8** Temporary storage of carton along the Exits (e.g. Above)

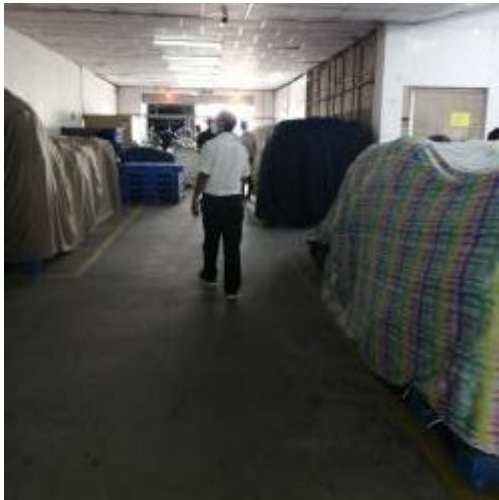
**Figure 9** Excessive ‘in-process’ storage stacked on Sewing floor

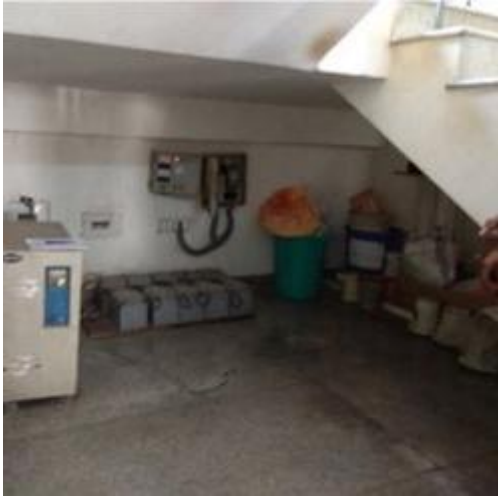
**Figure 10** Miscellaneous storage and UPS battery back-up under stairway

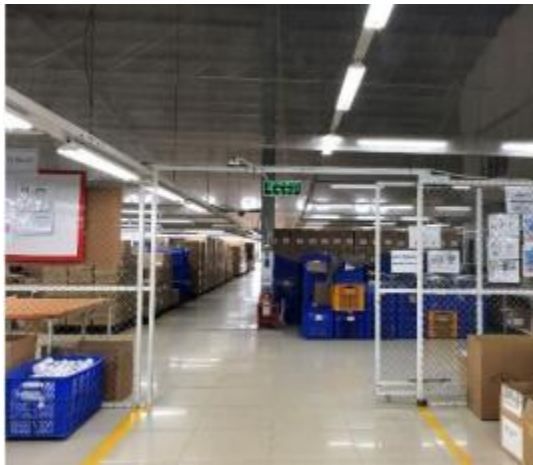
**Figure 11** Dedicated storage area separated by open wire enclosure (e.g. above)

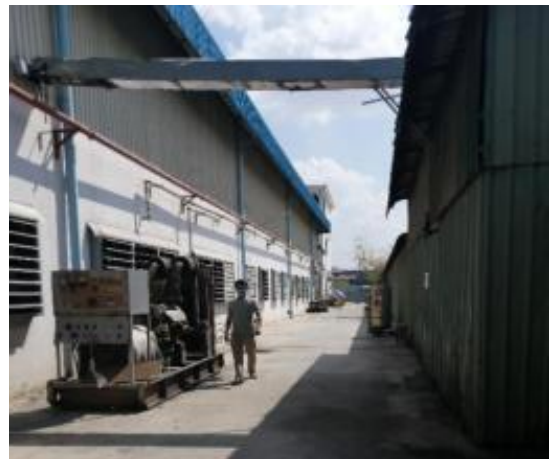
**Figure 12** Diesel cooled Transformer Adjacent Crèche and large window onto

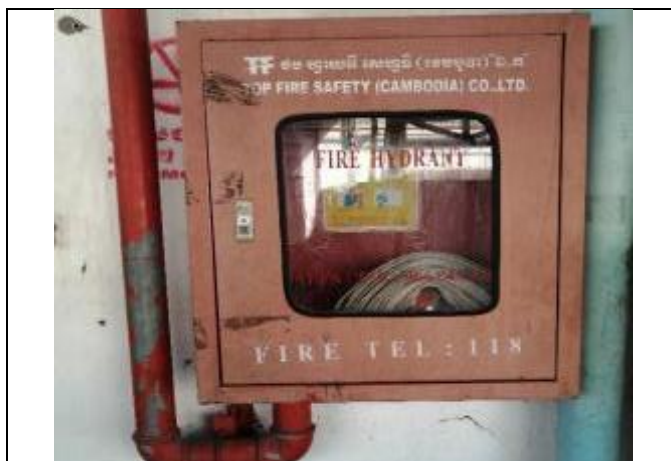
**Figure 13** Fire Hydrant and hose reel at half landing, located at height

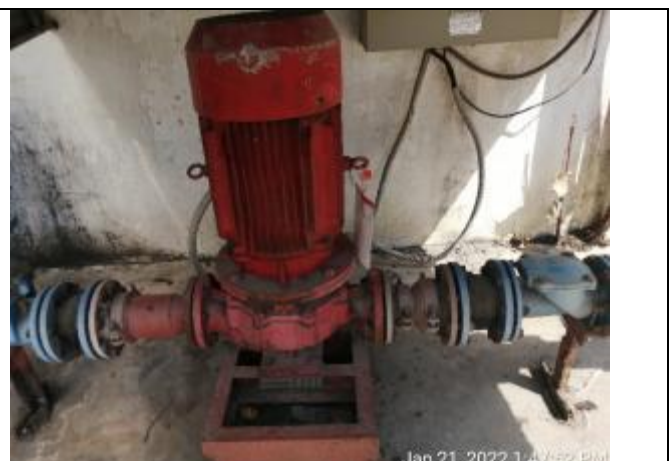
**Figure 14** Centrifugal suction fire water pump adjacent to reservoir

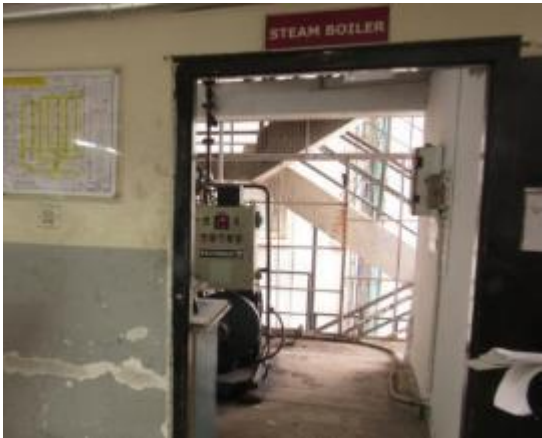
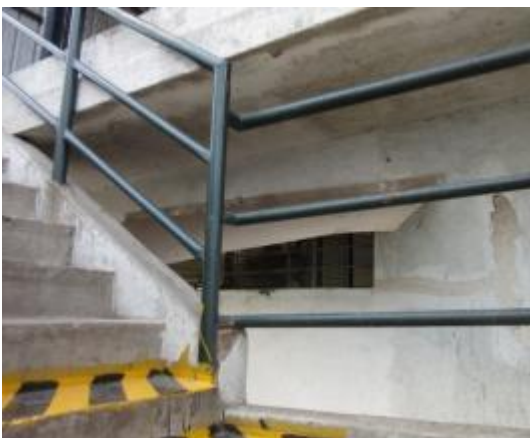
| Ref No. | Issue Type | Sub-Issue Type |
|---|---|---|
| <b>Figure xx</b> Boiler room with no enclosing wall facing onto external stair (e.g.: external stairs) | | <b>Figure xx</b> Unprotected window openings adjacent to external stair (e.g.: external stairs) |

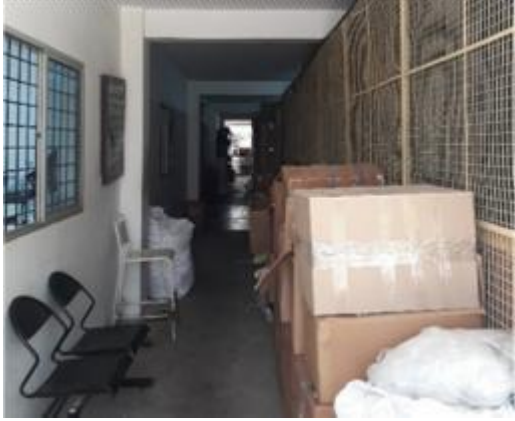
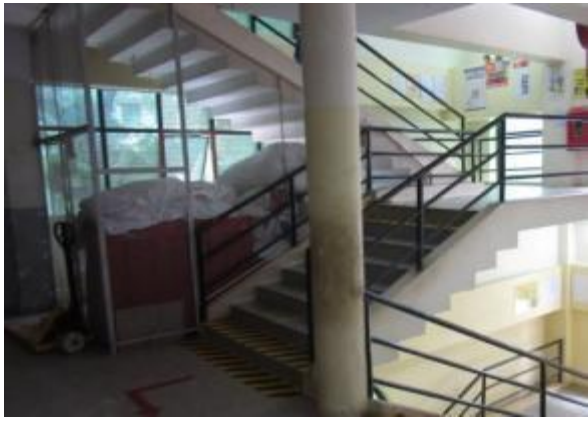
| Ref No. | Issue Type | Sub-Issue Type |
|---|---|---|
| <p><b>Figure xx</b> Each figure to have brief descriptive title (e.g. Uncontrolled storage on escape path)</p> | <p><b>Figure xx</b> Storage of waste textiles under stairway (e.g. Uncontrolled storage on escape path)</p> | |

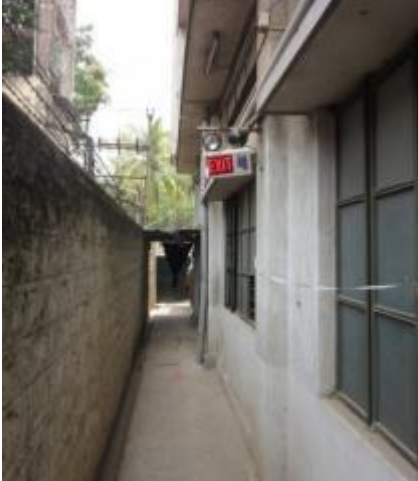
| Ref No. | Issue Type | Sub-Issue Type |
|---|---|---|
| <p><b>Figure xx</b> Narrow external corridor with windows unprotected from inside (e.g. Exit routes outside to place of safety)</p> | | <p><b>Figure xx</b> Each figure to have brief descriptive title</p> |

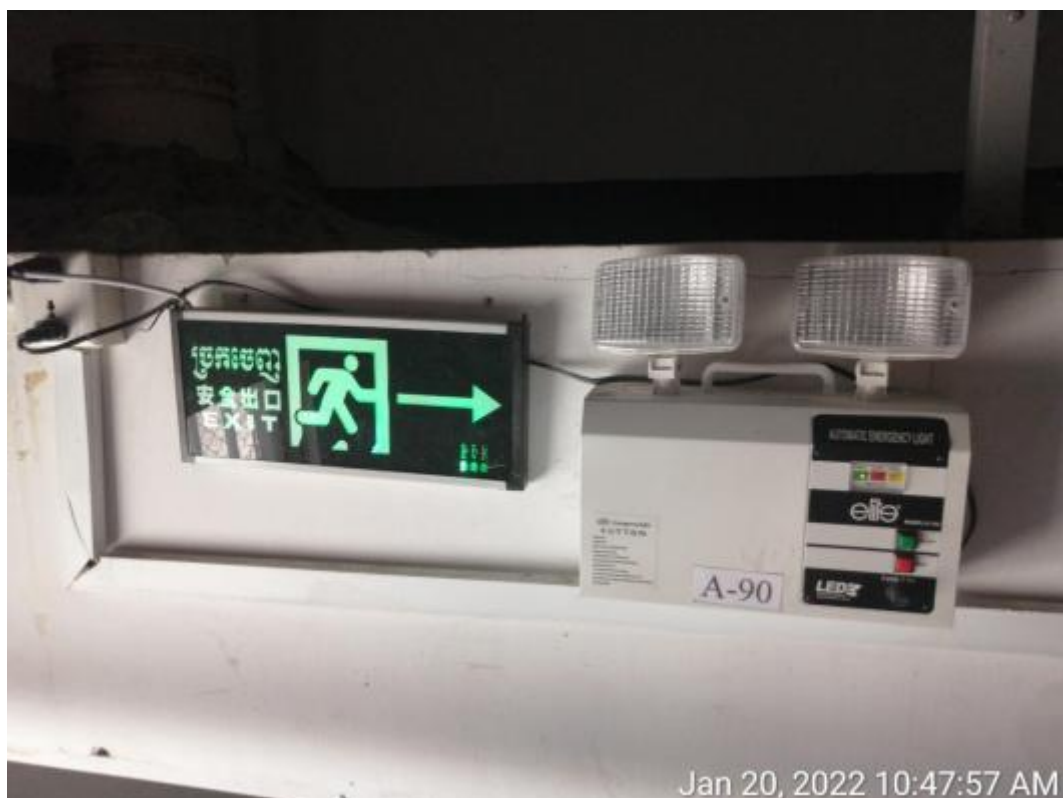
Emergency lighting throughout consisted of twin spot fittings mounted above doorways and final exits.

Figure N Emergency Lighting

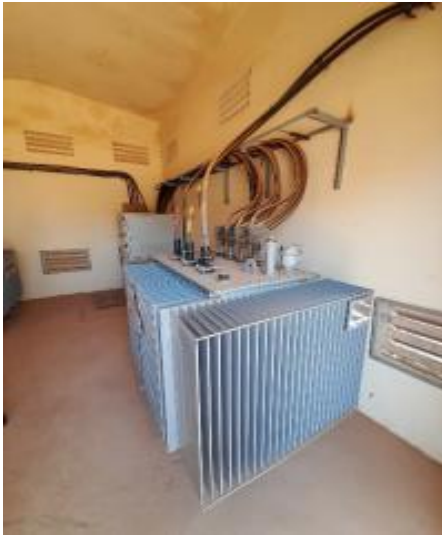
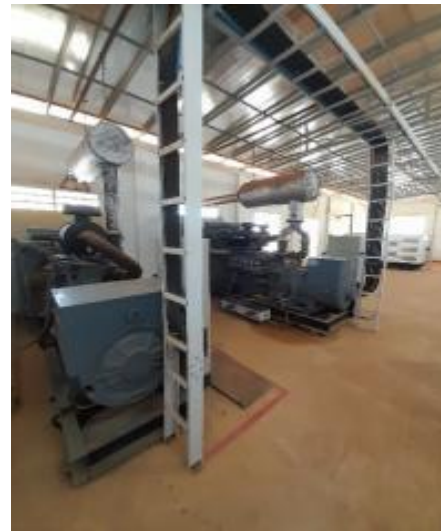
Power enters the site via 11kV overhead BESCOM supply which is connected to a tapping pole and 250kVA oil type transformer located outside boundary wall. The step-down voltage of 433V is connected to Main LT Panel located on ground floor.

One standby diesel generator of 200kVA is located on ground floor adjacent to the main LT panel room, the diesel is stored near to DG cabinet. The starting of DG is manual. 200kVA oil cooled voltage stabilizer is connected at the output side of transformer.

Figure N 250kVA Transformer and 200kVA DG set.

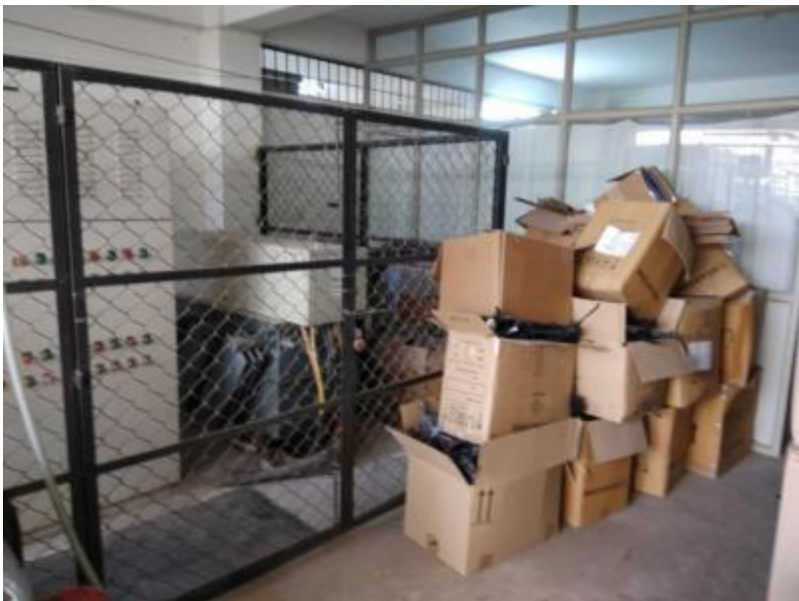
| Ref No. | Issue Type | Sub-header |
|---|---|---|
| Observations: Combustible material storage next to the main LT panel room metal fence. | | |
| <p style="text-align: center;">Figure N Storage of combustible material near main LY panel metal fencing.</p> | | |

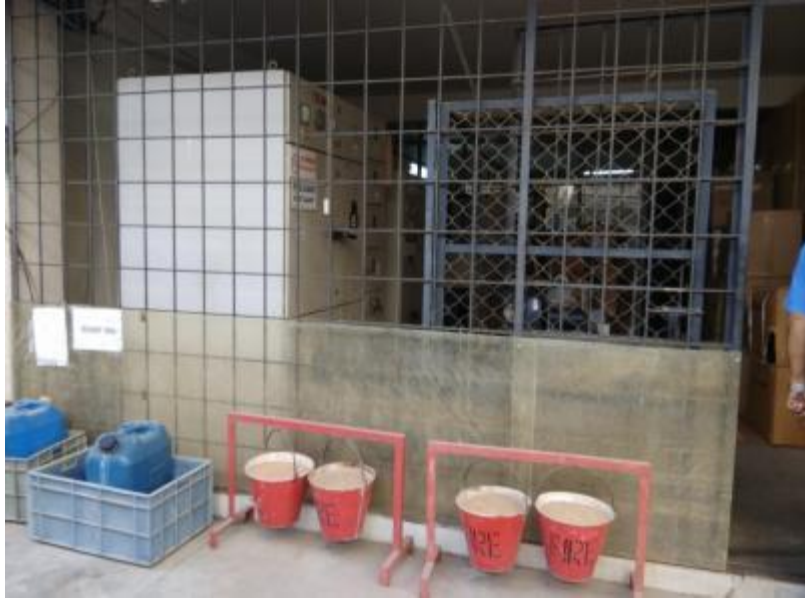
| Ref No. | Issue Type | Sub-Header |
|---|---|---|
| Observations: Exposed main electrical panel room to external weather condition. | | |
| Figure N Exposed Main Electrical panels | | |
