## LABS Initiative

# Methodology for Preliminary Safety Assessments in Indonesia

Issue 1.2| 24th May, 2023

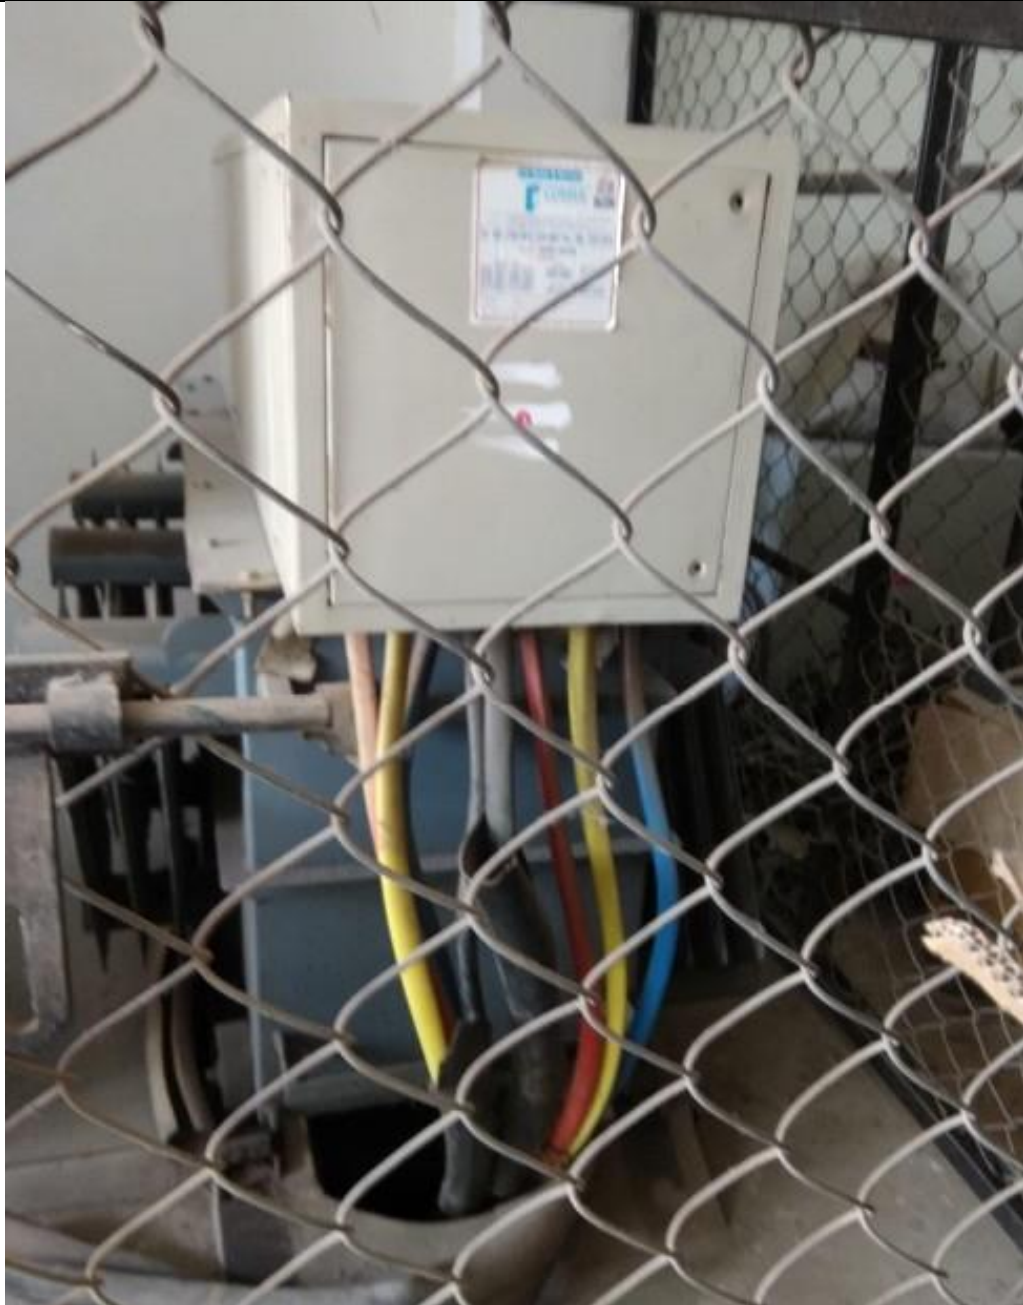
Observations: Cables are terminated without fixing of cable armor into the gland, there is no other insulation available on outer sheet.

Figure N Improper termination of cables.

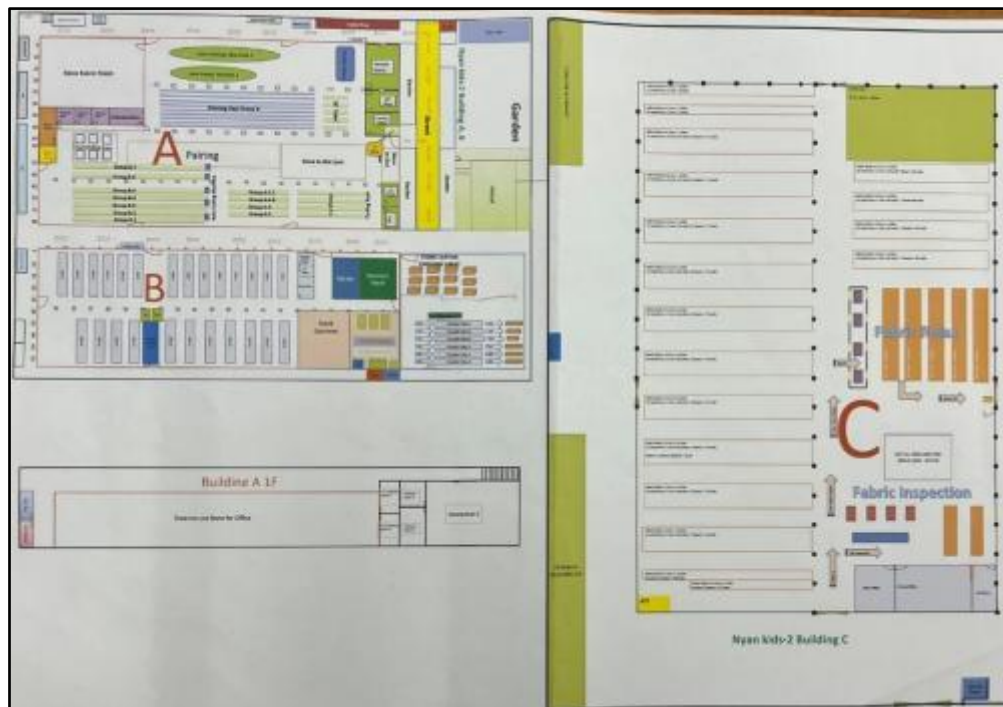
Figure 2: Building Cross Section and Occupancy

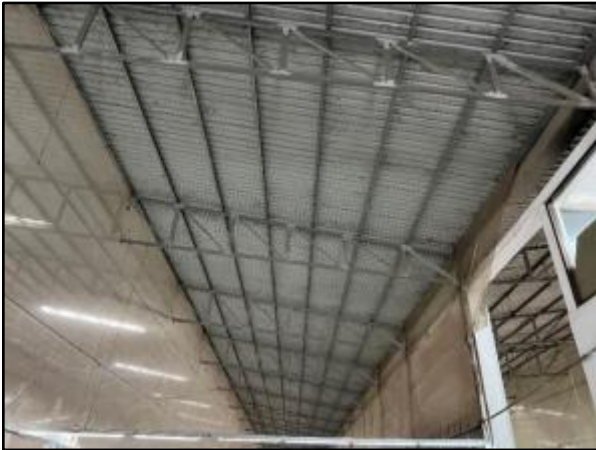
Figure 22: Roof truss system of building A

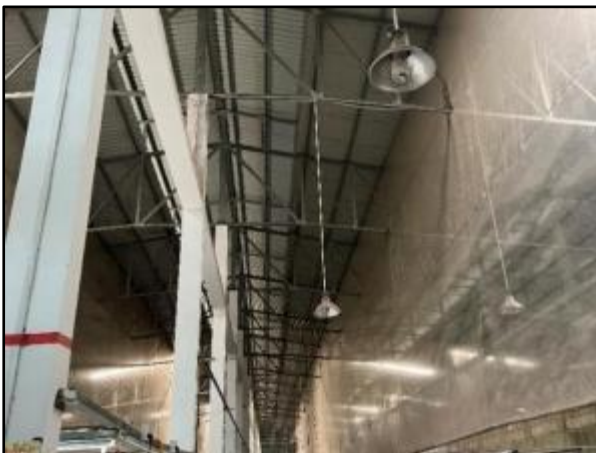
Figure 23: Truss system supported by concrete columns

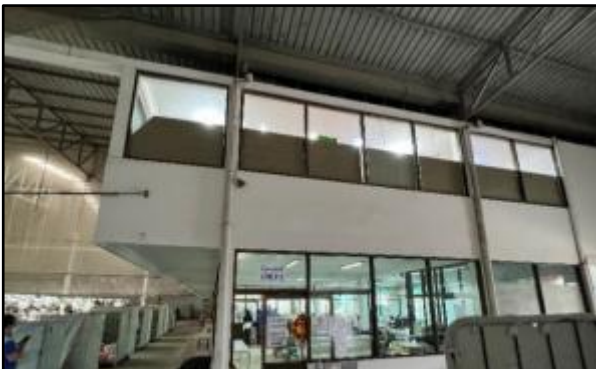
Figure 24: Cantilever floor of building A

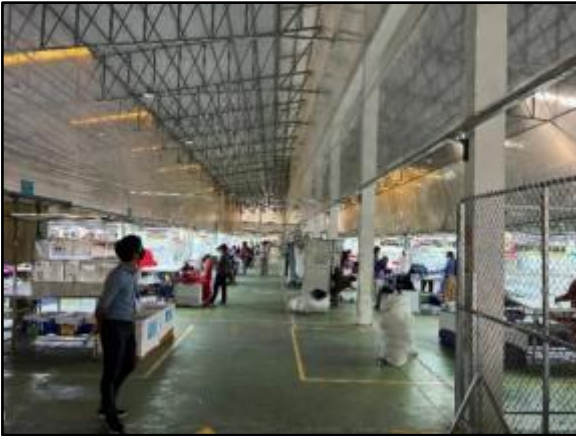
Figure 25: Structural system of building

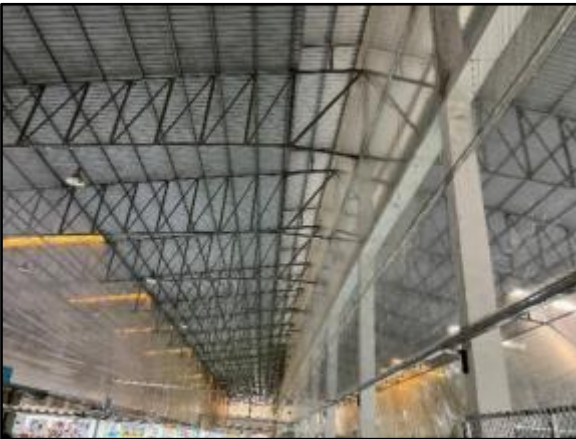
Figure 26: Roof truss system of building B

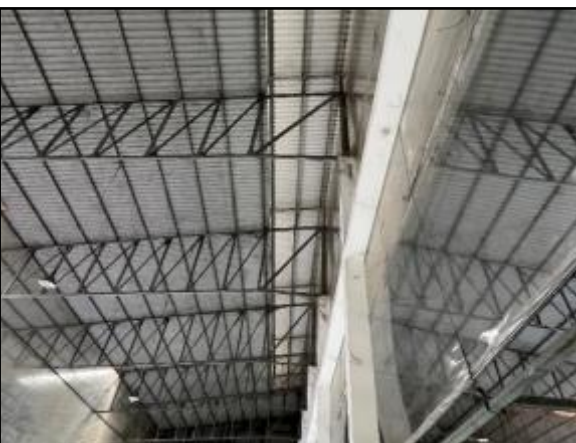
Figure 27: Zoom-in roof truss system of building B

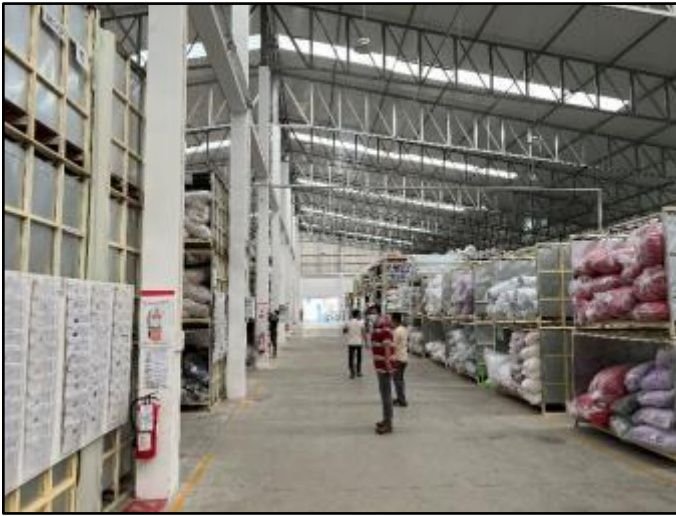
Figure 28: Inside view of the structural system

**Stability System:** Roof truss structure fixed to reinforcement concrete column. There was no wind bracing on roof.

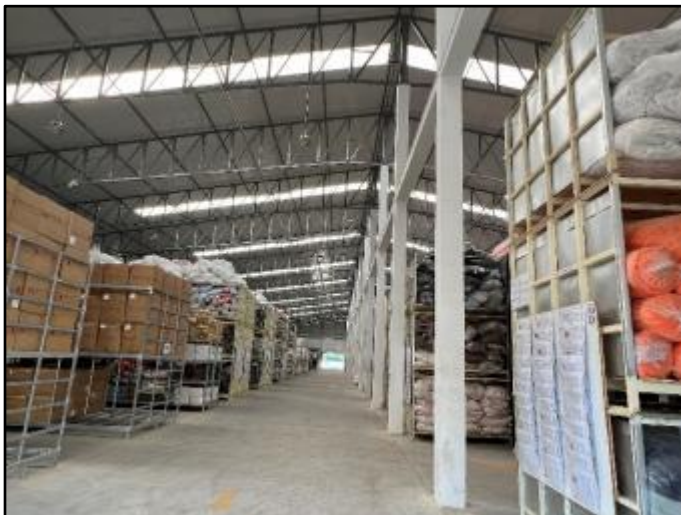
Figure 29: Truss system of the building

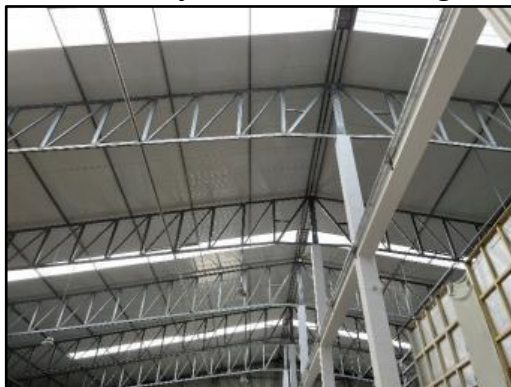
Figure 30: Zoom-in view of the truss system supported by the columns

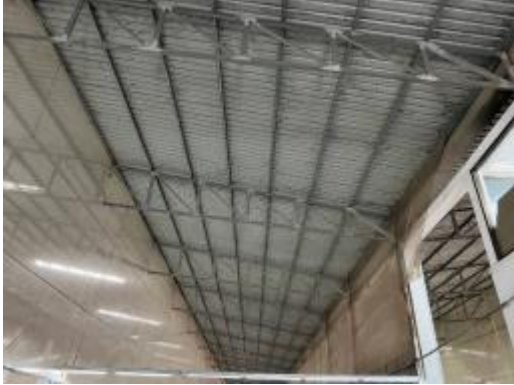
| Ref No. | Issue Type | Sub-Issue Type |
|---|---|---|
| Observations: No bracing were observed in Building A, B and C. | | |
| <p>Figure 33: No bracing in Building A</p> | | <p>Figure 34: No bracing in Building B</p> |

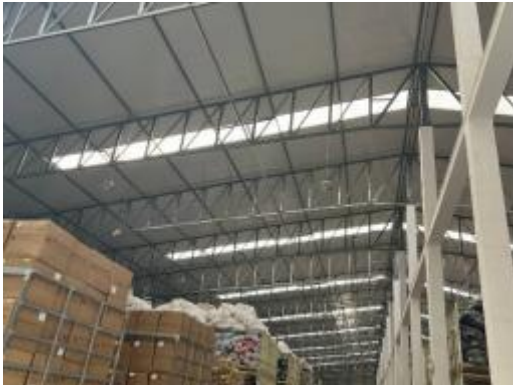
| Ref No. | Issue Type | Sub-Issue Type |
|---|---|---|
| <p>Figure 35: No bracing in</p> | | |

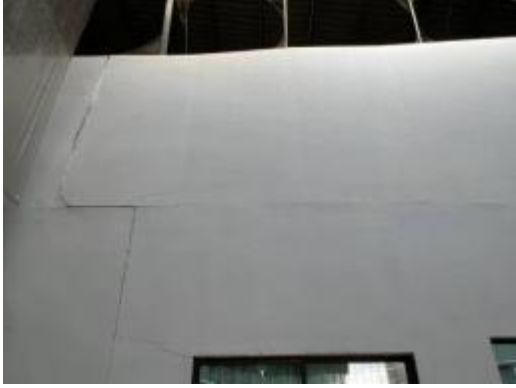
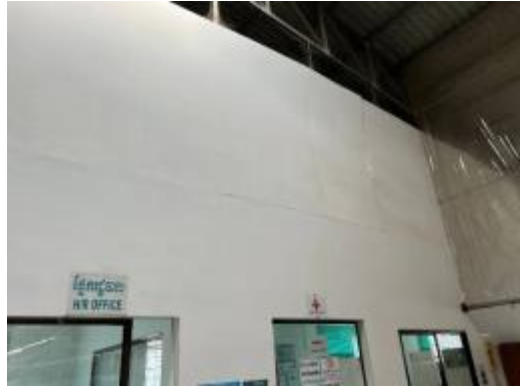
| Ref No. | Issue Type | Sub-Issue Type |
|---|---|---|
| Observations: Smartboard wall at HR/Nurse Office was cracked and bended | | |
| Figure 36: Smartboard wall was cracked and | | Figure 37: Smartboard wall was cracked and |

| Details Of Issue Found | Smartboard wall at HR/Nurse Office was cracked and bended |

| Recommended Action | Factory to appoint Structural Engineer to review extent and nature of cracks, dampness and monitor as necessary. Remedial measures to be implemented. Refer to clause 8.26 of the LABS Standard | | | |

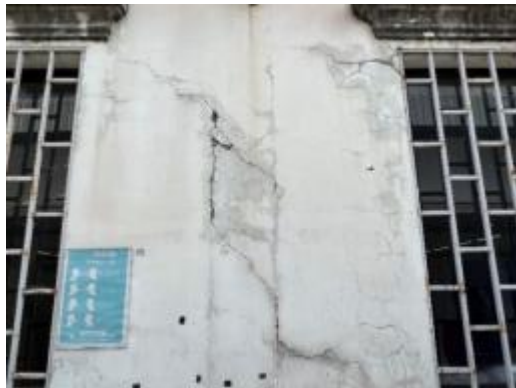
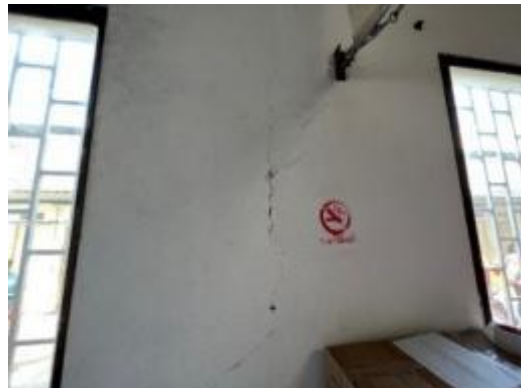
| Ref No. | Issue Type | Sub-Issue Type |
|---|---|---|
| Observations: Wall cracking at building A, B, C, and Hostel building | | |
| Figure 38: Wall cracking at building A | | Figure 39: Wall cracking at building A |

| Details Of Issue Found | Wall cracking at building A, B, C, and Hostel building | | | |

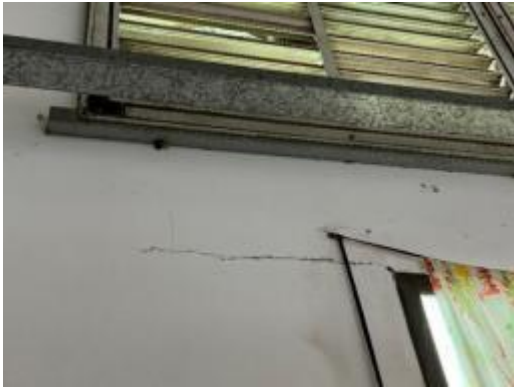
Figure 40: Wall cracking at building B

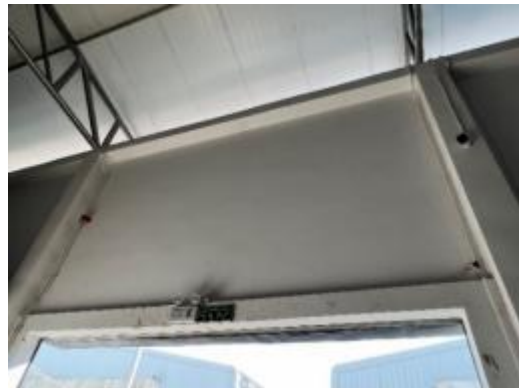
Figure 41: Wall cracking at building C

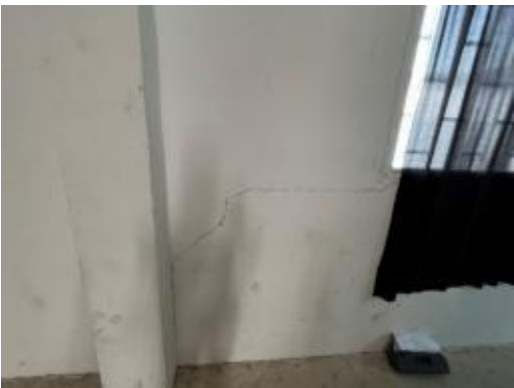
Figure 42: Wall cracking at building C

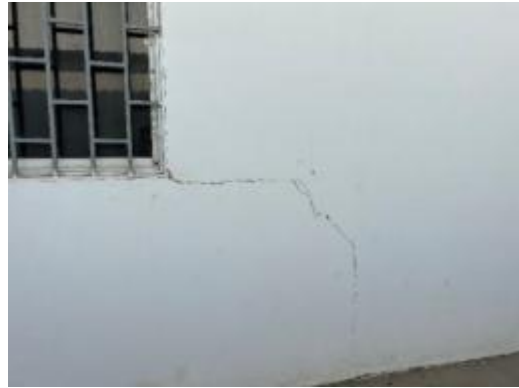
Figure 43: Wall cracking at building C

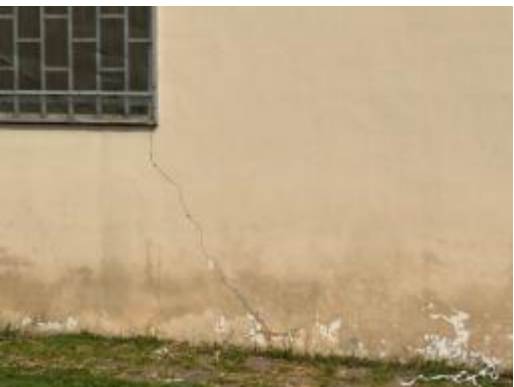
Figure 44: Wall cracking at Hostel building

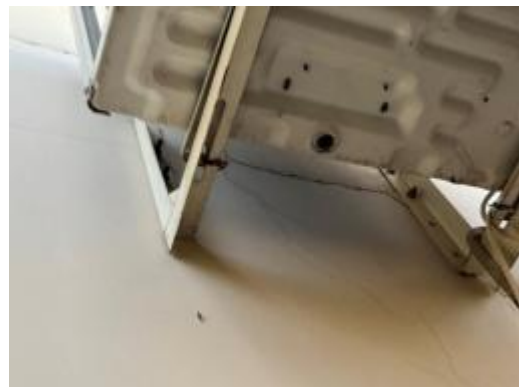
Figure 45: Wall cracking at Hostel building

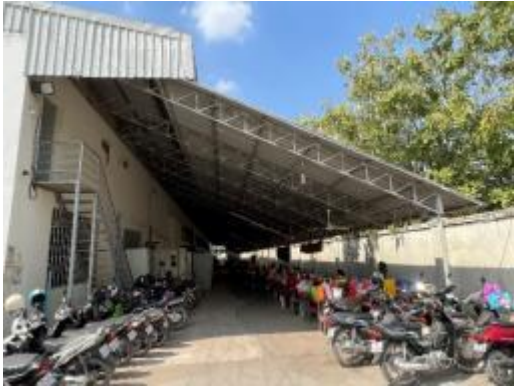
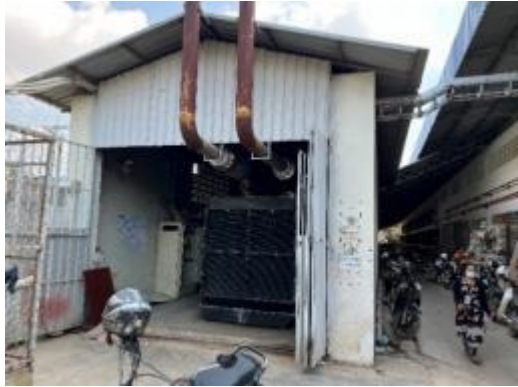
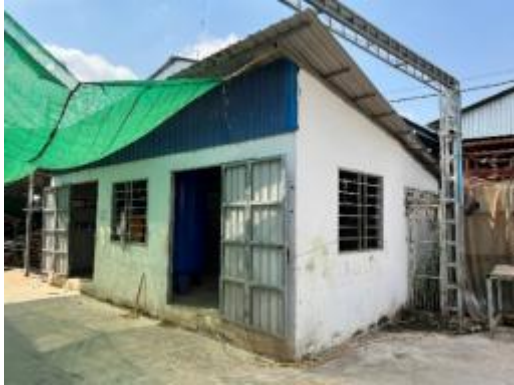
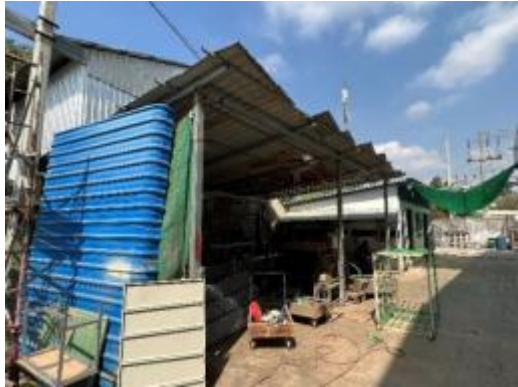
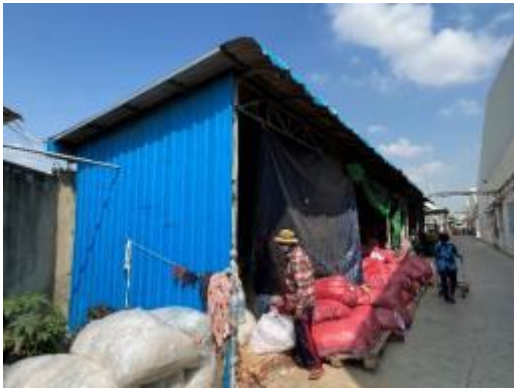
| Ref No. | Issue Type | Sub Issue Type |
|---|---|---|
| Observations: Dining Table Area, Generator room, Compressor Room, Scrap fabric storage, Workshop were built with unskilled worker | | |
| <p>Figure 46: Dining Table Area</p> | | <p>Figure 47: Generator room</p> |
| <p>Figure 48: Compressor Room</p> | | <p>Figure 49: Workshop</p> |
| <p>Figure 50: Scrap Fabric Storage</p> | | |

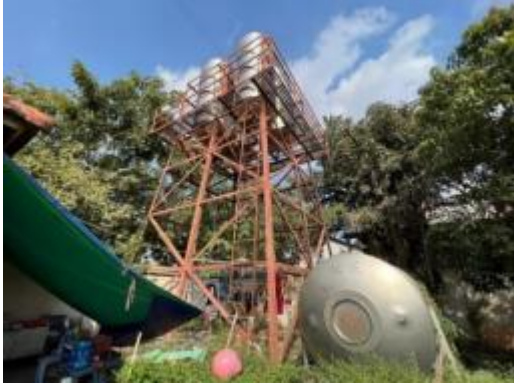
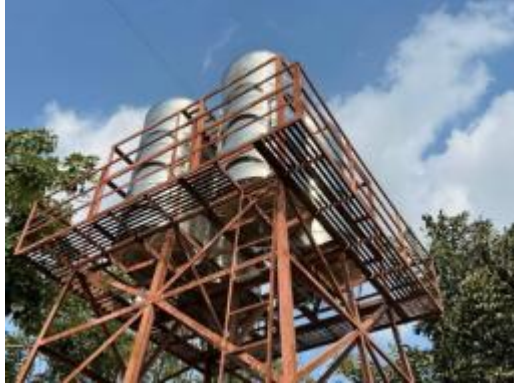
| Ref No. | Issue Type | Sub-Issue Type |
|---|---|---|
| Observations: Steel structure without calculation at water tank | | |
| Figure 51: Steel structure without calculation at water tank | | Figure 52: Steel structure without calculation at water tank |

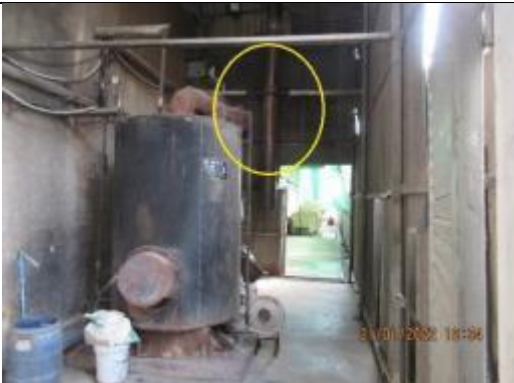
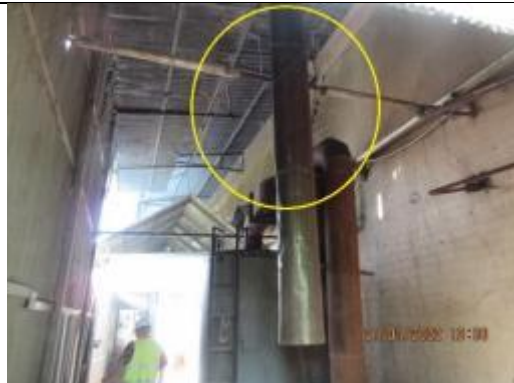
| Ref No. | Issue Type | Sub-Issue Type |
|---|---|---|
| Observations: The vertical support system was not apparent; the old chimney was hung without support. | | |
| Figure 53: Old chimney was hung without support | | Figure 54: Old chimney was hung without support |

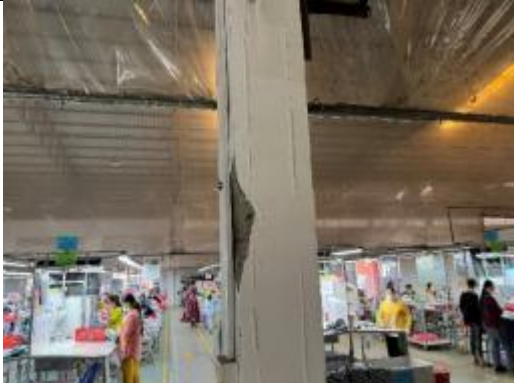
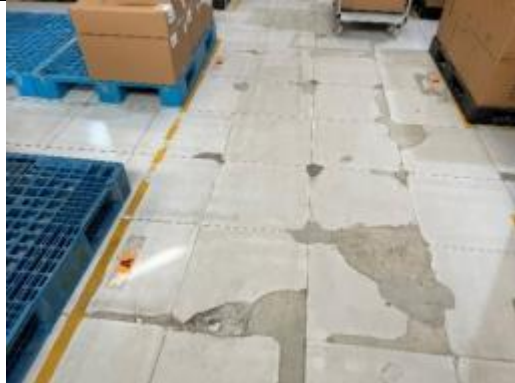
| Ref No. | Issue Type | Sub-Issue Type |
|---|---|---|
| Observations: Column damaged by drilling and observable broken floor tiles at building B | | |
| <p>Figure 55: Column damaged by drilling</p> | | <p>Figure 56: Broken floor tiles were observed</p> |

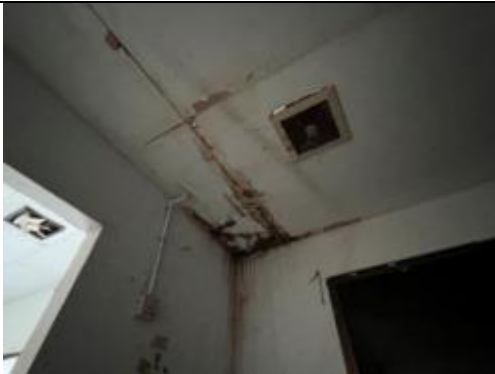
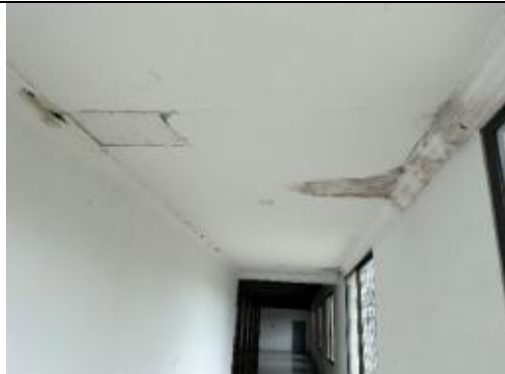
| Ref No. | Issue Type | Sub-Issue Type |
|---|---|---|
| Observations: Ceiling was damaged by water leakage at building A and mezzanine floor building A | | |
| <p>Figure 57: Ceiling has been damaged at building A</p> | | <p>Figure 58: Ceiling has been damaged at mezzanine floor</p> |

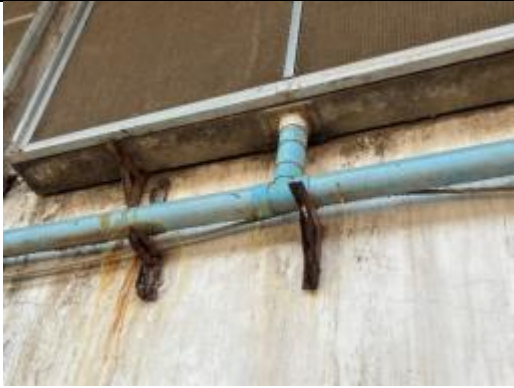
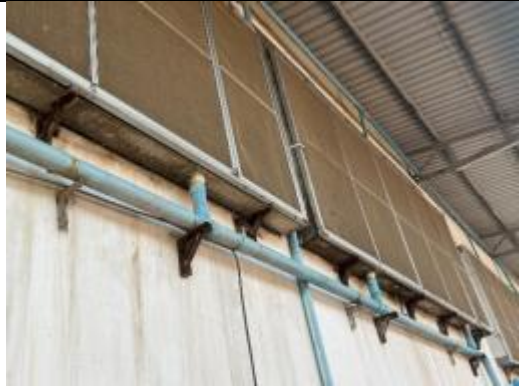
| Ref No. | Issue Type | Sub-Issue Type |
|---|---|---|
| Observations: Steel support corrosion at building B; Corrosion on steel structure supported Water tank. | | |
| <div><p>Figure 59: Steel support corrosion at building B</p></div> <div><p>Figure 60: Steel support corrosion at building B</p></div> | | |

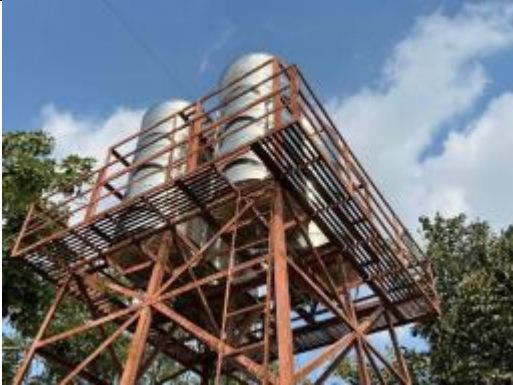
| Ref No. | Issue Type | Sub-Issue Type |
|---|---|---|
| <div><p>Figure 61: Corrosion on steel structure at water tank</p></div> | | |

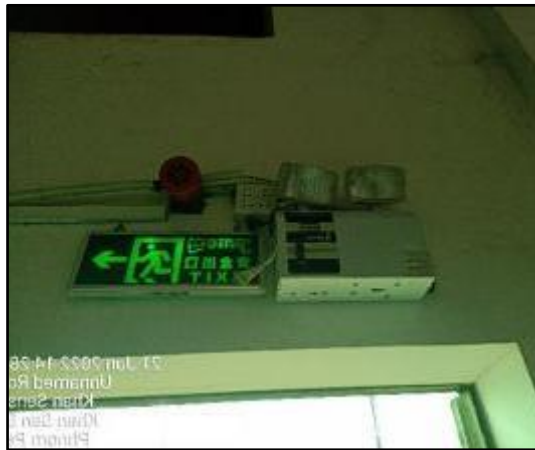
**Figure 10:** Inadequate back up power to emergency lighting

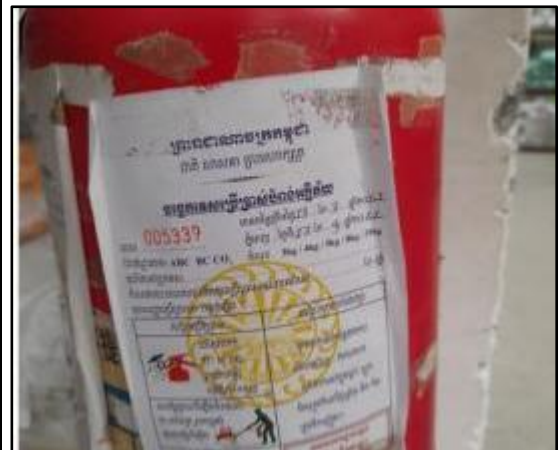
**Figure11:** Fire Extinguisher was not checked regularly at Dormitory

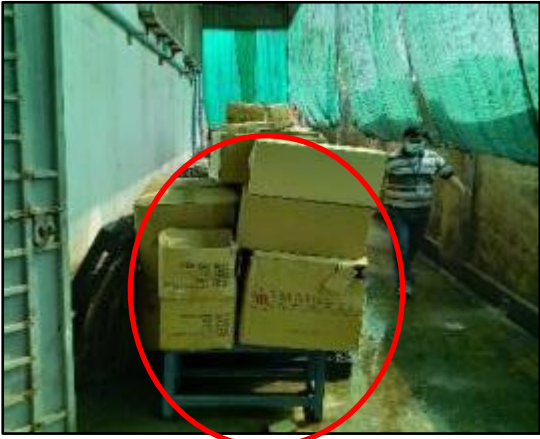
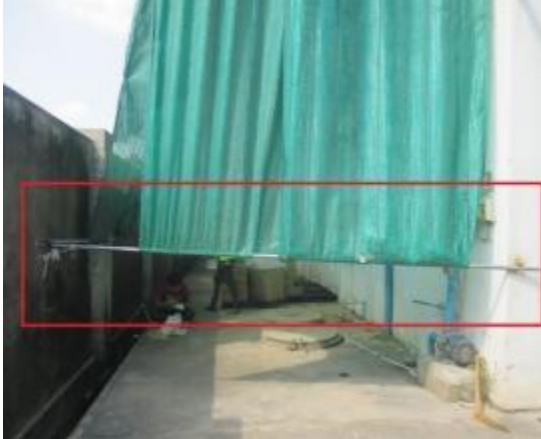
| Ref No. | Issue Type | Sub-Issue Type |
|---|---|---|
| The temporary storage and hard barrier were observed on the escape path from final exit at packing area of building B. | | |
| Figure 12: Temporary obstacle on the escape path from final exit at packing area – building B | | Figure 13: Hard barrier obstacle on the escape path from final exit at packing area - building B |

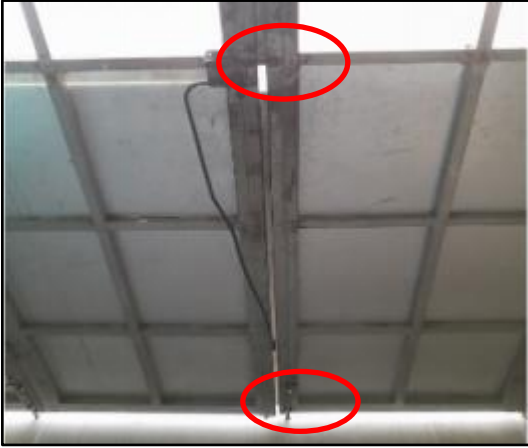
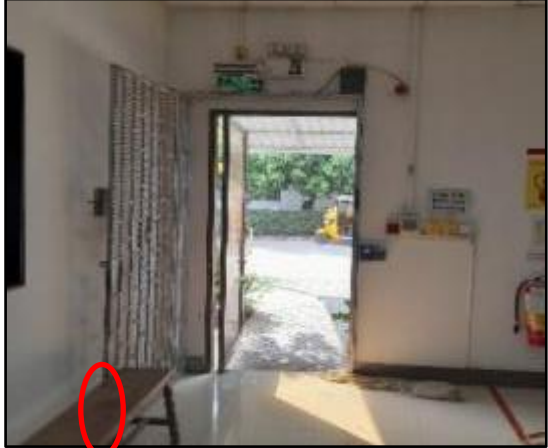
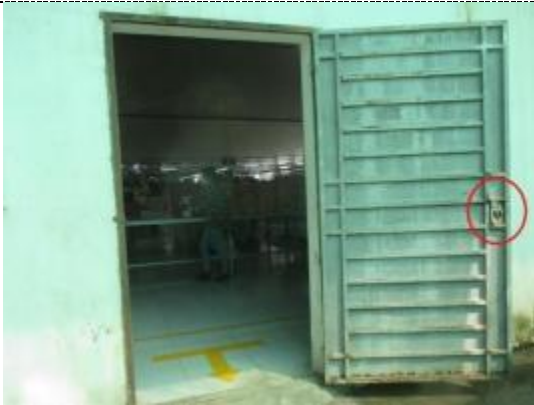
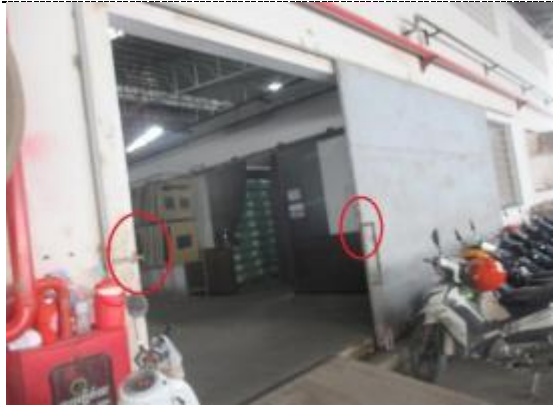
| Ref No. | Issue Type | Sub-Issue Type |
|---|---|---|
| Locking mechanism on the exit doors were observed in many exit doors of all buildings. | | |
| <p>Figure 14: Exit door with lock device at production buildings</p> | | <p>Figure 15: Exit door with lock device at dormitory</p> |
| <p>Figure 16: Inside locking mechanisms on the exit door at packing area of building B</p> | | <p>Figure 17: Outside locking mechanisms (ring) on the emergency exit door of building A</p> |

| Details Of Issue Found | Locking mechanism on the exit doors were observed in many exit doors of all buildings. |

| Recommended Action | Replace outside locks with locking mechanisms that allow easy opening from inside without the use of a key in accordance with Cl. 6.1 and 6.9 of the LABS Standard. |

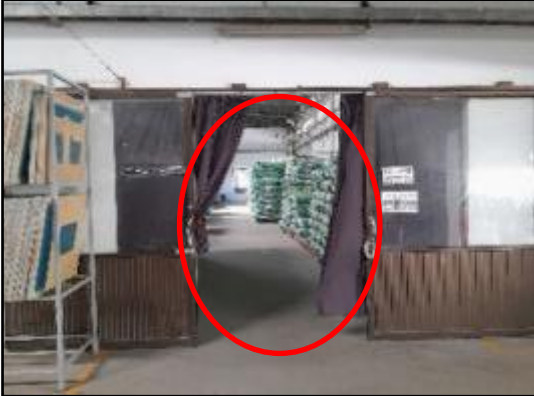
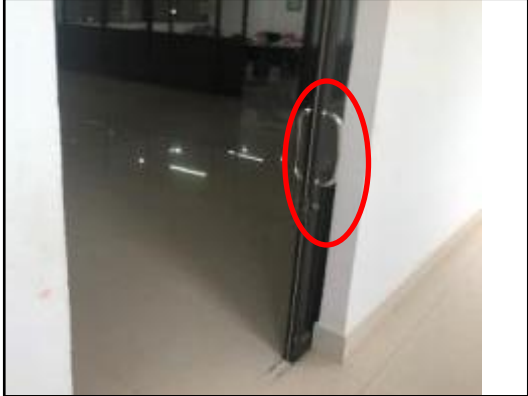
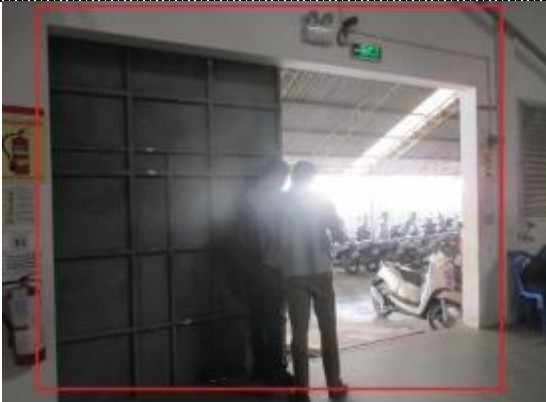
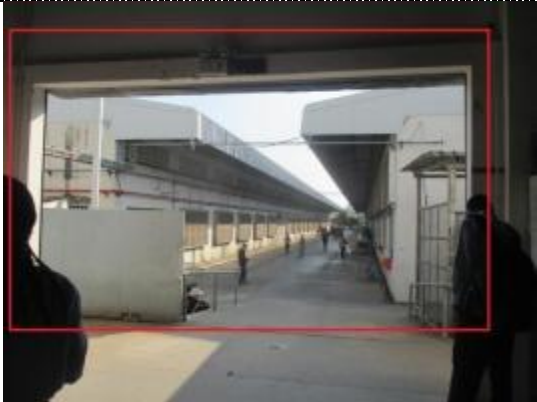
| Ref No. | Issue Type | Sub-Issue Type |
|---|---|---|
| Exit doors were not side hung to swing correctly: Sliding doors and rolling doors were used as internal and final exit doors of building A, B, and C. | | |
| Figure 18: Sliding door was used as internal exit at building A | | Figure 19: Sliding door was used as internal exit at building A (mezzanine floor) |
| Figure 20: Sliding door was used as final exit at building A | | Figure 21: Rolling door was used as final exit at building C |

| Details Of Issue Found | Exit doors are not side hung to swing correctly: Sliding doors and rolling doors were used as internal and final exit doors of building A, B, and C. |
| Recommended Action | Replace doors with side hung doors that open in the direction of escape in accordance with Cl.6.9 of the LABS Standard. |

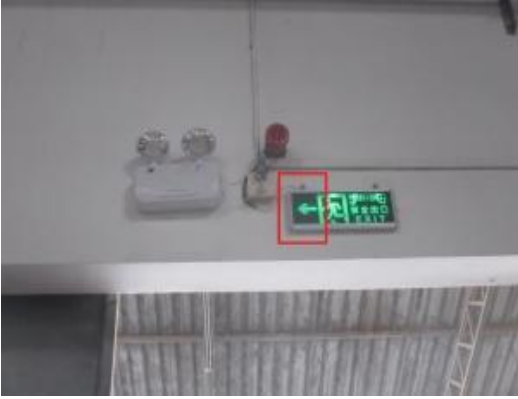
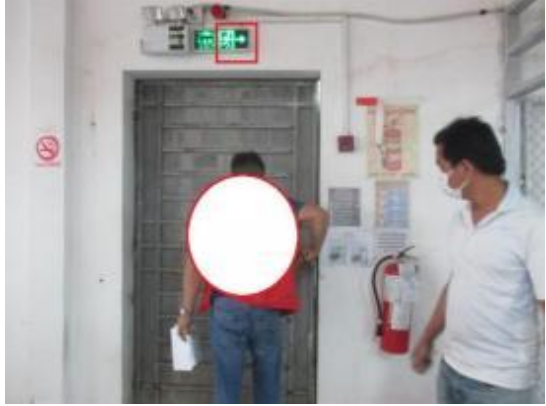
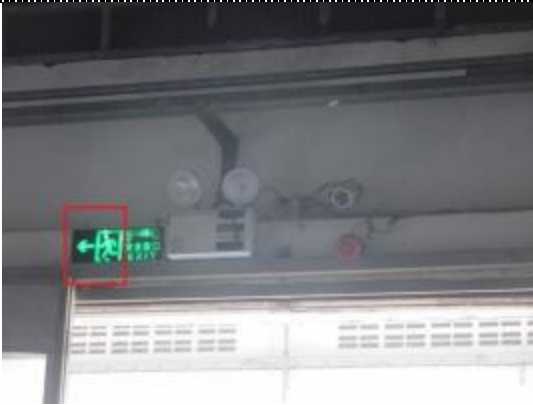
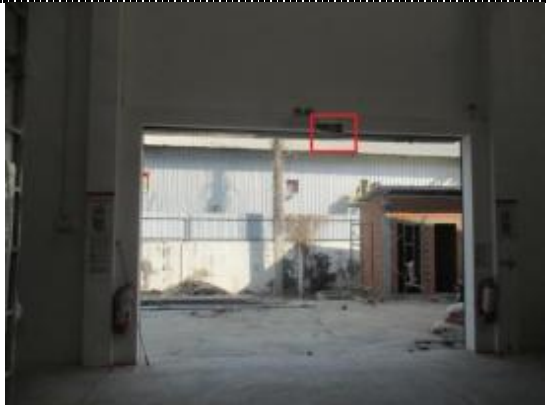
| Ref No. | Issue Type | Sub-Issue Type |
|---|---|---|
| Inconsistent exit signs on final exit doors near at building A, B, and C. | | |
| Figure 22: Inconsistent exit sign on final exit of building A | | Figure 23: Inconsistent exit sign on final exit of building B |
| Figure 24: Inconsistent exit sign on final exit of building B | | Figure 25: Inconsistent exit sign on final exit of building C |

| Details Of Issue Found | Inconsistent exit signs on final exit doors near at building A, B, and C. |
| Recommended Action | Provide consistent graphics to all emergency exit signage in accordance with Cl. 6.12 of the LABS Standard. |

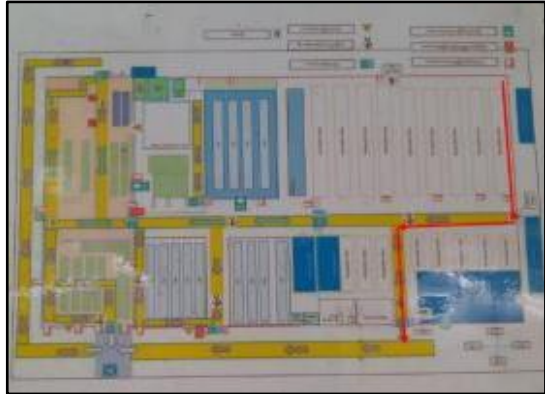
| Ref No. | Issue Type | Sub-Issue Type |
|---|---|---|
| Travel distance to alternative exit was excessive in Building A and B. | | |
| Figure 26: Travel distance at building A is 103m | | Figure 27: Travel distance building B is 85m |

| Details Of Issue Found | Travel distance to alternative exit was excessive in Building A and B. |
| Recommended Action | Provide additional floor exit/s to ensure that escape distances are not excessive to comply with Cl. 6.7 of the LABS Standard. |

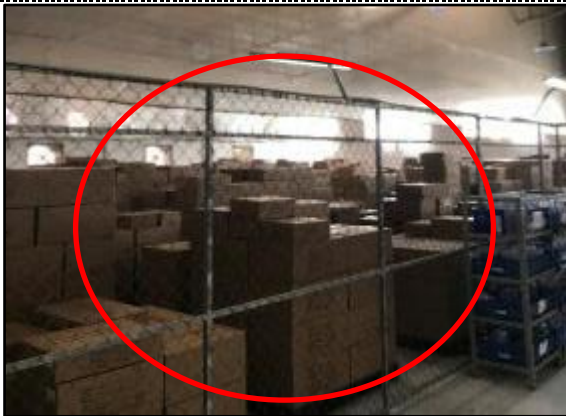
| Ref No. | Issue Type | Sub-Issue Type |
|---|---|---|
| <p>Excessive non-separated temporary storage areas were observed:</p> <p>The fabric storage was stocked at ground floor building A by 600m<sup>2</sup> (equals 6.5% total floor area) and finished goods storage at building B around 775m<sup>2</sup> (equals 11.8% total floor area). The fire separations were incomplete. Fire separation walls only around 3m in height. There was a gap between the wall and roof.</p> <p>Also, the materials were re-arranged per 30-100m<sup>2</sup> per block and clearances were only 1.6m – 2m and the heights were about from 1.5 – 3m.</p> | | |

Figure 28: Separation of different occupancies was incomplete between finished goods storage at building B

| Details Of Issue Found | Excessive non-separated temporary storage areas were observed: The fabric storage was stocked at ground floor building A by 600m <sup>2</sup> (equals 6.5% total floor area) and finished goods storage at building B around 775m <sup>2</sup> (equals 11.8% total floor area). The fir |

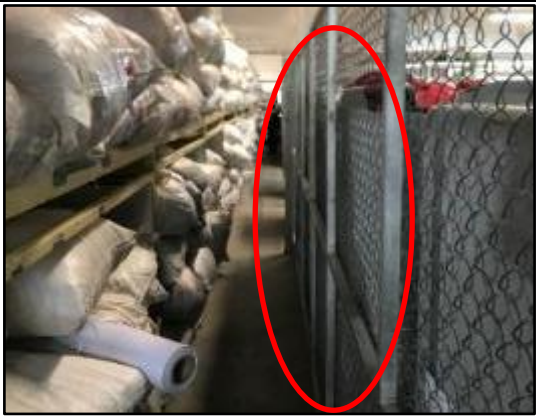
Figure 29: Separation of different occupancies was incomplete between storage area at building B

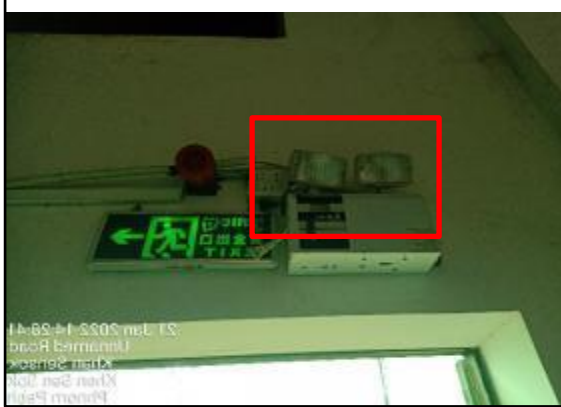
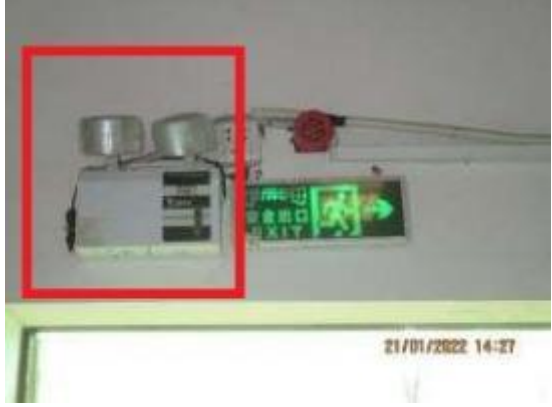
| Ref No. | Issue Type | Sub-Issue Type |
|---|---|---|
| Inadequate back up power for emergency lights at building A and B. | | |
| Figure 30: Inadequate back up power for emergency light at building A | | Figure 31: Inadequate back up power for emergency light at building B |

| Details Of Issue Found | Inadequate back up power for emergency lights at building A and B. |

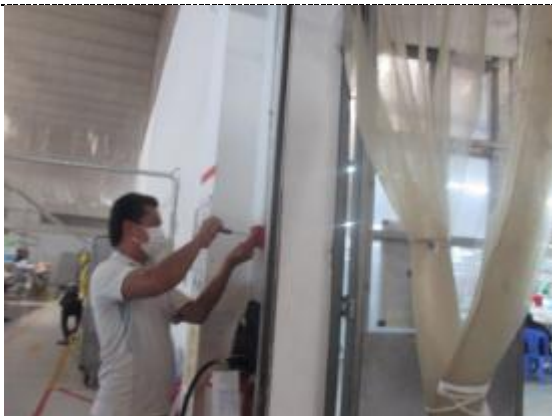
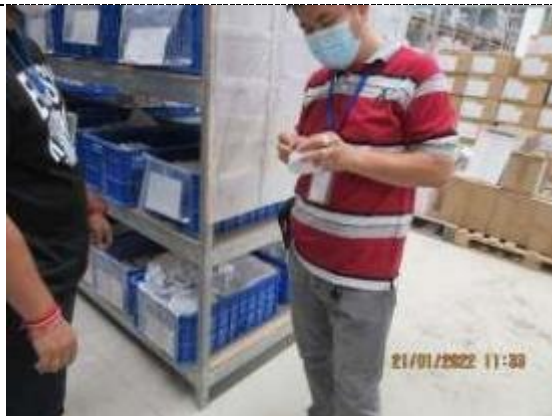
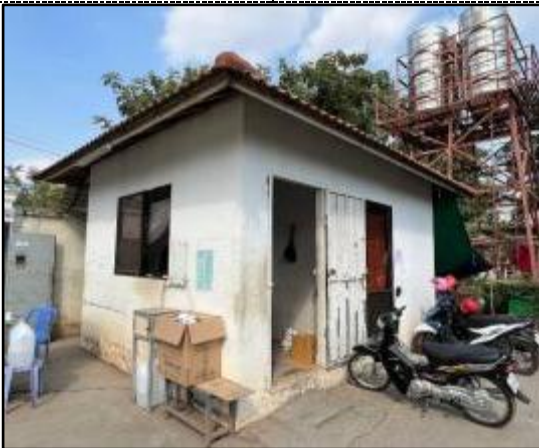
| Ref No. | Issue Type | Sub-Issue Type |
|---|---|---|
| Only spot smoke detector and fire alarm were installed locally in the buildings. There was no centralized alarm system for firefighting purpose. | | |
| Figure 32: Fire alarm only installed locally in the factory | | Figure 33: Smoke detector alarm only installed locally in the factory |
| Figure 34: No main fire alarm control panel for factory at security guard house | | |

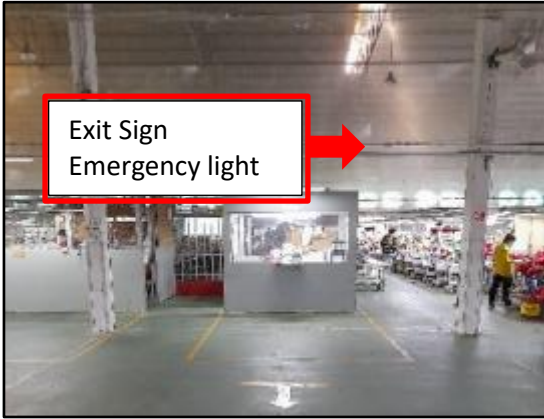
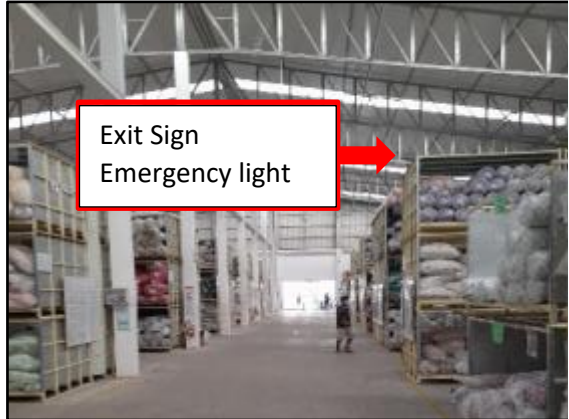
| Ref No. | Issue Type | Sub-Issue Type |
|---|---|---|
| Inadequate Emergency light and exit sign for escape path. | | |
| Figure 35: Inadequate emergency lights and exit sign | | Figure 36: Inadequate emergency lights and exit sign |

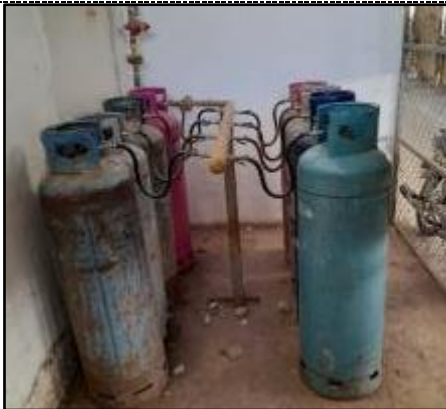
| Ref No. | Issue Type | Sub-Issue Type |
|---|---|---|
| No gas detector for gas storage close to building A. | | |
| Figure 37: No gas detector for gas storage close to building A | | |

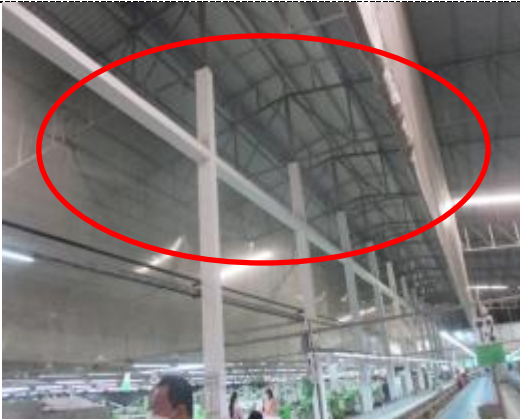
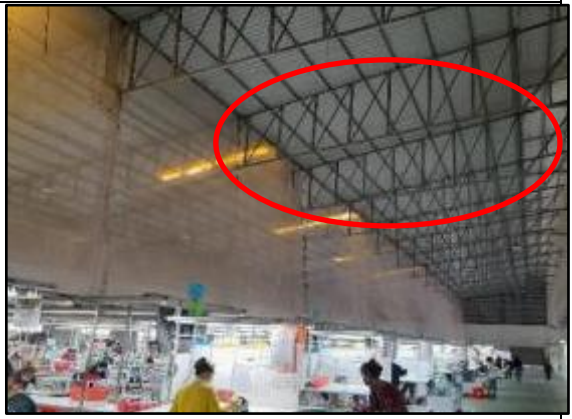
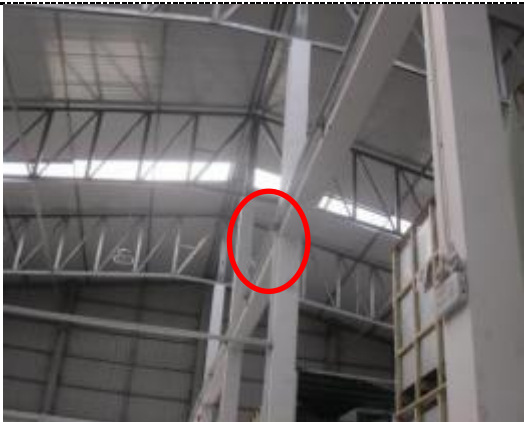
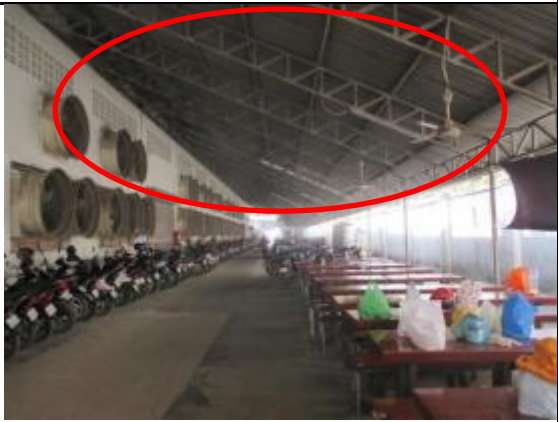
| Ref No. | Issue Type | Sub-Issue Type |
|---|---|---|
| Inadequate and incorrect positioning of fire detector coverage: The standalone (spot) type smoke detectors were applied some areas of buildings. However, the detectors spacing was too far between each detector (exceed 10m), far below the ceiling, and no smoke detector at canteen and motorbike parking. | | |
| Figure 38: Inadequate fire detector – building A | | Figure 39: Inadequate fire detector – building B |
| Figure 40: Incorrect position fire detector – building C | | Figure 41: No fire detector was installed at canteen and motorbike parking |

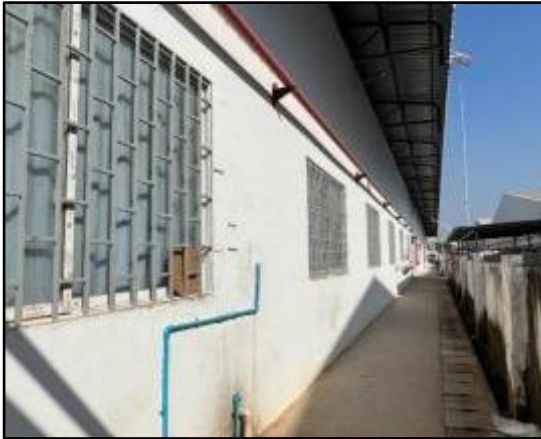
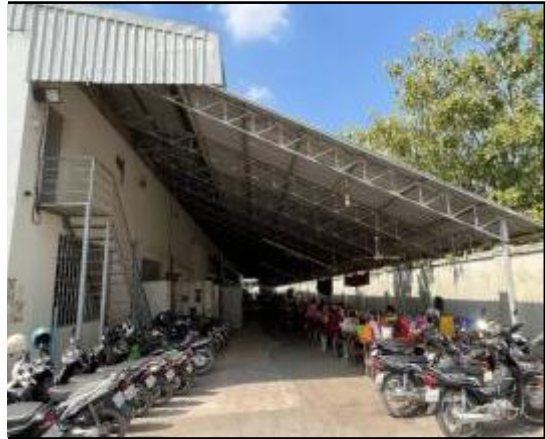
| Ref No. | Issue Type | Sub-Issue Type |
|---|---|---|
| Fire truck could not access all side of building A, B, and C. | | |
| Figure 42: Fire truck could not access at building C | | Figure 43: Fire truck could not access building A |

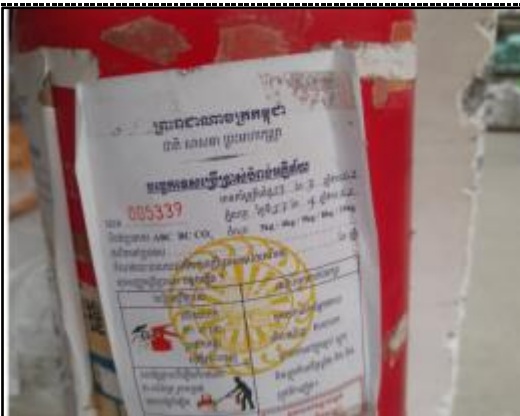
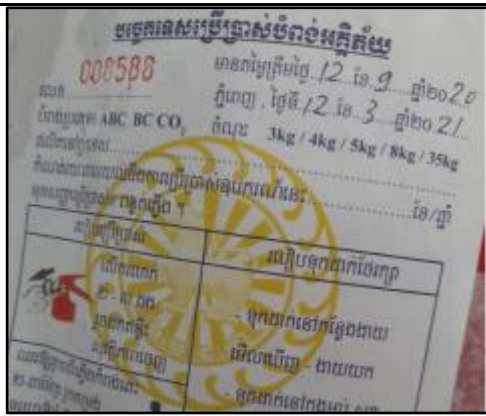
| Ref No. | Issue Type | Sub-Issue Type |
|---|---|---|
| Fire Extinguishers were not checked at dormitory. | | |
| Figure 44: Fire Extinguisher was not check | | Figure 45: Fire Extinguisher was not check |

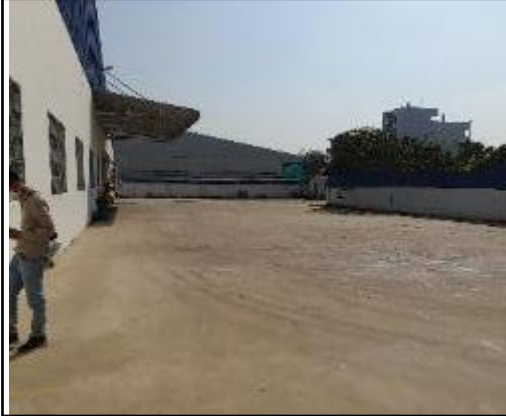
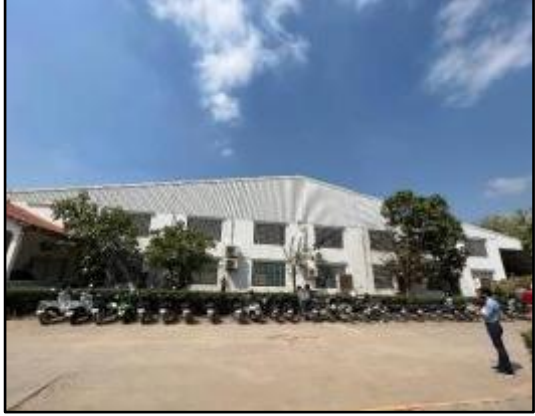
| Ref No. | Issue Type | Sub-Issue Type |
|---|---|---|
| Fire Hydrant was not available for the factory. | | |
| Figure 46: No fire hydrant at building C | | Figure 47: No fire hydrant at building A |

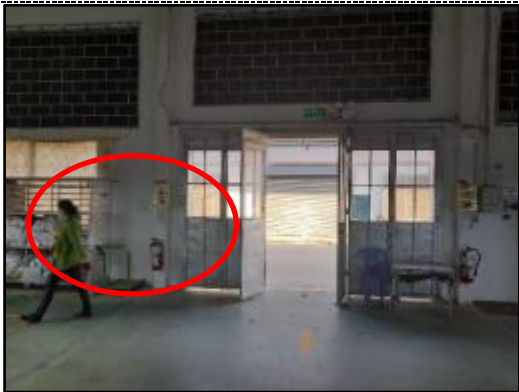
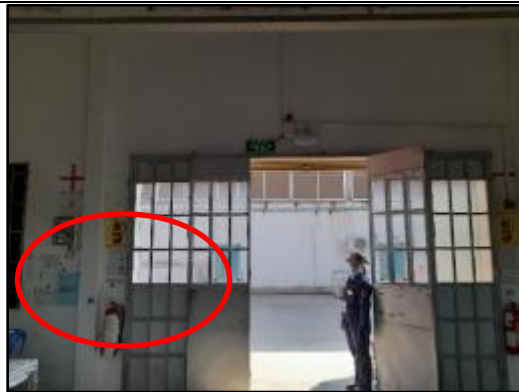
| Ref No. | Issue Type | Sub-Issue Type |
|---|---|---|
| <ul style="list-style-type: none"> <li>- Inadequate emergency layout post at building A and B.</li> <li>- No assembly point sign mentioned on emergency layout and outside buildings.</li> </ul> | | |
| Figure 48: Inadequate Emergency layout A | | Figure 49: Inadequate Emergency layout B |

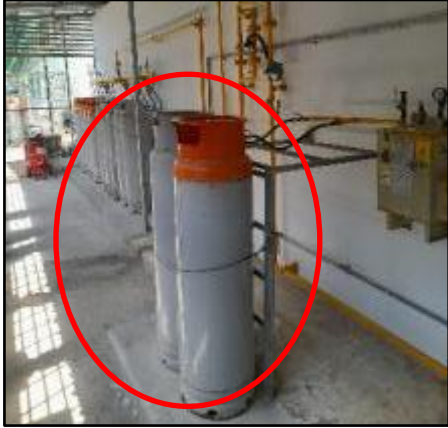
| Ref No. | Issue Type | Sub-Issue Type |
|---|---|---|
| Over capacity gas storage behind building B. | | |
| Figure 50 gas capacity storage behind building B | | |

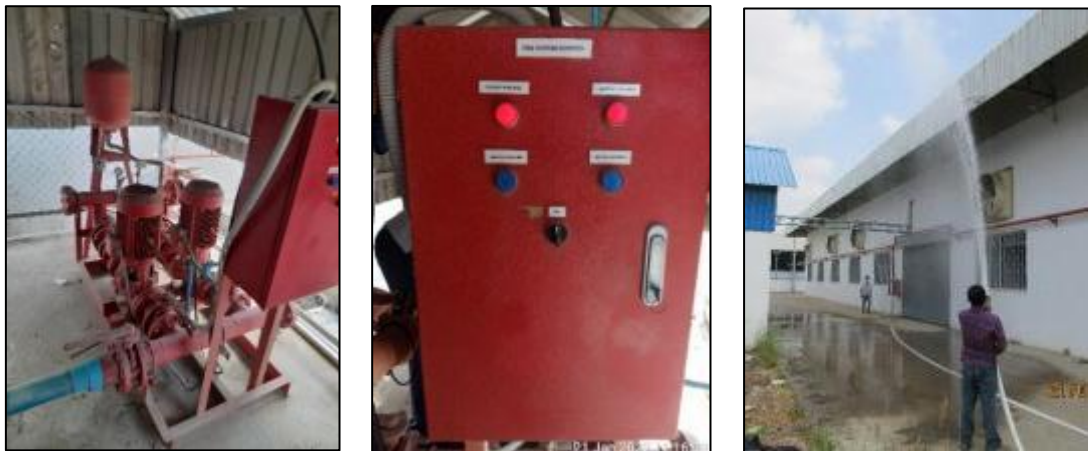
The fire pump station included 2 mains electrical pumps 11kW/each and no main diesel pump. Pumps can be started and worked fine and also pressure of around 5 bar was recorded during testing.

Figure 7: Fire Pump Station and Fire Hose testing
