## LABS Initiative

# Methodology for Preliminary Safety Assessments in Indonesia

Issue 1.2| 24th May, 2023

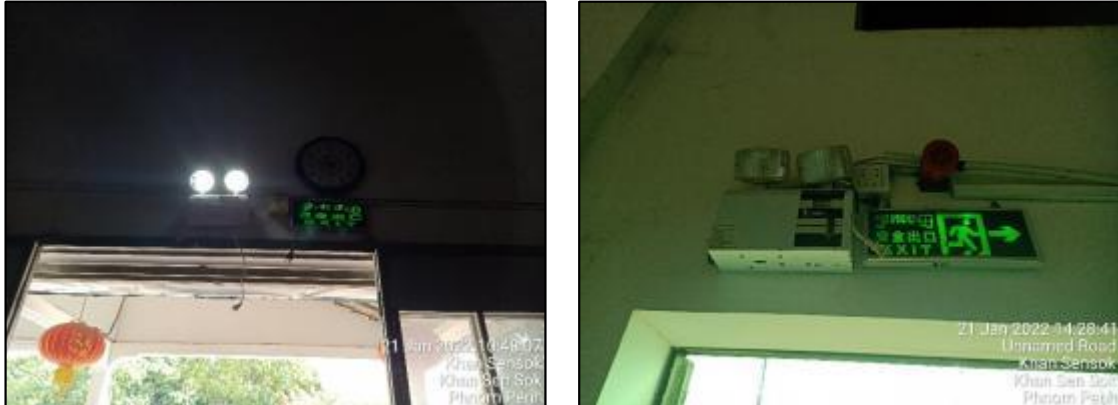
Figure 8: Emergency & Exit Lighting Testing Time at Building A

Random emergency and exit lights were tested at main production building; *some* were not working and some just lighted on less than 10 minutes with battery power.

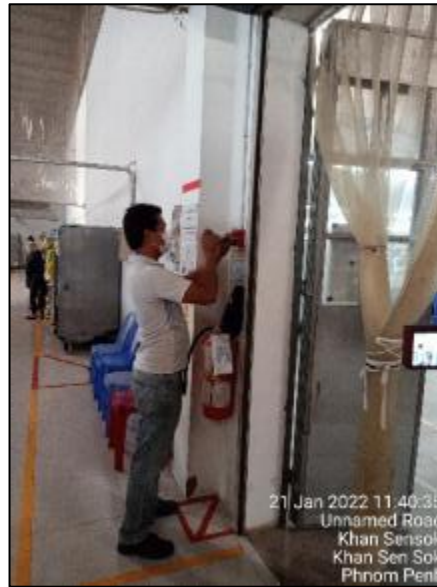
Witnessing the operation of the fire alarm system carry out for some local detectors and MCPs at Production Building B.

Figure 9: Fire Detection & Alarm (MCPs) tested at Building B.

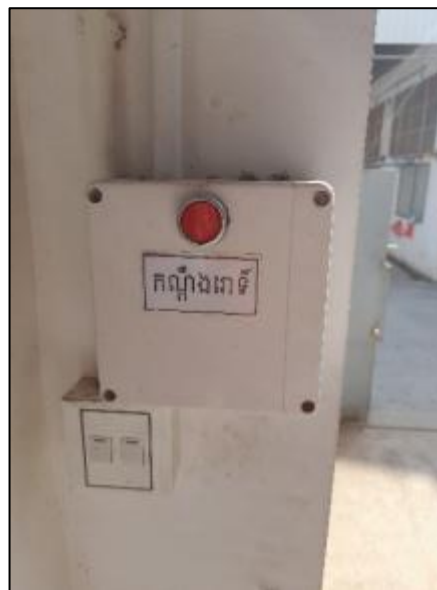
Figure 10: Fire Detection & Alarm (MCPs) tested at Building C.

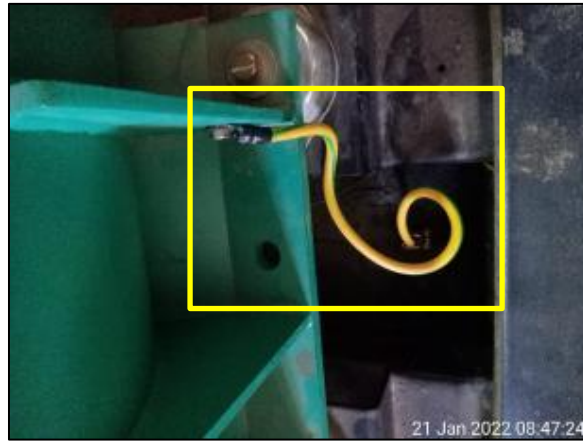
Figure 11: Incorrect size PE Earthing cable for generator at generator room.

Connection of metalwork (machines, electrical panels, transformer, DG set) was clearly evident. The Protective Earth (PE) was installed in Main Distribution Panel and then distributed to Sub-Panels. And some distribution board use localized Earthing System that installed next to each DB. There was no Earthing/Lightning schematic diagram available on the current factory. Inadequate size of earth conductors was observed during the factory inspection. Some motors and panels did not have Protective Earth (PE) connection. No Earth testing records for review.

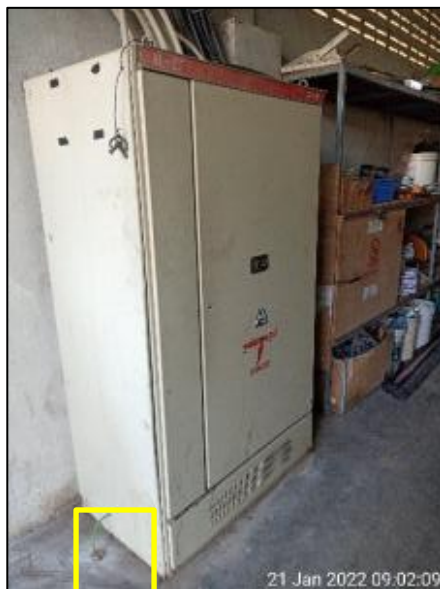
Figure 12: Incorrect size PE Earthing cable for generator panel at generator room.

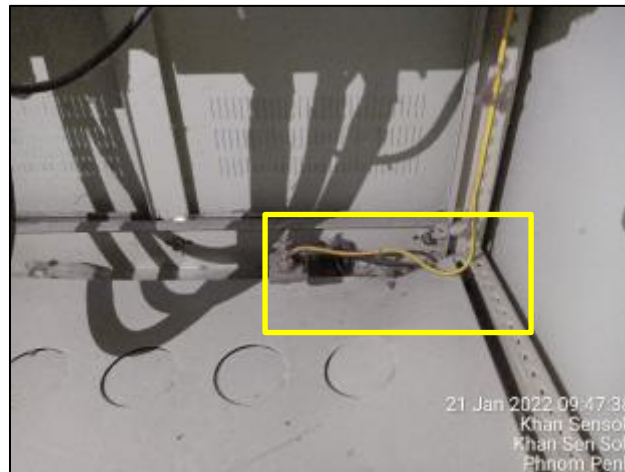
Figure 14: Missing PE Earthing bar installation for Electrical panel at building A

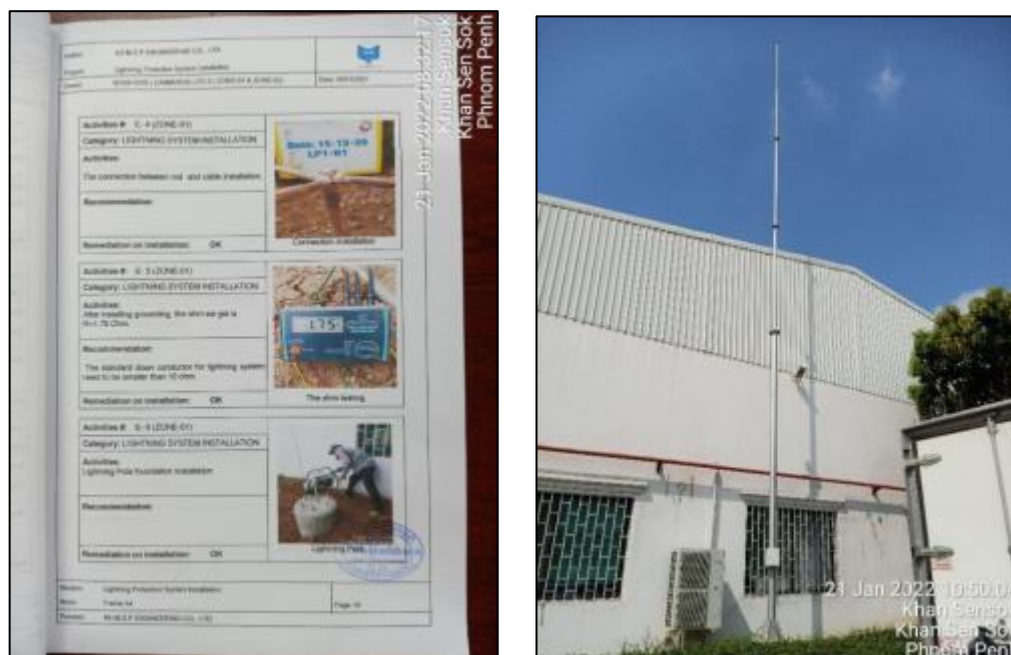
Figure 15: Lightning Protection System Air Terminal Zone 01 installed on Steel Pole near Building A with earthing resistance testing report.

A new Early Streaming Emission (ESE) lightning protection system is provided on the roof top of Main Production Building, however, there was no Lightning protection layout and record of testing and report provided for review.

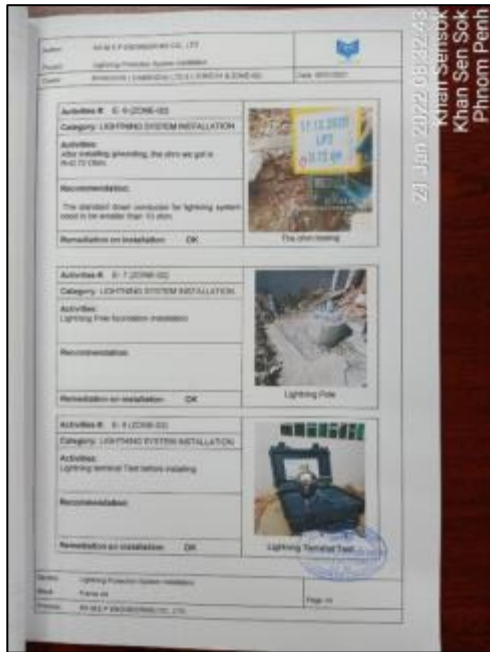
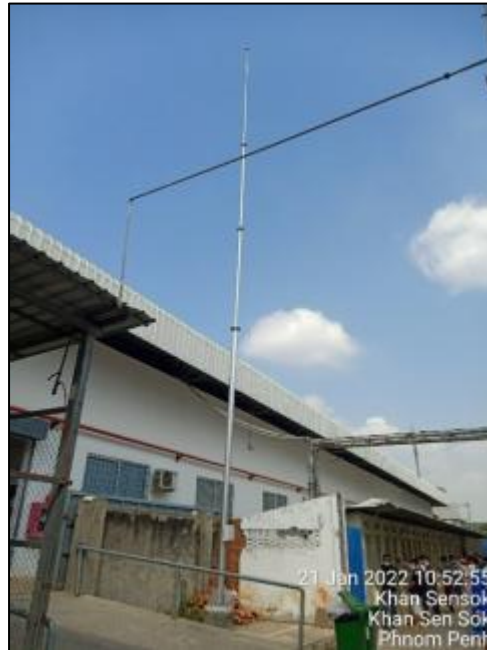
Figure 16: Lightning Protection System Air Terminal Zone 02 installed on Steel Pole near Building C with earthing resistance testing report.

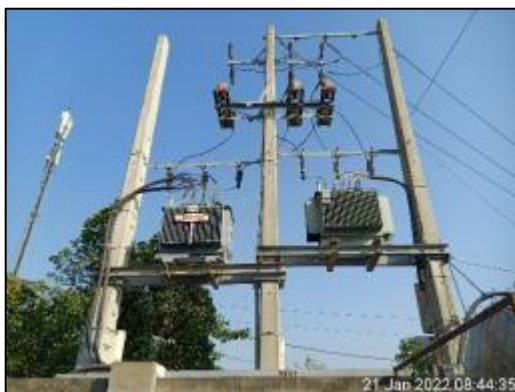
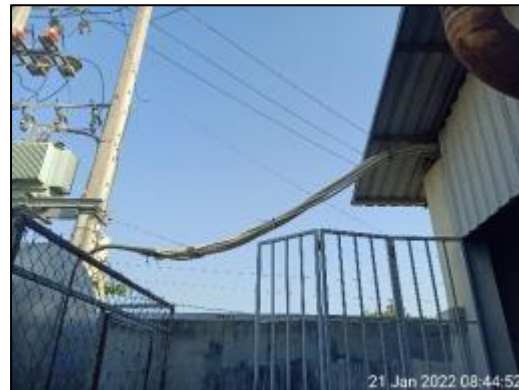
Figure 17: Pole mounted oil type transformers at outside of Factory Boundary (Belong to EDC) with overhead LV cables to LVMSB/MTS panel in Generator Room 01 near Building A.

One power entered the site via 22kV overhead supply which is connected to 2nos of 400kVA pole mounted oil type transformers located next to Generator and MTS room 01 near Building A and another 22kV overhead supply which is connected to 1nos of 400kVA pole mounted oil type transformer along the road behind the Building C. All of these pole mounted oil type transformers were installed outside the factory boundary (Belong to EDC) that could not be access. The low voltage cables from each oil type transformers to LVMSB/MTS/ATS room are installed overhead.

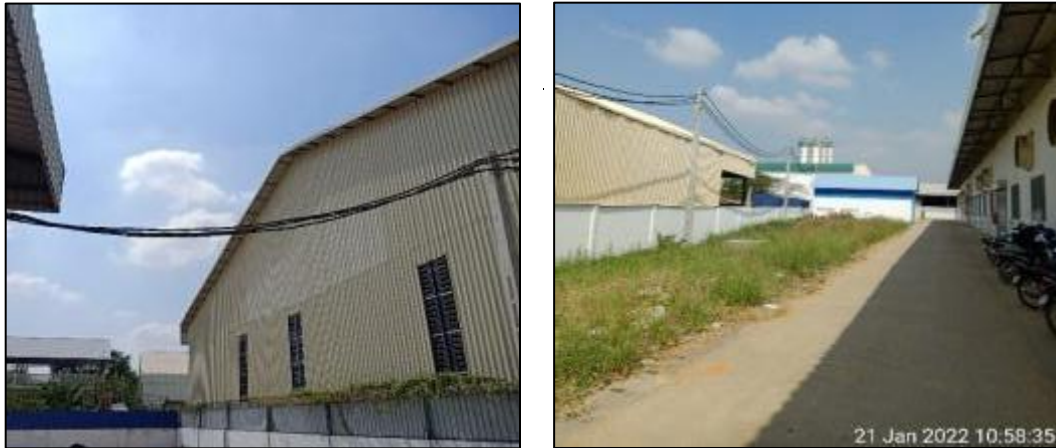
Figure 18: Incoming Overhead LV cables from another 400kVA Pole mounted oil type transformer to LVMD/ATS panel in Electrical Room inside Building C.

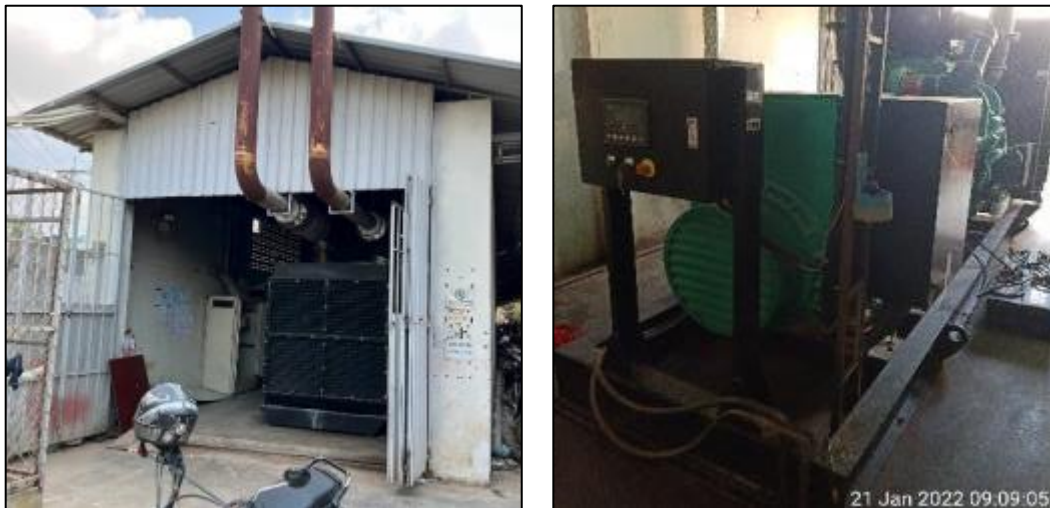
Figure 19: 900kVA Generator Room 01 without ventilation fan near Building A.

- 1nos of 900kVA with 1 set of 1000L fuel daily tank located at inside Generator Room 01 at Ground floor near Building A. The over ground Bulk Fuel storage located next to the generator room 01. In case of no primary power available, the generator 01 can be start in Auto Mode with Manual Transfer Switch (MTS) panels. This 900kVA supplies to 2 separated MTS panels that located inside Generator Room 01 and then supply to MDB-001B and MDB-002B accordingly in Electrical Room inside Building A. The LV cables from these MTS panels are installed overhead.

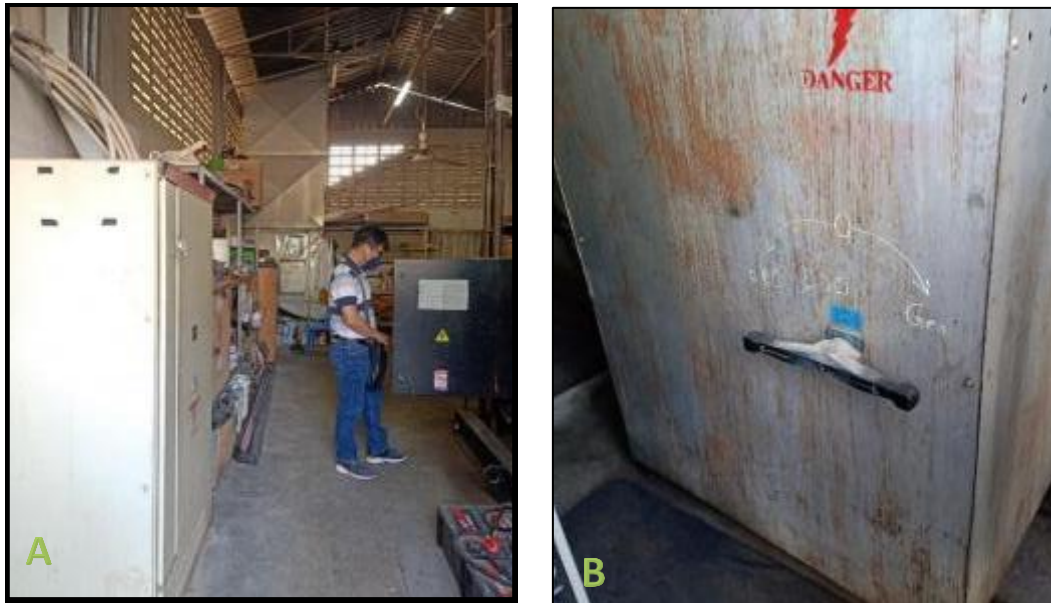
Figure 20:

- A: 1 side of MTS panel 01 connected from 1nos of 400kVA pole mounted oil type transformer and another side connected from 900kVA Diesel Generator 01.
- B: 1 side of MTS panel 02 connected from another 1nos of 400kVA pole mounted oil type transformer and another side connected from 900kVA Diesel Generator 01.
- 1nos of 500kVA with 1 set of 1500L fuel daily tank located at inside Generator Room 02 at Ground floor behind Building C. The Daily Fuel Tank for Generator 02 will be filled up by Manual by Factory Technician. In case primary power supply fails, the generator 02 can be start in Auto Mode with Auto Transfer Switch (ATS) panel in Electrical MDB-003B room inside Building C.

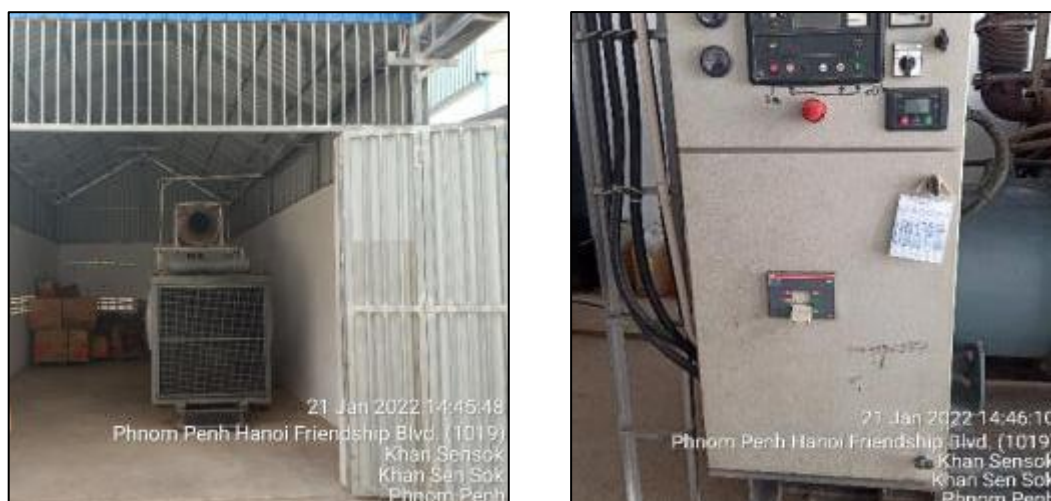
Figure 21: 500kVA Generator Room 02 without fan ventilation system at behind Building C.

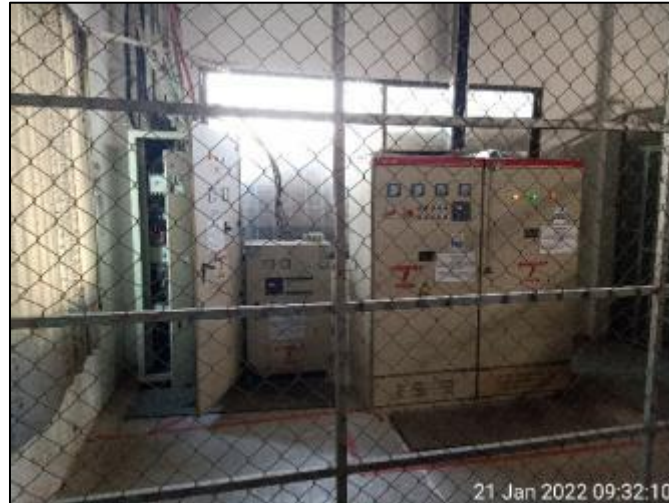
Figure 22: Main Distribution Boards (MDBs) insides building A.

The LV power from LVMSB/MTS panels in Generator room 01 & 02 were transferred to the Main Distribution Boards located in the main building A and C and then distributed power to the functional Distribution Boards and Sub-Distribution Boards inside each building and also to other buildings.

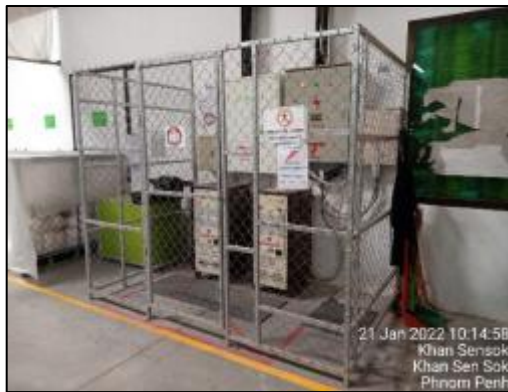
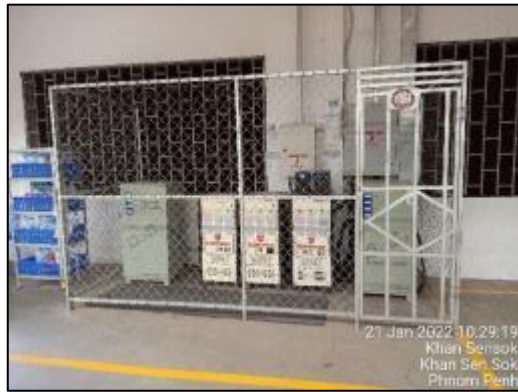
Figure 23: Distribution Boards (DBs) insides building A.

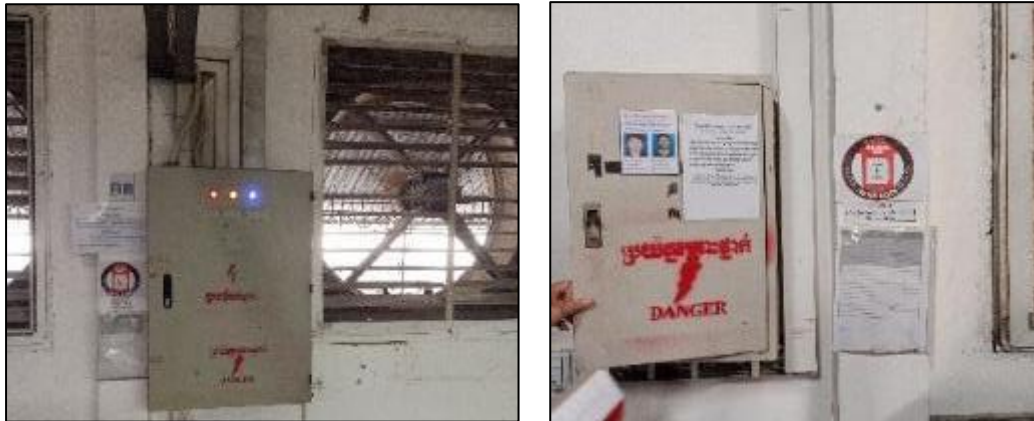
Figure 24: Sub Distribution Boards (SDBs) inside building A.

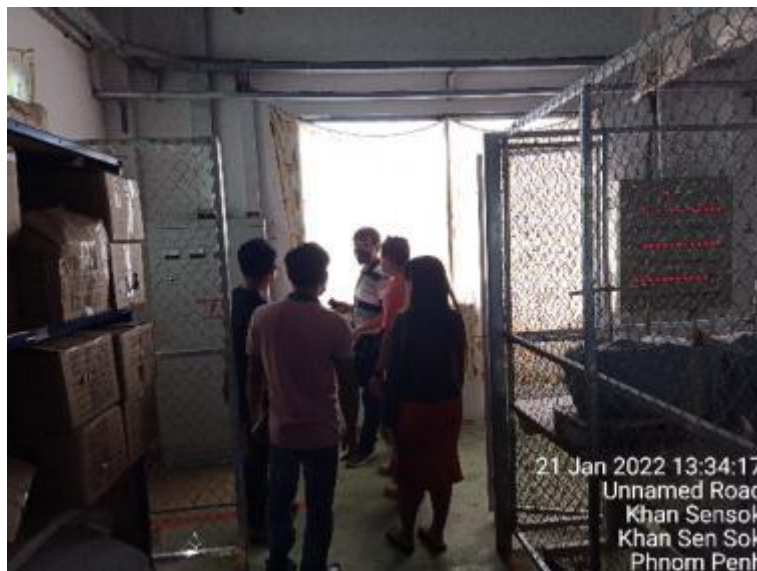
Figure 25: Distribution Boards (DBs) inside building B.

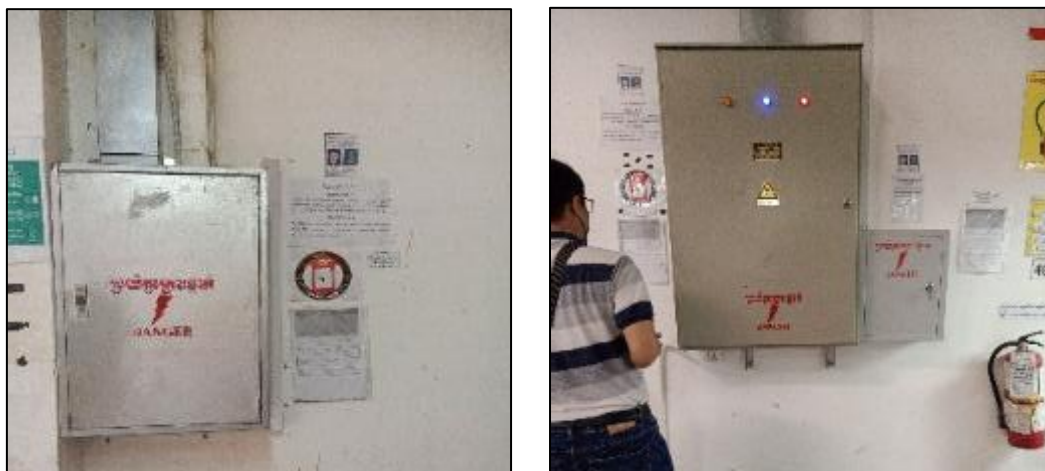
Figure 26: Sub-Distribution Boards (SDBs) inside Building B.

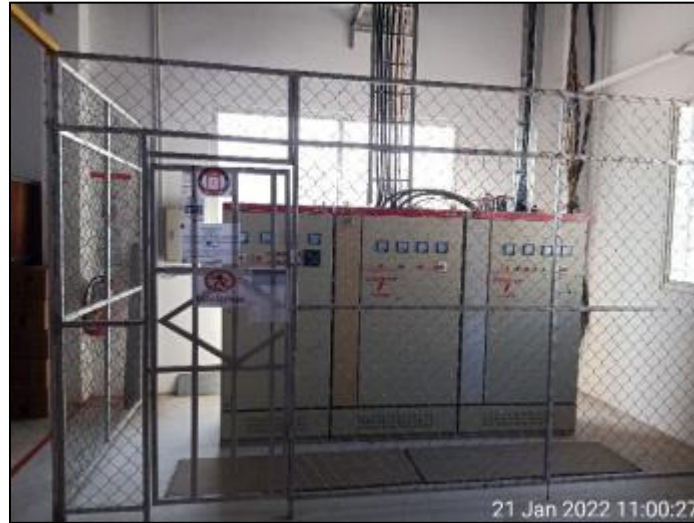
Figure 27: Main Distribution Boards (MDBs) inside Building C.

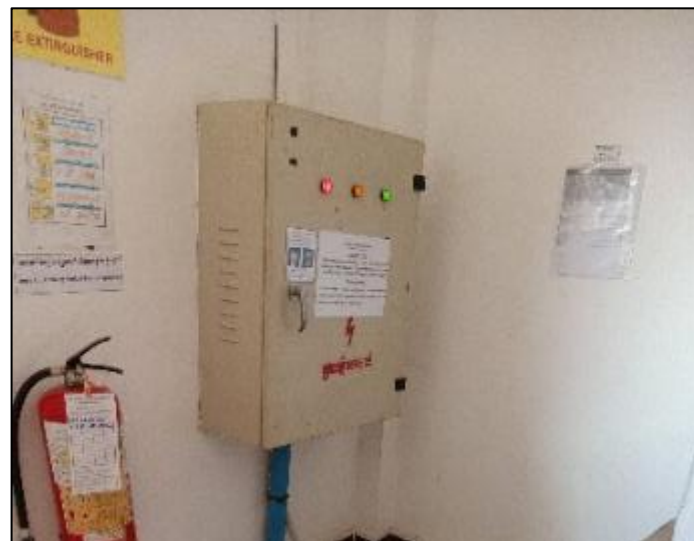
Figure 28: Distribution Board (DB) inside Hostel Building.

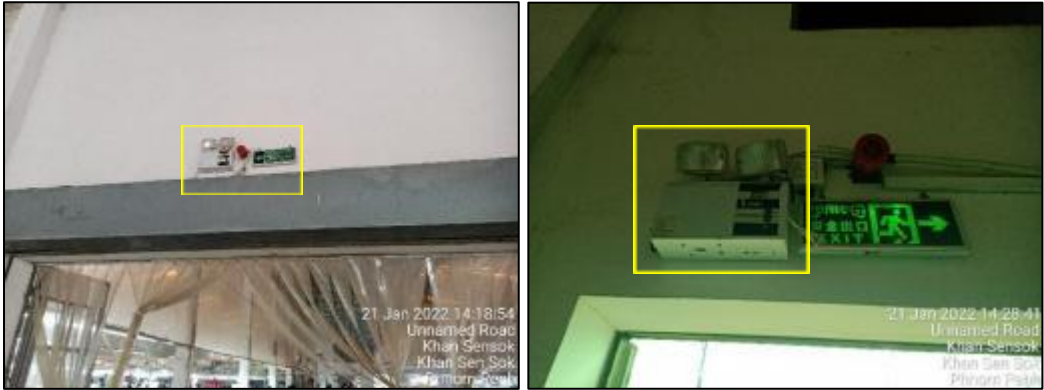
| Ref No. | Issue Type | Sub-Header |
|---|---|---|
| Observations: Random Emergency & Exit Lights were tested at Production Building A & B, some fittings were not working and some just lighted on less than 10minutes with Localized Battery Backup. | | |
| <p>Figure 29: Power Back Up Fail for Emergency &amp; Exit Light in Production during testing.</p> | | |

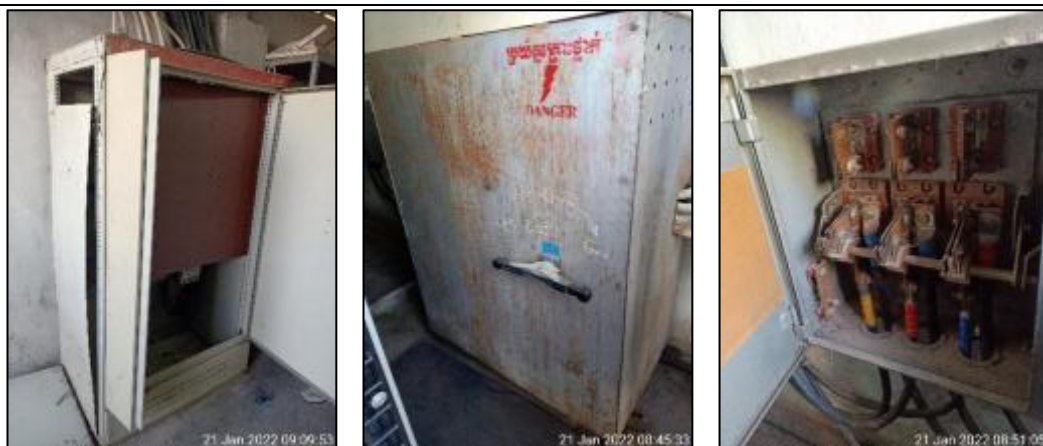
Figure 33: No Earthing bonding cable connected Electrical Panel Door Frames in Generator Room 01.

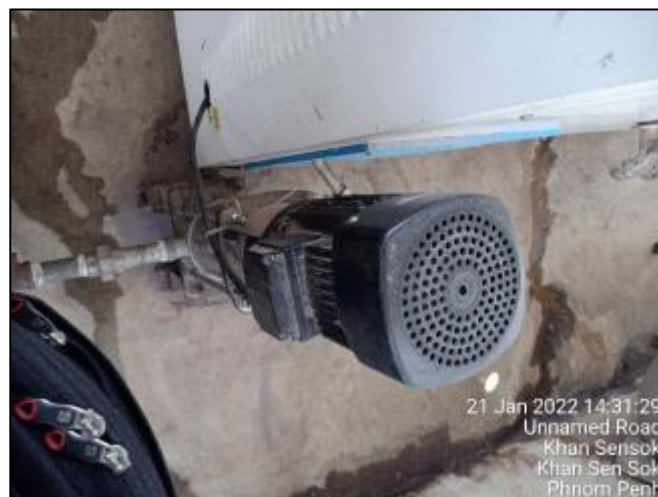
Figure 35: No Earthing bonding cable connected to boiler and pump boiler enclosure.

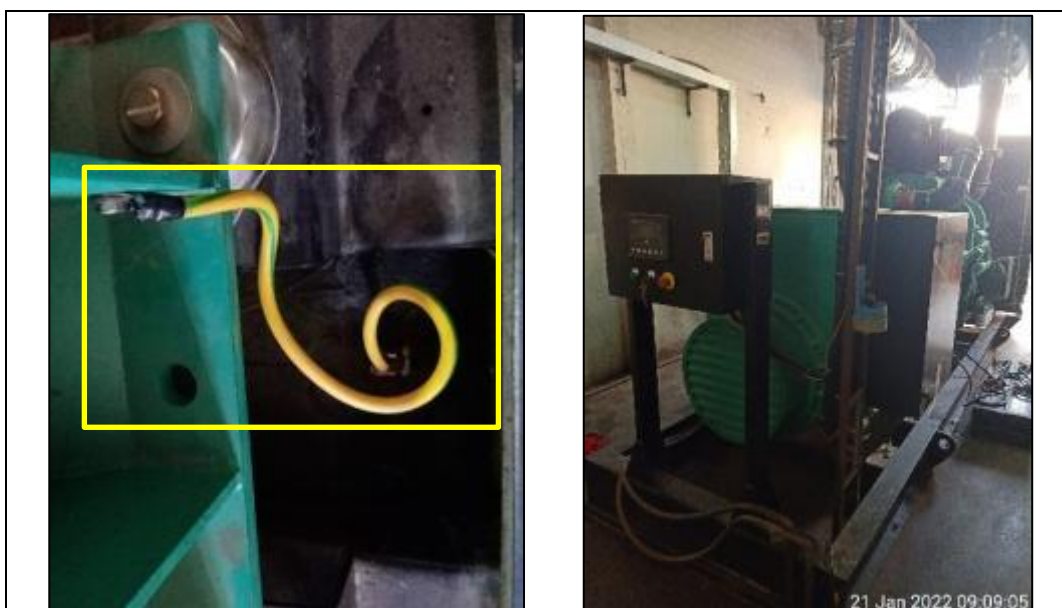
| Ref No. | Issue Type | Sub-Header |
|---|---|---|
| Observations: There were insufficient generator 01 & 02 earthing with two separate points. | | |

Figure 37: Insufficient generator 01 earthing with two separate points.

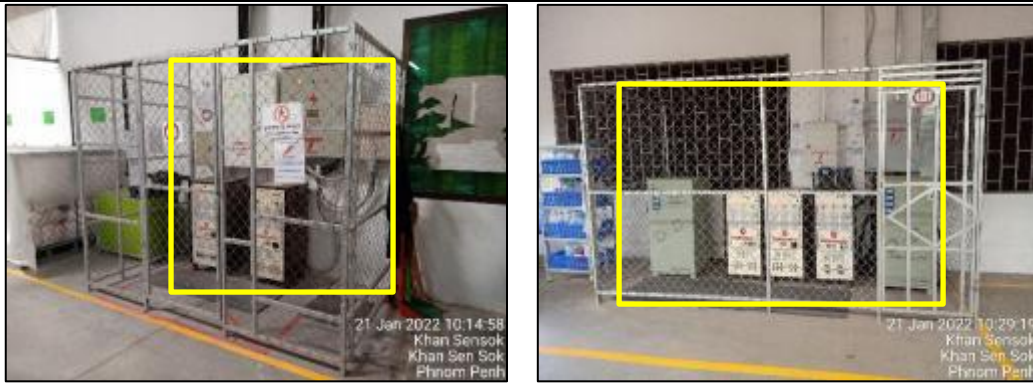
Observations: There is insufficient access found in DBs locations in Building A.

Figure 41: Insufficient Access to wall mounted DBs that blocked by floor standing Voltage Stabilizers.

| Details Of Issue Found | There is insufficient access founded in DBs locations in Building A. |

| Recommended Action | According to LABS Standard Clause 10.7.2 and Clause 10.9.4, factory should appoint competent Electrical Engineer to check and provide the sufficient access for maintenance and operation. |

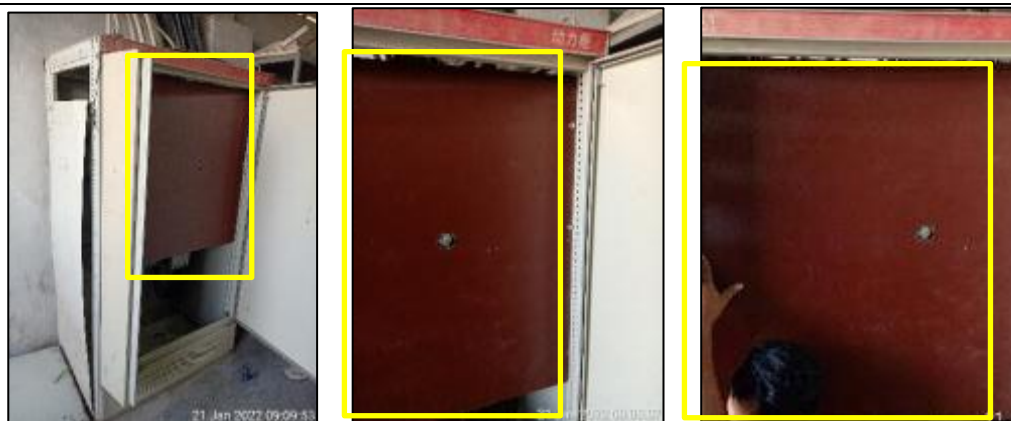
Observations: LVMSB/MTS panels cover damaged and replaced with unsafe flash guard when need to open to the LVMSB/MTS 01 & 02 cover in Generator Room 01 near Building A.

Figure 42: Panels cover damaged and replaced with unsafe flash guard when need to open to the LVMSB/MTS 01 & 02 cover.

| Details Of Issue Found | LVMSB/MTS panels cover damaged and replaced with unsafe flash guard when need to open to the LVMSB/MTS 01 & 02 cover in Generator Room 01 near Building A. |
| Recommended Action | According to LABS Standard Clause 10.12.1 and Clause 10.12.3, factory should appoint competent Electrical Engineer to check and repair it. |

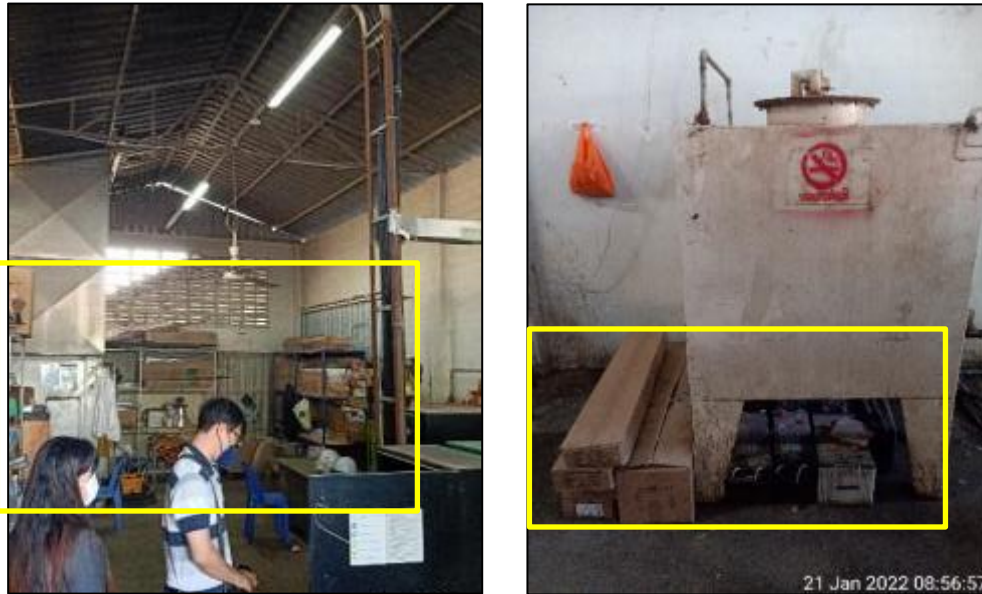
Observations: The Generator Room 01 & 02 used as a storage with combustible materials.

Figure 43: Combustible materials store inside generator room 01.

| Details Of Issue Found | The Generator Room 01 & 02 used as storage with combustible materials. |
| Recommended Action | According to LABS Standard Clause 10.9.4, factory should appoint competent Electrical Engineer to check and clean it. |

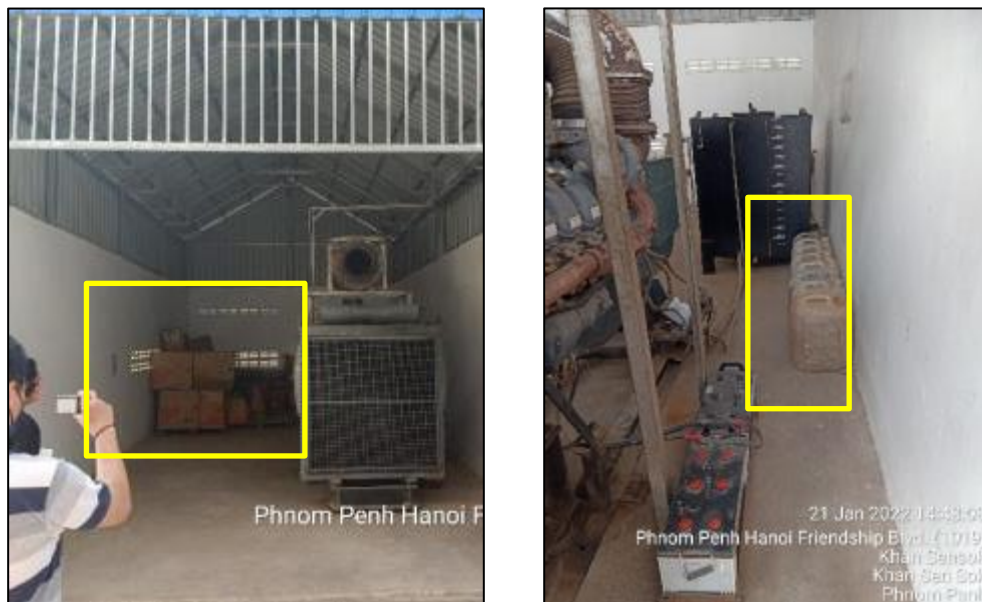
Figure 44: Combustible materials store inside generator room 02.

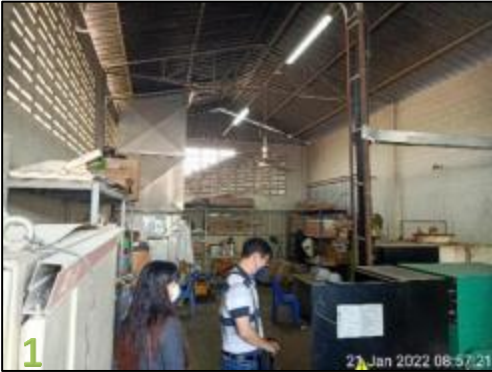
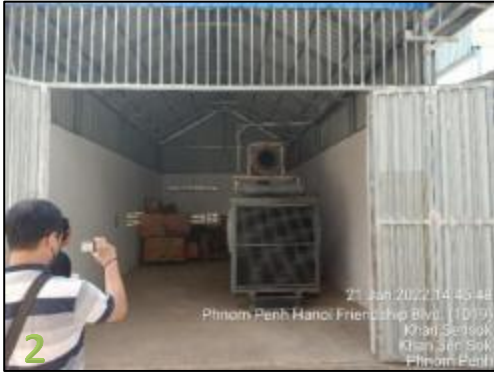
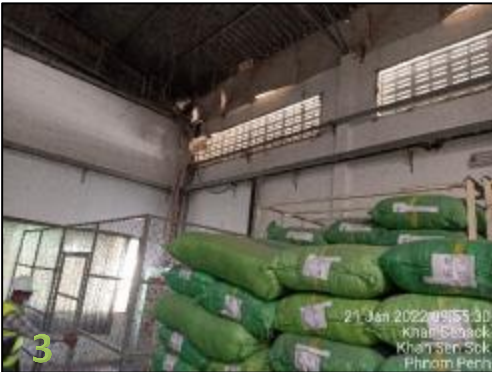
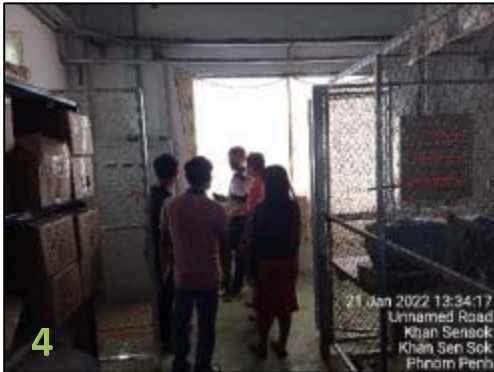
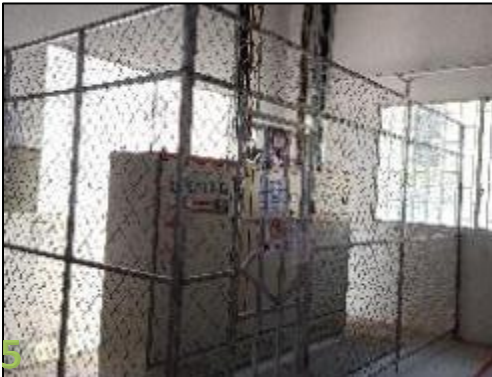
| Ref No. | Issue Type | Sub-Header |
|---|---|---|
| <p>Observations: There were Inadequate/No number of Normal and Emergency Lighting inside:</p> <p>1. The two of Generator Rooms (Generator 01 &amp; 02)</p> <p>2. MDB/DB room/location inside Building A, B and C</p> | | |
| <div> </div> <p>Figure 45: Inadequate/No number of Normal and Emergency Lighting inside:</p> <p>1. Generator Room 01 near Building A</p> <p>2. Generator Room 02 behind building C</p> | | |

- 3.MDBs Electrical Room inside Building A
- 4.DBs Electrical Room inside Building B
- 5.MDBs Electrical Room inside Building C

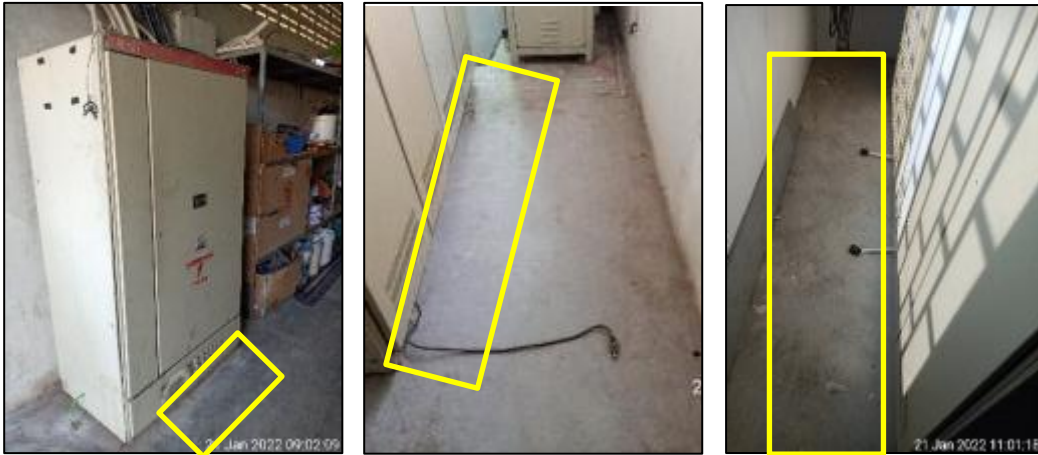
Observations: There were inadequate rubber floor mats for:

1. MSB/MTS in Generator Room 01
2. MDB and also for DB in some locations inside each Building A, B and C.

Figure 46: Inadequate rubber floor mats for MTS-01 panel, MDBS & DBs panel.

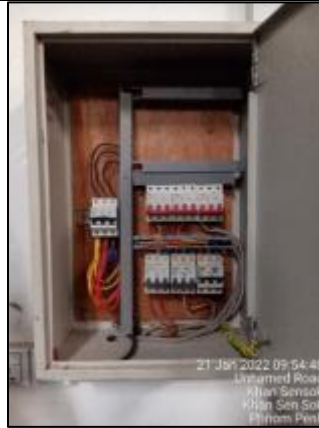
Observations: There were Combustible/flammable materials (wood) installed in SDB-001B in Building A and SDB-0016B in Building B.

Figure 47: Combustible/flammable materials (wood) installed in SDB-001B.

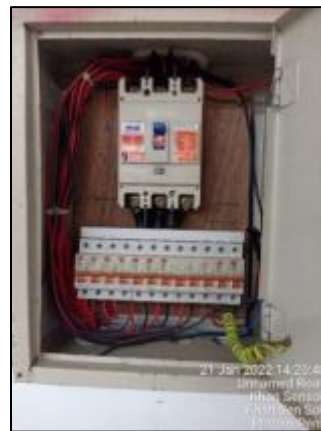
Figure 48: Combustible/flammable materials (wood) installed in SDB-0016B.

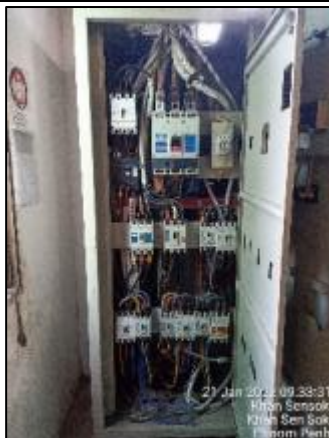
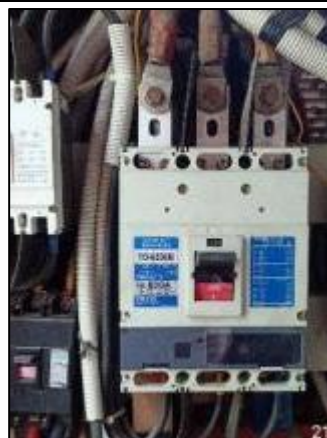
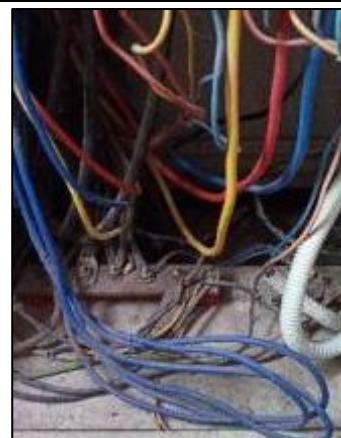
Observations: Inadequate cable segregation found for LV cables inside MDB-001B in Building A

Figure 49: Inadequate cable segregation for LV cables inside MDB-001B

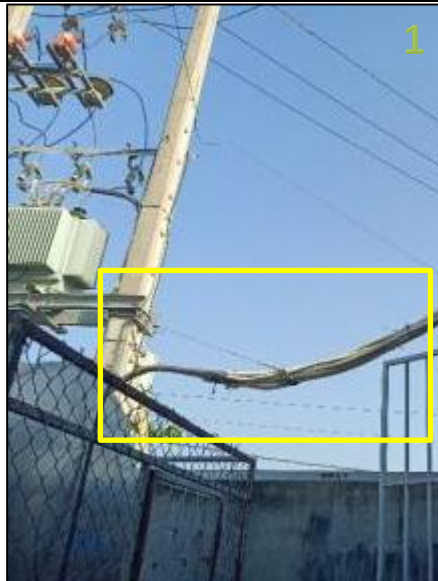
1. Inadequate cable support for LV incoming cables from EDC to Generator room
2. Inadequate cable support for LV cables from Generator room to MDB room inside Building A
3. Inadequate cable support for LV cables in DB-002B location in Building A and the current transformer was installed outside of DB.
4. Inadequate cable support for LV cables in Fire System Control Panel location in FF Pump station.

Figure 50: Inadequate cable support for:

- 1.LV incoming cables from EDC to Generator room
- 2.LV cables from Generator room to MDB room inside Building A
- 3.LV cables in DB-002B location in Building A and the current transformer was installed outside of DB.
- 4.LV cables in Fire System Control Panel location in FF Pump station.

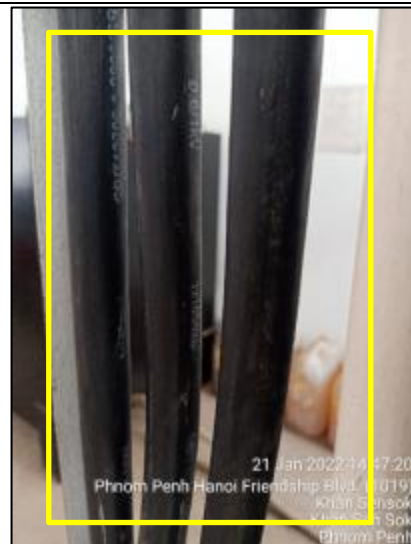
1. Small cable 185 sqmm Cu/XLPE/PVC connected from big breaker 800A at 500kVA Generator 02 panel in Generator room 02 at behind building C.
2. Small cable 240 sqmm Cu/XLPE/PVC connected from 1250A ATS and then connected to big breaker 800A at MDB-003B inside building C.

Figure 54: Under size of phases cable cross-sectional area compare to circuit breaker from Generator 02 panel to ATS panel inside Building C.

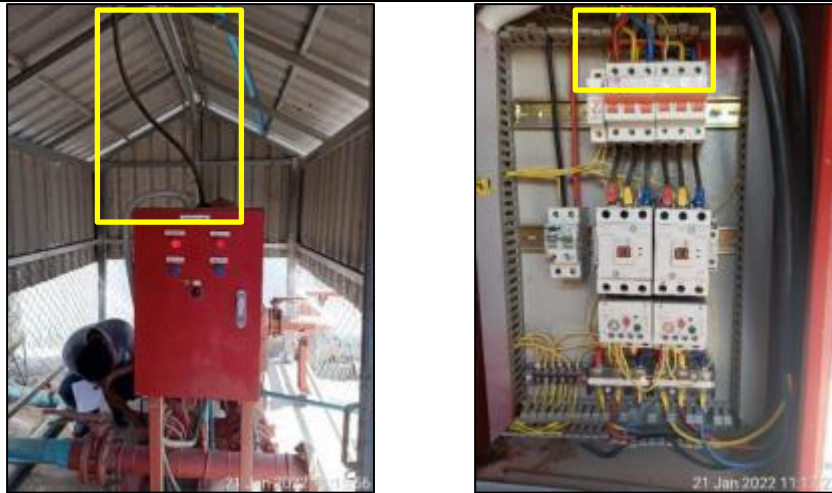
Observations: Normal insulation power cables connected from Main Distribution Board inside Building A to Fire System control panel in FF pump station and Unprotected Outgoing cables/circuits (Circuits drawn without protective device) from Generator 01 panel to both of MTS panel 01 & 02.

Figure 57: Normal insulation power cables from MDB in Building A to FF pump control panel.

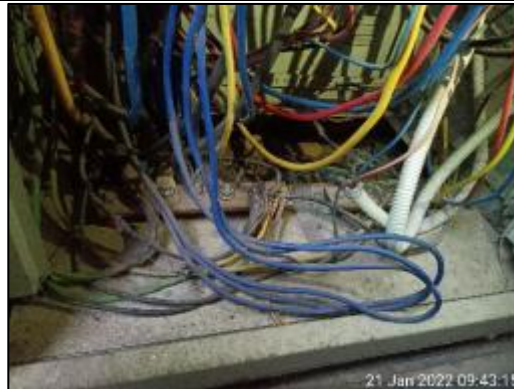
1. MDB-001B in Building A
2. DB-004B in Building A

Figure 60: Lint and Dust in MDB-001B.

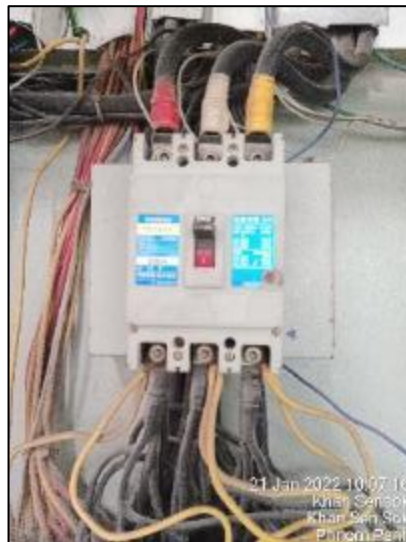
Figure 61: Lint and Dust in DB-004B
