LABS Initiative

Methodology for Preliminary Safety Assessments in India

256287-00

Issue 5 | 26 October 2018

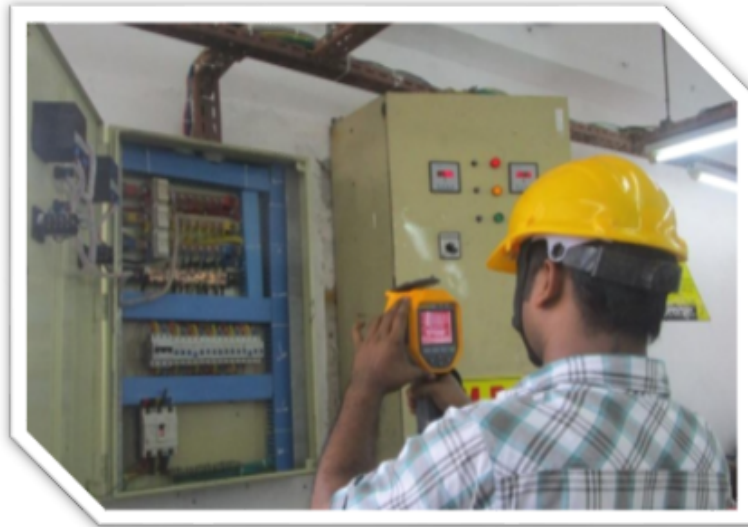
Thermographic Scanning

Using an Infra--Red camera, scan electrical equipment, operating at normal conditions.

Identify connections operating at a higher than normal temperature.

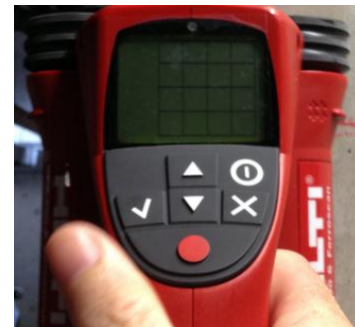
Step 3 “Image Scan”

- “Image Scan” is recommended as it allows 4x4 scan grid (600x600mm area) and gives details for bar size and cover
- “Quick scan” is a single row and gives indication of steel with cover, but not diameter
- The third option is a collection of 9 image scans to cover an area of 1.8mx1.8m

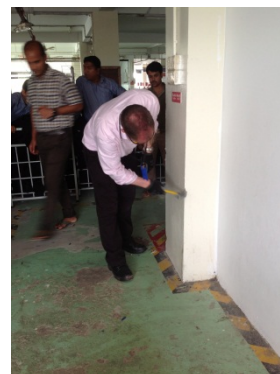
Step 2. Remove render

- I. Mark out a square using the Ferro scan crayon approximately 150mm by 150mm.
- II. Wear gloves and eye protection provided in the kit bag.
- III. Using the geological hammer or hammer and chisel break off the surface render.
- IV. Note that you will not be able to 'grind' the surface right to the edge of the 'breakout'.

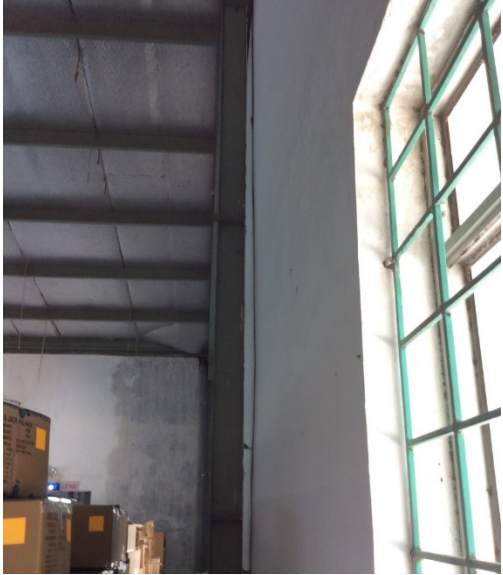
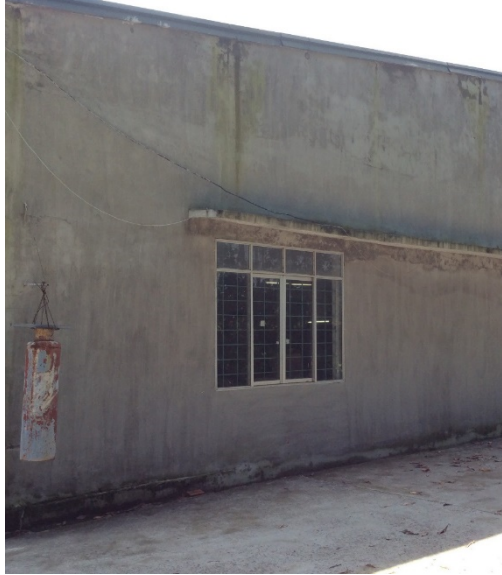
Ref No.	STRUC-1
Observations: Bowing of unrestrained masonry wall on northern gable of Building 5-10. Apparent deflection to concrete canopy on this wall.

Figure N Bowing of masonry wall which is not restrained by steel columns in gable – c.30-40mm deflection at mid height of wall

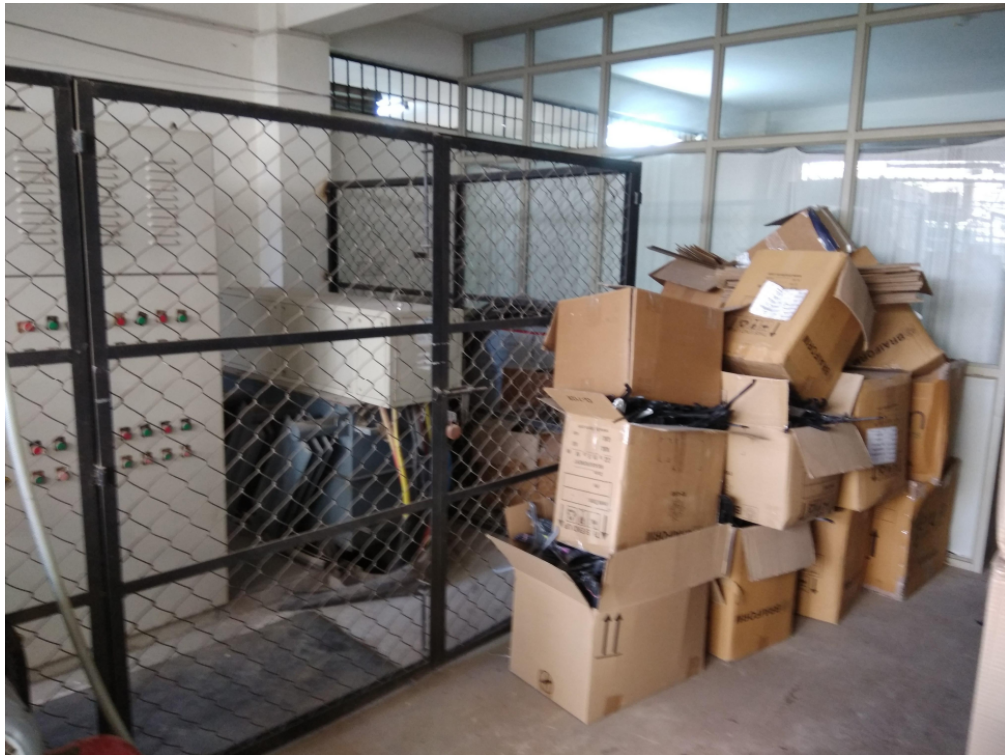
Ref No.	Issue Type	Sub-header
ELEC-n	E5 : Distribution	Combustible/flammable materials present
Observations: Combustible material storage next to the main LT panel room metal fence.

Figure N Storage of combustible material near main LY panel metal fencing.

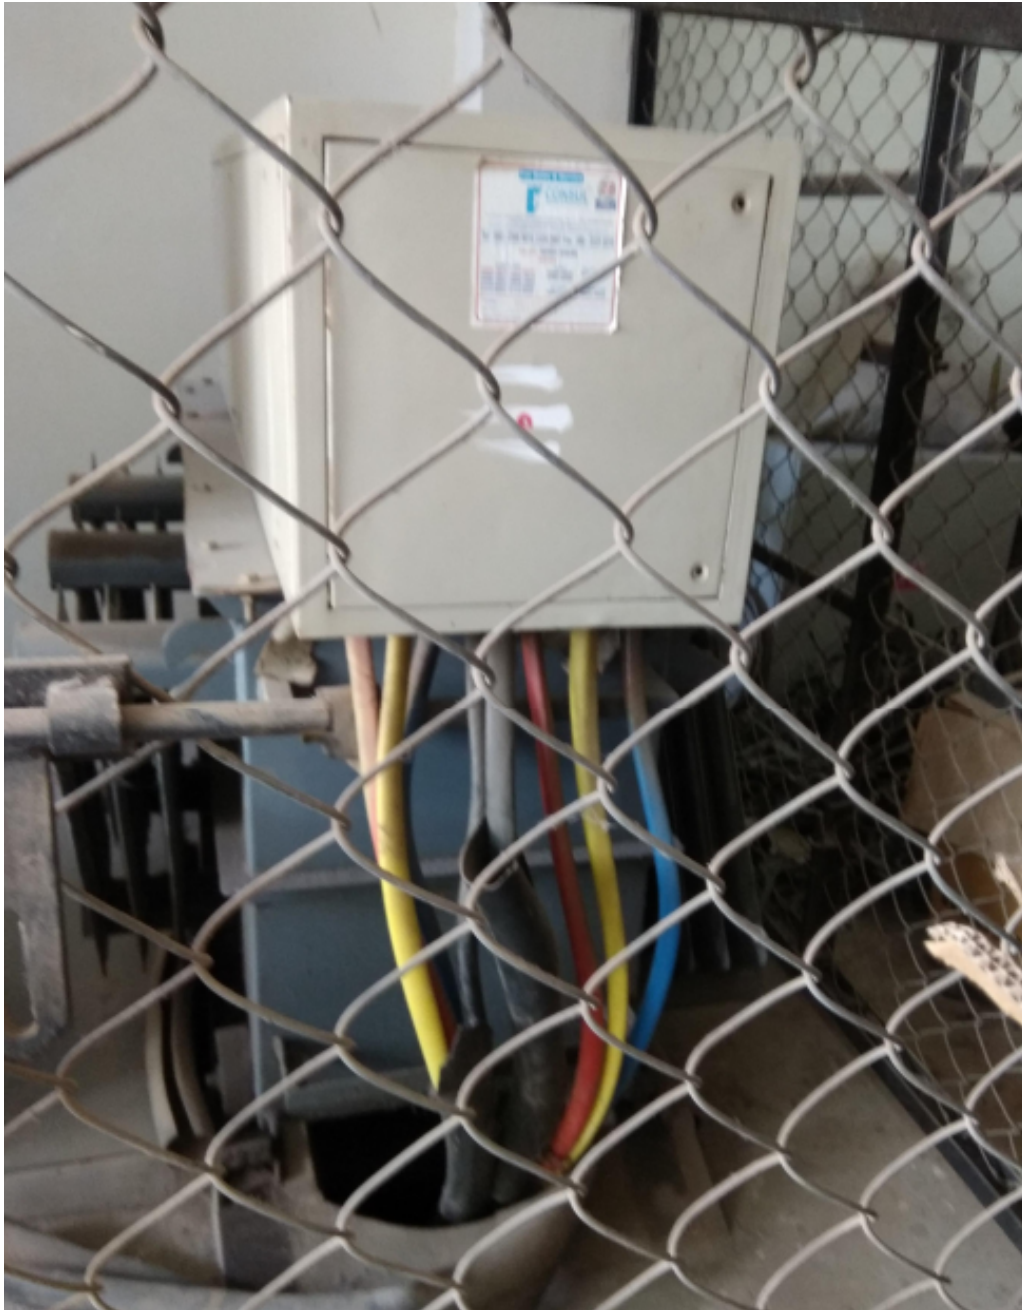
Observations: Cables are terminated without fixing of cable armour into the gland, there is no other insulation available on outer sheet.

Figure N Improper termination of cables.

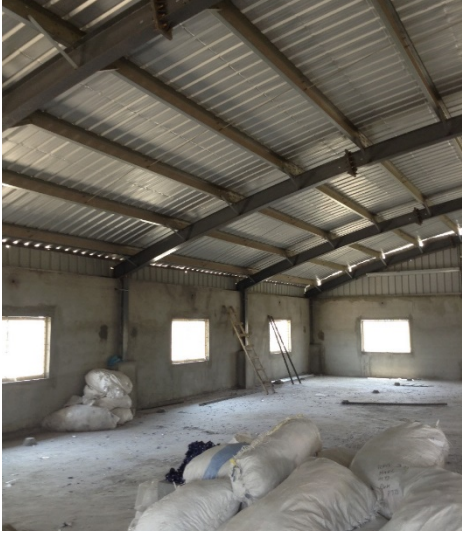
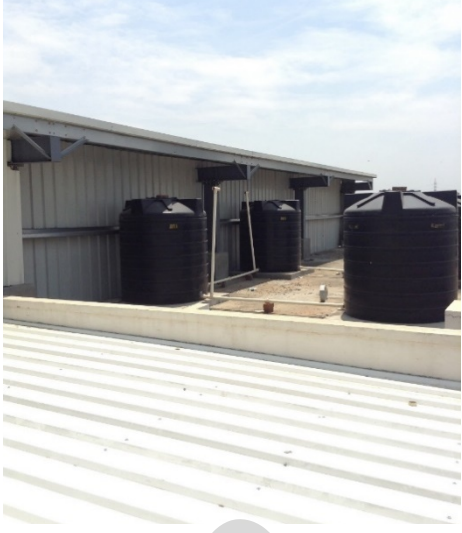
Ref No.	STRUC-2
Observations: New storage area at roof level – it is not clear that the existing roof slab has been designed for this condition

Figure 14 Construction of the storage area in progress on the terrace which shall add load on the terrace.

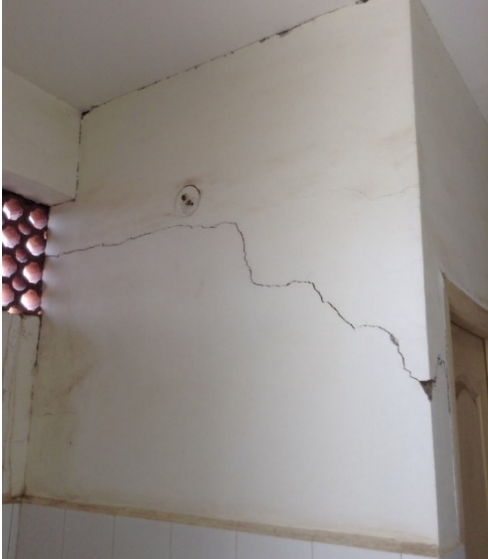
Ref No.	STRUC-4
Observations: Extensive cracking to non-structural masonry walls on cantilever portions of structure to south elevation

Figure 17 Cracks in cantilever portion in the partition walls

Figure 18 Cracks in cantilever continuing through the terrace

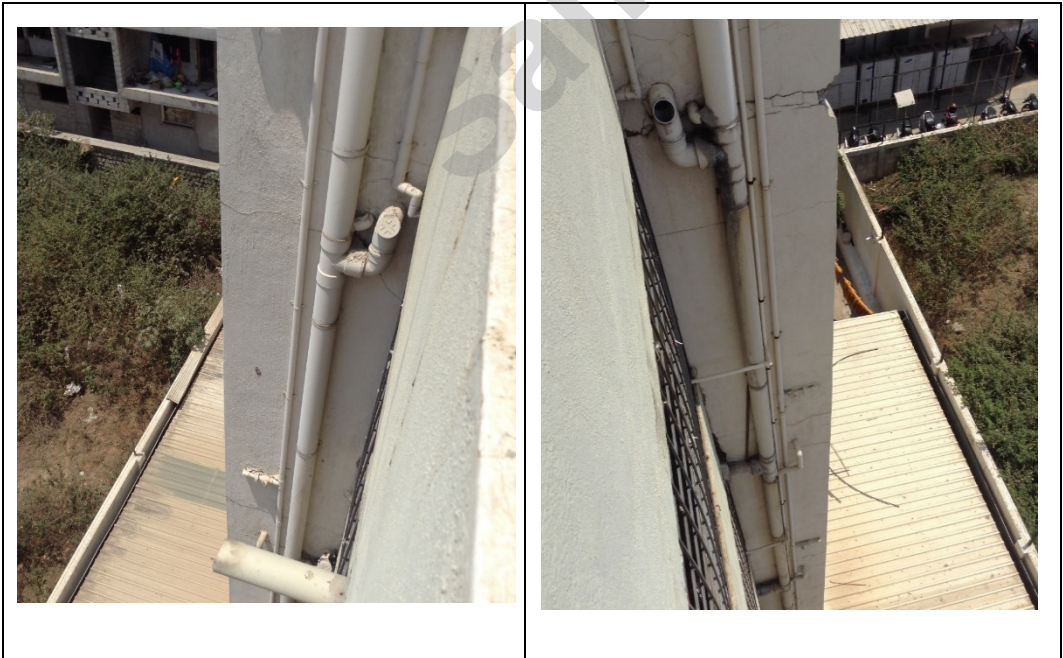
Figure 19 Cracks in cantilever area at floor levels

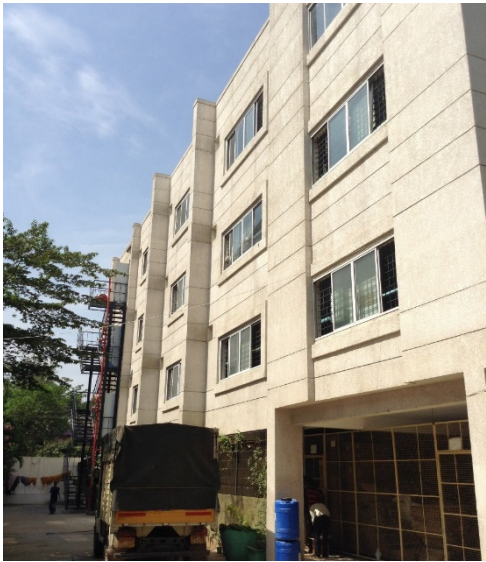
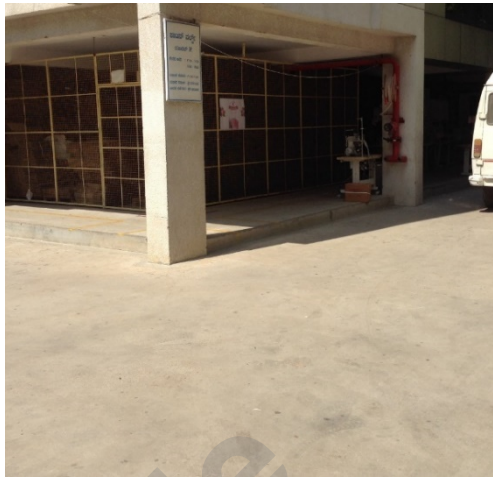
Ref No.	STRUC-5
Observations: Columns at the north east corner of the building adjacent near entrance gate are in danger of being accidentally hit by vehicles entering/ leaving the facility.

Figure 21 Unprotected column in loading/unloading area

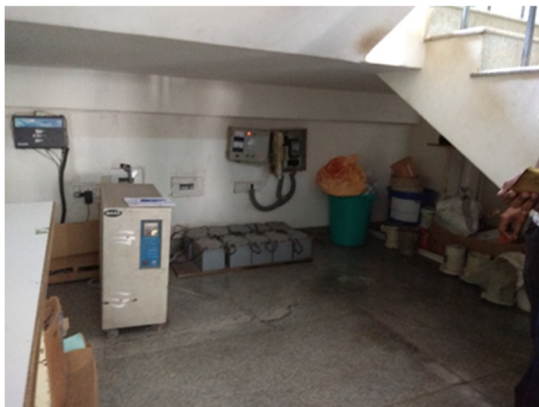
Figure 12 UPS and back-up batteries stored under NW Stair flight

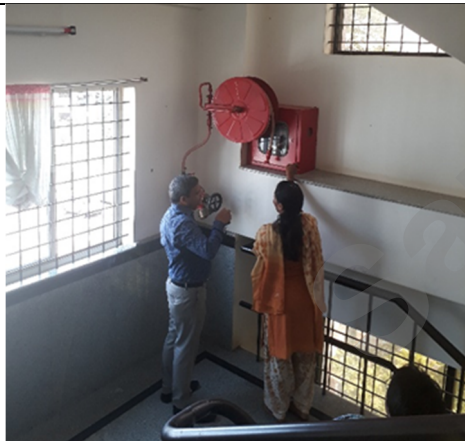
Figure 16 Fire hydrant and hose reel at half landing, located at height

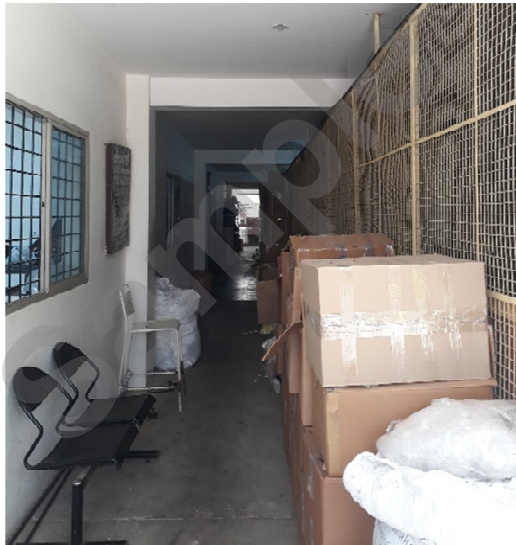
Ref No.	Issue Type	Sub-Issue Type
FIRE-10	Fire Protection - Construction	Storage areas
Observation		
<p>Designated storage areas not separated with FR construction</p> <p>The Storage area on 4th Floor is separated with fire rated construction from the Production area, but doors are not fire rated and self-closing.</p> <p>The Storage area at Ground Floor is not separated from other occupancies, and exceeds the permissible amount of non-sprinklered storage. Part of this area is covered by sprinklers, but this system does not meet LABS Standards requirements for sprinkler coverage.</p>

<p>Figure 34 Storage on Ground Floor without fire rated protection from the colouring area.</p>

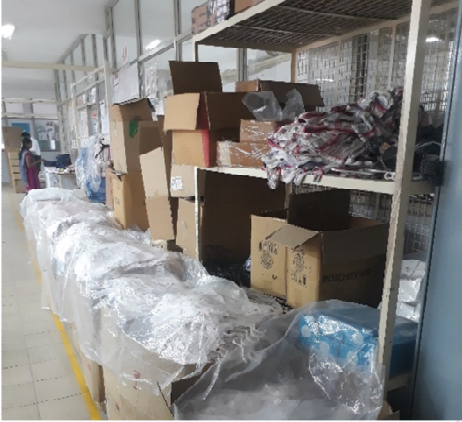
Ref No.	Issue Type	Sub-Issue Type
FIRE-11	Fire Protection - Construction	Storage areas
Observation		
<p>Excessive areas of 'in-process' storage open to production areas</p> <p>'In-process' storage on 1st Floor was seen to be in excess of the maximum allowable storage for open storage on non sprinklered floors. The approximate storage area was noted as 32m² in this area.</p>

<p>Figure 35 'In-process' storage on 1st Floor without fire rated separating wall from production floor.</p>

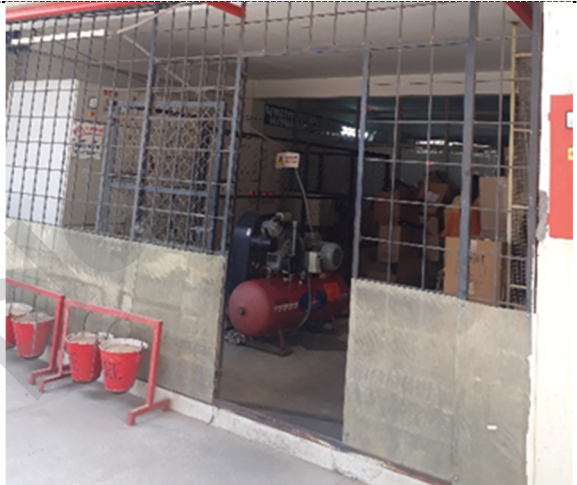
Ref No.	Issue Type	Sub-Issue Type
FIRE-12	Fire Protection - Construction	Other high risk areas
Observation		
HV and Compressor enclosure inadequate.		
The HV Room and Compressor are open to production area at Ground Floor and located on escape path with no fire rated separation.

Figure 36 HV and compressor room open to production areas, escape paths.		Figure 37 HV and compressor room open to production areas, escape paths

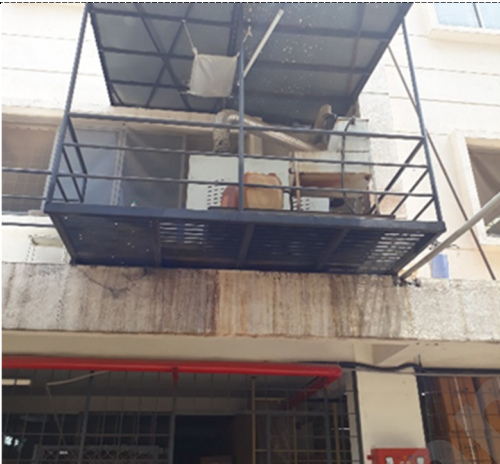
Ref No.	Issue Type	Sub-Issue Type
FIRE-13	Fire Protection - Construction	Other high risk areas
Observation		
<p>Boiler enclosure inadequate.</p> <p>The Boiler is open to the production area at 1st Floor level and exposed to the exterior exit route along the W side of the building as pointed out above.</p>

<p>Figure 38 Boiler located near windows that opens in production area</p>

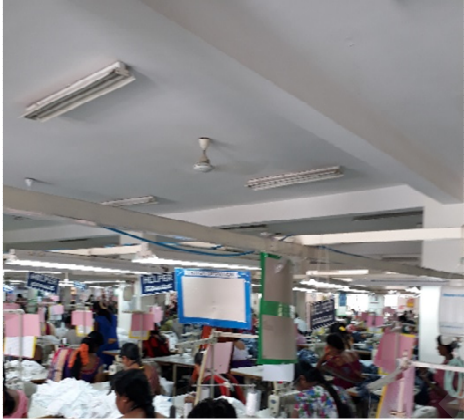
Ref No.	Issue Type	Sub-Issue Type
FIRE-15	Fire Safety Systems	Fire Detection
Observation		
<p>Inadequate Fire Detector coverage.</p> <p>Only one smoke detector per floor has been provided in production area on typical floors. No smoke detectors in Ground floor store area. All occupied as well as non-occupied spaces in the building should be covered with an automatic fire detection system.</p>

<p>Figure 40 Only 1 smoke detector provided in production area</p>

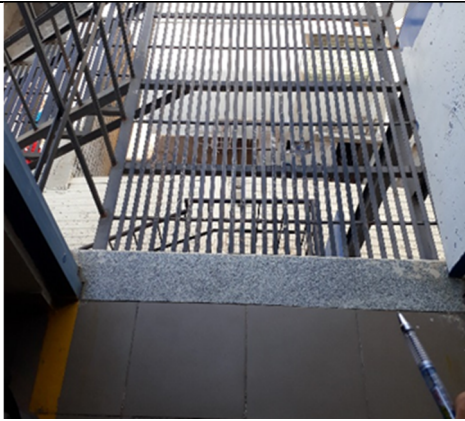
<p>Figure 46 External stair steeper than 45° and no Emergency Lighting provided</p>
