LABS Initiative

Methodology for Preliminary Safety Assessments in Vietnam

256287-00

Issue 3 | 29 October 2018

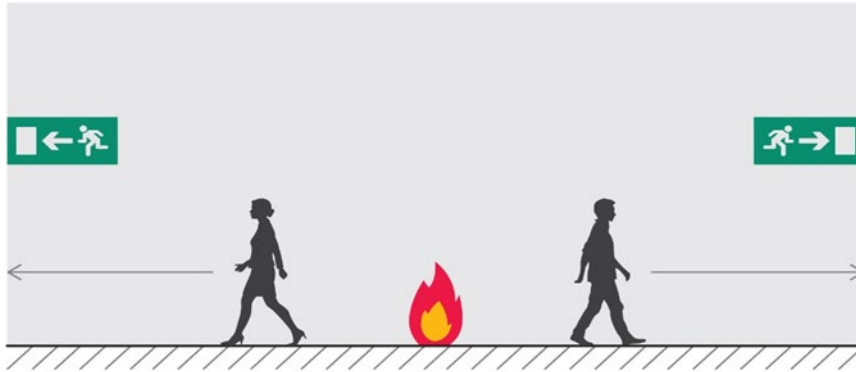
A general principle of design for means of escape is that persons should have alternative directions of escape. This is so that in the event of a fire, occupants can escape without having to approach the fire source.

Figure 5 Alternative directions of escape

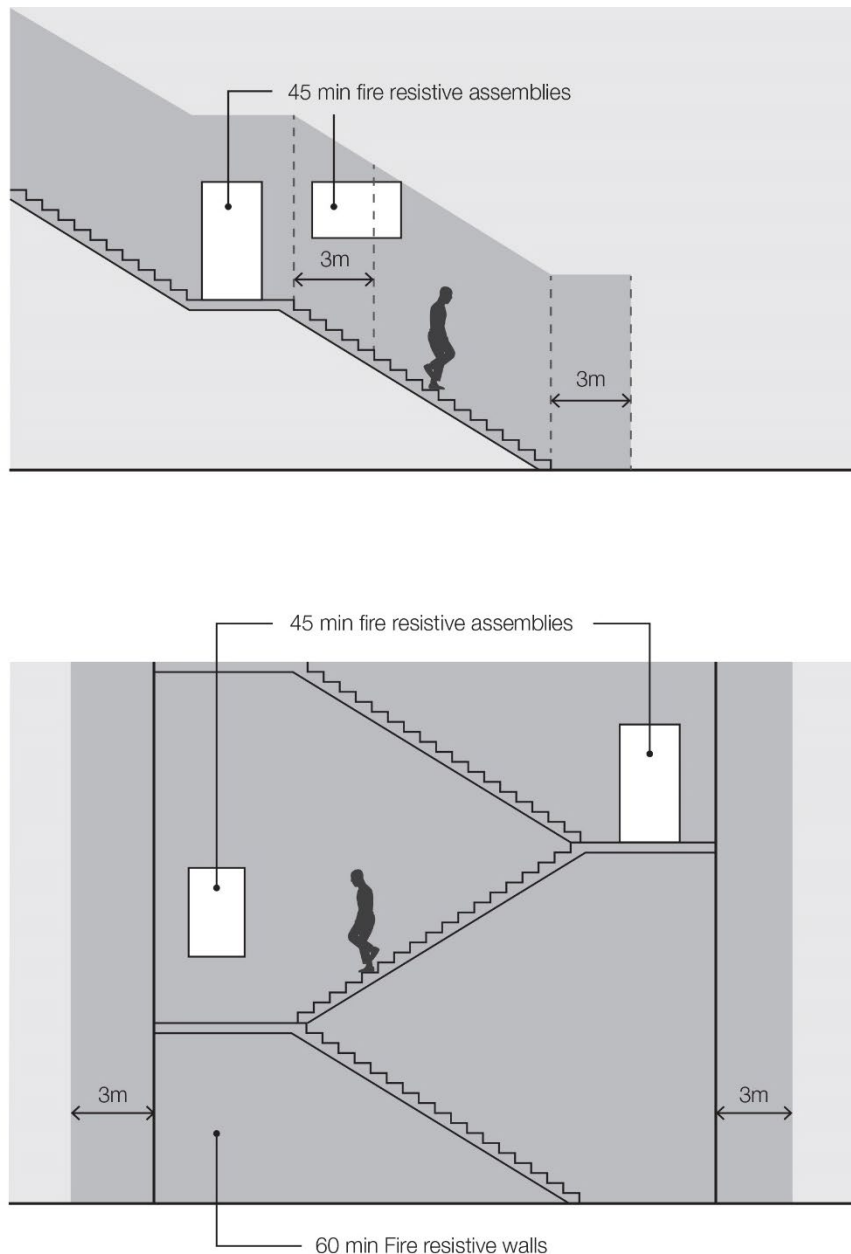
Figure 9 Protection of external escape stairs

- Within 3.0m horizontally of the nonrated wall or unprotected opening.
- Extending from the finished ground level to a point 3.0m above the topmost landing of the stairs or to the roofline, whichever is lower.

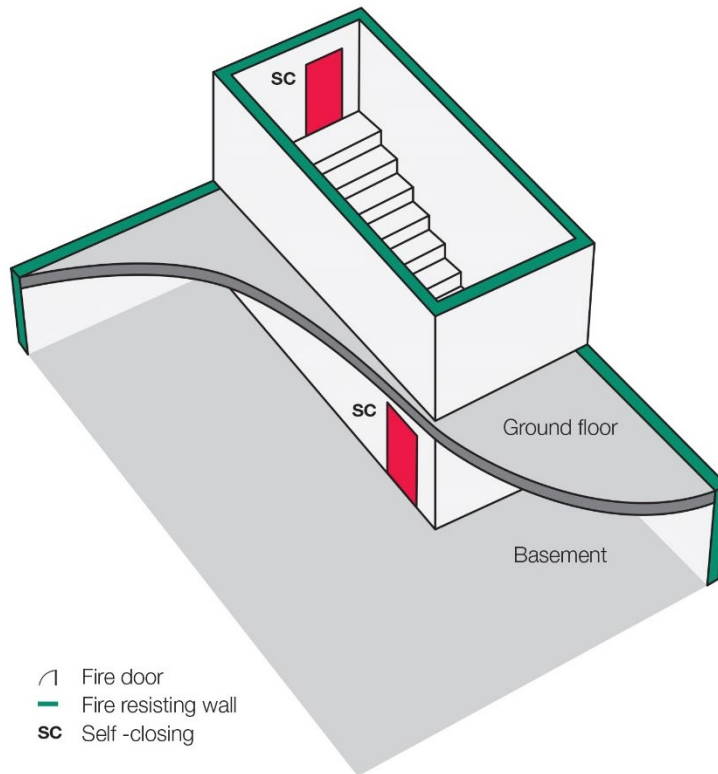
Figure 10 Sketch showing the basic requirements for protecting a basement opening

Basements need special protection from the upper floors, so the Assessor will note how this separation is achieved and particularly whether there is a vestibule provided as part of the separation mechanism for the stair penetration. This should be a fire rated separation with self-closing doors to stair and vestibule as shown in the Figure 10 below:

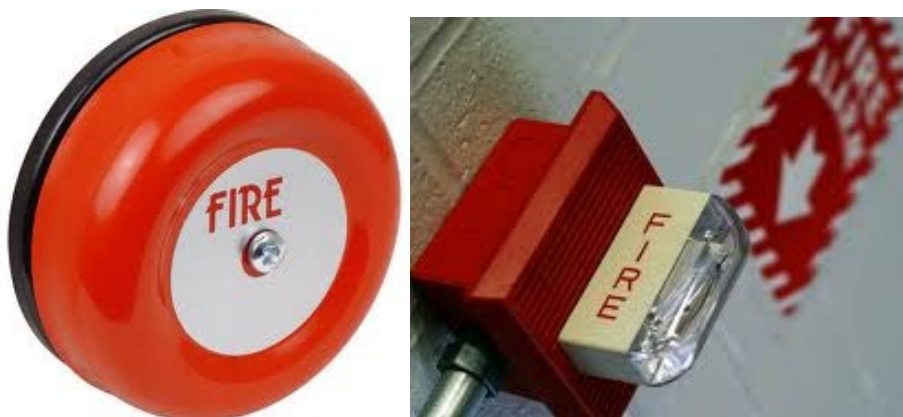
Figure 14 Example automatic sounder (left) and visual notifier (right)

It is very important that alarm will be heard so the sounders should provide a minimum sound level usually around 65dB throughout the building but importantly 5dBA above any background noise. This is particularly important in noisy places such as factories or places where people may have ear protection. In some circumstances the sounders would need to be augmented with visual strobes.

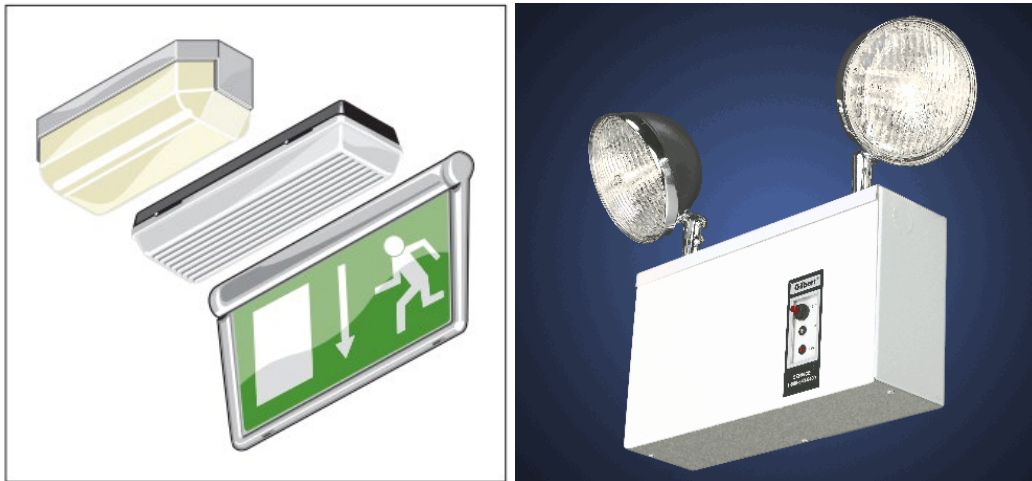
Figure 15 Example luminaire emergency escape lighting and illuminated escape sign (left) and stand-alone spotlight emergency light (usually battery powered)

Emergency escape lighting (luminaires) can be stand-alone dedicated units or incorporated into normal light fittings.

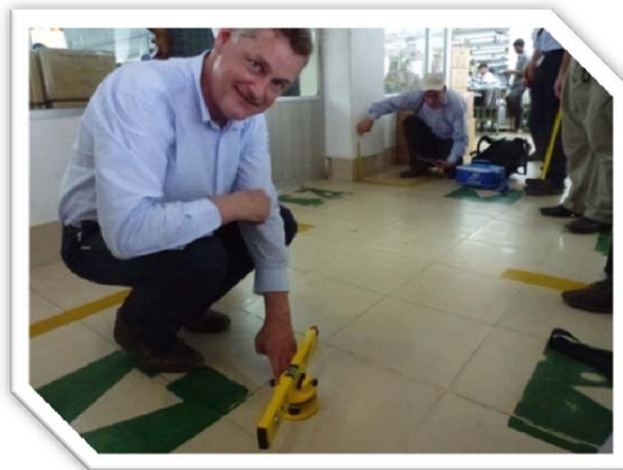
A laser level

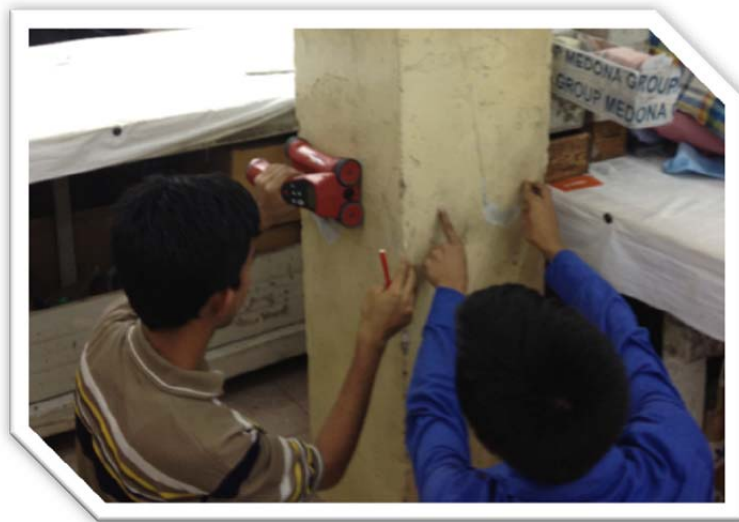
Check reinforcement

With a Ferro Scanner

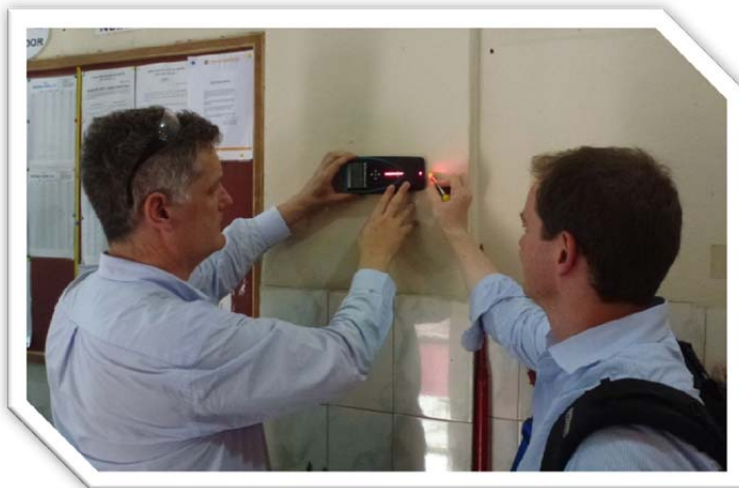
With a Cover Meter

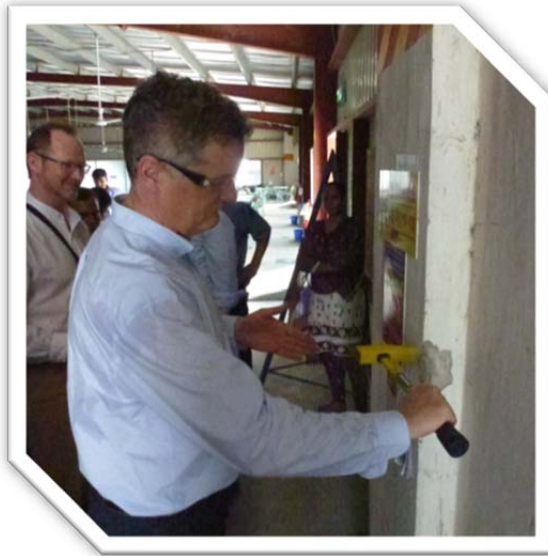
Check concrete

Make a small opening in the mortar

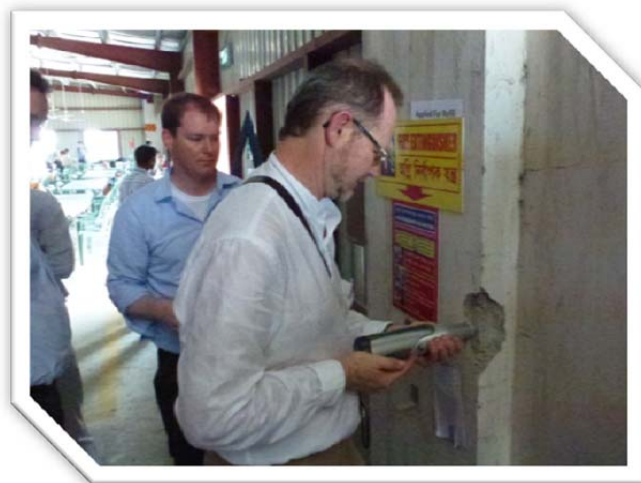
Test with the Rebound Hammer

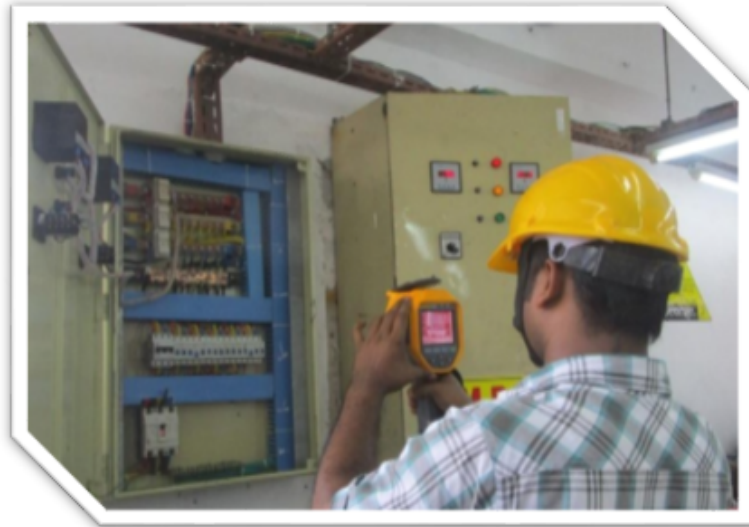
Using an Infra--Red camera, scan electrical equipment, operating at normal conditions.

Identify connections operating at a higher than normal temperature.

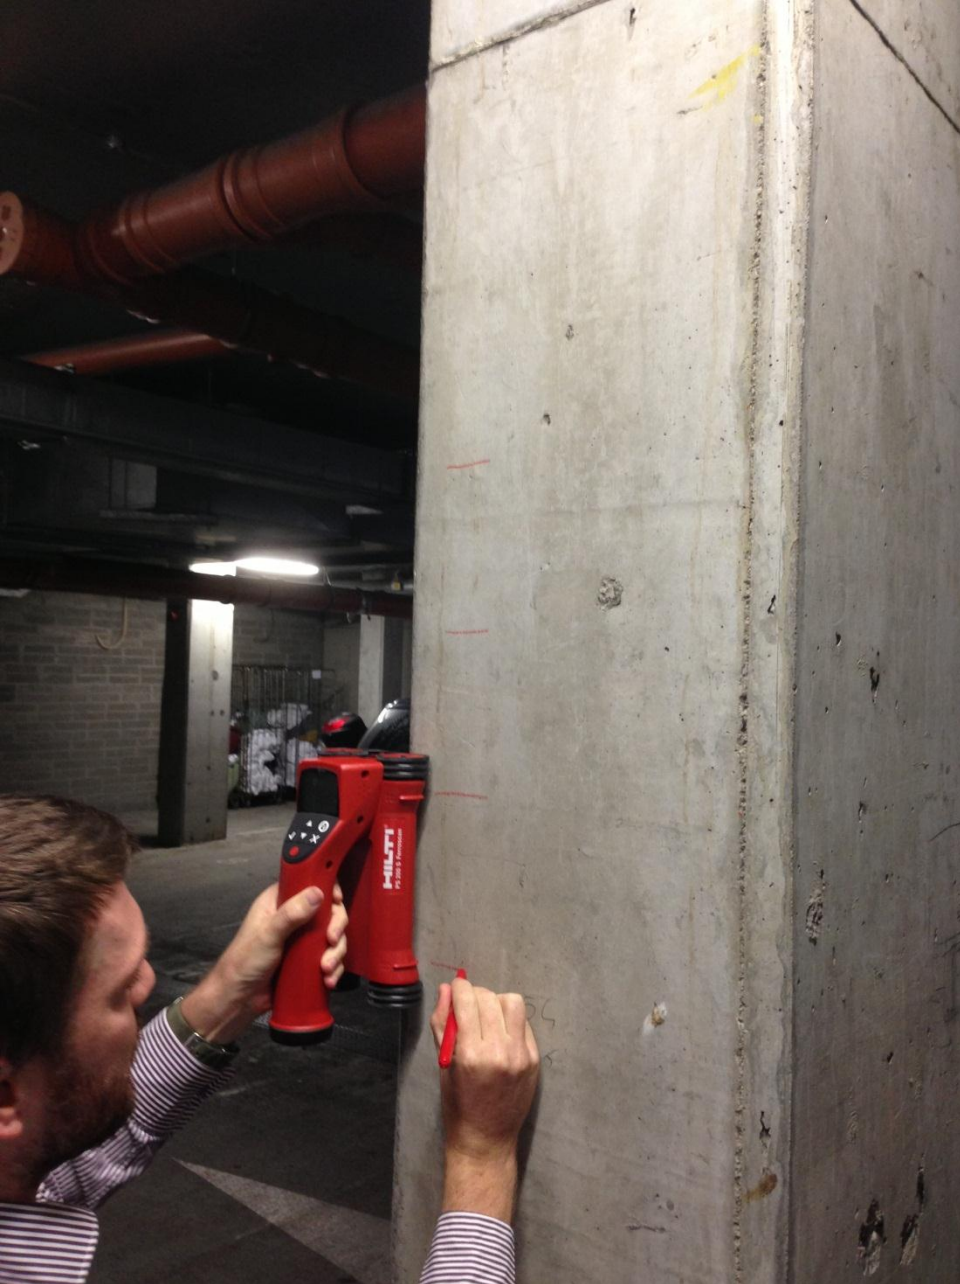
Step 1 Horizontal Guidelines

Create horizontal guide lines on surface of concrete using the lugs on the scanning device (150mm apart)

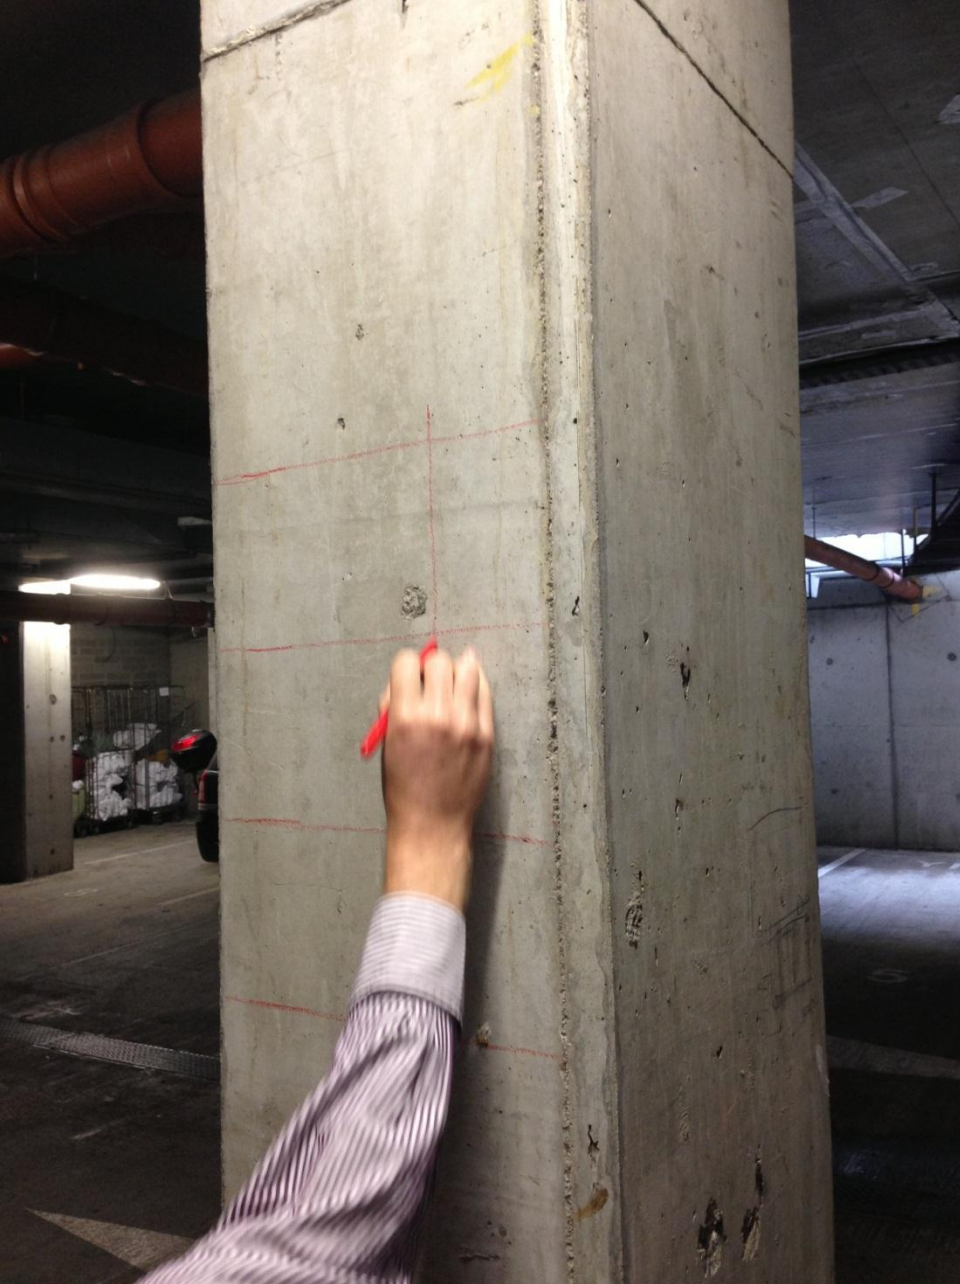
Step 2 Vertical Guidelines

Mark vertical guide lines on surface of concrete

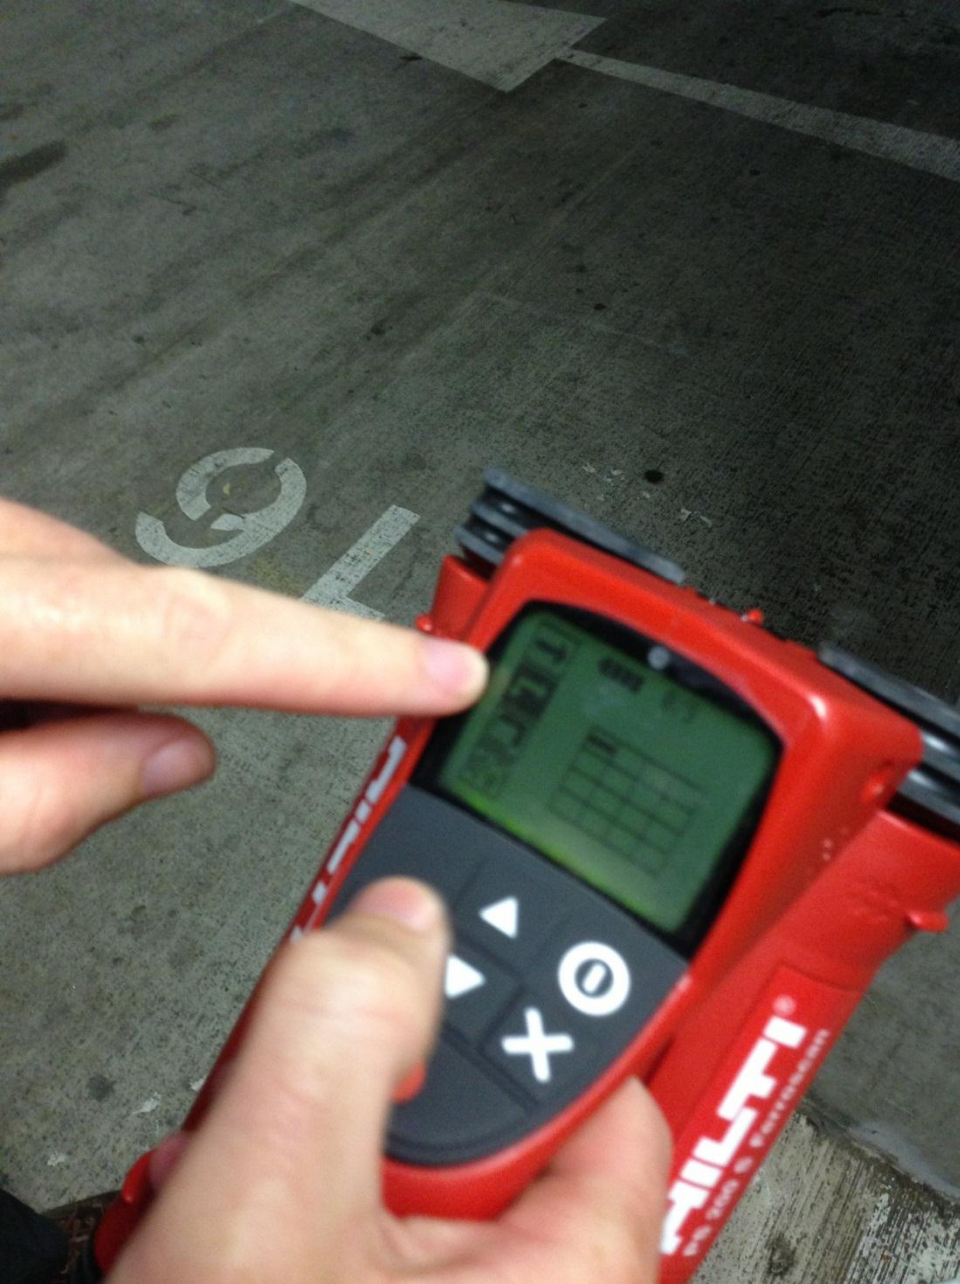
- For narrow column as shown here, a single vertical scan is sufficient to pick up the shear link steel
- The vertical main steel is picked up by the horizontal scan

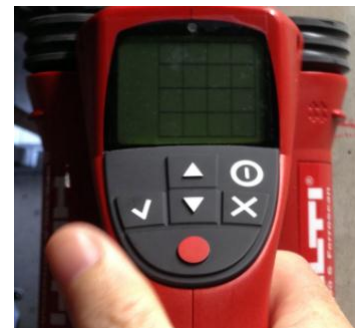
Step 3 “Image Scan”

- “Image Scan” is recommended as it allows 4x4 scan grid (600x600mm area) and gives details for bar size and cover
- “Quick scan” is a single row and gives indication of steel with cover, but not diameter
- The third option is a collection of 9 image scans to cover an area of 1.8mx1.8m

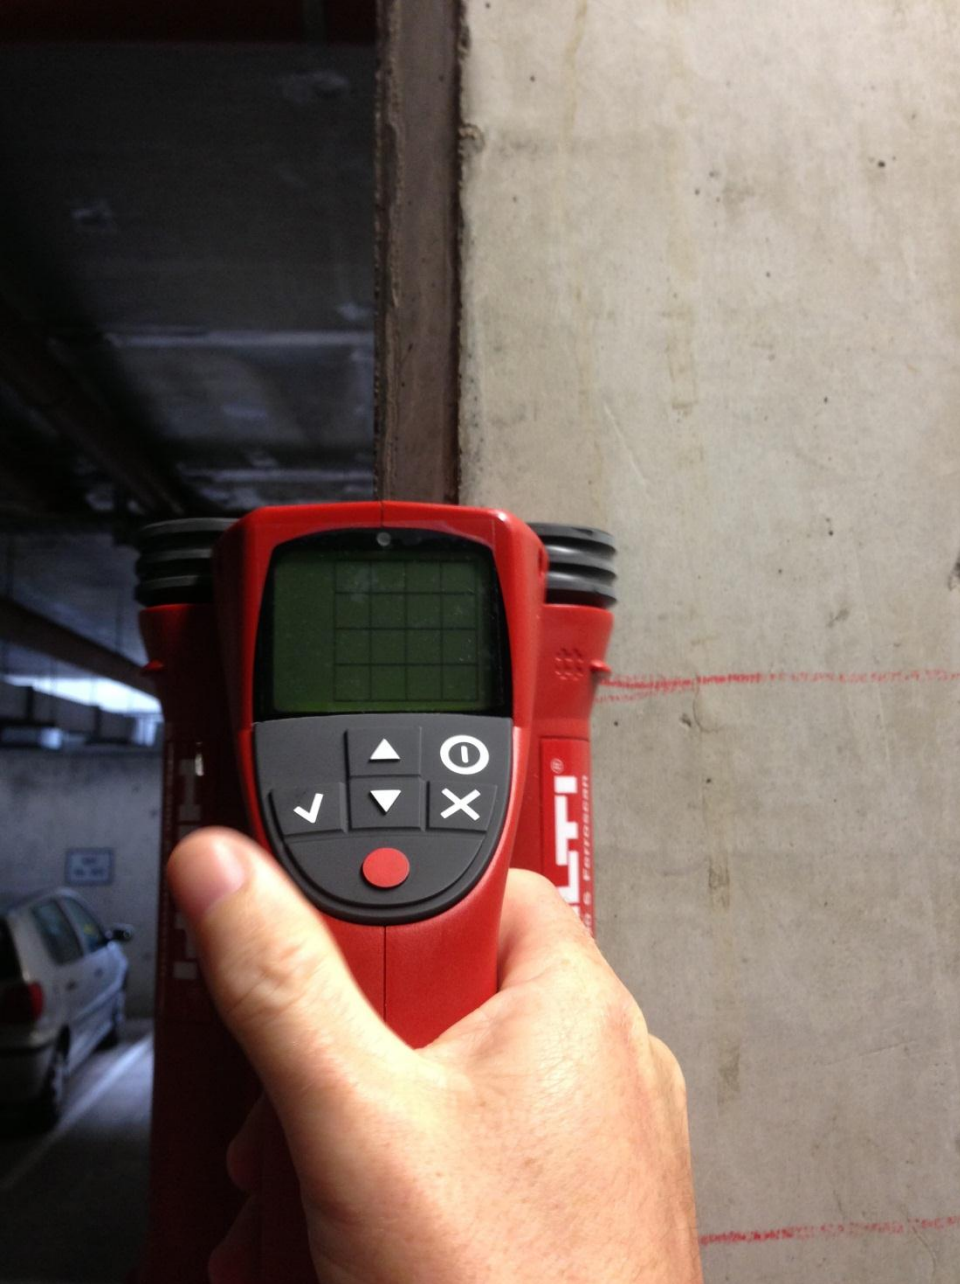
Step 4 Horizontal Scan Row 1 START

- I. Place the scanner such that
 - the centre is in line with the outside face of the column (there is a plastic lug at the centre on the top face of the scanner which indicates where the scan starts)
 - the plastic lug on the side of the scanner is lined up with the guideline (see photo below)
- II. Press the

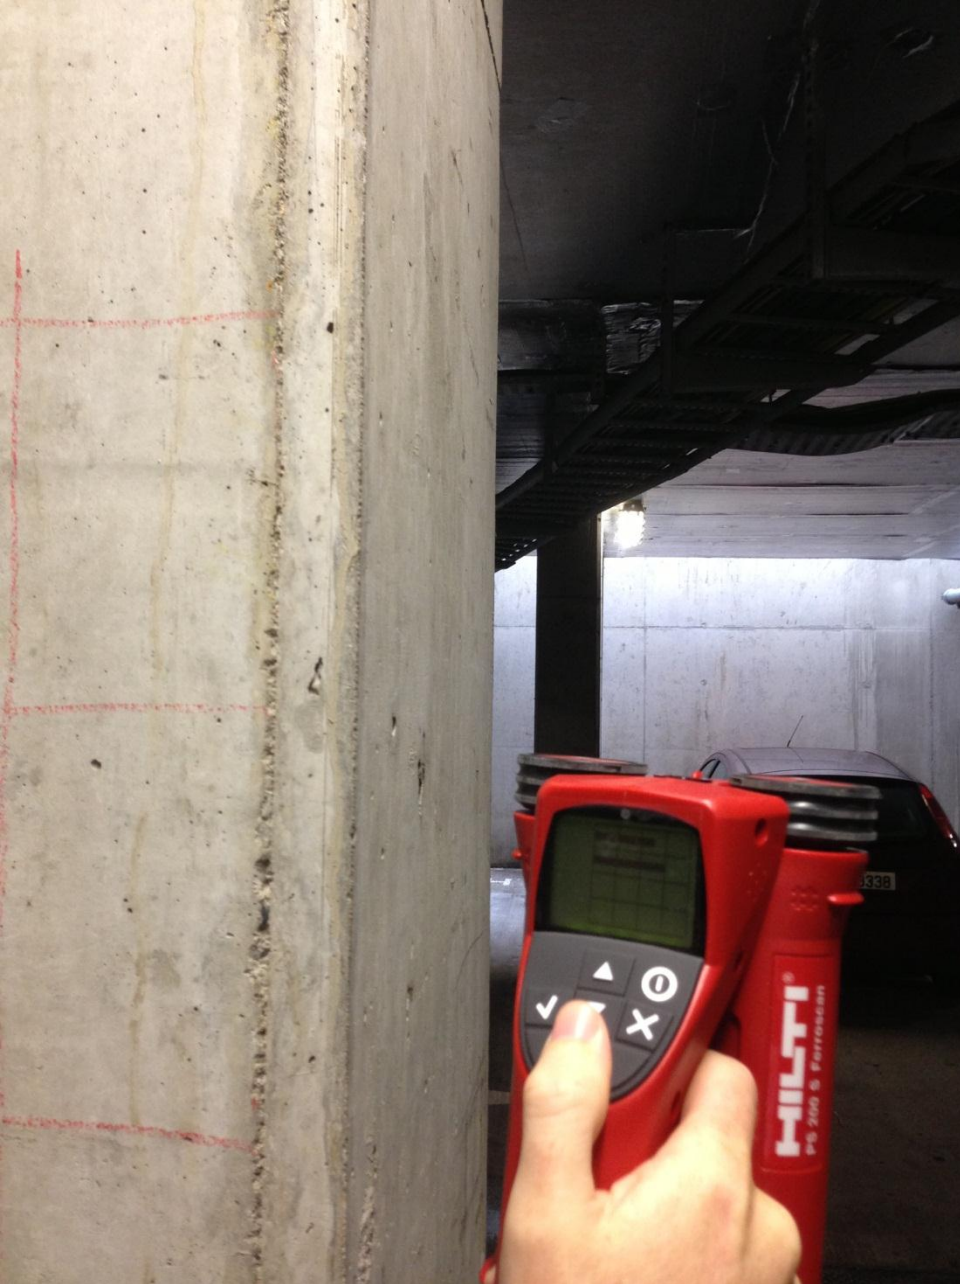
Step 5 Horizontal Scan Row 1 END

Roll off the column. If you have scanned 600mm the scanner will stop automatically. If not you should press the

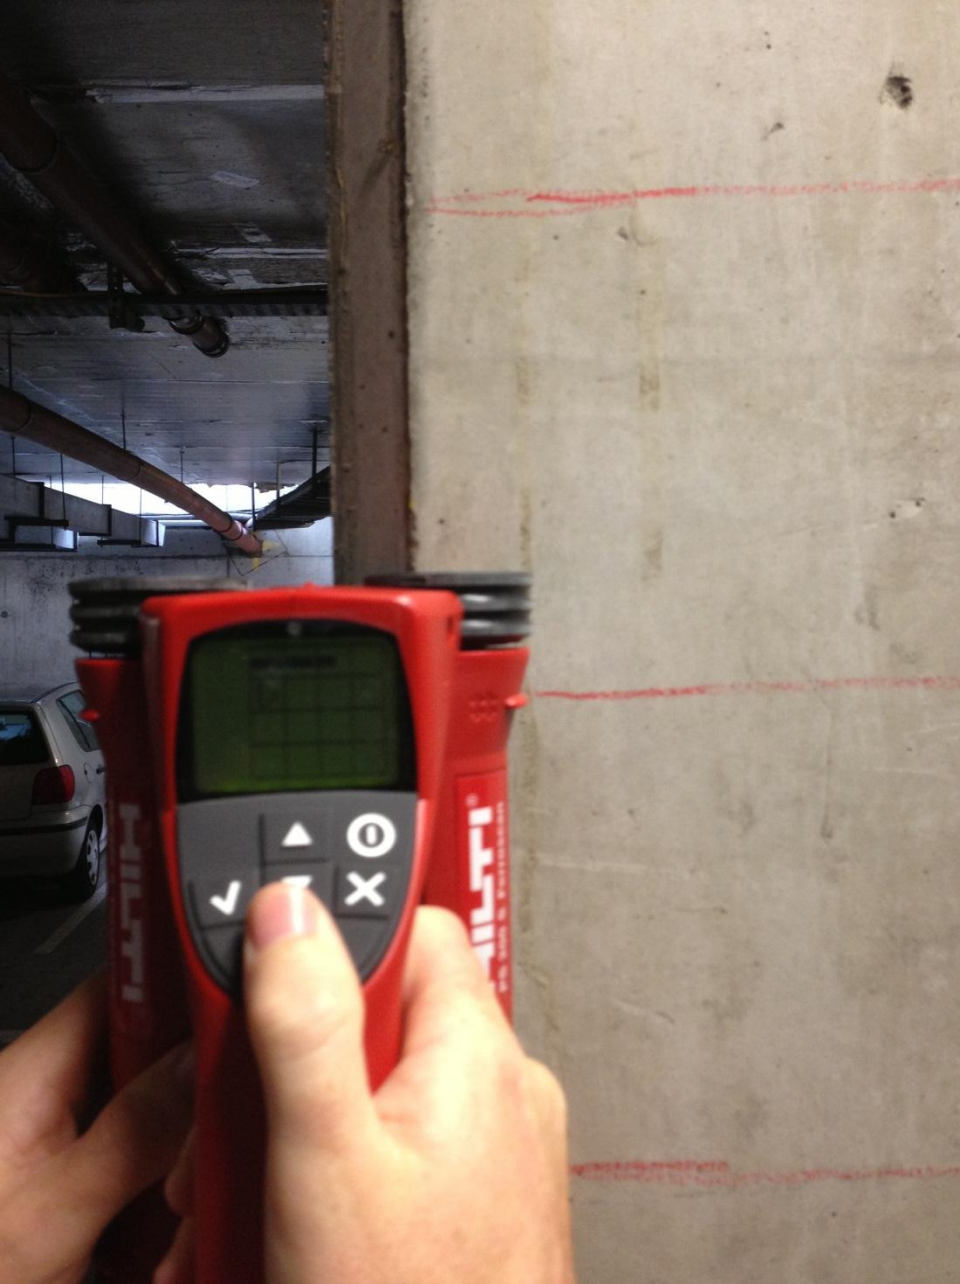
Step 6 Complete Horizontal Scans

Repeat for rows 2, 3, and 4,
following the guidelines carefully

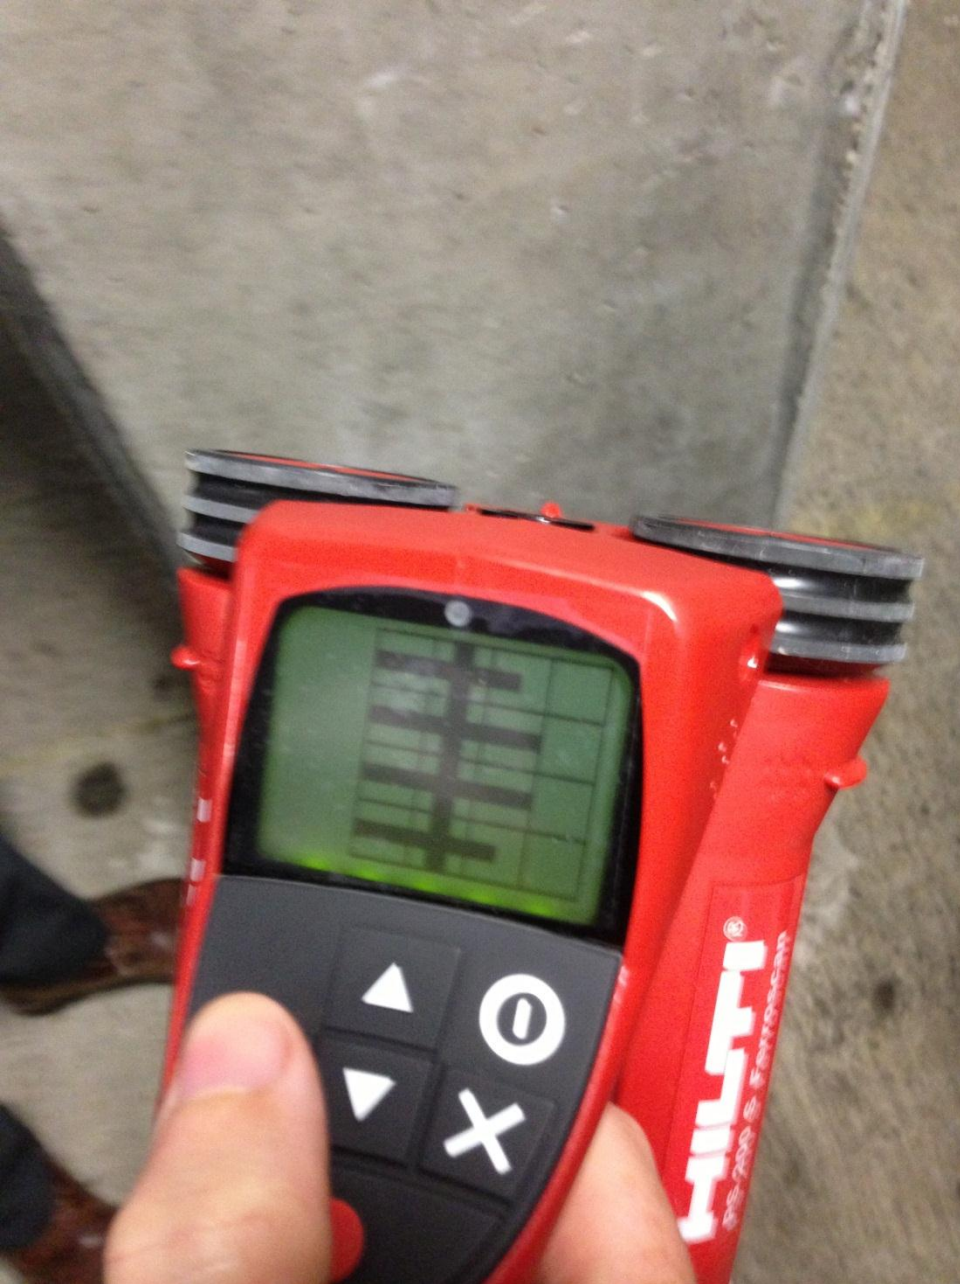
Step 7 Vertical Scans

On completion of all rows and strips, press the

button to complete image scan.

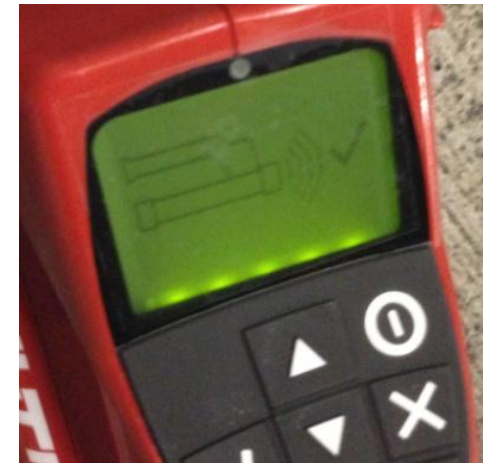
Step 9 Transfer Scan to Monitor

- The scanning device should also register a successful scan, see below

Blue shows steel.

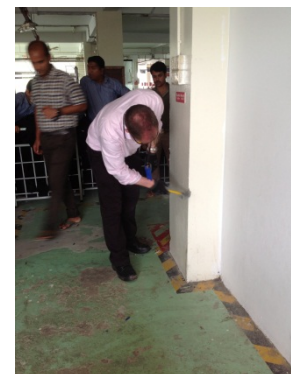
Step 2. Remove render

- I. Walk the entire factory first. Identifying columns that will be suitable for testing. Removal of render is a dusty process and this needs to be communicated to the factory owner.
- II. Columns where the render is already damaged is likely to be accepted more readily by the owner.
- III. If there is a column where there is evidence that a core has been previously taken, locate a Schmidt Hammer test here.
- IV. Removing render during lunch breaks can be favourable as the process will attract lots of attention from workers.
- V. Choose a typical column at the lowest possible level.
- VI. Choose a typical column at an upper floor.
- VII. If time permits or if tests are very low or variable, select other columns.
- VIII. Carbonation increases the hardness of concrete. Thus external columns without render will likely return higher results than internal columns that have been rendered.

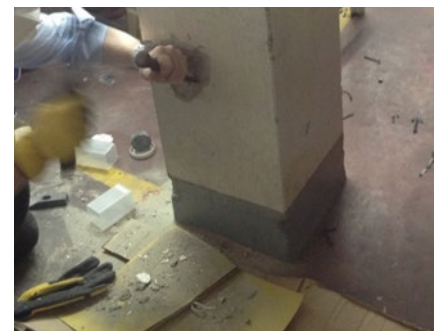
- I. Mark out a square using the Ferro scan crayon approximately 150mm by 150mm.
- II. Wear gloves and eye protection provided in the kit bag.
- III. Using the geological hammer or hammer and chisel break off the surface render.
- IV. Note that you will not be able to 'grind' the surface right to the edge of the 'breakout'.

You are aiming to have a prepared surface of at least 100mm x 100mm.

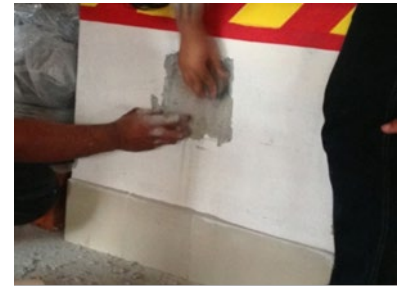
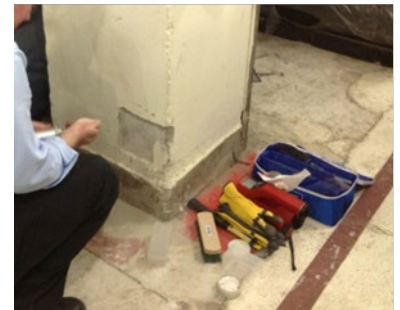
Step 4. Schmidt Hammer use

- I. Wear gloves and the dust mask provided in the kit bag (use a new mask each day).
- II. Using the abrasive stone, grind heavily textured or soft surfaces, or surfaces with loose mortar, until they are smooth and free of loose material over an area of at least 100mm by 100mm. If lots of aggregate is visible, a larger area may need to be prepared. Smooth-formed or trowelled surfaces may be tested without grinding.
- III. Using the brush provided in the kit bag remove surface dust.
- IV. Remove any water present on the surface of the concrete.

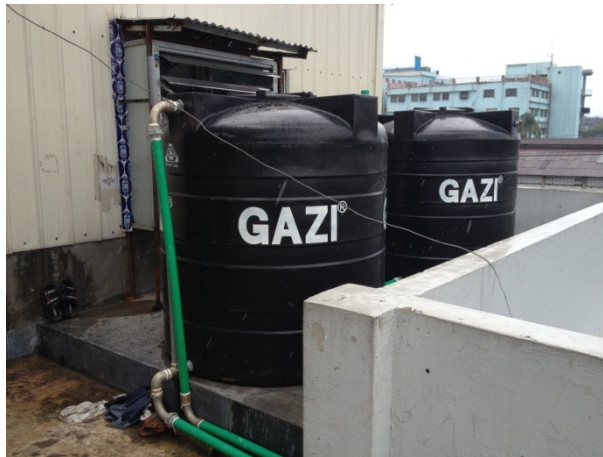
Measure height of plinths and calculate weight

Record tank capacities and consider total load on slabs, beams or columns

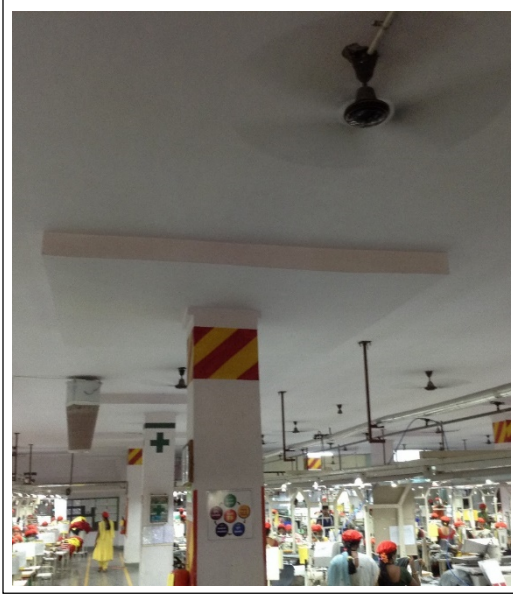
Figure N Typical flat slab with drop panels

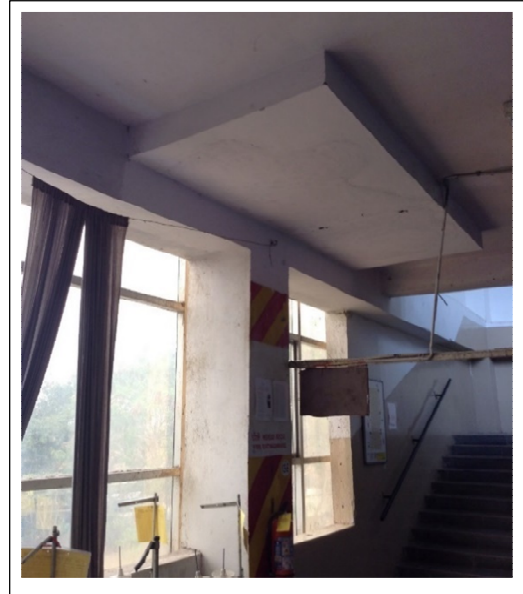
Figure N Typical floor structure at link between Part A and B

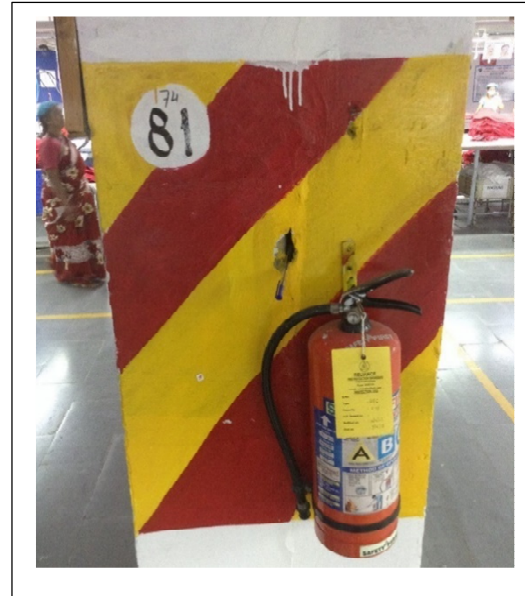
Figure N Double column at MJ

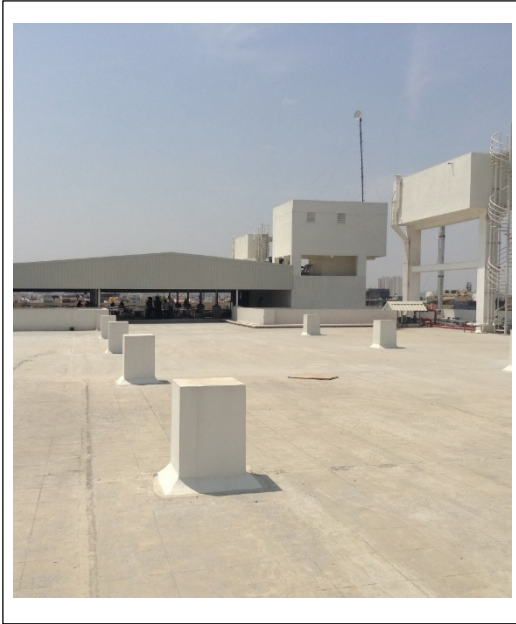
Figure N Water tank on columns at Roof level – GL E/7-8. Approx. storage – 24,000 litres Similar tank at GL E/2-3

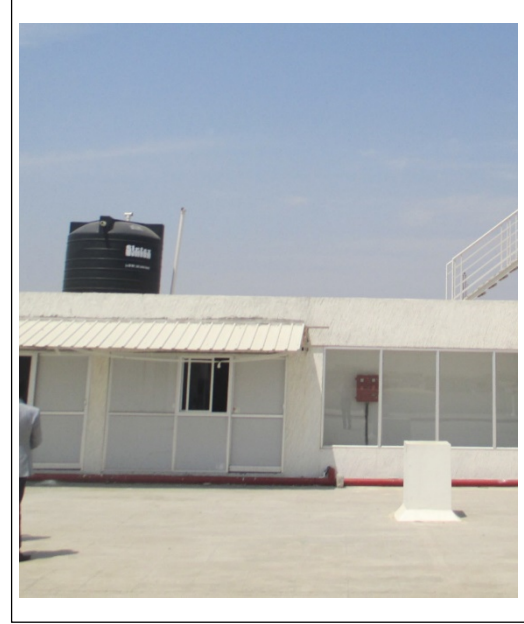
Figure N 10,000 litre tank at GL 0-11/D-E

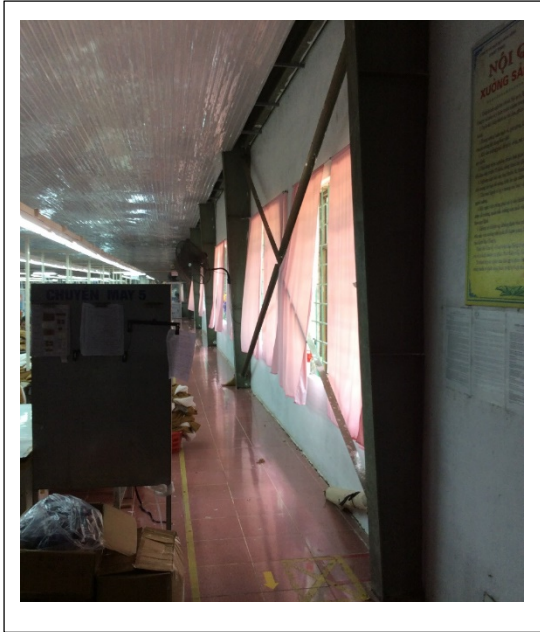
Figure N Typical braced bay – suspended ceilings throughout so portal frames not visible. External masonry wall built tight to outside of column flange

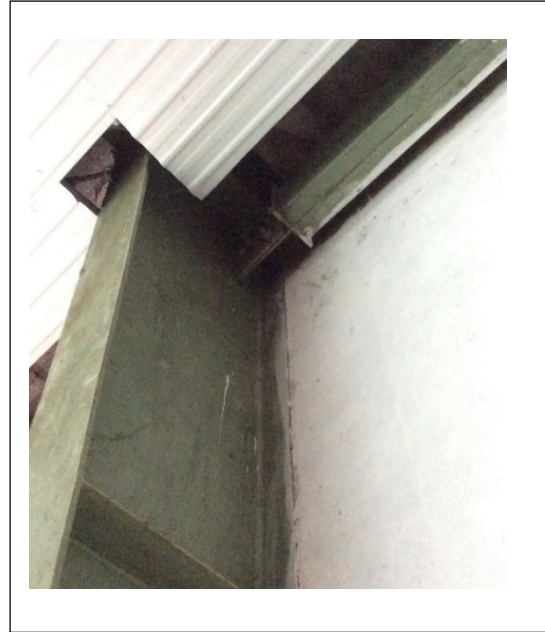
Figure N Typical eaves detail – eaves beam visible

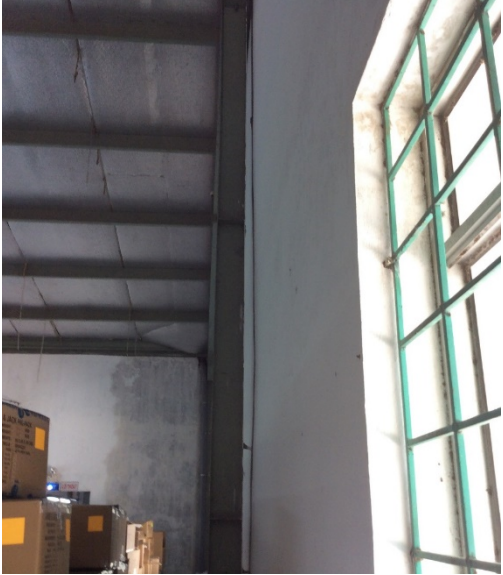
Ref No.	STRUC-1
Observations: Bowing of unrestrained masonry wall on northern gable of Building 5-10. Apparent deflection to concrete canopy on this wall.

Figure N Bowing of masonry wall which is not restrained by steel columns in gable – c.30-40mm deflection at mid height of wall

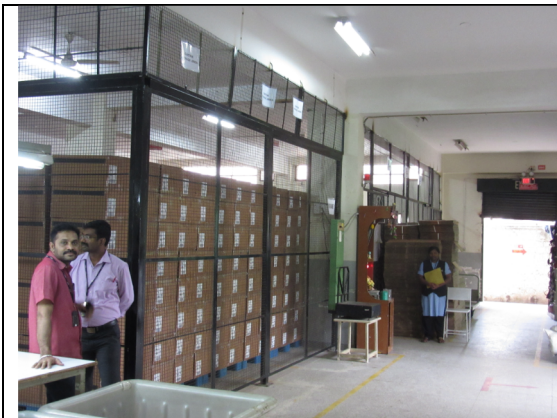
Figure 11 Dedicated storage area separated by open wire enclosure (eg. above)

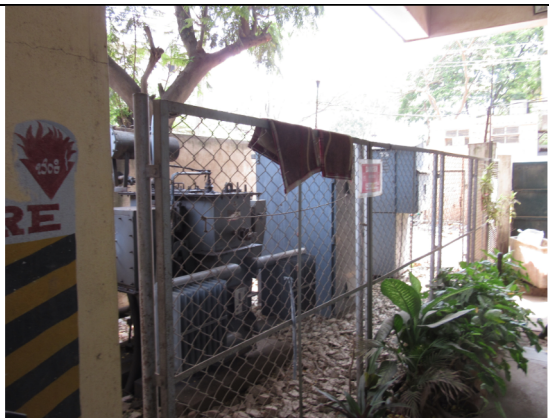
Figure 12 Diesel cooled Transformer adjacent Crèche and large window onto Stair

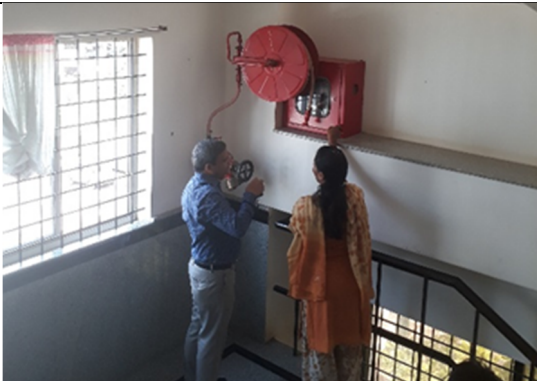
Figure 13 Fire Hydrant and hose reel at half landing, located at height

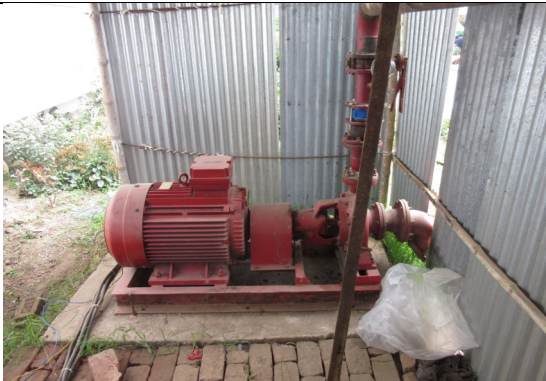
Figure 14 Centrifugal suction fire water pump adjacent to reservoir

The type of pump set to supply the fire hoses with firefighting water from the stored water reservoir should be noted, particularly the types and condition of both main pump and backup pump.

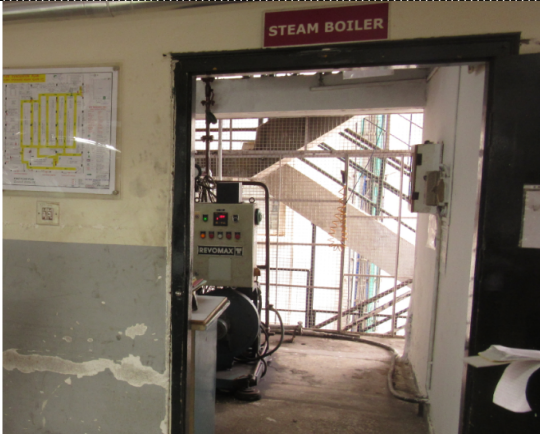
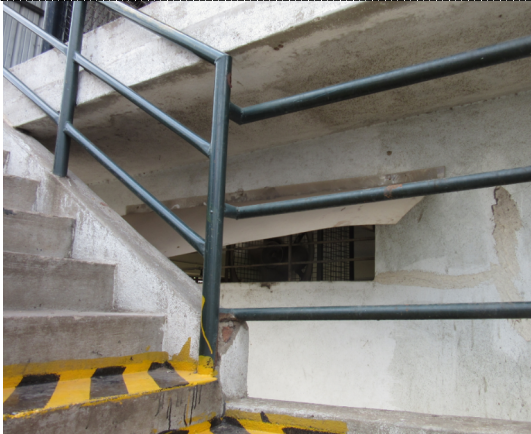
Figure xx Boiler room with no enclosing wall facing onto external stair (eg: external stairs)		Figure xx Unprotected window openings adjacent to external stair (eg: external stairs)

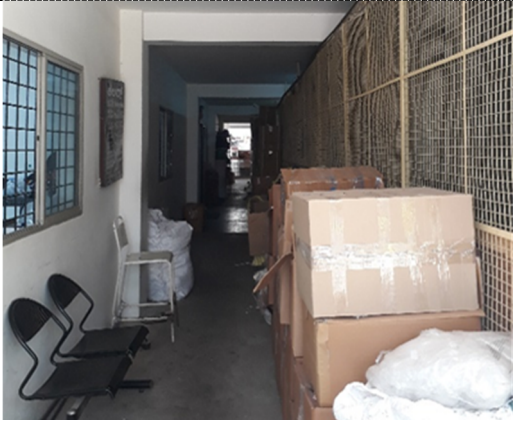
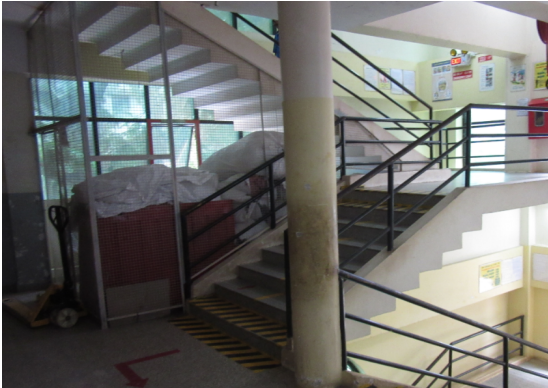
Figure xx Each figure to have brief descriptive title (eg Uncontrolled storage on escape path)		Figure xx Storage of waste textiles under stairway (eg Uncontrolled storage on escape path)
Figure xx Each figure to have brief descriptive title		Figure xx Each figure to have brief descriptive title

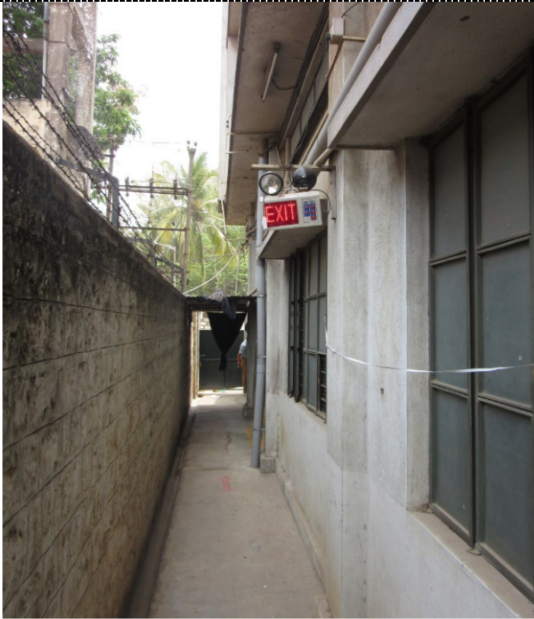
Figure xx Narrow external corridor with windows unprotected from inside (eg. Exit routes outside to place of safety)		Figure xx Each figure to have brief descriptive title

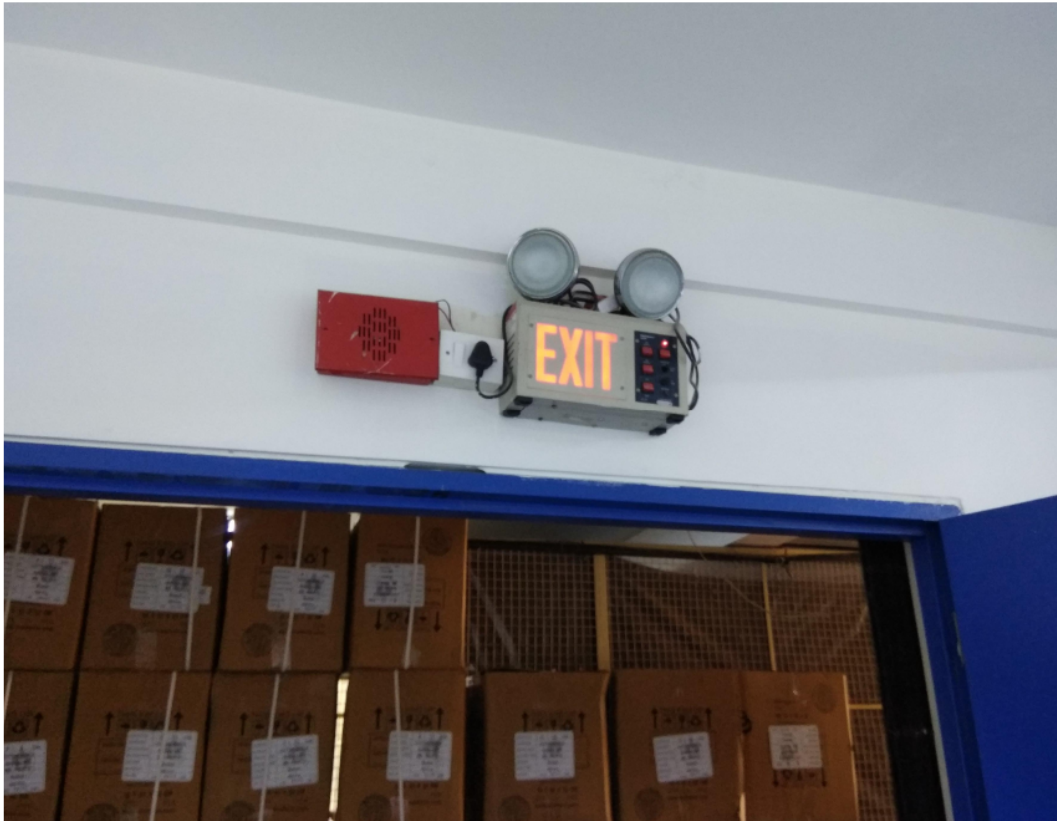
Figure N Emergency Lighting

Emergency lighting throughout consisted of twin spot fittings mounted above doorways and final exits.

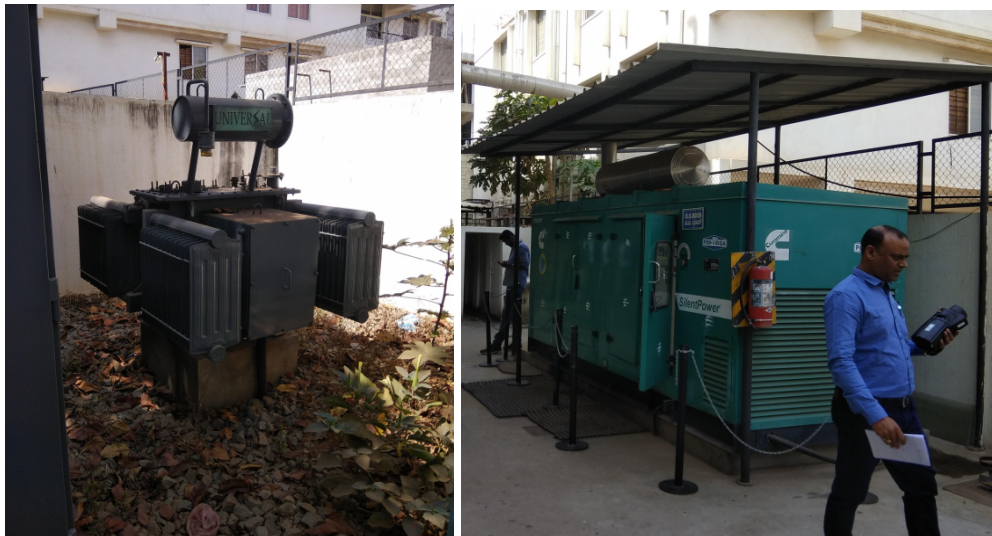
Figure N 250kVA Transformer and 200kVA DG set.

Power enters the site via 11kV overhead BESCOM supply which is connected to a tapping pole and 250kVA oil type transformer located outside boundary wall. The step-down voltage of 433V connected to Main LT Panel located on ground floor.

One standby diesel generators of 200kVA is located on ground floor adjacent to the main LT panel room, the diesel is stored near to DG cabinet. The starting of DG is manual. 200kVA oil cooled voltage stabiliser is connected at the output side of transformer.
