LABS Initiative

Methodology for Preliminary Safety Assessments in Vietnam

256287-00

Issue 3 | 29 October 2018

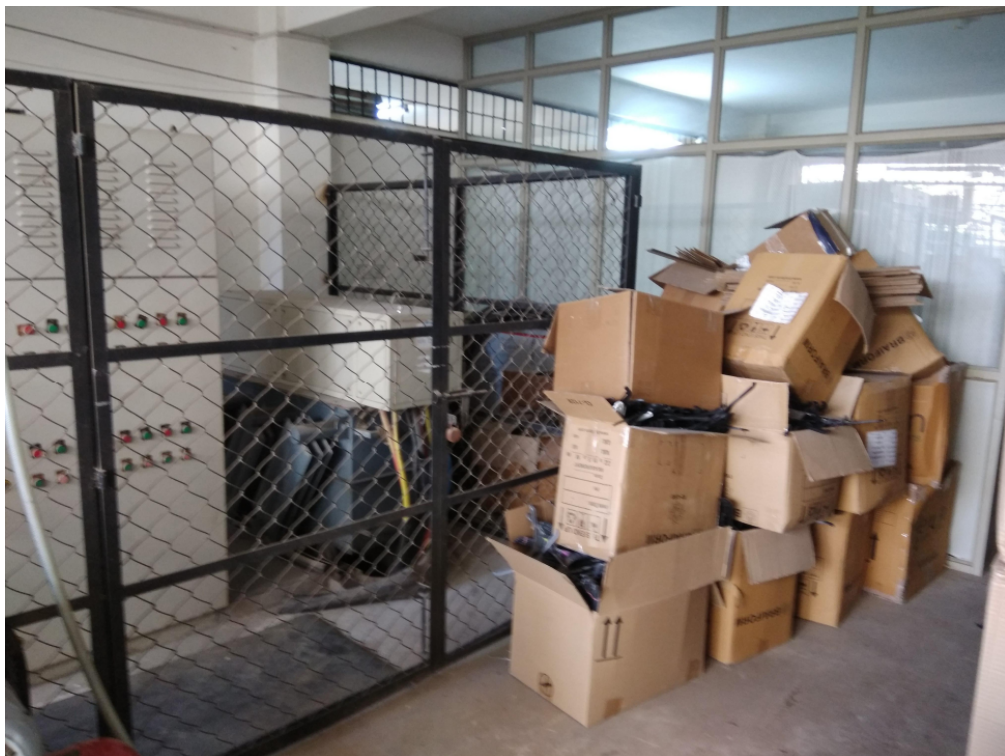
Ref No.	Issue Type	Sub-header
ELEC-n	E5 : Distribution	Combustible/flammable materials present
Observations: Combustible material storage next to the main LT panel room metal fence.

Figure N Storage of combustible material near main LY panel metal fencing.

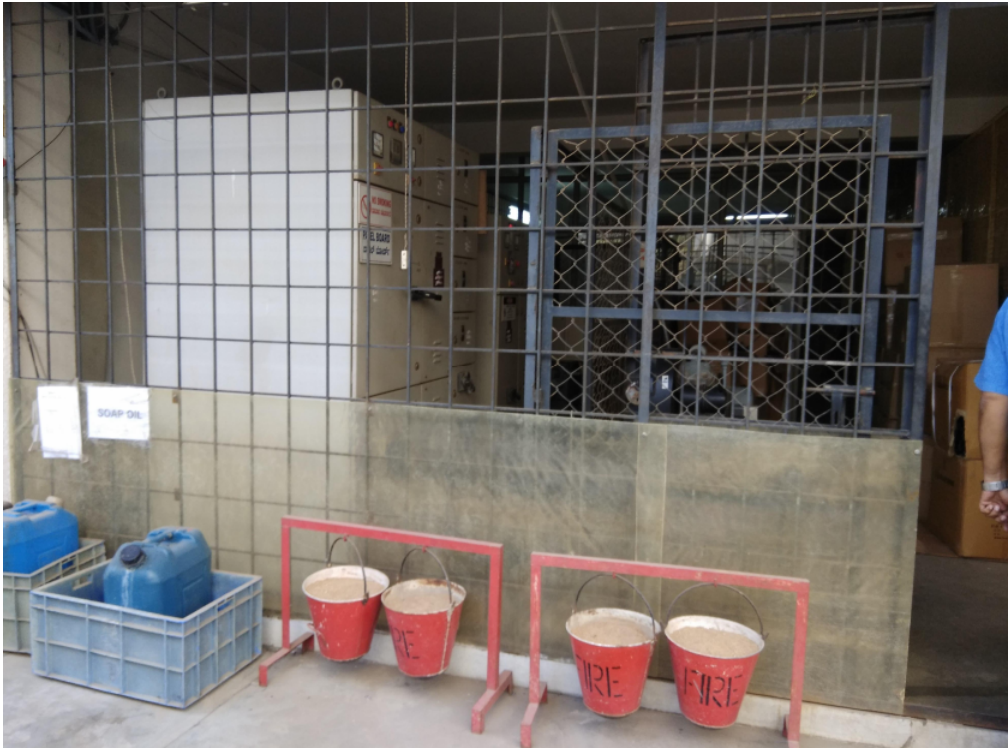
Ref No.	Issue Type	Sub-Header
ELEC – n+1	E5 : Distribution	Inadequate protection against direct contact
Observations: Exposed main electrical panel room to external weather condition.

Figure N Exposed main Electrical panels

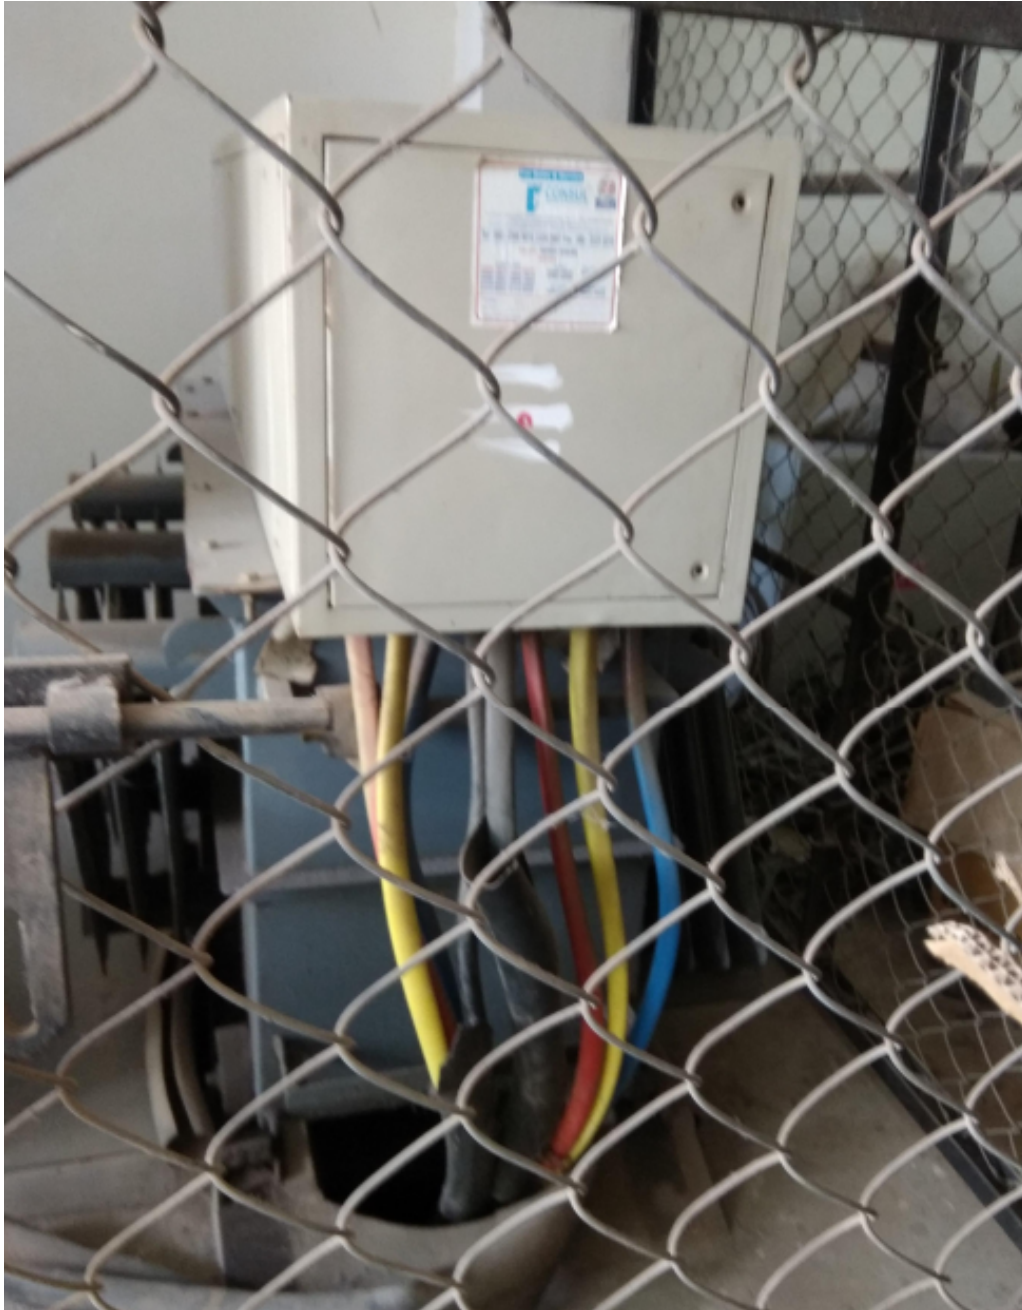
Observations: Cables are terminated without fixing of cable armour into the gland, there is no other insulation available on outer sheet.

Figure N Improper termination of cables.

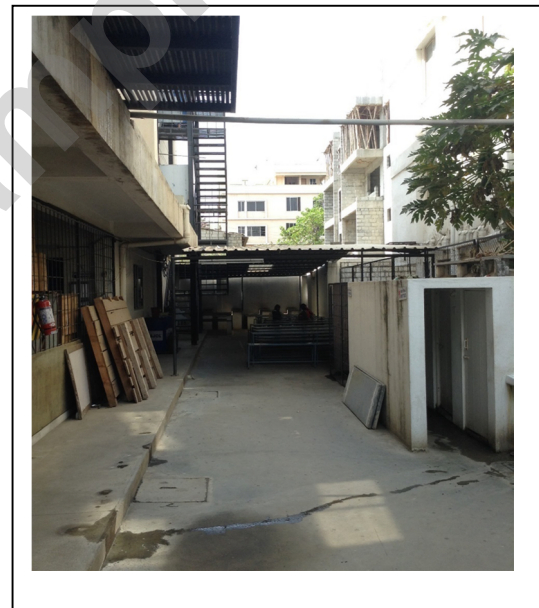
Figure 6 West Elevation with
covered canteen to south of building

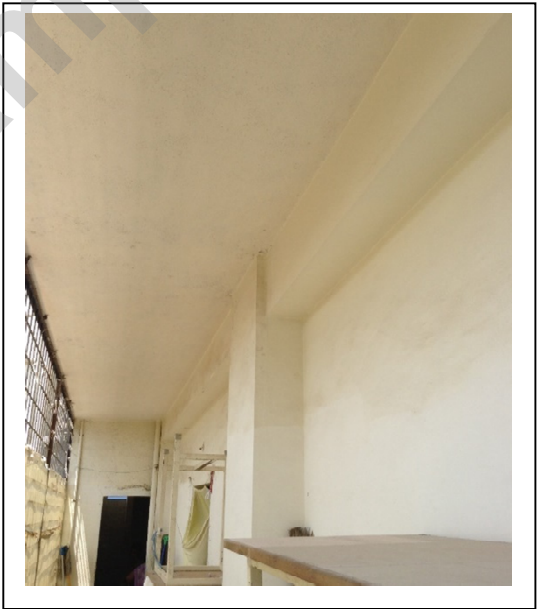
Figure 9 Typical slab cantilever to south elevation – 1.5m cantilever

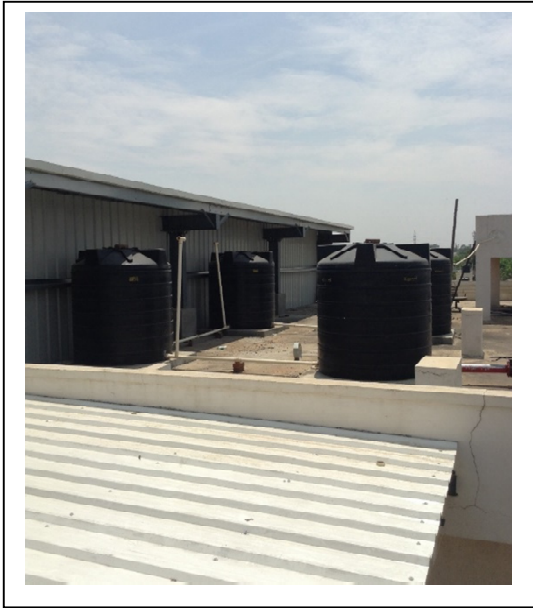
Figure 10 Water tanks on terrace – 4 no. 3000l tanks and 2 no. 2000l tanks

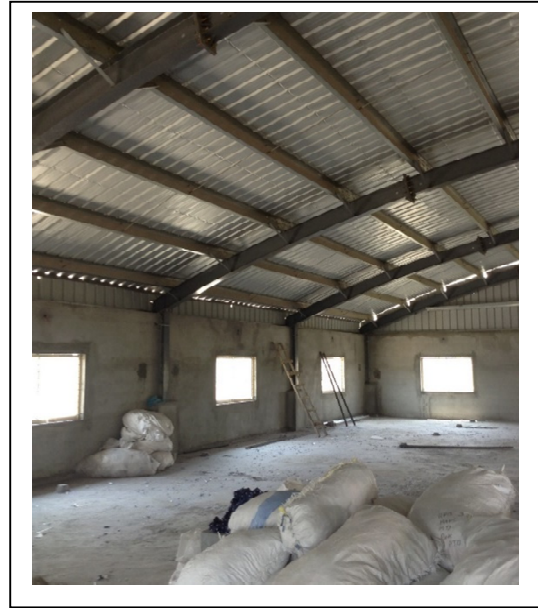
Figure 11 Additional steel structure on 4th floor

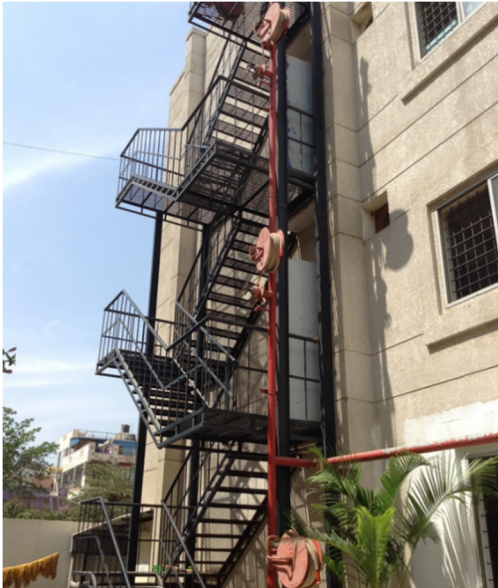
Ref No.	STRUC-1
Observations: External steel staircases are apparently non –engineered and are poorly laterally restrained to the main building

Figure 12 Part of staircase is cantilevered. No bracing in either steel staircase.

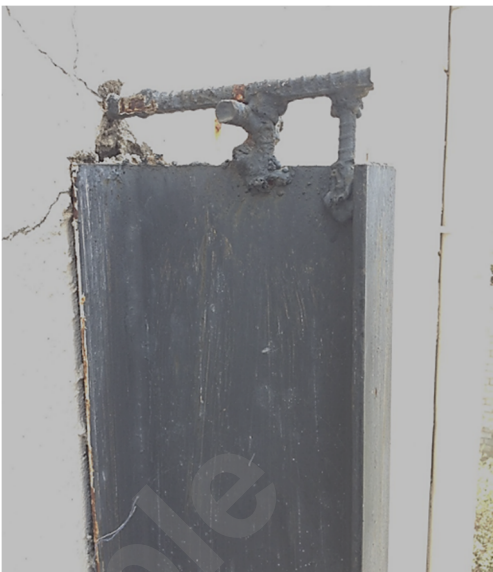
Figure 13 Stairs poorly restrained to main building

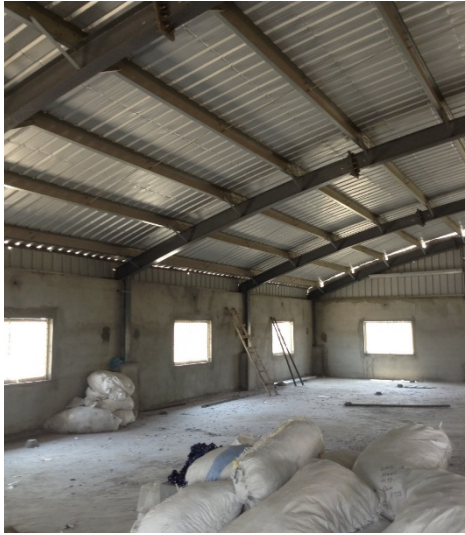
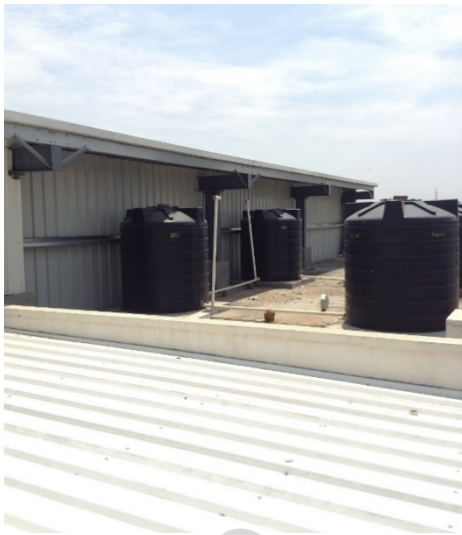
Ref No.	STRUC-2
Observations: New storage area at roof level – it is not clear that the existing roof slab has been designed for this condition

Figure 14 Construction of the storage area in progress on the terrace which shall add load on the terrace.

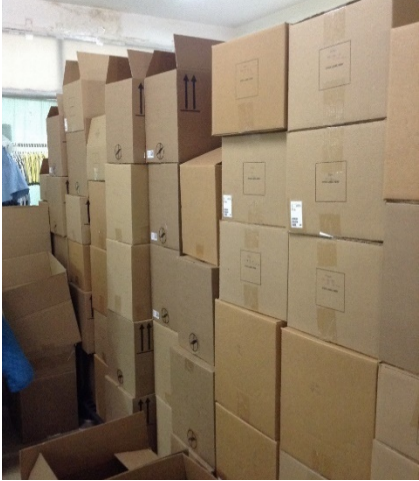
Ref No.	STRUC-3
Observations: Uncontrolled storage in areas of the factory - no safe loads plan posted in the factory

Figure 16 Storage area on 1st floor

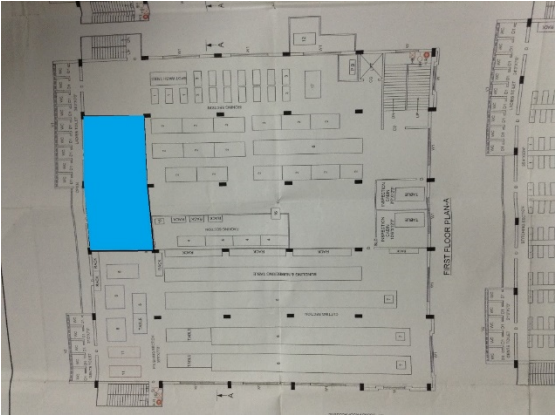
Figure 17 Storage area on 1st floor level highlighted in blue

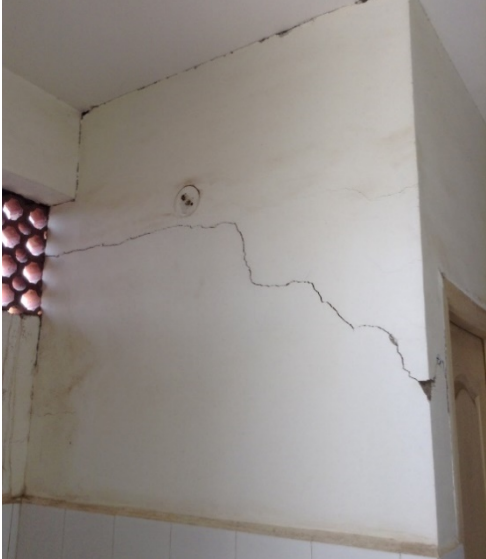
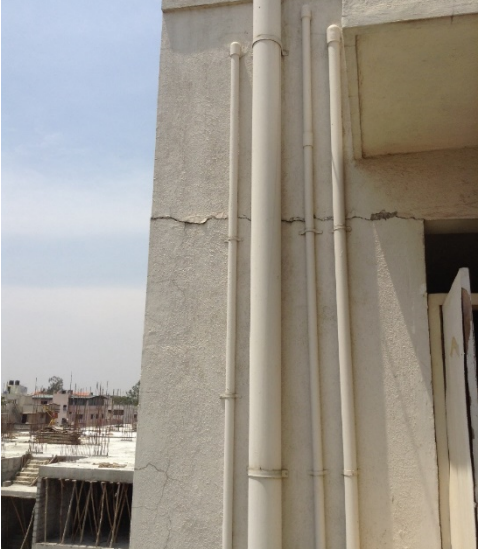
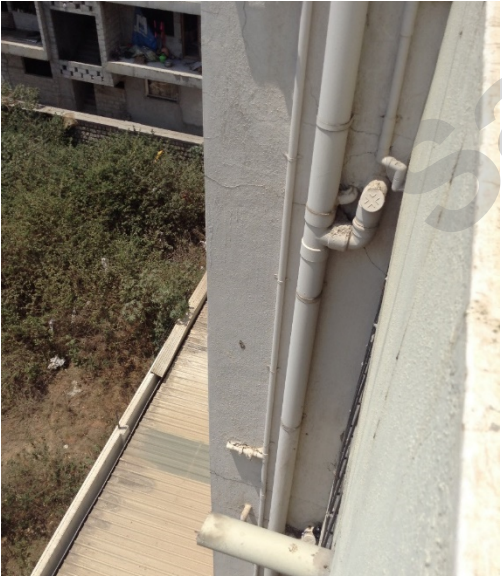
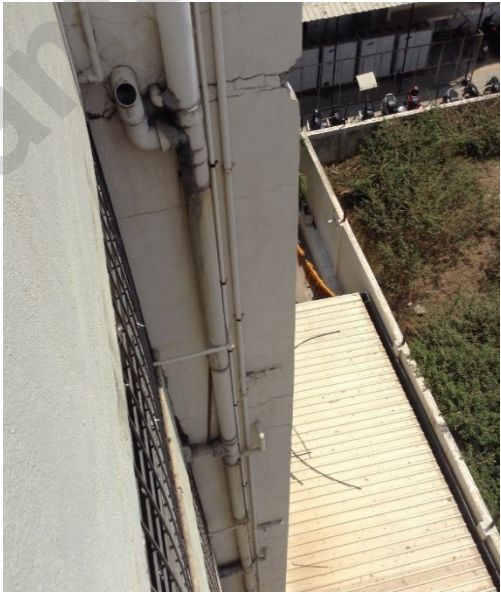
Ref No.	STRUC-4
Observations: Extensive cracking to non-structural masonry walls on cantilever portions of structure to south elevation

Figure 19 Cracks in cantilever area at floor levels

Figure 20 Cracks in cantilever at floor levels

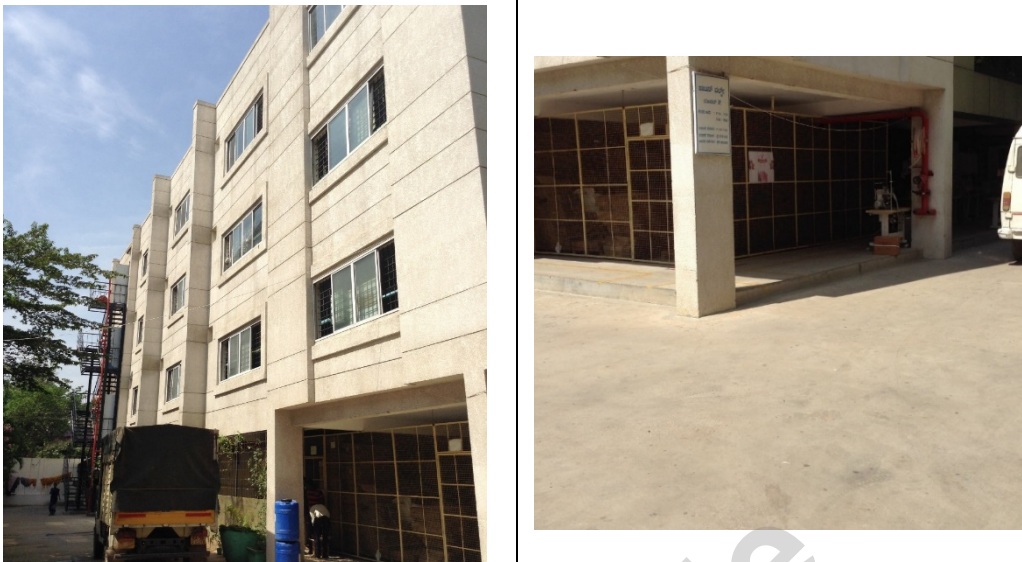
Ref No.	STRUC-5
Observations: Columns at the north east corner of the building adjacent near entrance gate are in danger of being accidentally hit by vehicles entering/ leaving the facility.

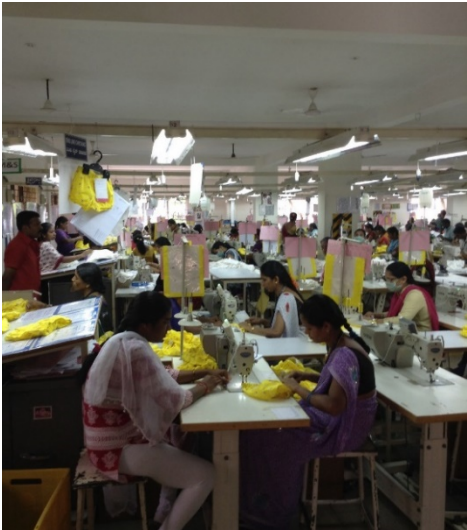
Ref No.	STRUC-6
Observations: No structural drawings available.

Figure 24 Structural drawings not available

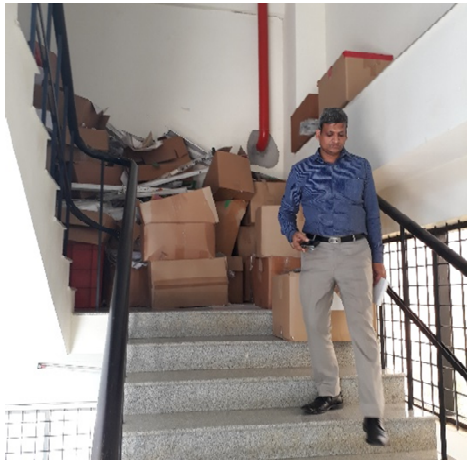
Figure 10 Evacuation pathways obstructed by uncontrolled storage

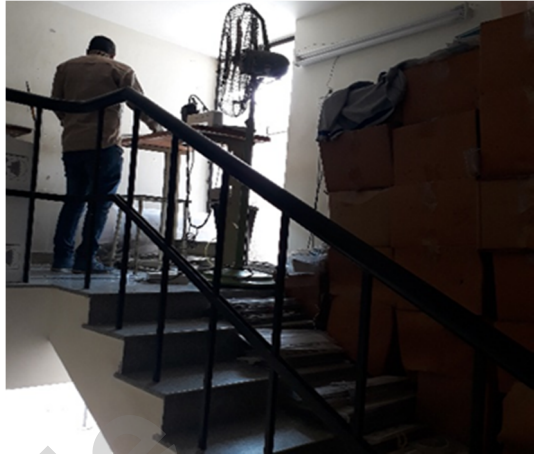
Figure 11 Evacuation pathways obstructed by uncontrolled storage

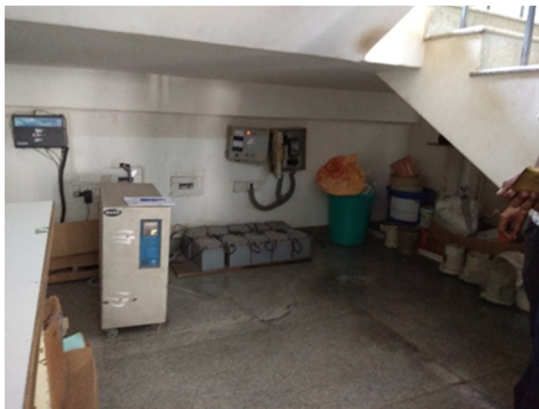
Location	Description
1 st Floor	Storage in racks adjacent to cutting tables, 'in-process' storage area approximately 32m ² .
Under NW Stair, Ground Floor	Under stair flights, UPS battery and other paper storage
Electrical HV room, Ground Floor	Material, waste storage near Electrical Panel room.

Figure 12 UPS and back-up batteries stored under NW Stair flight

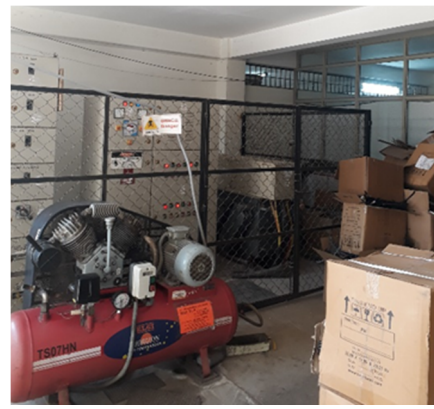
Figure 13 Carton box stored near HV Electrical Room

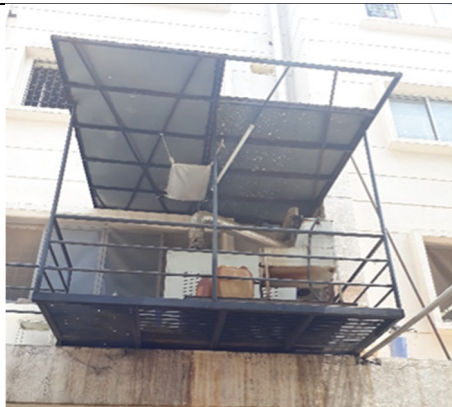
Installation	Type	Location	Separated from Production Area	Separated from Exit Path
Generator	Diesel, with day storage of fuel	Outside the main building, but on the escape path way	Yes	No
Boiler	Electric	1 st Floor ledge, near window to production area	No	No
Transformer	Electric	External Oil Cooled Transformer	Yes	Yes
Compressor	Diesel	Adjacent discharge area of SW Stair	No	No
Chemicals Storage	N-A	N-A	N-A	N-a

Figure 14 Boiler on ledge 1st Floor next to production area window

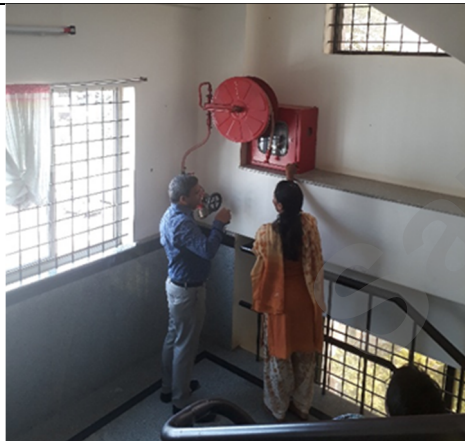
Internal hydrant outlets at SE and NW Stair landings
Internal Hose reels	Hose reels provided together with internal hydrant outlets at SE and NW Stair landings
Handheld Fire Extinguishers (HHFE)	Provided, but number of extinguishers seems deficient
Automatic suppression system	Sprinkler provision partially in store room on ground floor. There is no stand-by pump set to pump the water to the roof tanks should the existing submersible pump fail. The water storage on the roof is insufficient to provide sprinkler water should the submersible pump fail, so a back-up is required.
Smoke Ventilation	None
Access for Fire Fighting vehicles	Access to N and E façades of the building

Figure 16 Fire hydrant and hose reel at half landing, located at height

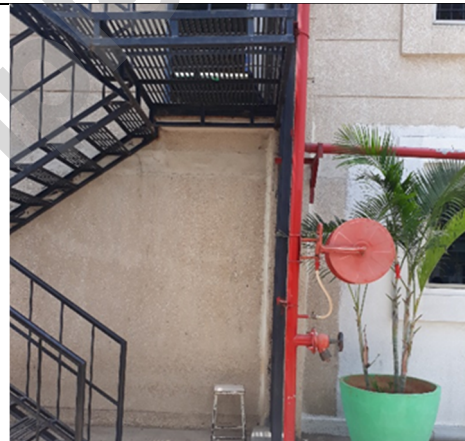
Figure 17 Hydrant connection and hosereel at discharge area SW Stair

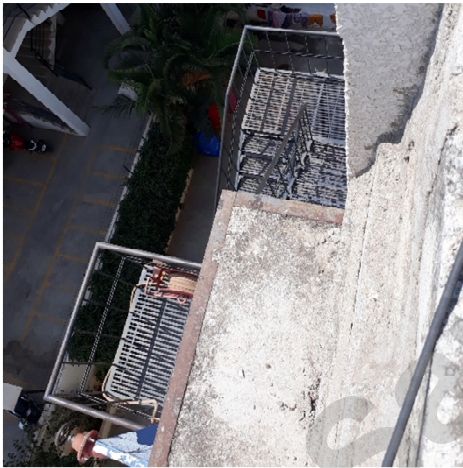
Ref No.	Issue Type	Sub-Issue Type
FIRE-1	Means of Escape	Floor Exits
Observation		
<p>Insufficient numbers of floor exits</p> <p>From fourth floor, there is only 1 exit staircase. The other two external staircase terminate at 3rd floor</p> <p>Public will be allowed up to the Showroom, and no alternative direction of escape from fourth floor.</p> <p>Travel distance exceeds allowed limits in LABS Standard for single means of escape.</p>

<p>Figure 18 SE Stair (external) up to 3rd Floor level</p>

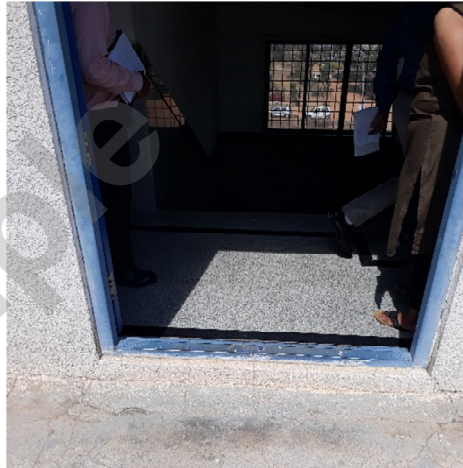
<p>Figure 19 Exit 3 from Roof level into NW Stair</p>

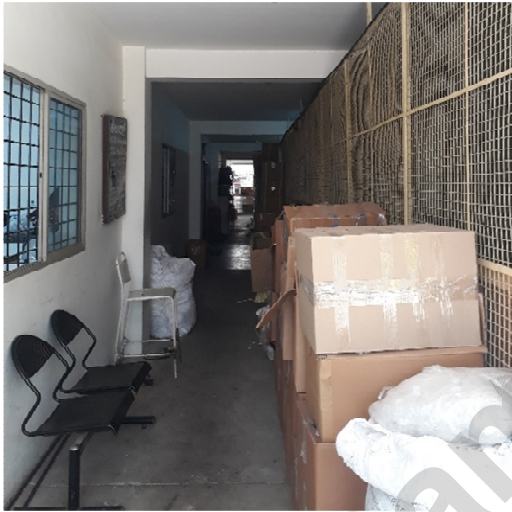
Ref No.	Issue Type	Sub-Issue Type
FIRE-2	Means of Escape	Escape Paths
Observation		
<p>Escape paths not free from temporary obstacles on ground floor Colouring area and Embroidery area.</p> <p>Uncontrolled storage obstructs the escape paths.</p> <p>Kitchen door opening blocks route from Canteen to Final Exit on SW side</p>

<p>Figure 20 Uncontrolled storage on escape path</p>

CAP Priority	Response	Issue Type	Company Plan Of Action
FP1	FIRE-2	F1: Means of Escape	Proper housekeeping needed in Ground floor storage room. Ensure pathways on exit routes clear of all temporary storage and other obstacles Change the Kitchen Door to open inwards or direct the people towards SE Stair Exit
FP1	FIRE-3	F1: Means of Escape	Replace doors with side hung doors that open in the direction of escape in accordance with Cl. 6.1, 6.3 and 6.9 of the LABS Standard. Replace outside locks with locking mechanisms that allow easy opening from inside without the use of a key in accordance with Cl. 6.1, 6.3 and 6.9 of the LABS Standard
FP1	FIRE-1	F1: Means of Escape	Extend one of the two external stairs(SE stair or SW Stair) up to 4th Floor level, and create an alternate escape path to the landing of this stair at 4th Floor level.
FP1	FIRE-16	F3: Fire Safety Systems	Provide a Fire Alarm activation linked to smoke detectors to comply with Cl. 5.9 of the LABS Standard

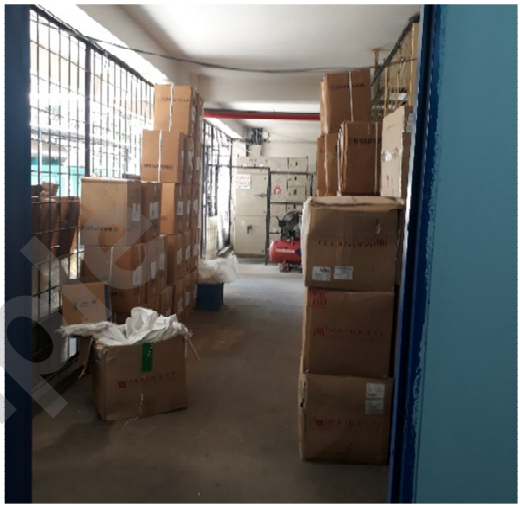
<p>Figure 21 Uncontrolled storage on escape path to Final Exit</p>

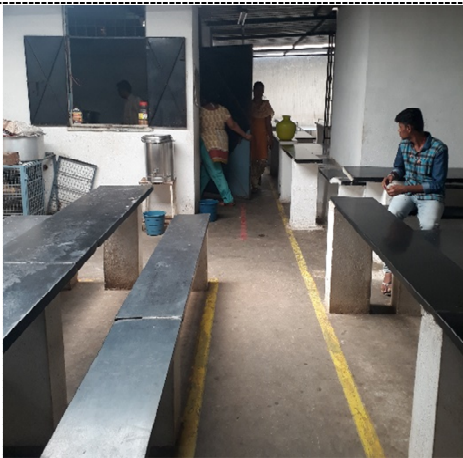
<p>Figure 22 Escape path through open Canteen obstructed by Kitchen door (in background)</p>

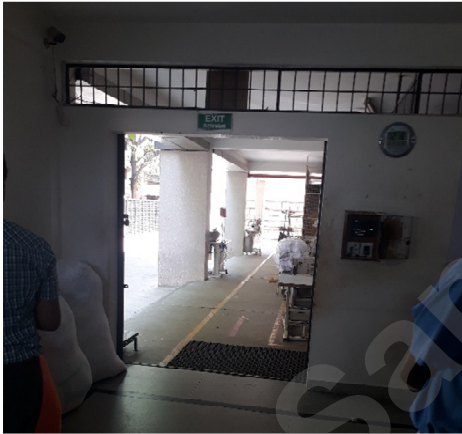
Ref No.	Issue Type	Sub-Issue Type
FIRE-3	Means of Escape	Exit Doors
Observation <p>Exit doors not side hung to swing correctly in direction of escape. Exit doors not always easily openable, doors have locking devices</p> <p>Sliding doors are located at the Final Exit from the NW Stair exiting on the N side and leading directly to the road outside, as well as on the Final Exit on the W side adjacent to the HV room leading into the narrow external escape corridor along the W face of the building.</p> <p>The Final Exit from the Crèche area also has a sliding door with locking device</p>

<p>Figure 23 Final Exit door from NW Stair lobby</p>

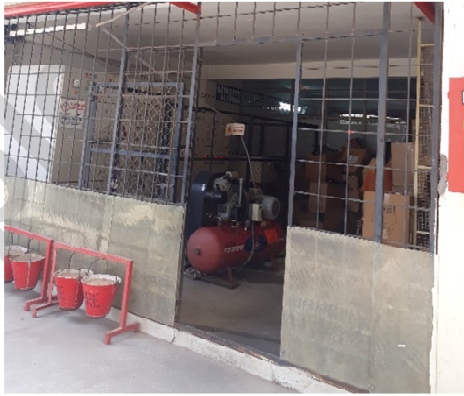
<p>Figure 24 Final Exit at HV and Compressor area adjacent to NW stair</p>

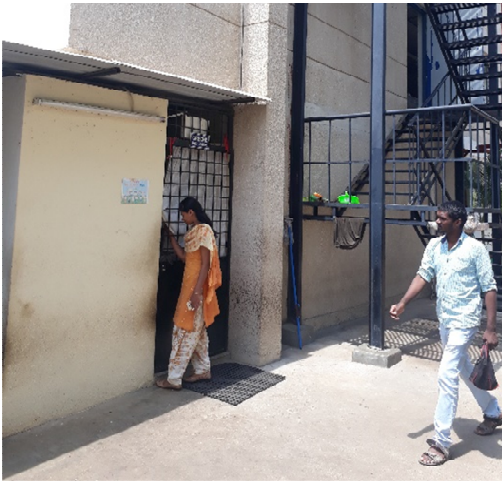
<p>Figure 25 Floor Exit door from Crèche adjacent to SE Stair</p>

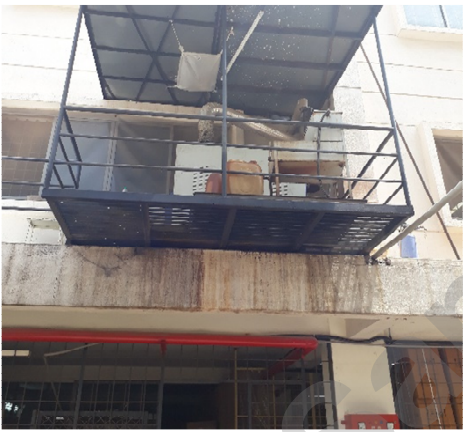
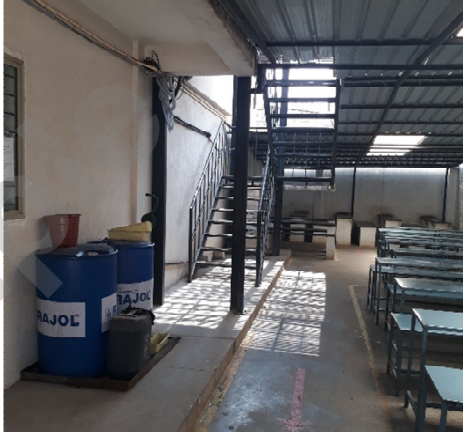
Ref No.	Issue Type	Sub-Issue Type
FIRE-4	Means of Escape	Final Exits
Observation		
<p>People not able to move safely away from the building directly on exiting to outside.</p> <p>Occupants exiting from the Final Exit from the Canteen in the SW corner of the building, and those discharging from the SW Stair, do not have a protected route along which to move away from the building.</p> <p>The route leads past unprotected fuel storage, the suspended Boiler and the diesel generator before exiting on the N side of the building.</p>

Figure 26 Boiler on escape path from Canteen and from SW stair		Figure 27 Fuel storage and canteen table in final means of escape

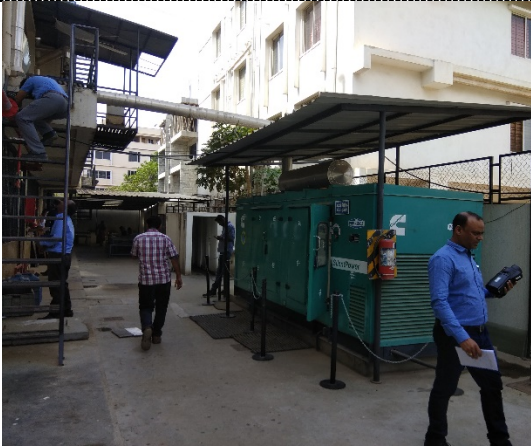
Figure 28 DG on escape path from Canteen and from SW stair

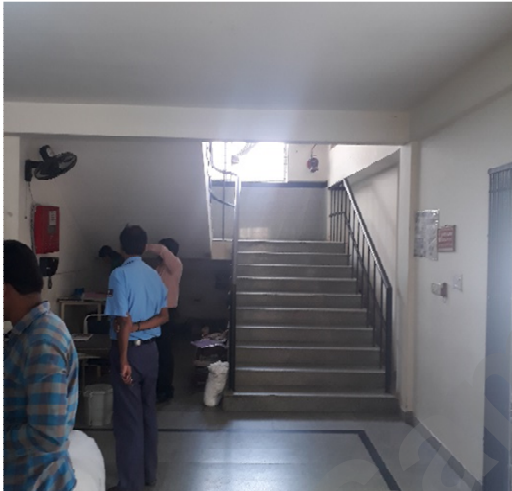
Ref No.	Issue Type	Sub-Issue Type
FIRE-5	Fire Protection- Construction	Protection of openings
Observation		
<p>Lack of enclosure of Stairs connecting more than 2 floors.</p> <p>The main NW Stair from 4th to Ground Floor levels is open to the accommodation it passes through at all levels, and discharges into a lobby on ground that is unprotected from the and production area on typical floor.</p>

Figure 29 NW Stair open to un protected lobby on ground and production area on typical floors above

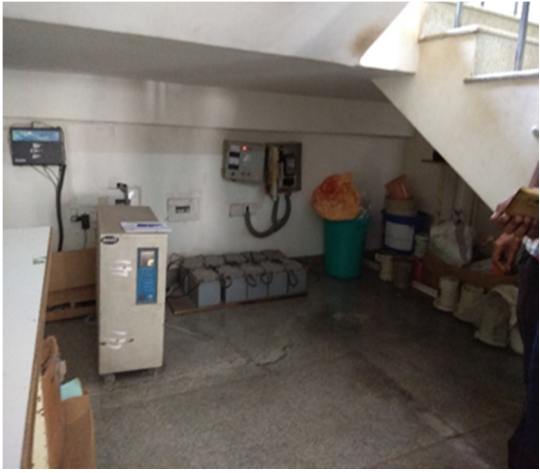
Ref No.	Issue Type	Sub-Issue Type
FIRE-6	Fire Protection- Construction	Protection of openings
Observation		
UPS and Storage under stair needs to be separated with a FR enclosure

<p>Figure 30 UPS and back-up batteries stored under NW Stair flight</p>

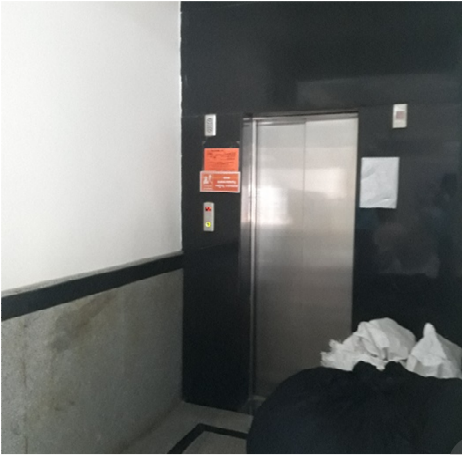
Ref No.	Issue Type	Sub-Issue Type
FIRE-8	Fire Protection - Construction	Protection of openings
Observation		
<p>Other vertical openings through compartment floors.</p> <p>The lift hoist rises from Ground through to 4th Floor with no fire rated enclosure, linking all these floors via a large vertical opening.</p>

<p>Figure 32 Lift at NW Stair between 4th and Ground Floor levels, open to lobby and production areas</p>

Sub Issue Detail	F2.1.6 No adequate fire rated separation of lifts shafts
Reference Number	FIRE-8
Details Of Issue Found	The lift hoist rises from Ground through to 4th Floor with no fire rated enclosure, linking all these floors via a large vertical opening. There is a penetration for electrical services passing through all floors without fire stopping
CAP Priority	FP2
Recommended Action Deadline Date	25 May 2018
Responsible Person	
Recommended Action	The elevator shaft to be enclosed with fire rated construction in accordance with Cl. 4.8 and 5.11 of the LABS Standard
Comments	
Photo(s)

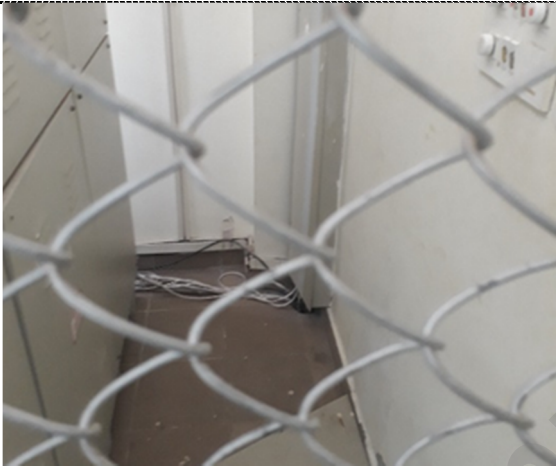
Ref No.	Issue Type	Sub-Issue Type
FIRE-9	Fire Protection - Construction	Protection of openings
Observation		
Other vertical openings through compartment floors.		
There is a penetration for electrical services passing through all floors without fire stopping

Figure 33 Service penetration from HV Electrical room on ground floor to LV rooms on all floor above up to 4 th floor

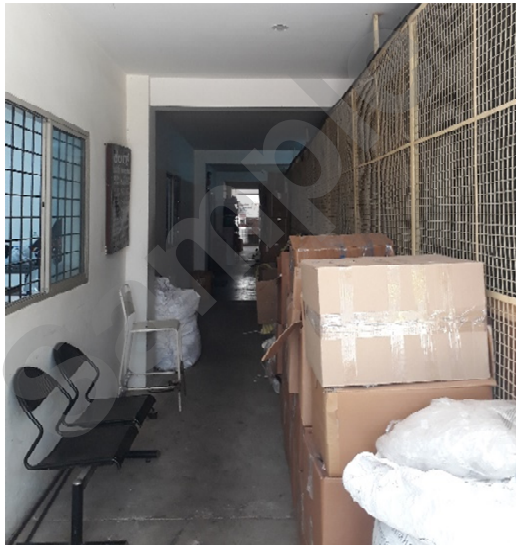
Ref No.	Issue Type	Sub-Issue Type
FIRE-10	Fire Protection - Construction	Storage areas
Observation		
<p>Designated storage areas not separated with FR construction</p> <p>The Storage area on 4th Floor is separated with fire rated construction from the Production area, but doors are not fire rated and self-closing.</p> <p>The Storage area at Ground Floor is not separated from other occupancies, and exceeds the permissible amount of non-sprinklered storage. Part of this area is covered by sprinklers, but this system does not meet LABS Standards requirements for sprinkler coverage.</p>

<p>Figure 34 Storage on Ground Floor without fire rated protection from the colouring area.</p>

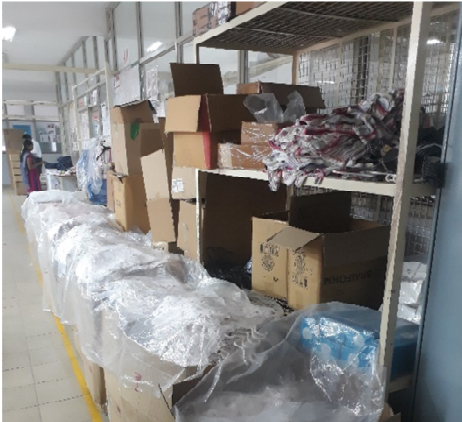
Ref No.	Issue Type	Sub-Issue Type
FIRE-11	Fire Protection - Construction	Storage areas
Observation		
<p>Excessive areas of 'in-process' storage open to production areas</p> <p>'In-process' storage on 1st Floor was seen to be in excess of the maximum allowable storage for open storage on non sprinklered floors. The approximate storage area was noted as 32m² in this area.</p>

<p>Figure 35 'In-process' storage on 1st Floor without fire rated separating wall from production floor.</p>

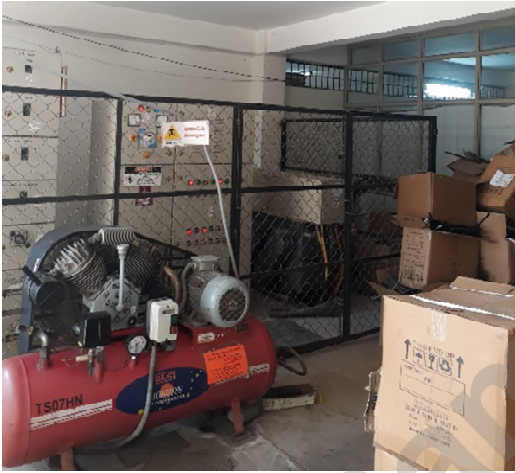
Ref No.	Issue Type	Sub-Issue Type
FIRE-12	Fire Protection - Construction	Other high risk areas
Observation		
HV and Compressor enclosure inadequate.		
The HV Room and Compressor are open to production area at Ground Floor and located on escape path with no fire rated separation.

Figure 36 HV and compressor room open to production areas, escape paths.		Figure 37 HV and compressor room open to production areas, escape paths

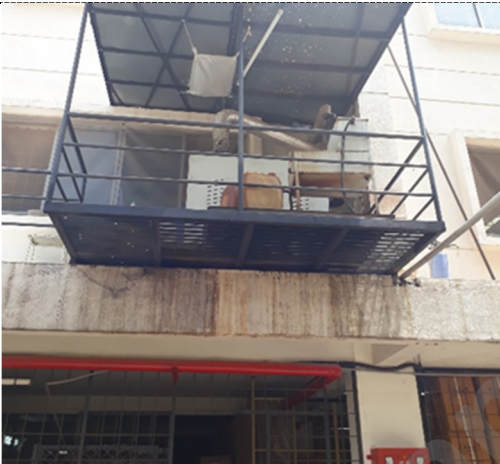
Ref No.	Issue Type	Sub-Issue Type
FIRE-13	Fire Protection - Construction	Other high risk areas
Observation		
<p>Boiler enclosure inadequate.</p> <p>The Boiler is open to the production area at 1st Floor level and exposed to the exterior exit route along the W side of the building as pointed out above.</p>

<p>Figure 38 Boiler located near windows that opens in production area</p>

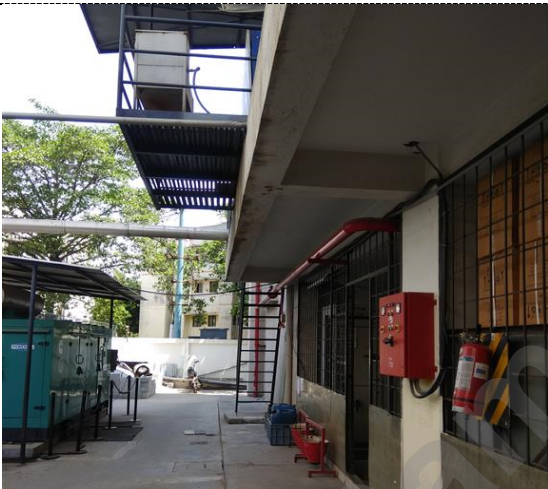
Ref No.	Issue Type	Sub-Issue Type
FIRE-14	Fire Protection - Construction	Other high risk areas
Observation		
<p>Generator enclosure inadequate.</p> <p>The Diesel Generator has no fire rated enclosure and is exposed to the exterior exit route along the W side of the building. There is restricted space to provide an enclosure and maintain enough workspace within the enclosure</p>

<p>Figure 39 DG and Boiler located on the exit path</p>

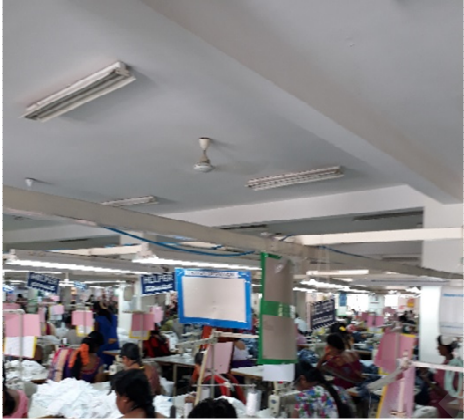
Ref No.	Issue Type	Sub-Issue Type
FIRE-15	Fire Safety Systems	Fire Detection
Observation		
<p>Inadequate Fire Detector coverage.</p> <p>Only one smoke detector per floor has been provided in production area on typical floors. No smoke detectors in Ground floor store area. All occupied as well as non-occupied spaces in the building should be covered with an automatic fire detection system.</p>

<p>Figure 40 Only 1 smoke detector provided in production area</p>

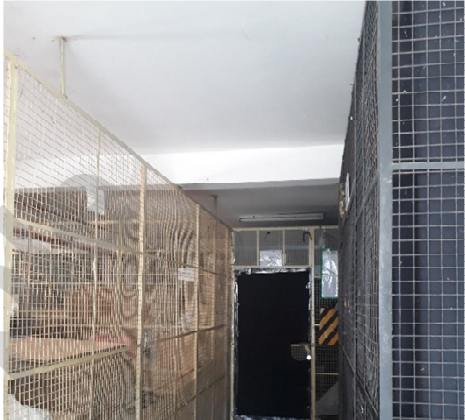
<p>Figure 41 No Smoke detection storage area on Ground floor</p>

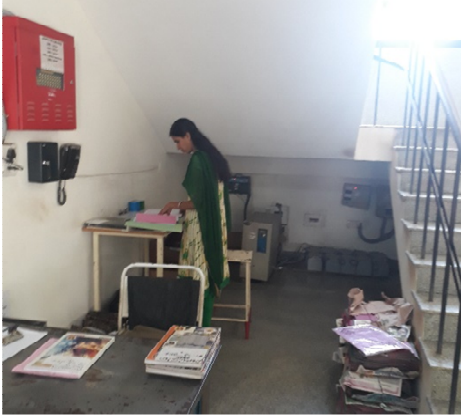
<p>Figure 42 Fire Alarm Panel at the main entrance of the building</p>

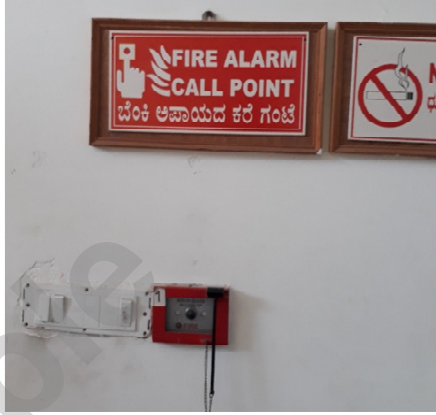
Ref No.	Issue Type	Sub-Issue Type
FIRE-16	Fire Safety Systems	Fire Alarms
Observation		
<p>Incorrect or no automatic Fire Alarm activation.</p> <p>Only manual alarm activation has been provided for most areas. Automatic activation of an alarm is required to give warning of a fire is detected anywhere in the building</p>

<p>Figure 43 Manual call point near LV Electrical Room on Typical floor</p>

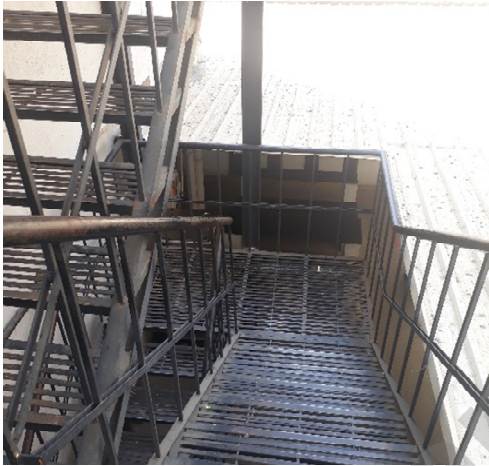
Ref No.	Issue Type	Sub-Issue Type
FIRE-17	Fire Safety Systems	Emergency Lighting
Observation		
<p>Insufficient Emergency Lighting for escape pathways.</p> <p>No emergency lighting is provided for the external SW Stairway and escape corridor down the W face of the building. The external stair has a gradient steeper than 45° and should have handrails both sides and good emergency lighting.</p>

<p>Figure 44 No Emergency Lighting provided on the external escape staircase</p>

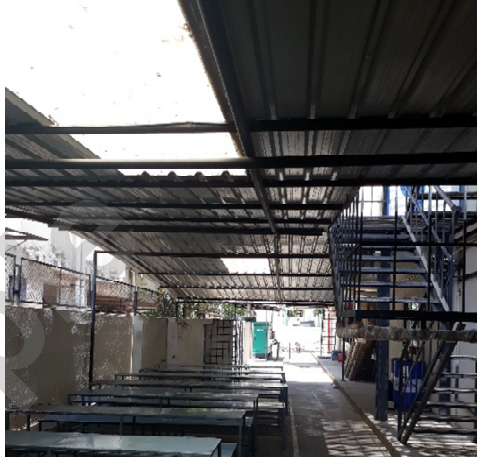
<p>Figure 45 No Emergency Lighting on the exterior periphery exit route</p>

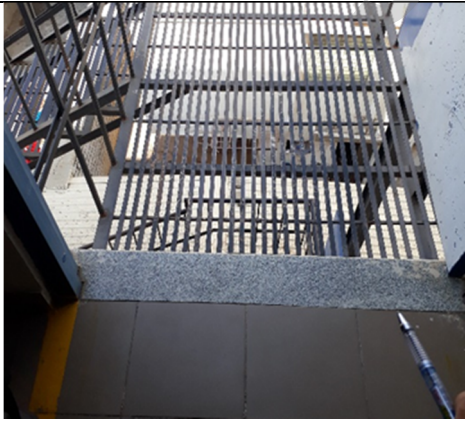
<p>Figure 46 External stair steeper than 45° and no Emergency Lighting provided</p>

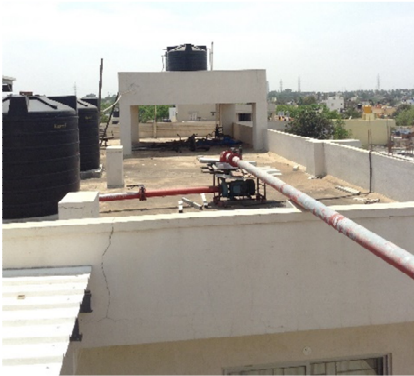
Ref No.	Issue Type	Sub-Issue Type
FIRE-18	Provisions for Fire Fighting	Fire Safety Systems
Observation		
<p>Inadequate water pump-set and/or standby pump</p> <p>There is no stand-by pump set to pump the water to the roof tanks should the existing submersible pump fail. The water storage on the roof is insufficient to provide firefighting water should the submersible pump fail, so a back-up is required.</p>

<p>Figure 47 Fire Tank and Pump on roof</p>

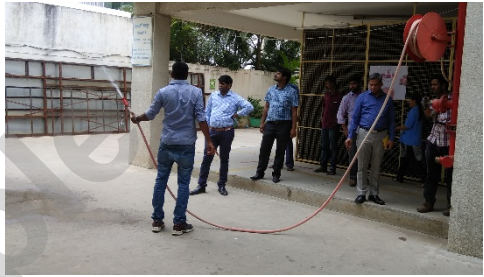
<p>Figure 48 Not enough pressure in hose reel without pump and pump is not automatic.</p>

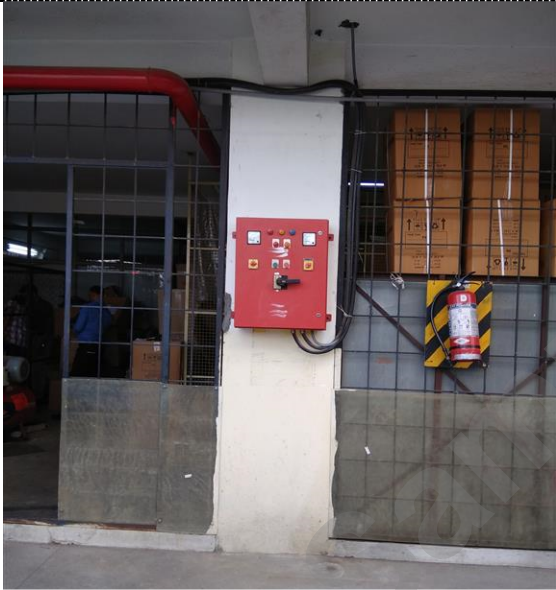
Ref No.	Issue Type	Sub-Issue Type
FIRE-19	Provisions for Fire Fighting	Fire Safety Systems
Observation		
Insufficient portable fire extinguishers.		
The number and distribution of hand-held fire extinguishers appeared to be insufficient to comply with the LABS Standard requirements

Figure 49 Single fire extinguisher for this area, located on outside of the building

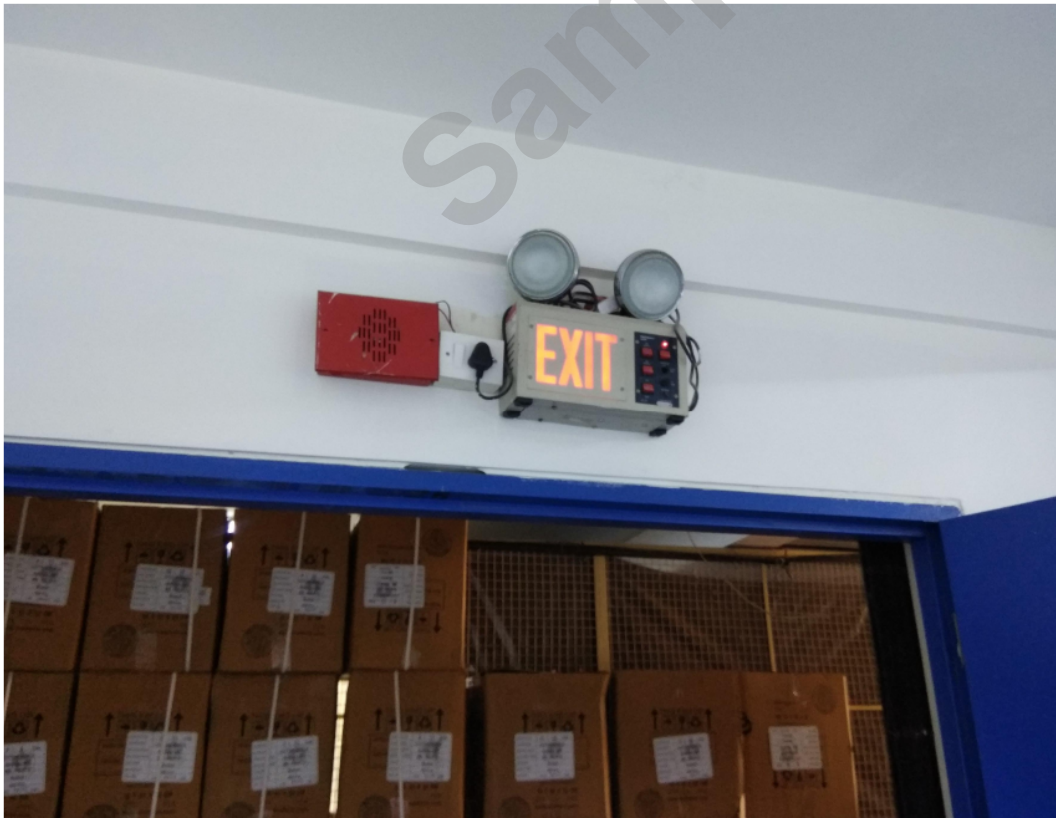
Emergency lighting throughout consisted of twin spot fittings mounted above doorways and final exits.

Figure 3 Emergency Lighting

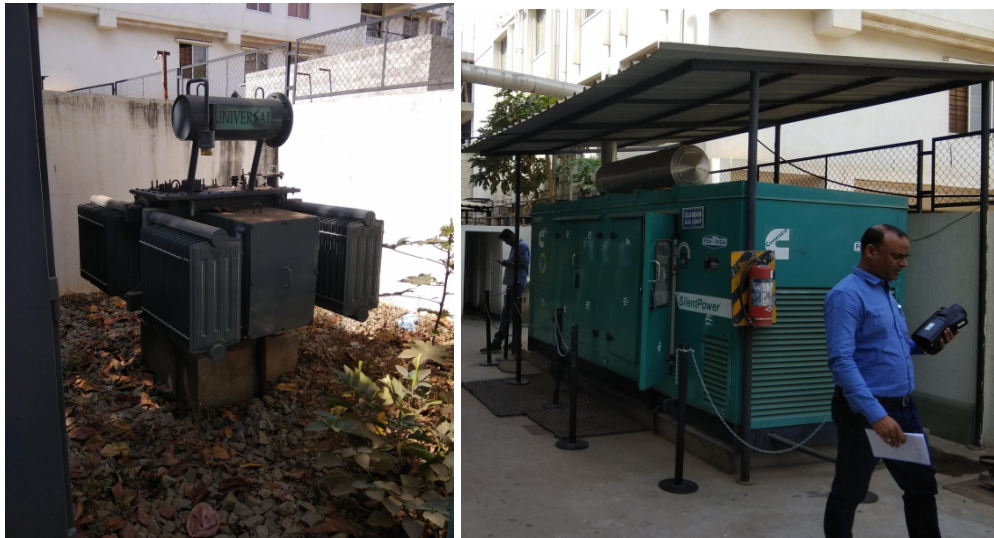
Power enters the site via 11kV overhead BESCOM supply which is connected to a tapping pole and 250kVA oil type transformer located outside boundary wall. The step-down voltage of 433V connected to Main LT Panel located on ground floor.

One standby diesel generators of 200kVA is located on ground floor adjacent to the main LT panel room, the diesel is stored near to DG cabinet. The starting of DG is manual. 200kVA oil cooled voltage stabiliser is connected at the output side of transformer.

Figure 4 250kVA Transformer and 200kVA DG set.

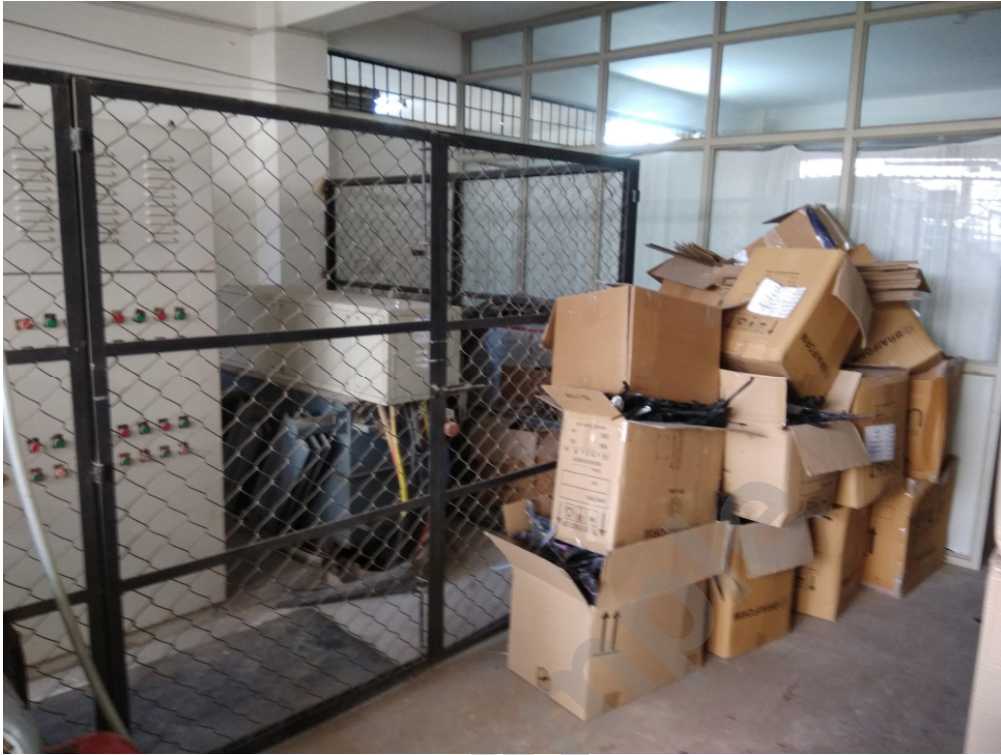
Ref No.	Issue Type	Sub-Issue Type
ELEC-1	E5 : Distribution	Combustible/flammable materials present
Observations: Combustible material storage next to the main LT panel room metal fence.

Figure 6 Storage of combustible material near main LY panel metal fencing.
