LABS Initiative

Methodology for Preliminary Safety Assessments in Vietnam

256287-00

Issue 3 | 29 October 2018

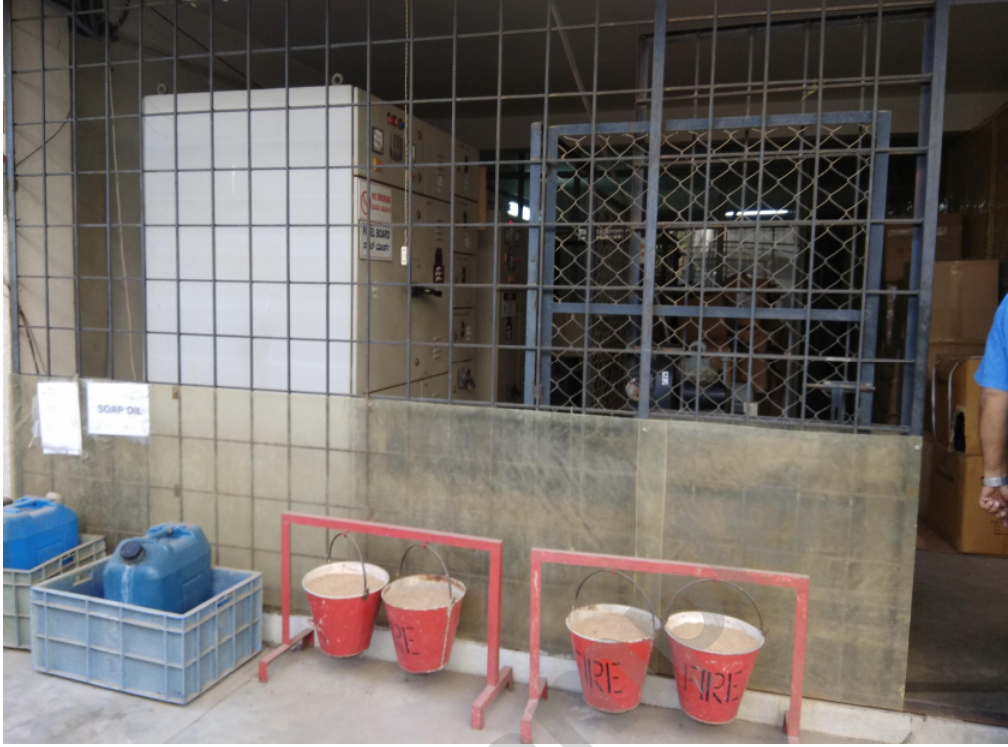
Ref No.	Issue Type	Sub-Header
ELEC-2	E5 : Distribution	Inadequate protection against direct contact
Observations: Exposed main electrical panel room to external weather condition.

Figure 7 Exposed main Electrical panels

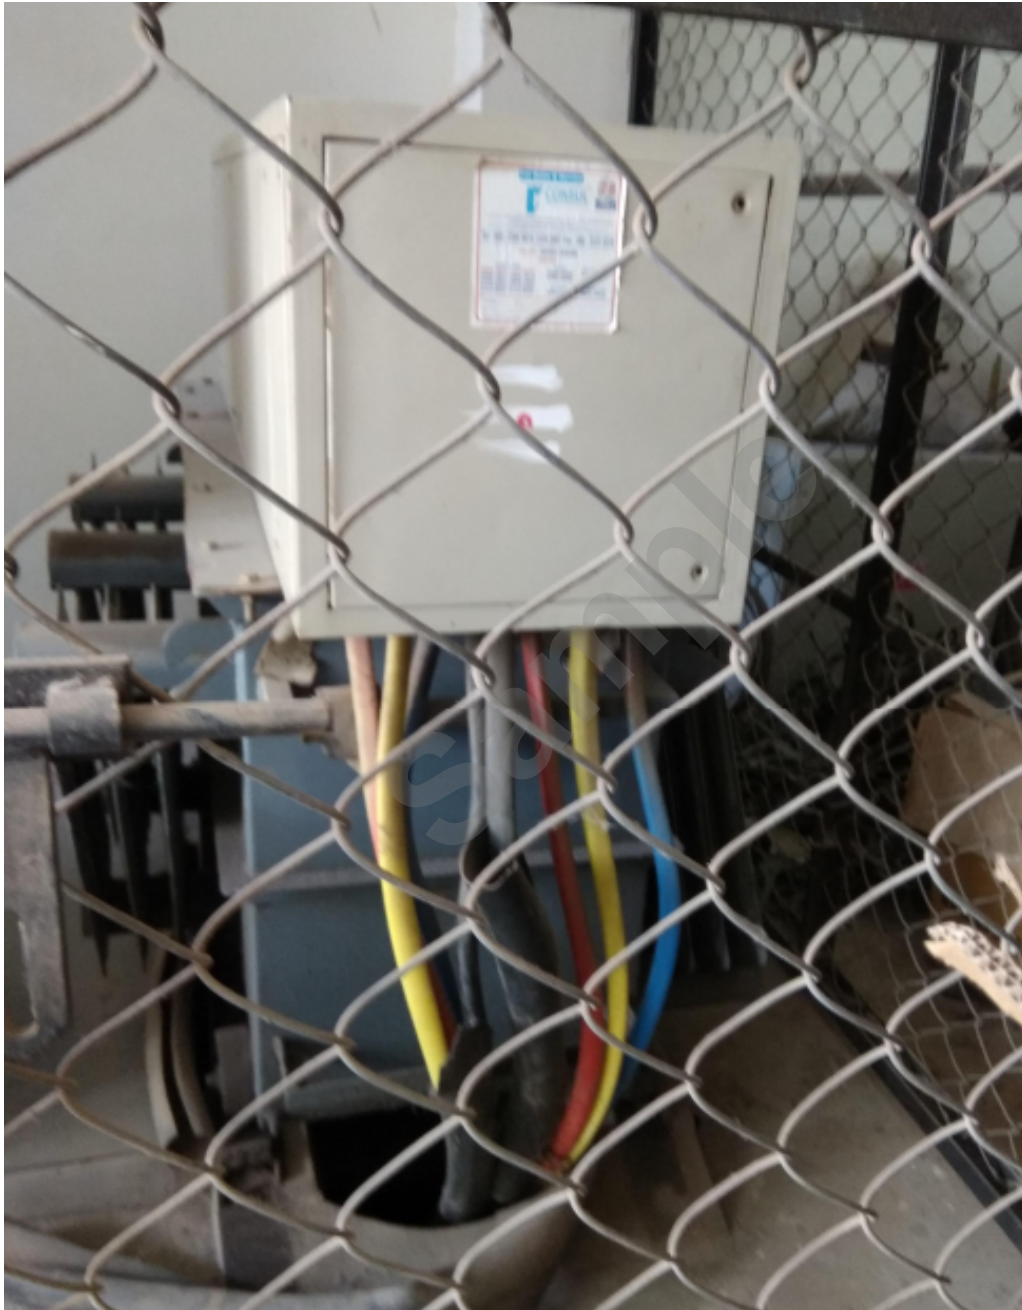
Observations: Cables are terminated without fixing of cable armour into the gland, there is no other insulation available on outer sheet.

Figure 8 Improper termination of cables.

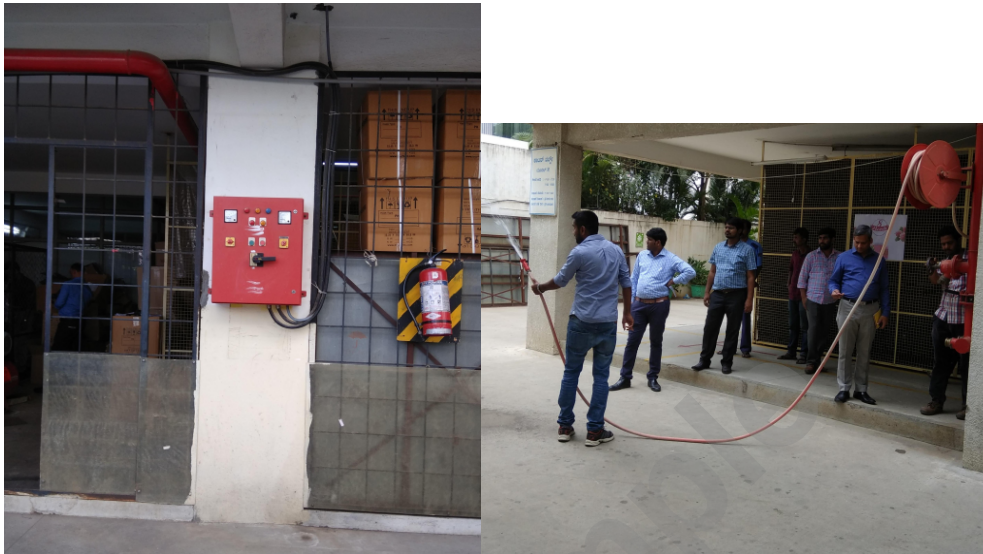
Observation: Manual fire pump connection. During the fire pump testing it was found that the pump was tripping due to lower setting of contactor. Later it was changed to higher setting and then pump started manually. The connection of fire pump panel is not updated on main SLD (single line diagram)

Figure 9 Manual operation of fire pump.

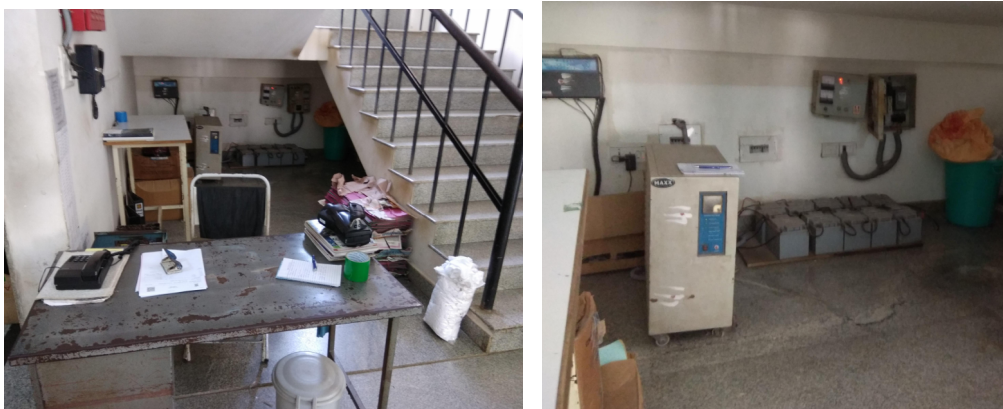
Observation: Life safety UPS kept under staircase and the batteries were stored on wooden ply. Improper human access to shown space.

Figure 10 improper keeping of life safety UPS and its batteries.

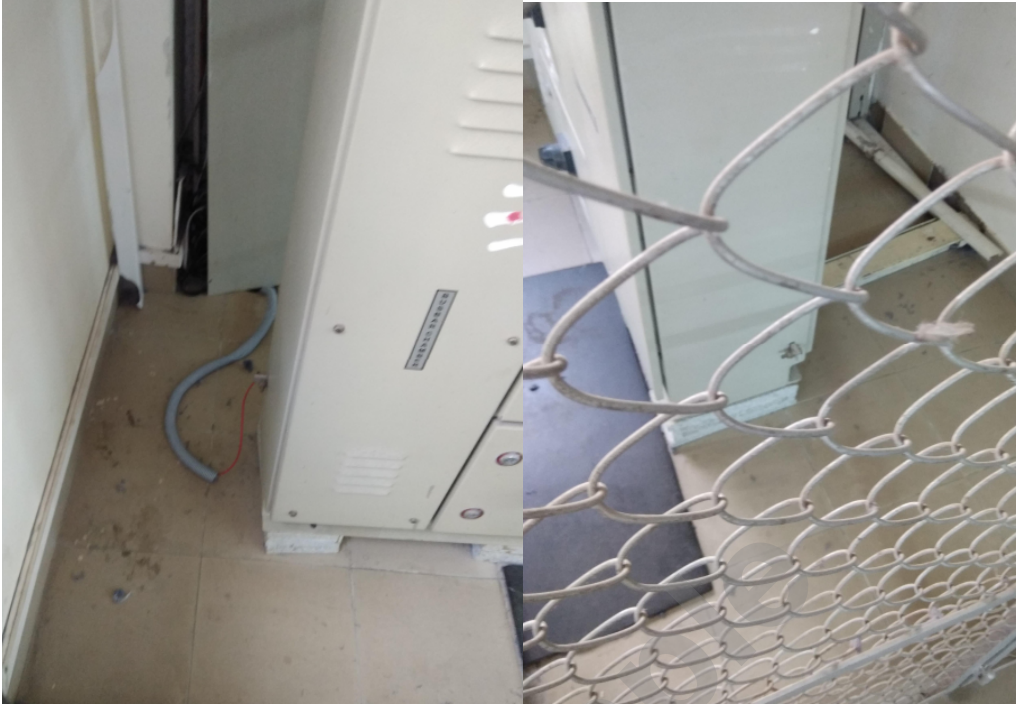
Ref No.	Issue Type	Sub-Header
ELEC-6	E2 : Earthing and Bonding	Insufficient bonding of equipment
Observation: Improper earthing connection and missing earthing connection to floor panel.

Figure 11 Improper and missing earthing connection.

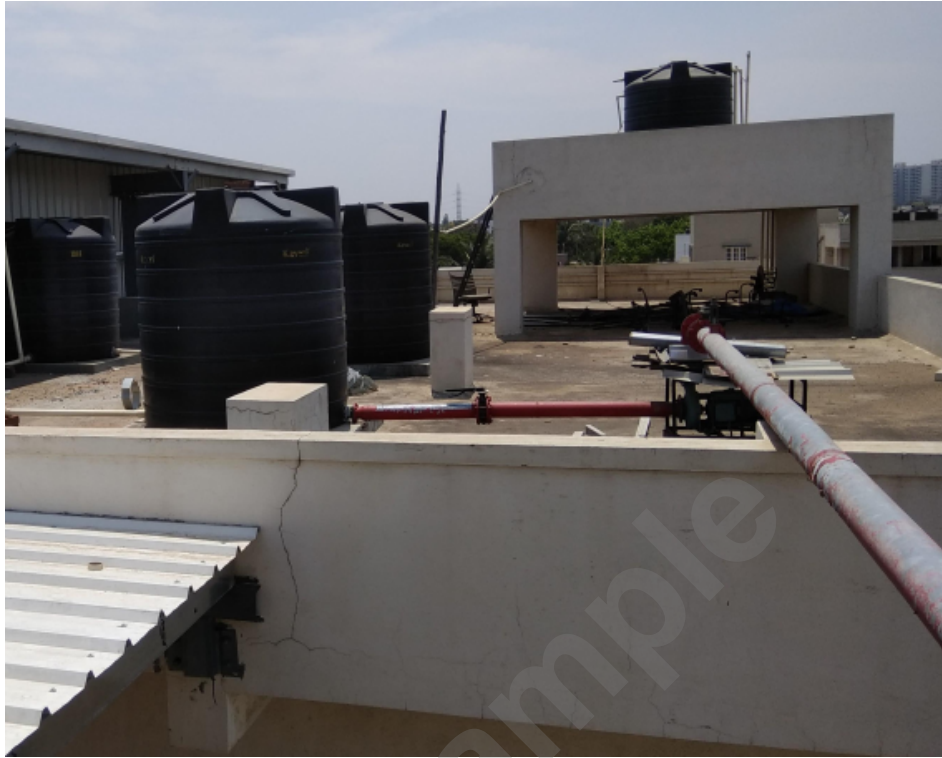
Observation: The fire pump location on terrace does not have any proper path for human access.

Figure 12 No proper human access to fire pump on terrace.

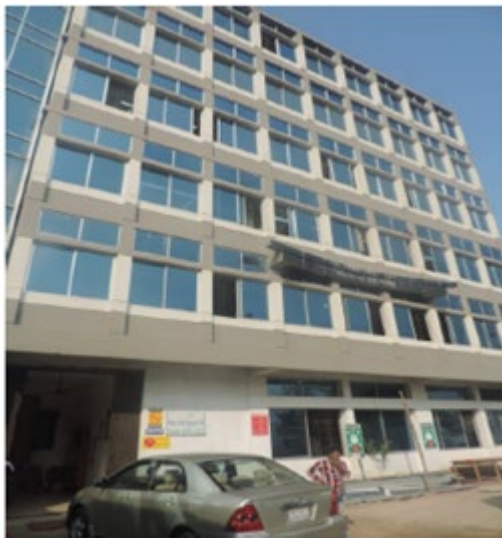
L1.1 C1 – Concrete Moment Resisting Frame

Concrete moment-resisting frame construction consists of concrete beams (or flat slabs) and columns that resist both lateral and vertical loads. There may be a few bays infilled with masonry, but if there is more extensive infill, it would be categorized as a C3 building type.

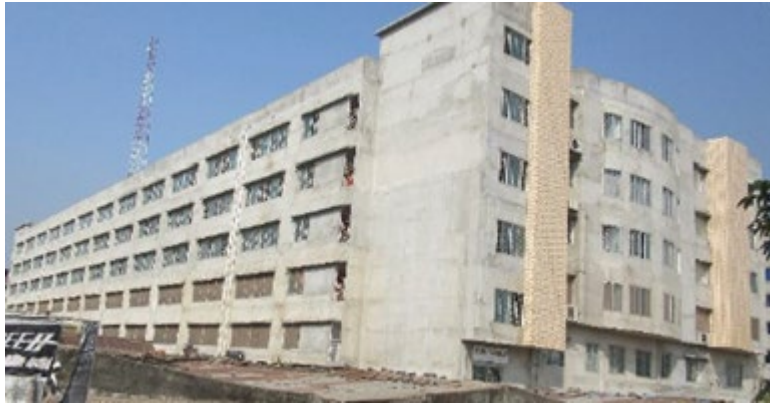
L1.2 C2 Concrete Shear Wall

Building primary lateral load resisting system consists of RC shear walls which are continuous from foundation to the top floor. Basement wall are not considered. The amount and distribution of the shear walls is proportional to the seismic demand. If the total section area of the shear walls are quite low (i.e. less %0.5 of the floor area) than it would be better to classify the building as C1 or C3.

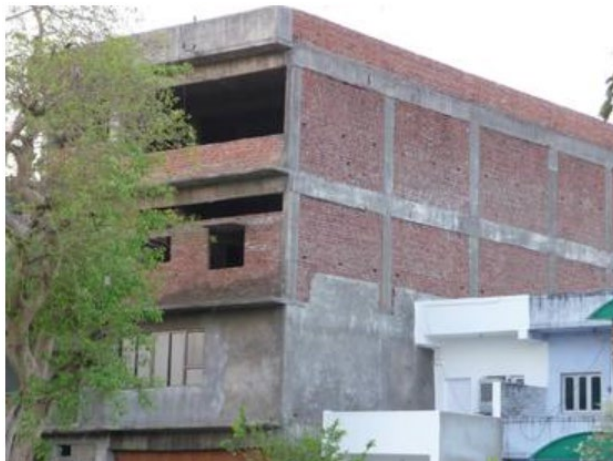
L1.3 C3 Concrete Frame with Unreinforced Masonry Infill

Concrete moment-resisting frame construction consists of concrete beams (or flat slabs) and columns with an infill masonry wall inline with the frames. If the perimeter infill masonry walls are as in below figure the buildings shall be classified in this category. Note that typically RC RMG buildings tend to have perimeter infill walls at the edge of the cantilever floor slabs i.e. outside of the column-beam interface, in this case the buildings shall be classified as C1.

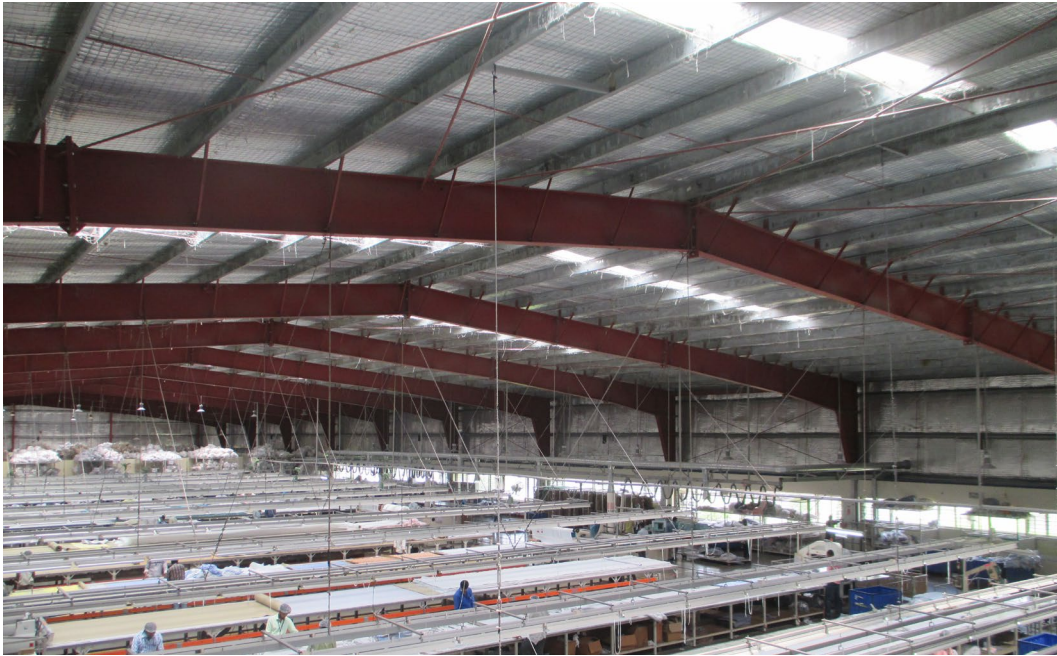
L1.4 S3 Steel Light Frame

They are typically one story in height typically one bay steel portal frame structures with or without interior columns, and often enclose a large floor area. Proper horizontal (roof level) and vertical bracing (longitudinal direction) is required to resist seismic loads.

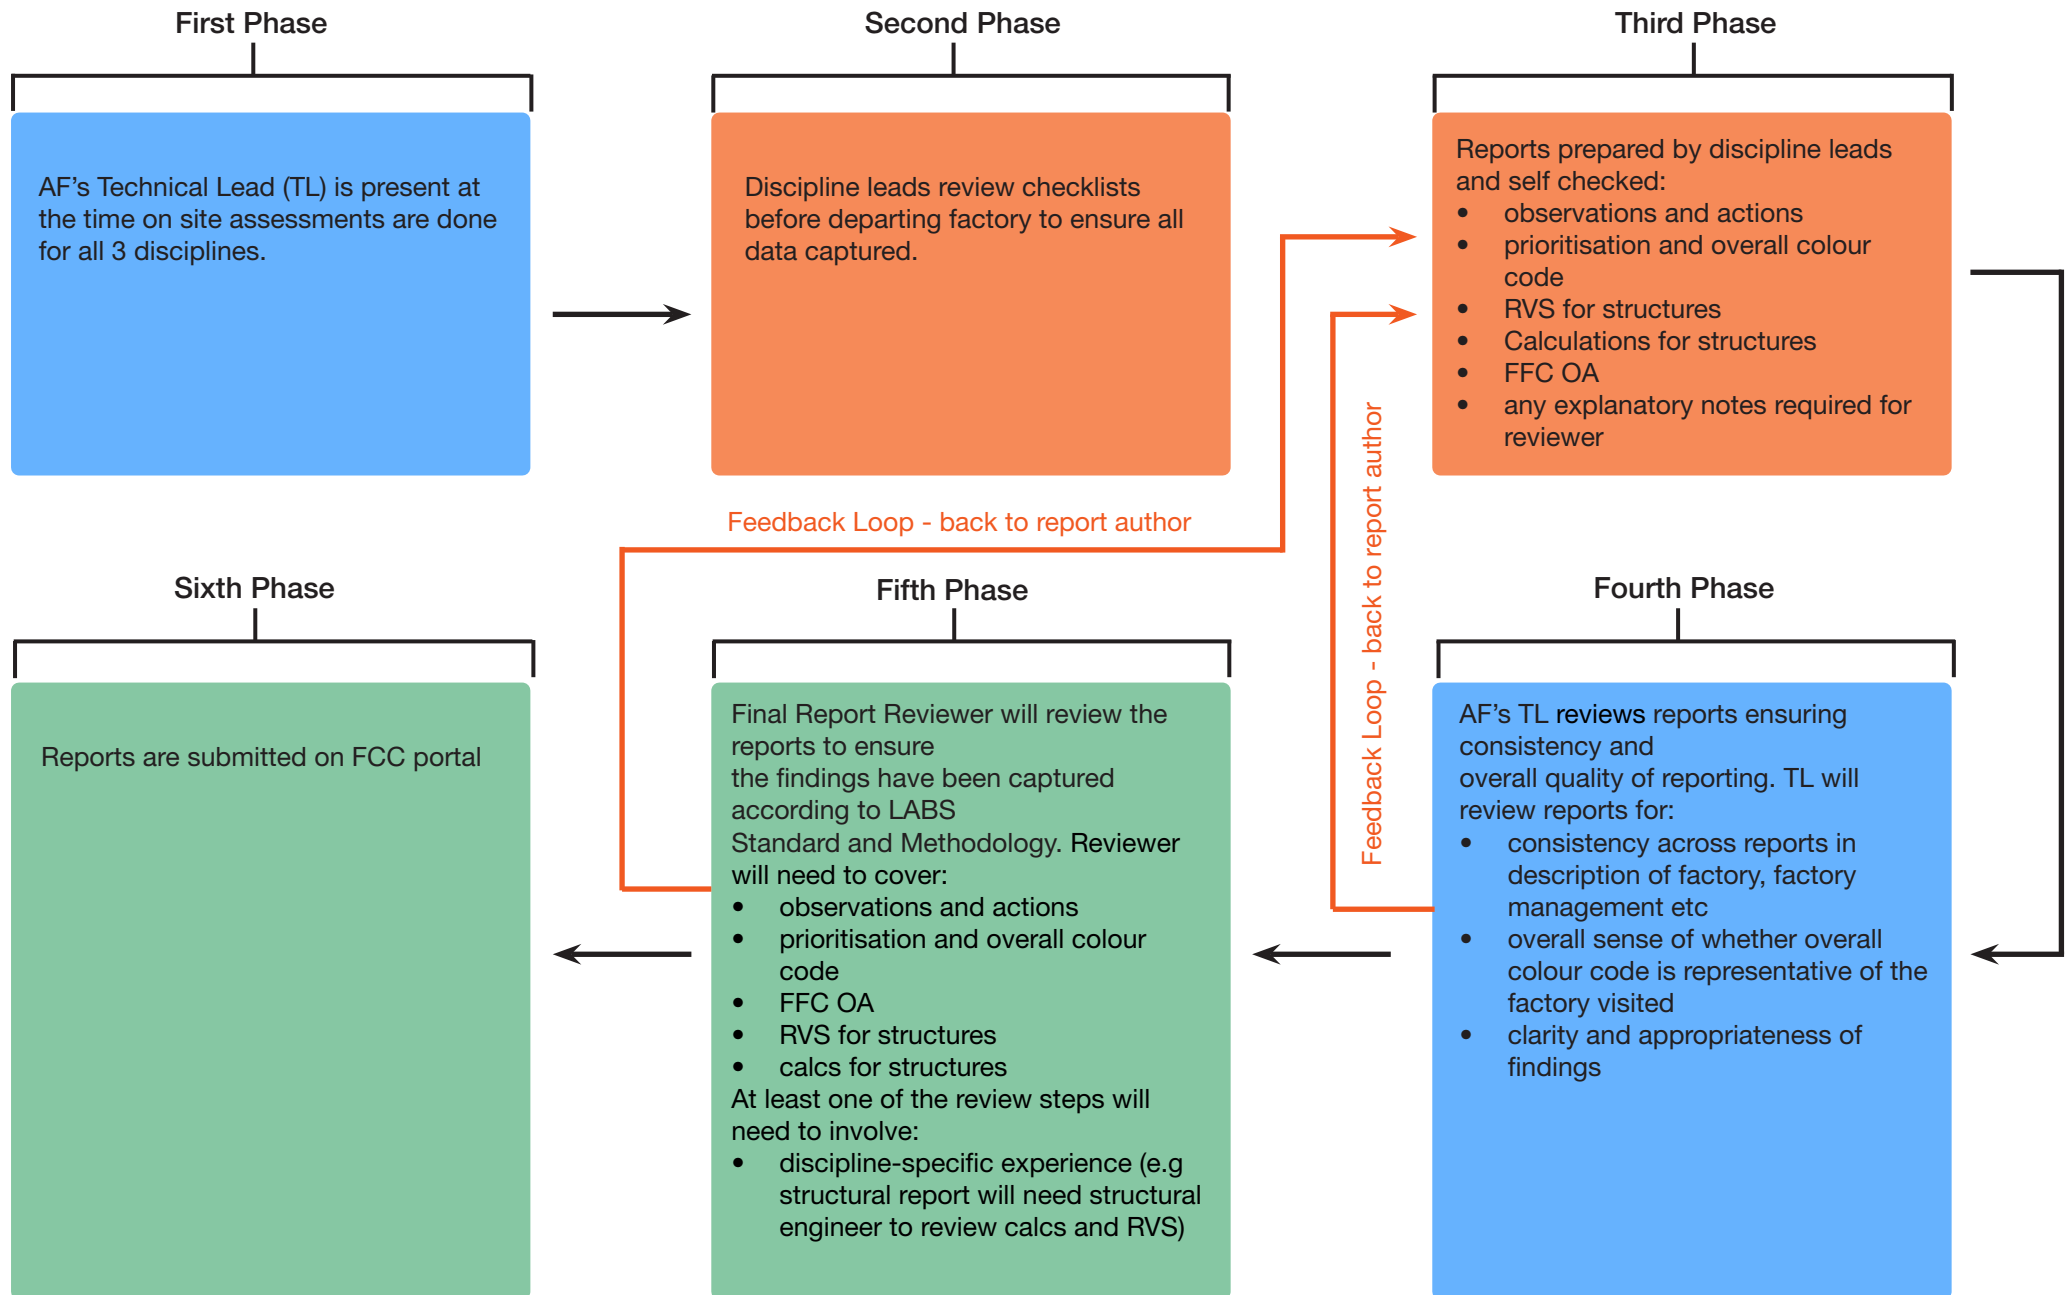
M1 Quality Control Flowchart

Quality Control by Assessment Firms (AF)
