**LABS**

**LABS - GOOD PRACTICES SHARING**

**25th Nov 2024**

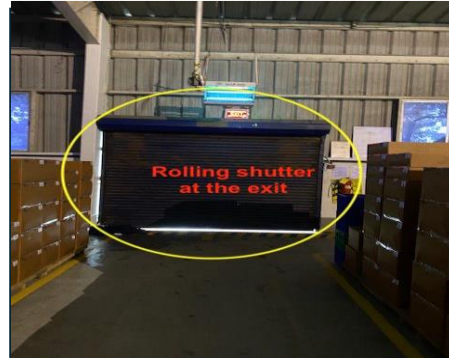
Rolling Shutter at Emergency Exit

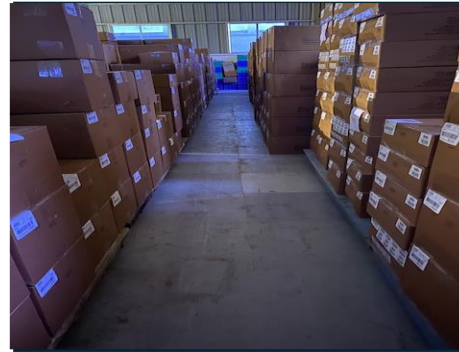
Storage Area Without Sprinkler System

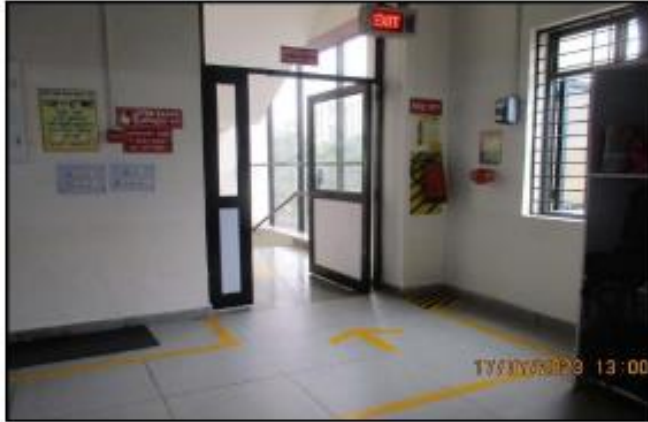
Normal Exit doors with lockable device

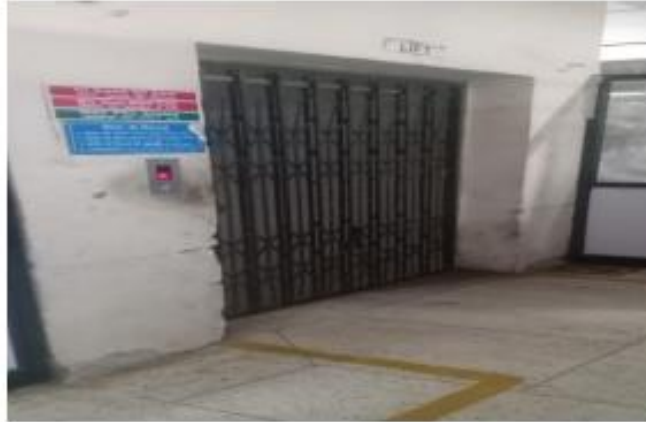
No separation of lift shaft

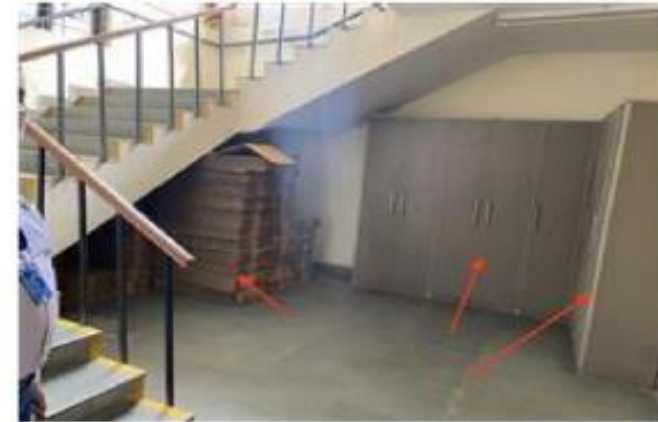
Material Storage under the staircase

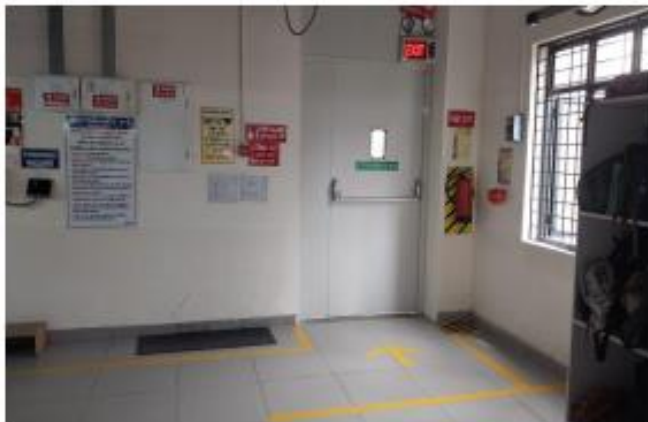
Fire rated door with push bar

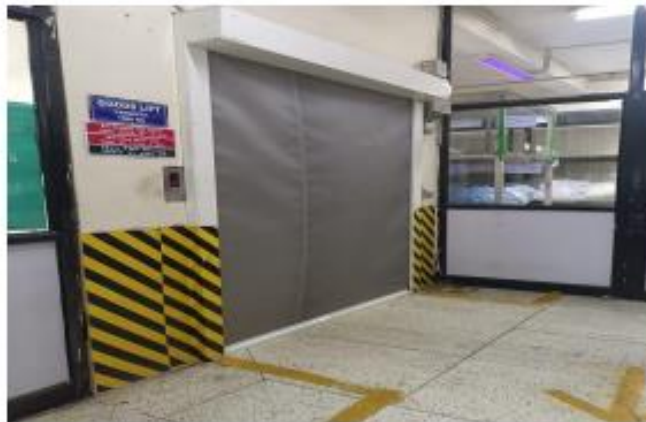
Fire curtain provided

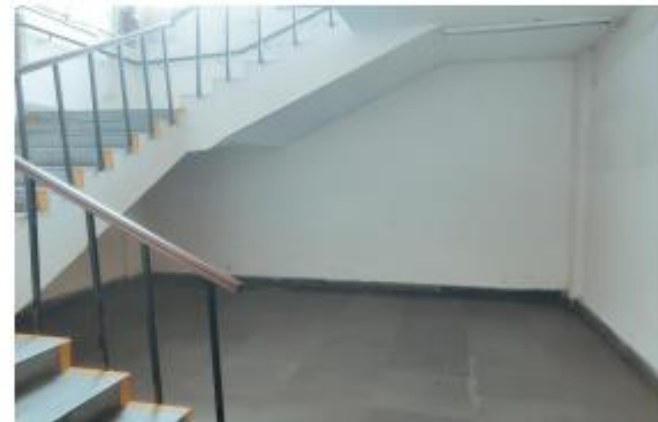
Clear staircase practices

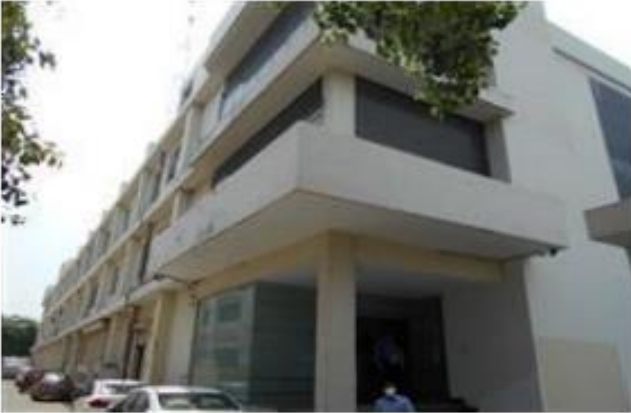
Unprotected Structural column

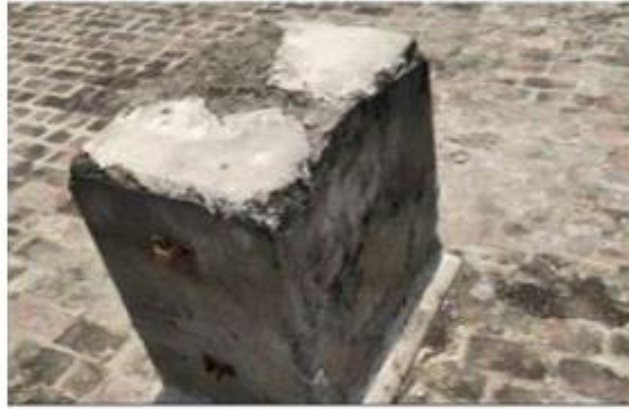
Dampness on Roof

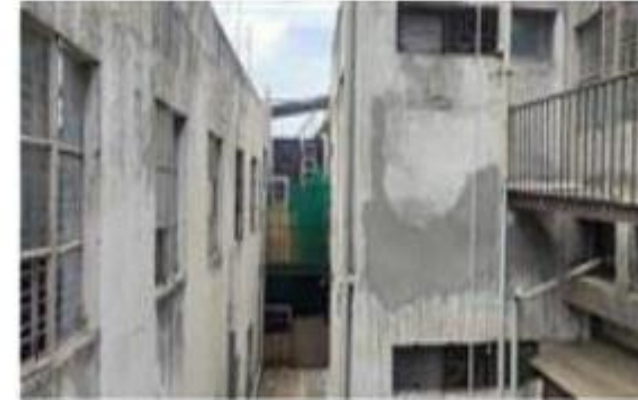
Lack of Building Maintenance

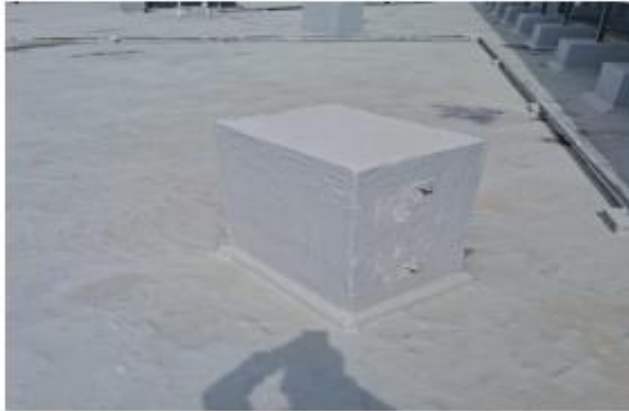
Dampness fixed with Water proofing

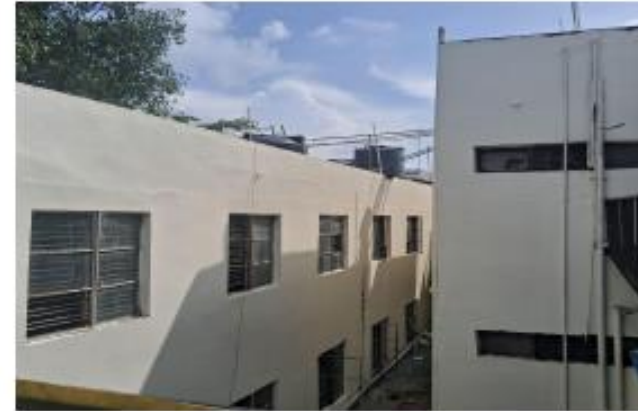
Preventive Building Maintenance

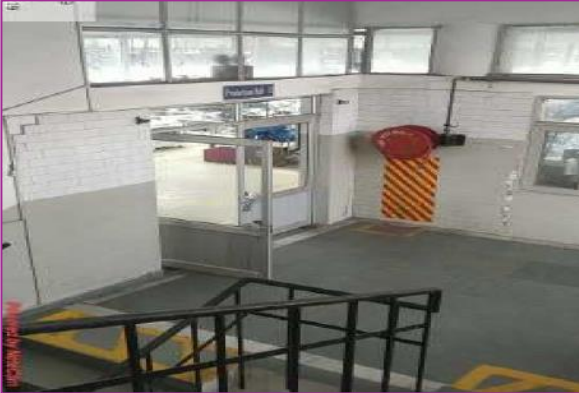
- Lack of enclosure of Stairs connecting more than 2 floors.
- Unsealed penetrations in stair enclosures

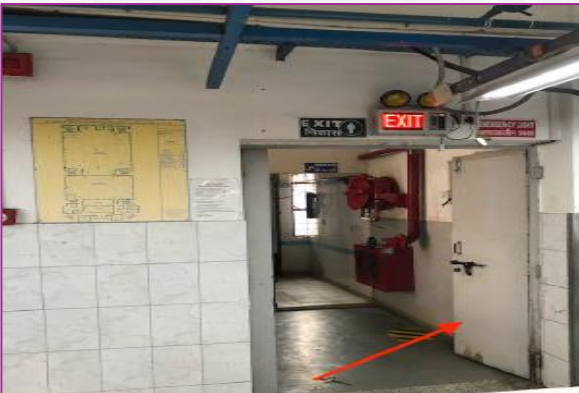
- Absence of fire-rated doors in the main exit at the production building.
- Fire-rated self-closing doors are not provided at protected staircases.
- Factory Building has more than two floors and the FR self-closing doors are not found provided on the stairs.

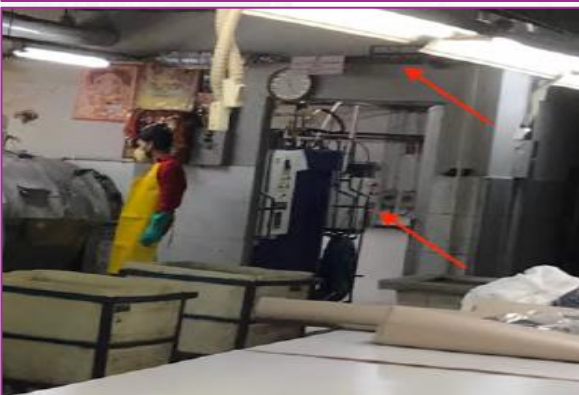
- Boilers installed on 2nd floor with washing without enclosure.
- Designated storage areas not separated by FR construction.
- Transformer room at Building 2 without FR-rated construction.

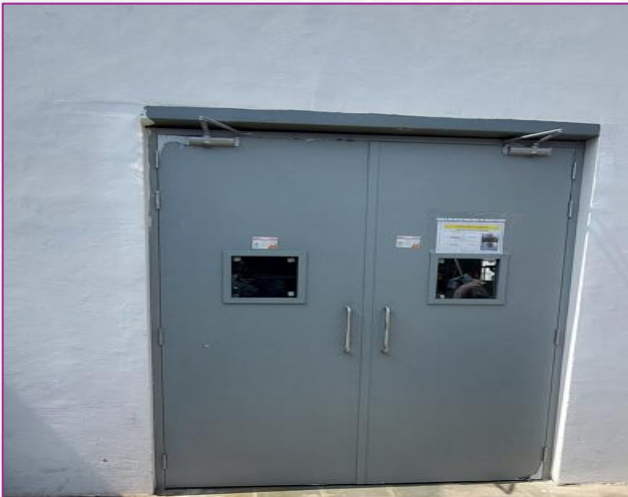
Self-closing Fire door

**Remediation-** The factory has replaced the normal doors with self-closing, fire-rated doors.

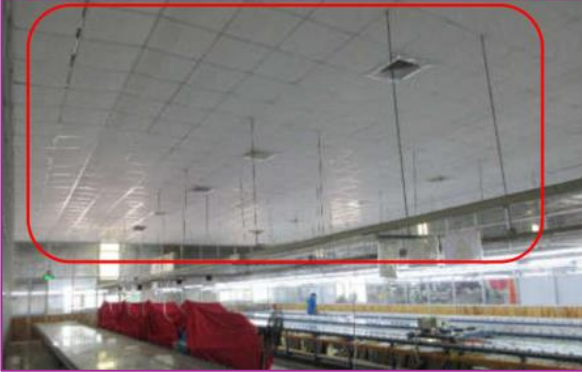
- Inadequate Fire Detector coverage.
- The provided smoke detection system is insufficient to cover the entire area of the factory.

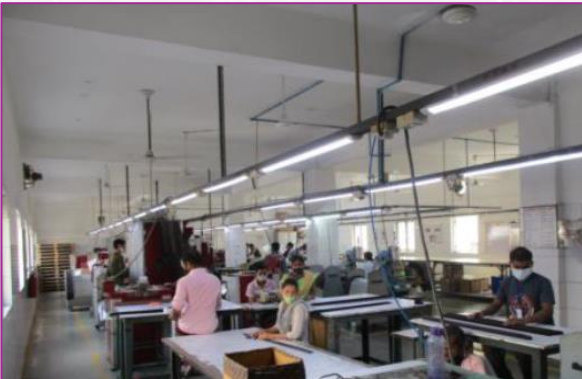
- Audible alarms with less commute observed in the basement and ground floor.
- Fire Alarm System were not installed in few locations.

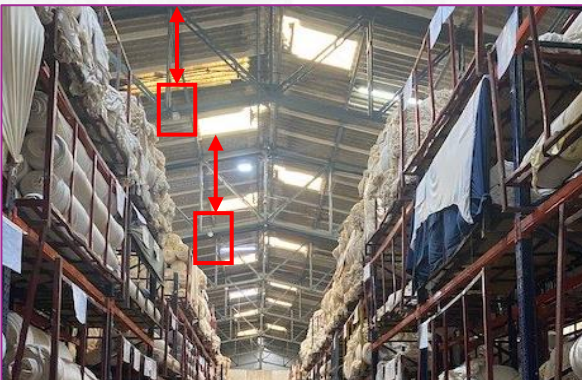
- Detectors are installed at low level from the true ceiling.
- Incorrect fire detector positioning was found at some places.

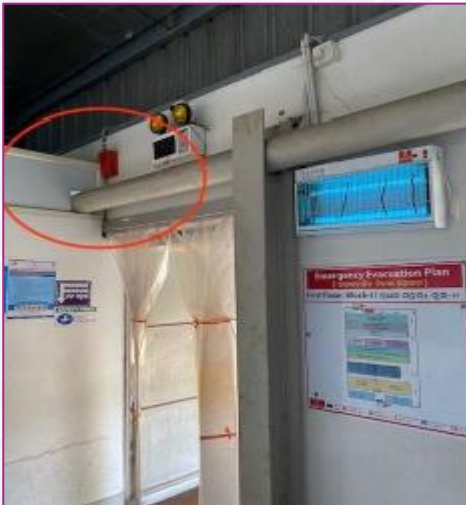
Extra hooters are added near exits

**CAP-** To improve the audibility of the fire alarm, an additional fire alarm will be installed.

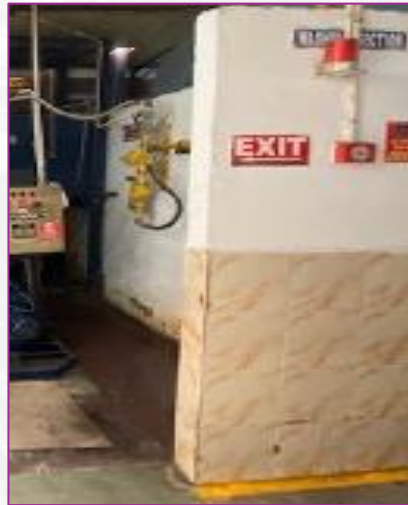
Visual hooters are added in utility area

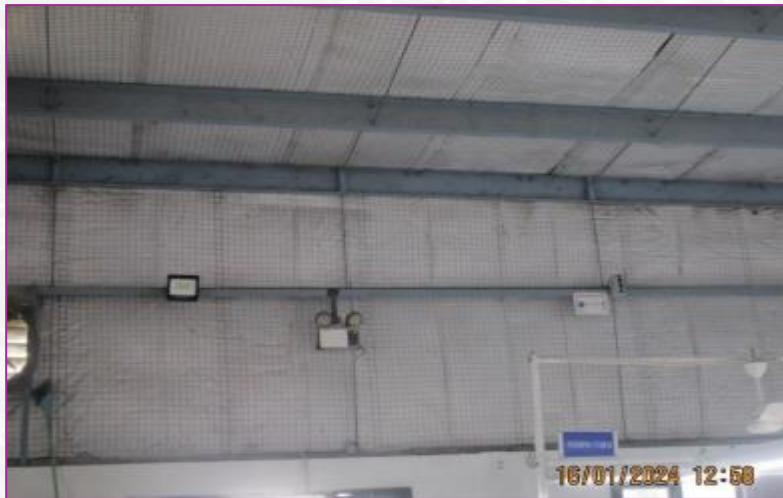
**Observation —** Smoke detector positioning was inadequate and found installed below ceiling level.

Beam type smoke detector installed for high roof

**Remediation-** The factory has installed beam type smoke detector over ceiling more than 20 feet and replaced smoke detector to the highest point of the ceiling in 14 ft ceiling.

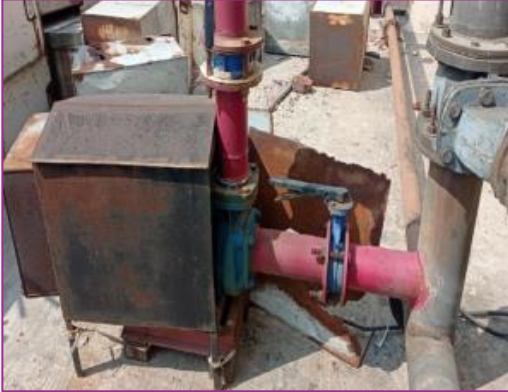
- Absence of fire pumps in the installed fire water line at the premises.
- Pump-set back-up not provided
- Only single fire pump installed for fire-fighting purpose.
- Diesel backup fire pump not provided.

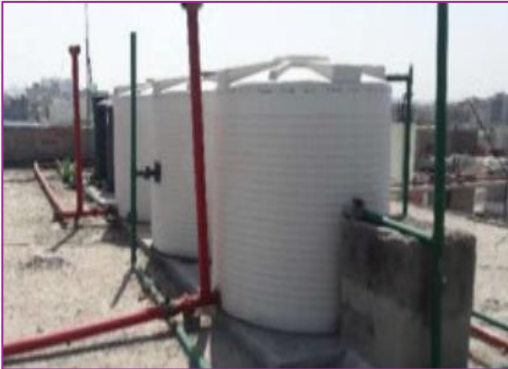
- Insufficient water storage on premises for firefighting systems.
- Only 10 KL dedicated water available for fire fighting.

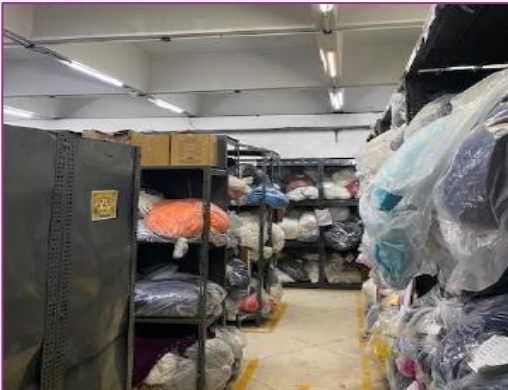
- A Non-Sprinklered storage area exists with excessive storage and is not effectively separated by FR separation with production areas.
- No fire-rated compartmentation is provided between the non-sprinklered storage area.

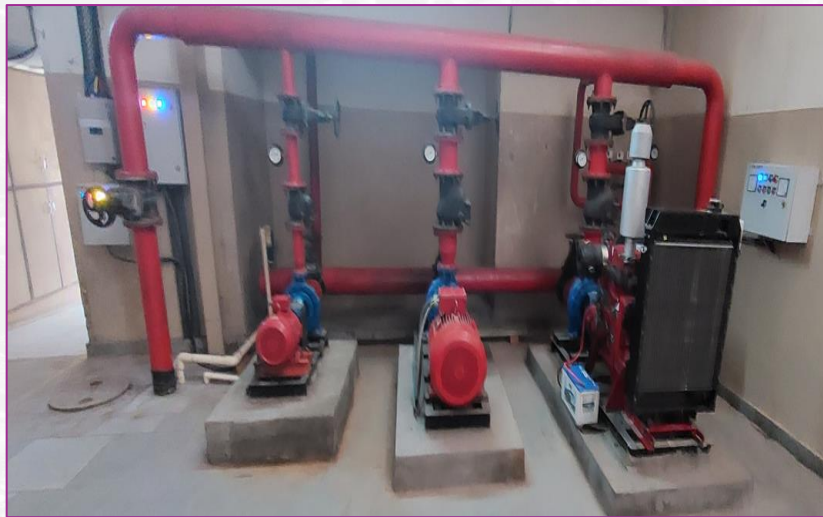
**Observation** — Only single fire pump installed for fire-fighting purpose. .

All 3 Fire pumps are installed

**Remediation-** The factory has installed 3 fire pump jockey pump, main pump and diesel powered pump in the premises.

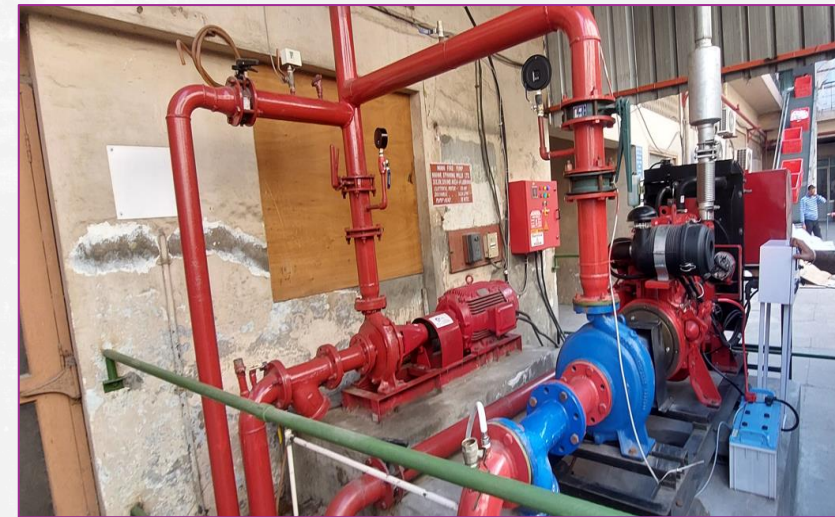
Backup Fire pumps are installed

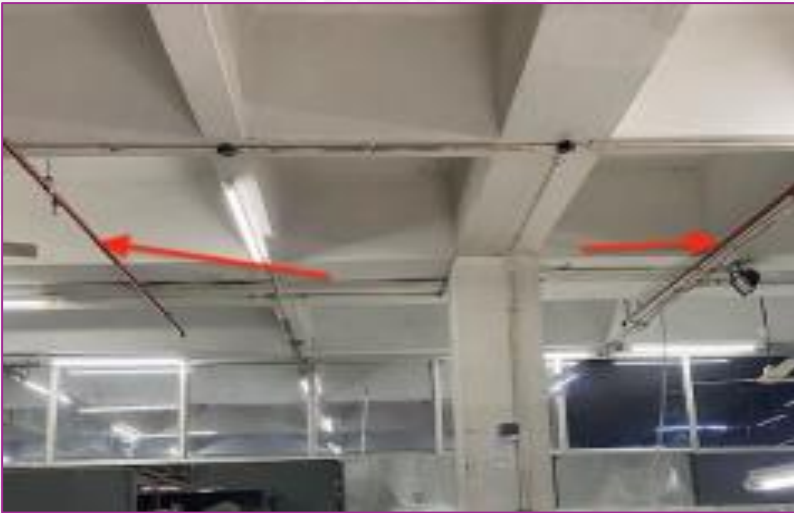
Additional water tanks installed by factory

**Remediation-** The factory has installed sprinklers in storage areas.

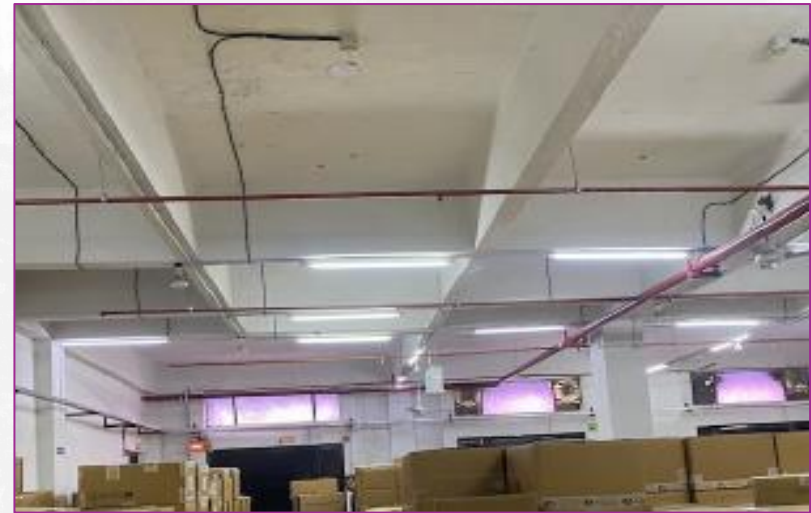
**Observation** — A Non-Sprinklered storage area exists with excessive storage and is not effectively separated by FR separation with production areas.

Sprinklers installed in material store

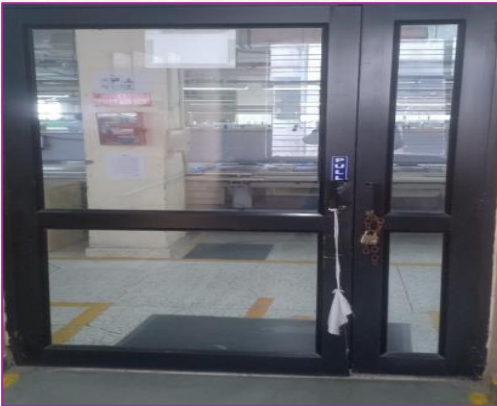
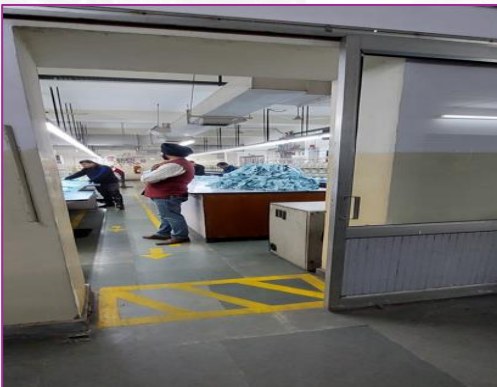
- Exit doors in the factory have locking devices /have rolling shutters with the locking mechanism.
- Exit doors not side hung to swing correctly in the direction of escape.
- Lockable device installed over exit door from outside.

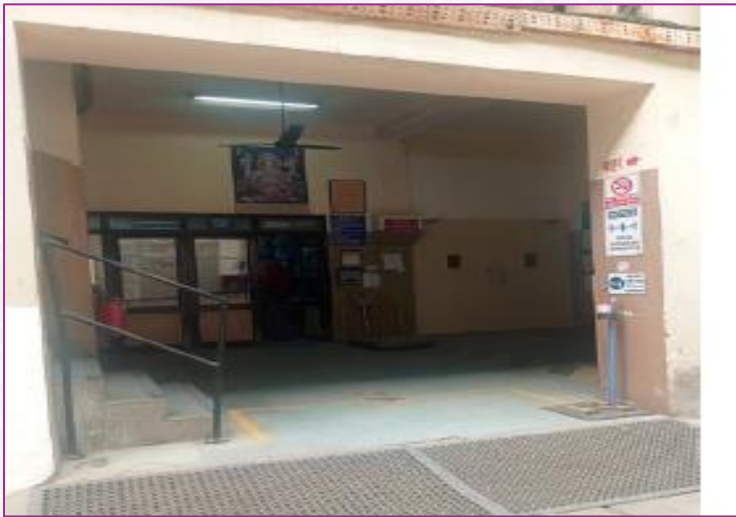
**Observation** — The factory exit door is equipped with a locking mechanism and a rolling shutter.

Rolling shutter has been removed

**Remediation-** The factory has installed Fire rated door at the final door with push bar in place of shutter or have removed shutter.

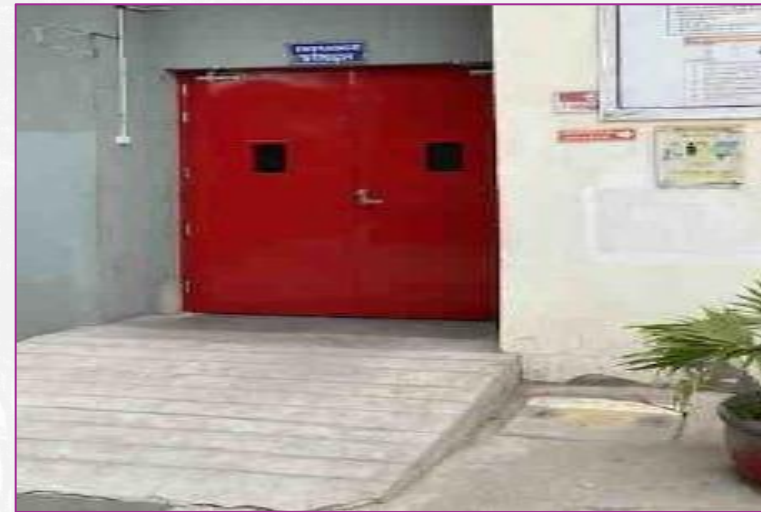
Fire door has been installed

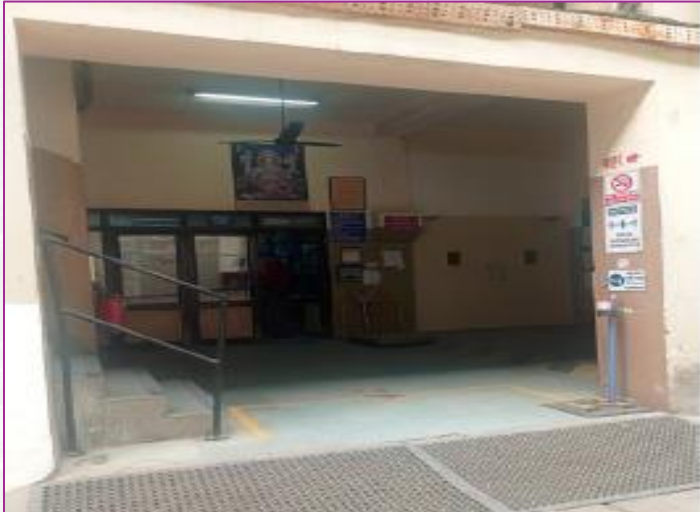
**Observation —** The factory exit door is equipped with a locking mechanism and a rolling shutter.

**Remediation-** The factory have removed shutter and kept exit open.

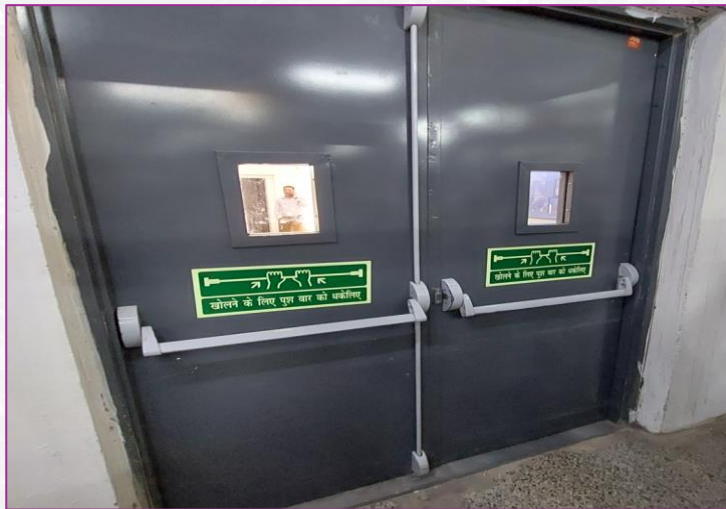
**Observation** — Lockable device installed on all exit doors from outside/inside .

Push bar has been install over doors

**Remediation-** The factory has installed a fire-rated door with a push bar or mechanism that allows for bypassing the outside lock from the inside.

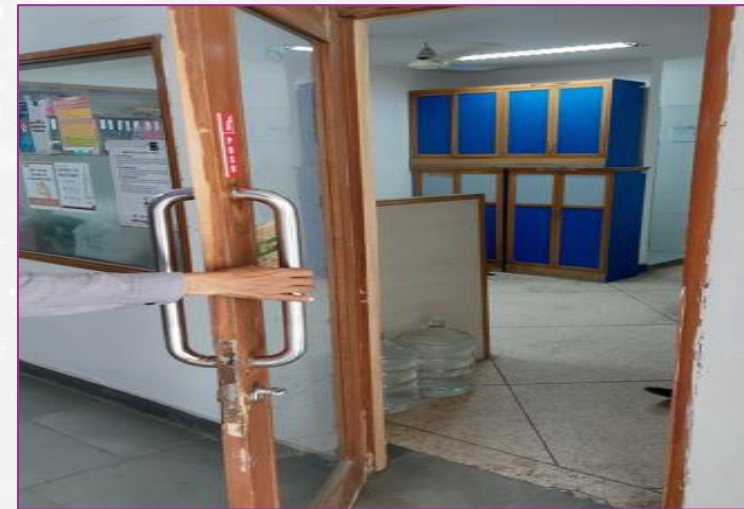
Rotating latch mechanism installed to bypass lock

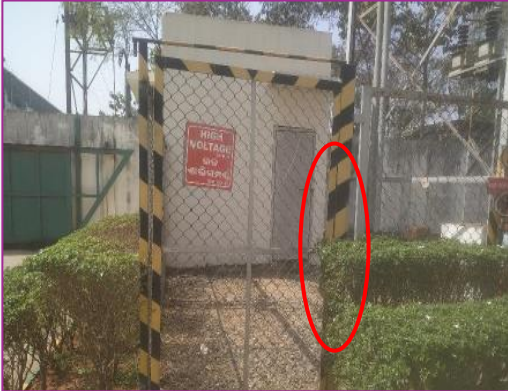
- Gate at the transformer yard is not looped with the fence for continuity of earthing
- Equipotential bonding (body earthing) to dissipate static charge not provided to Diesel day tank.

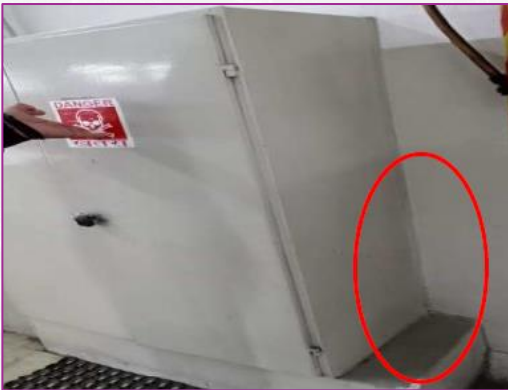
- Proper body earthing not evident in various distribution boards.
- Single body earthing provided to DG set.
- Earthing not provided to MS roof truss.

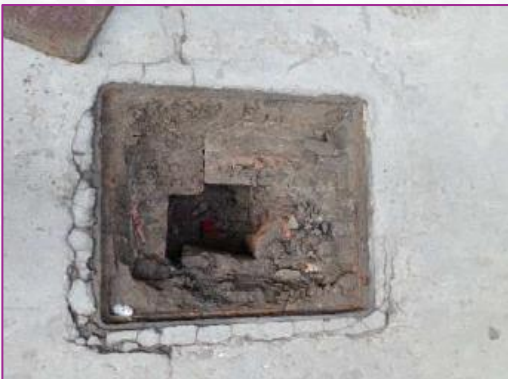
- Earth pits were found not maintained properly.
- Detail & layout plan of earth pit not available with the factory.

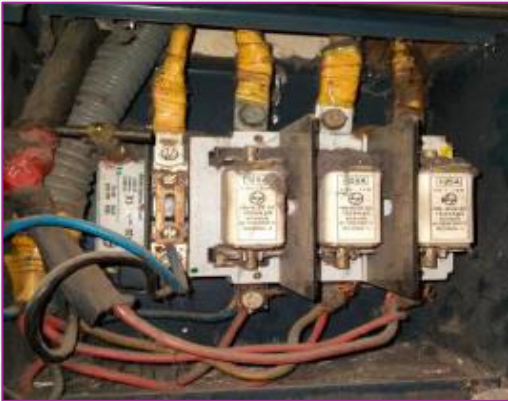
- Lint & Dust observed inside electrical panels.

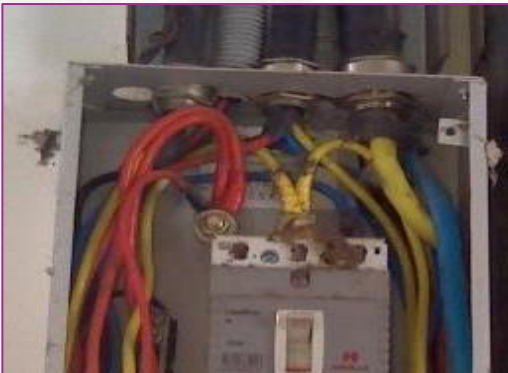
- Cables were not terminated with proper lugs and glands
- Glands were missing inside the electrical panel, allowing access for insects.

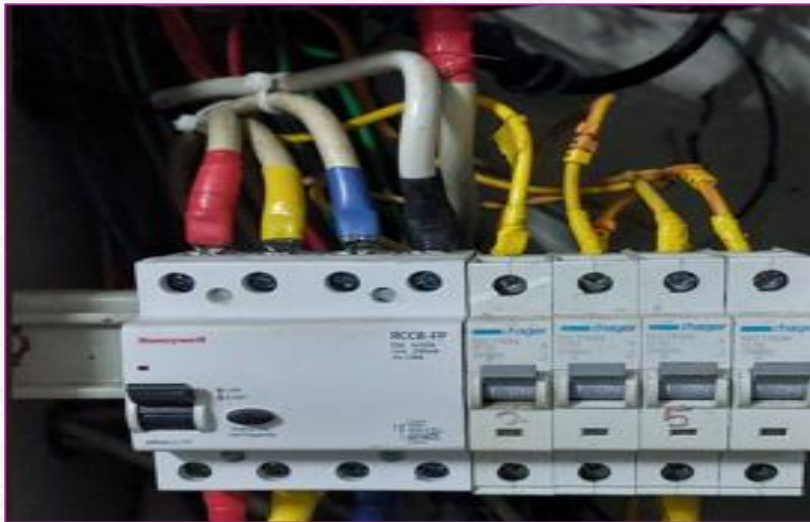
Lugs provided for electrical panel

**CAP-** Lugs and glands will be provided for electrical fitting.

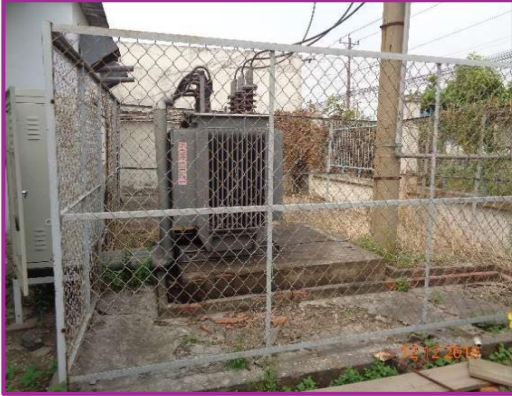
- Adequate warning/danger, voltage level signage were not posted over transformer, substation.

- Hazardous installations such as compressors, PNG skid, DG etc are found installed adjacent to the production floor or in exit route.

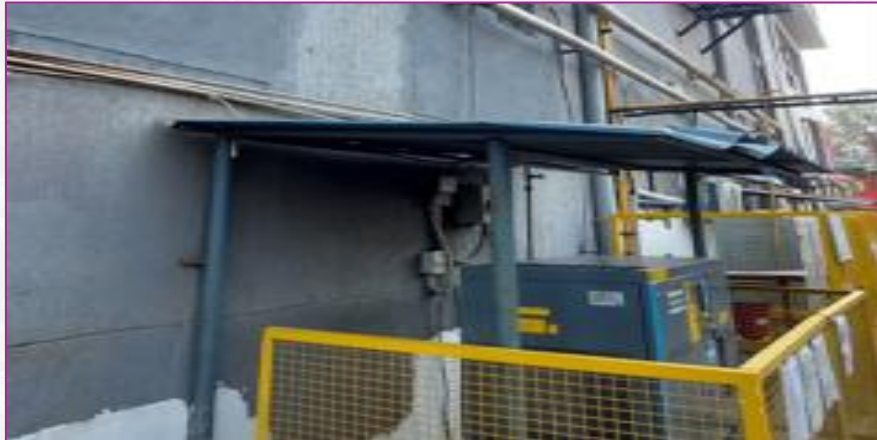
**Observation —** Hazardous installation installed adjacent to production with glass window towards production.

Window opening towards compressors has been closed

**Remediation-** The factory has provided separation between hazardous installation and production.

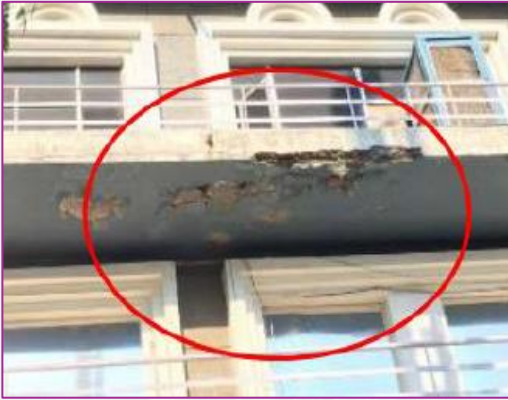
- Significant corrosion making the structural element (beams, columns, truss) etc ineffective that may lead further structural damage.

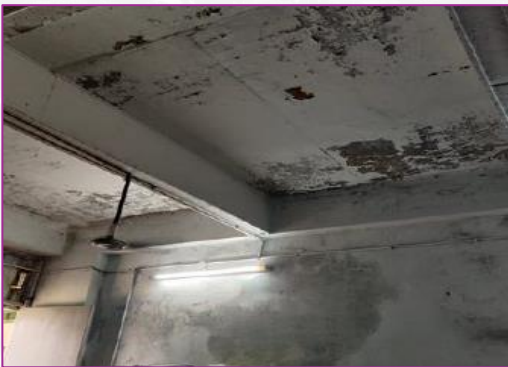
- Dampness observed over Floor Roof and walls.

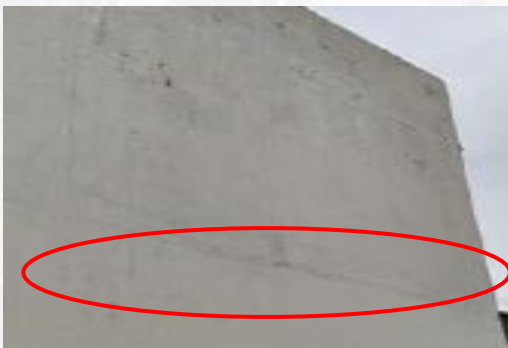
- Cracking observed over back side of building
- Cracks were observed over columns/beams

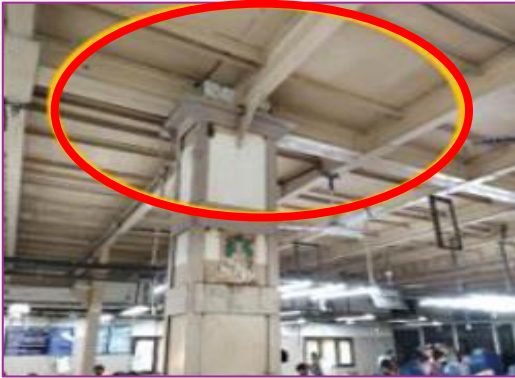
- Intermediate column stress check as jacketing work with steel angle section visible over column

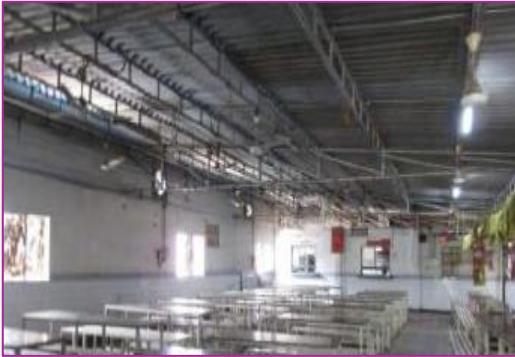
- Seismic bracings are not provided for added MS structures as lateral support structural system.

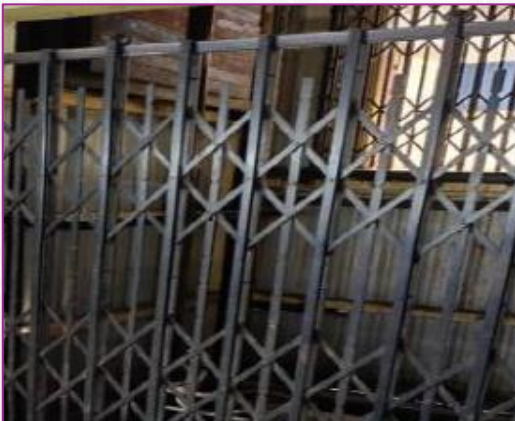
- Goods Lift Side walls & 2nd floor External walls at North, West Side found to be inadequate to resist later forces

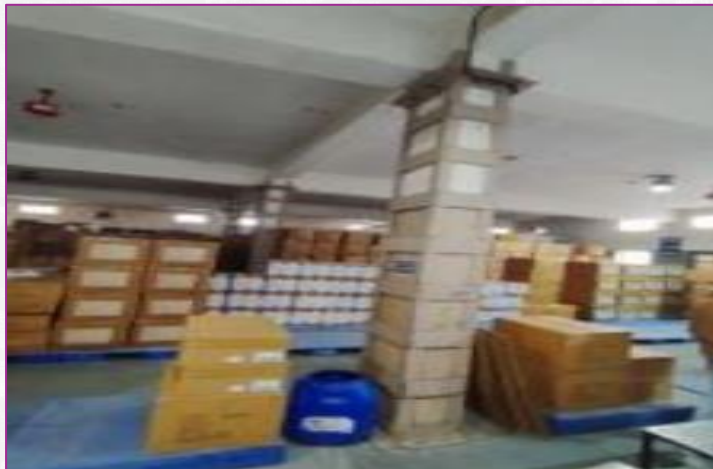
**Observation** — Intermediate column were observed stress due to overloading.

Jacketing provided for column level below

**Remediation-** The factory has assessed all column in building and provided jacketing of below column, verified through the structural engineer

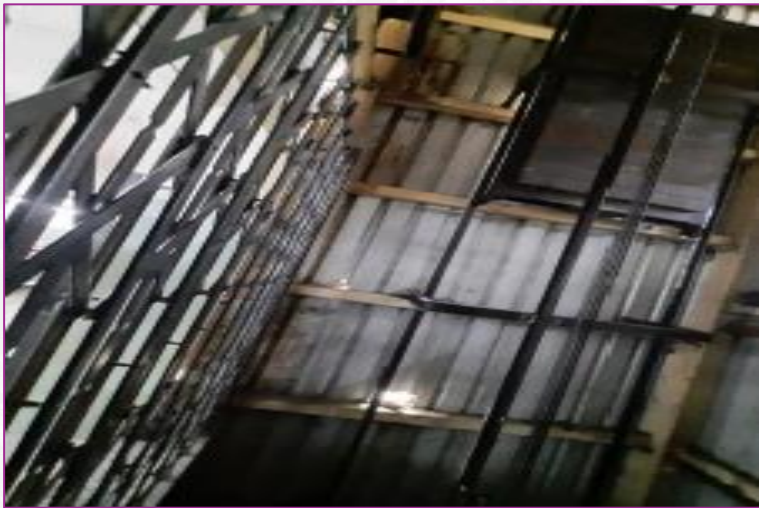
**Observation** — Goods Lift Side walls & 2nd floor External walls at North, West Side found to be inadequate to resist later forces.

Structural member has been reinforced

**Remediation-** The factory has appointed structural consultant and provided support member in lift
